<b>AIRCRAFT ACCIDENT REPORT AND EXECUTIVE SUMMARY</b>
---

<b>Reference:</b>		CA18/2/3/10051		
<b>Helicopter Registration</b>		ZU-RDX	<b>Date of Accident</b>		9 October 2021	<b>Time of Accident</b>		1150Z
<b>Type of Helicopter</b>		RotorWay Executive 162F		<b>Type of Operation</b>		Private (Part 94)		
<b>Pilot-in-command Licence Type</b>		Private Pilot Licence (H)		<b>Age</b>	65	<b>Licence Valid</b>		Yes
<b>Pilot-in-command Flying Experience</b>		<b>Total Flying Hours</b>		2 359		<b>Hours on Type</b>		158
<b>Last Point of Departure</b>		Morning Star Aerodrome, Western Cape Province						
<b>Next Point of Intended Landing</b>		Morning Star Aerodrome, Western Cape Province						
<b>Damage to Helicopter</b>		Substantial						
<b>Location of the accident site with reference to easily defined geographical points (GPS readings if possible)</b>								
Morning Star Aerodrome at GPS co-ordinates determined to be 33°45'44.37" South 018°32'54.69" East, at an elevation of 200 feet (ft)

<b>Probable Cause</b>								
It is probable that the V-belt was severed during transitioning phase which caused failure of the tail rotor, rendering the helicopter uncontrollable. Subsequently, the pilot lost

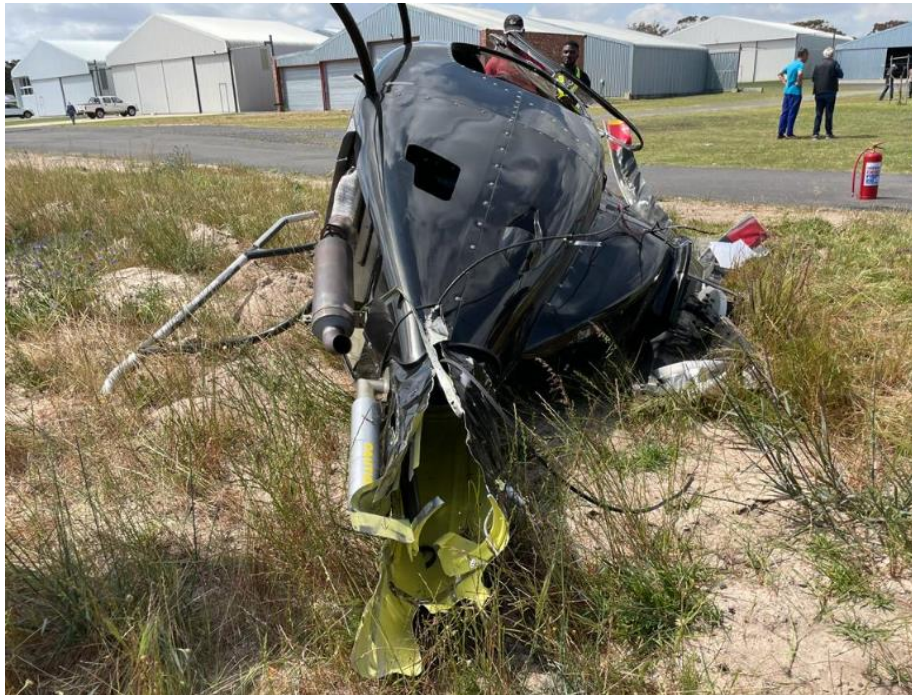
1.3.1. The helicopter sustained substantial damage.

Figure 2: The helicopter as it came to rest. (Source: Owner)

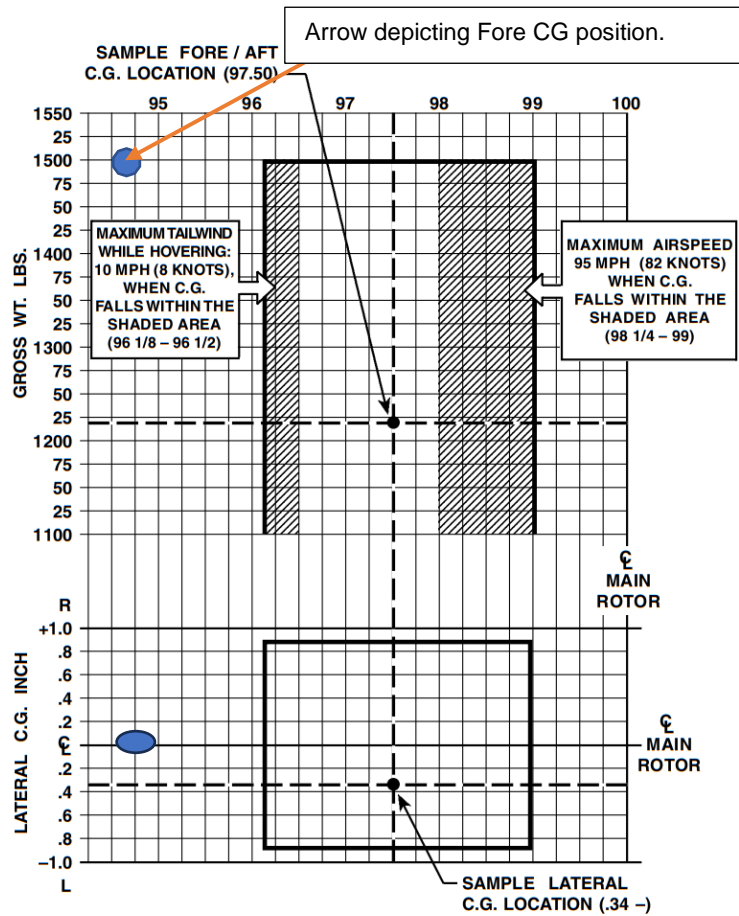
**Chart 1:** Centre of Gravity chart showing CG out of limits.

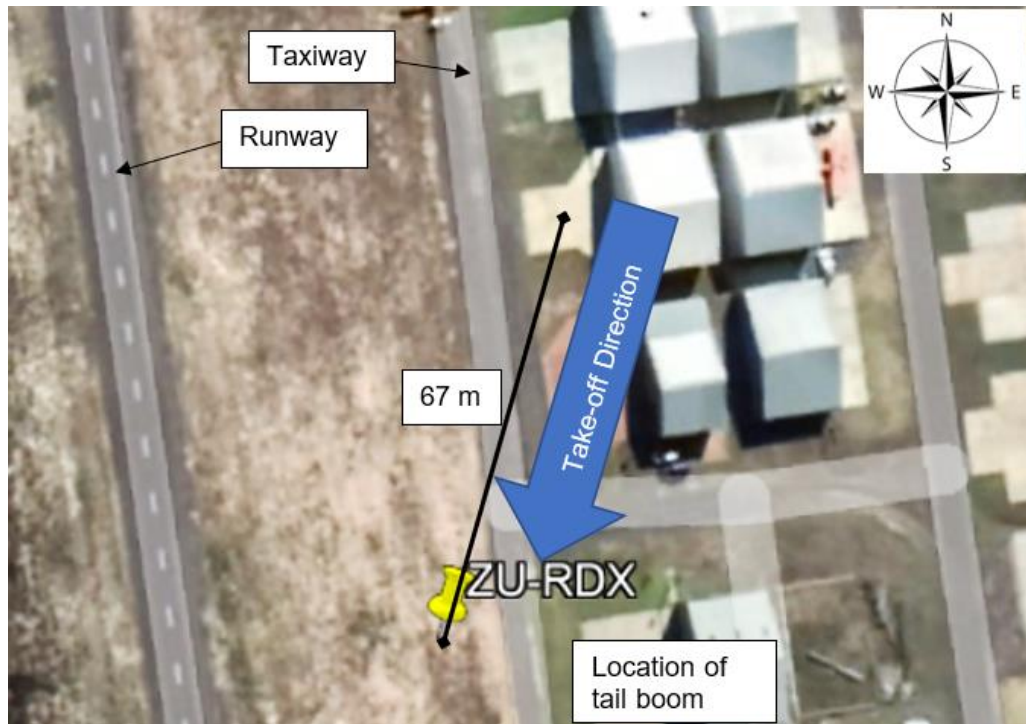
- The main wreckage was found approximately 67m from the take-off point and the tail boom was located approximately 12m east of the main wreckage.
- The helicopter landed on the soft sand between the main runway and the taxiway; it rested on its right side with the nose facing north-east.

- The structure sustained impact damage from the mid-section towards the tail section; the cabin structure remained intact.

**Figure 3:** Wreckage location and information. (Source: Google Earth)

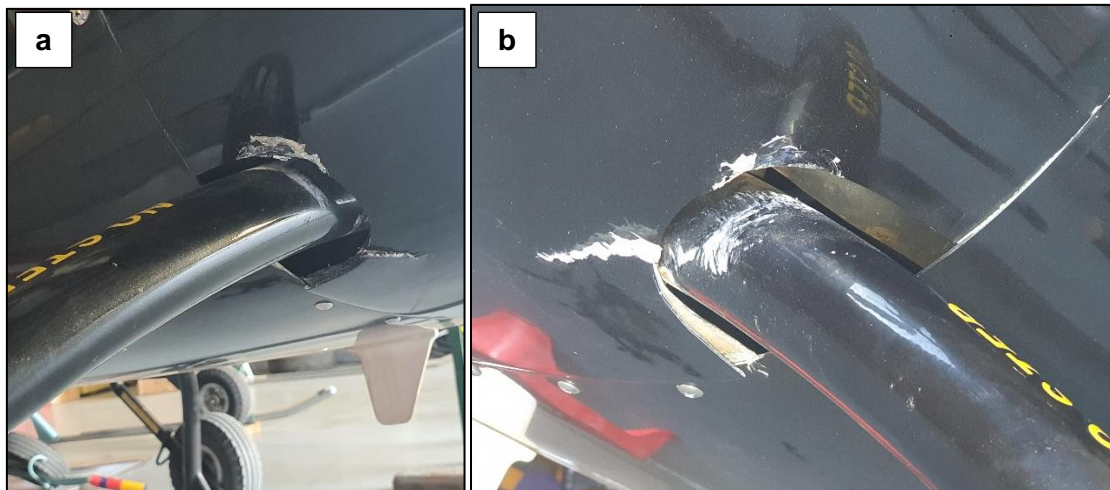
1.12.3 Examination of the helicopter's skids and fuselage indicated that the helicopter contacted the ground with its left skid first. This is an indication that the helicopter yawed to the left when the pilot lost control.

**Figure 4:** Damage on (a) right-side skid, and (b) left-side skid.

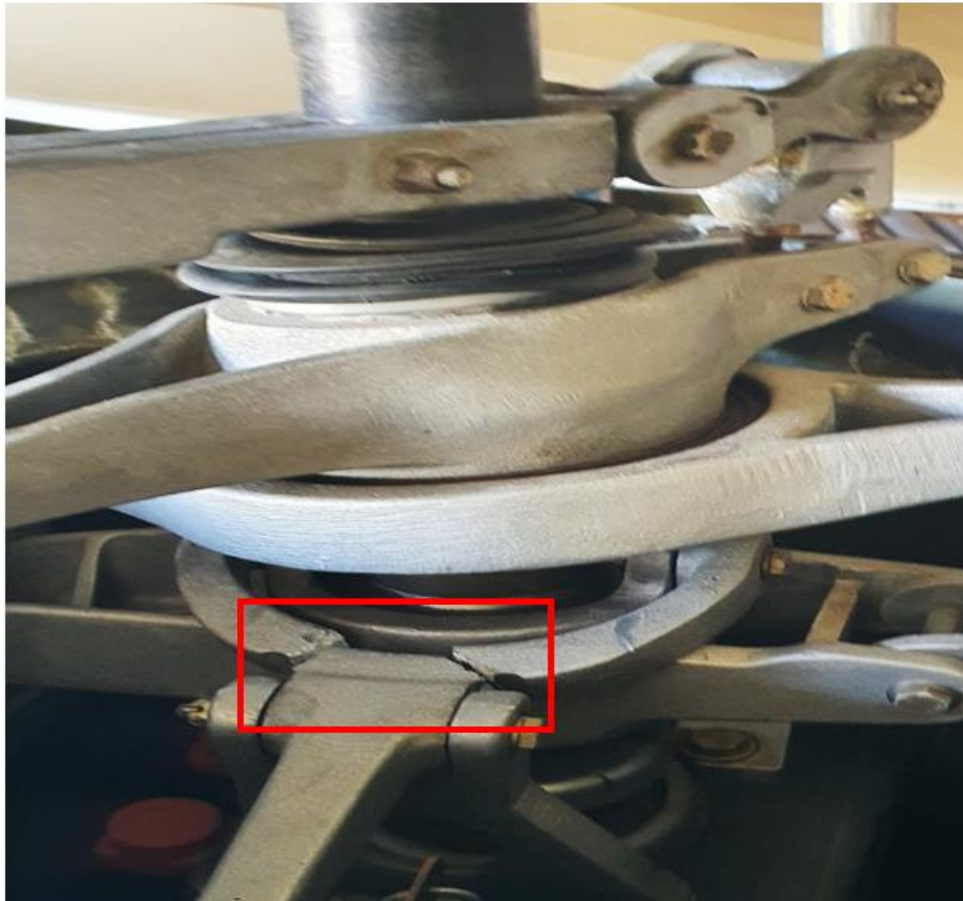
1.12.4 The collective scissor linkage casting was fractured.

**Figure 5:** The red block shows the fractured joint component of the main rotor hub's non-rotating swashplate.

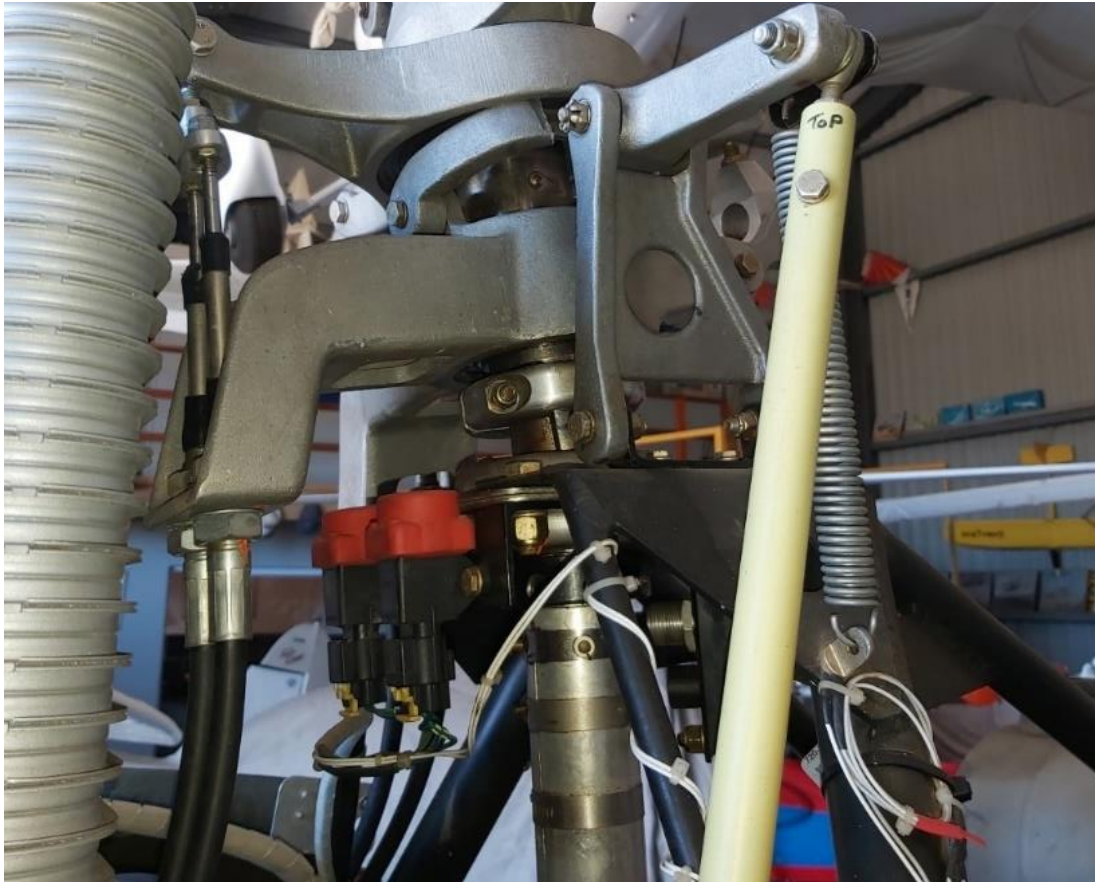
1.12.5 Both main rotor blades and the pitch links were still attached; the main rotor hub had a slight bent to the left (when viewed from the rear of the helicopter).

**Figure 6:** The linkages on the helicopter.

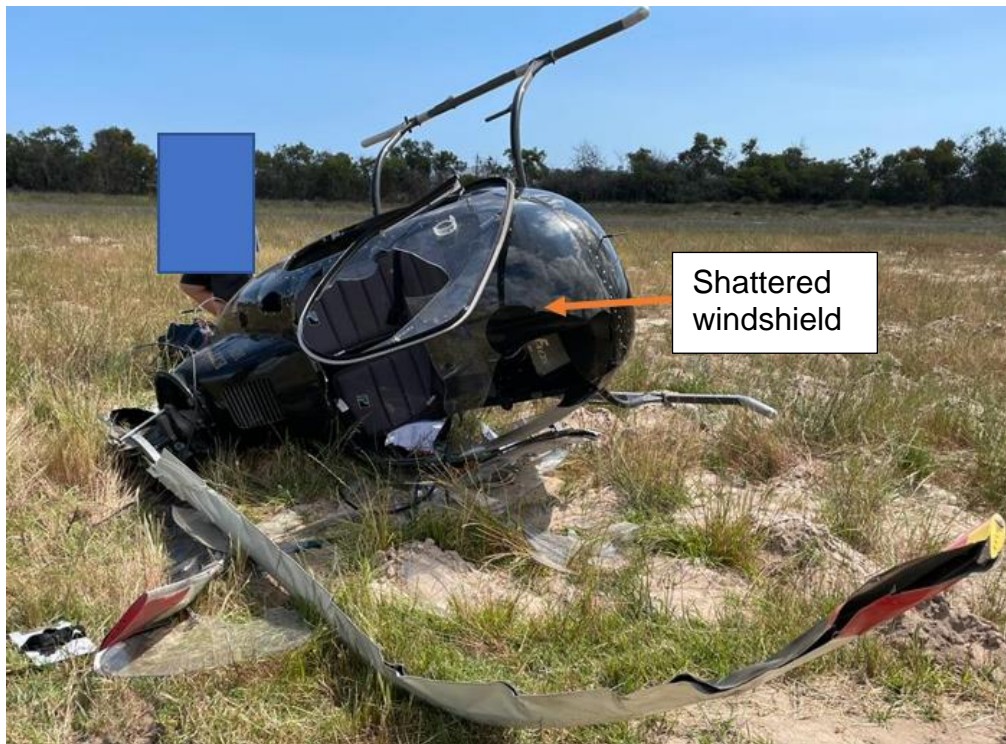
1.12.6 The windshield was found broken from the top of the cabin, which is consistent with the pilot's description of how he had kicked the windshield to exit the helicopter together with the passenger.

**Figure 7:** Final resting position of the helicopter. (Source: Pilot)

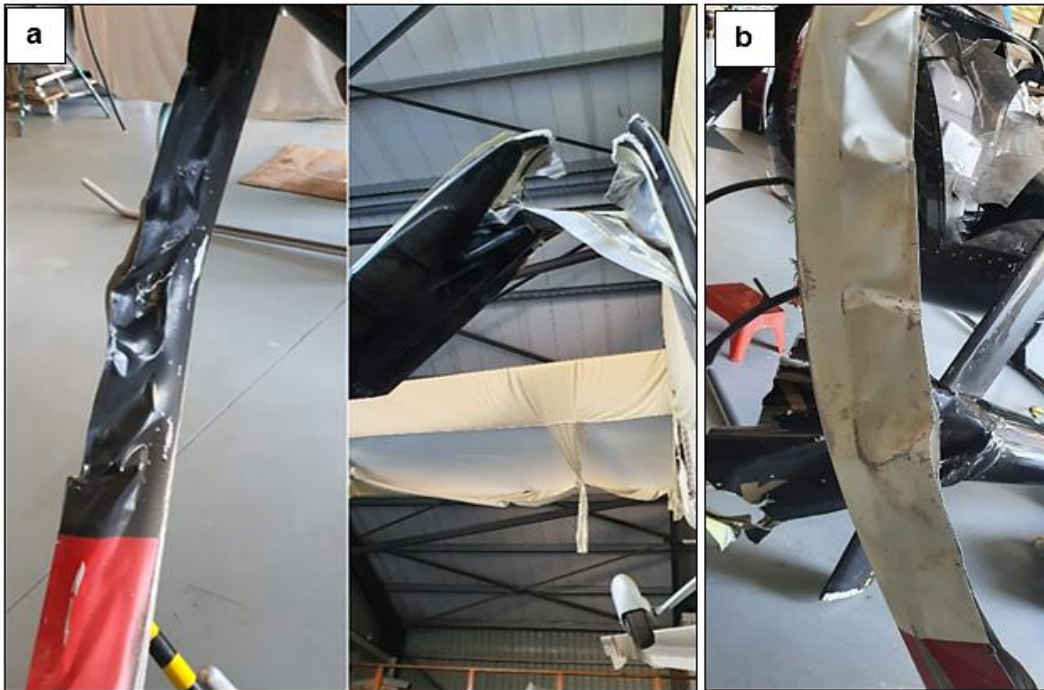
1.12.8 One of the blades broke near the root and had deformation signs in the mid-section part of the leading edge (Figure 9a). The other blade showed no distortion near the root section; however, it exhibited similar impact deformation signs on the centre of its trailing edge; this blade also had separated near its tip section of the trailing edge (Figure 9b). The deformations are indicative of metal-to-metal contact at low rotation speed, and the blade's fractures are indicative of slow separation exhibited by its tensile nature. This overload occurred when the helicopter rolled to its right side.

**Figure 8:** (a). The broken leading edge rotor blade with deformation. (b) The trailing edge deformed blade which separated at the blade tip.

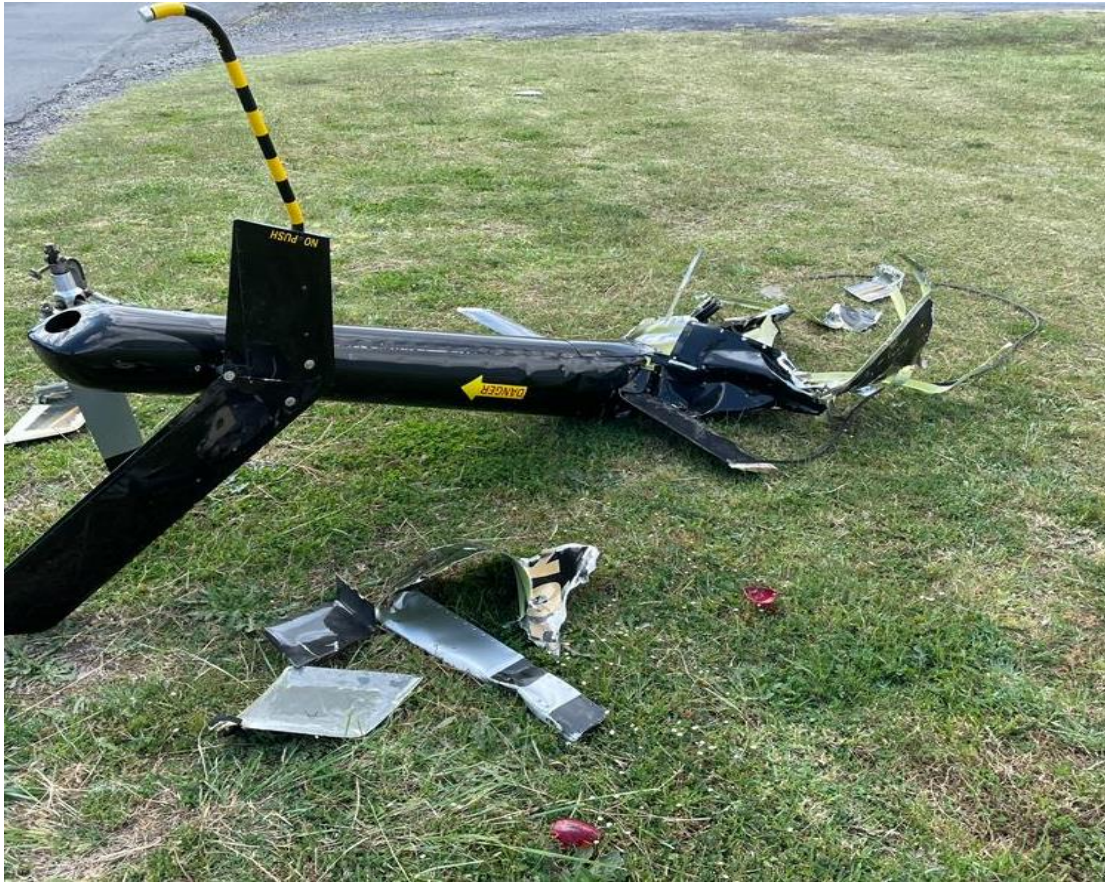
1.12.9 One of the tail rotor blades separated on impact. The tail gearbox/output shaft was found intact. Continuity check between the gearbox and the output shaft was conducted, and the drive was positive.

**Figure 9:** The tail boom after the accident. (Source: Owner/Pilot)

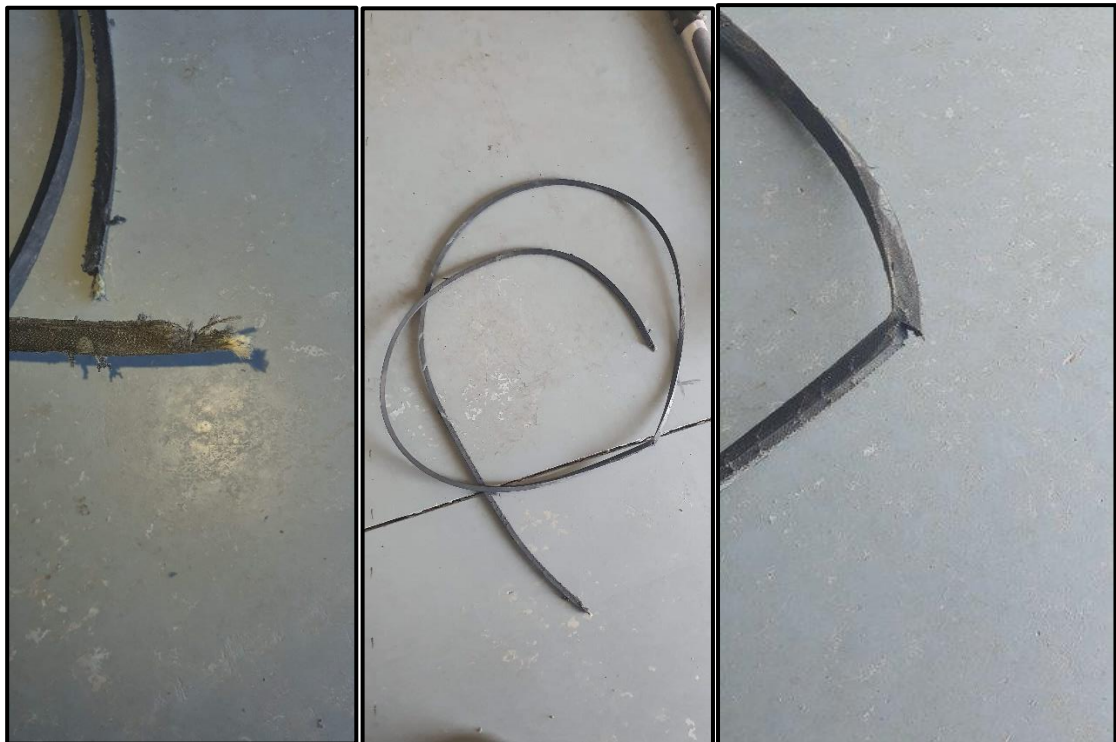
1.12.10 The drive V-belt was found next to the tail boom, torn and damaged (see Figure 11). The tail boom assembly had impact damage which was consistent with the bent main rotor hub and main rotor deformation.

**Figure 10:** The V-belt condition at the accident site post-accident.

- 2.2.12. After the accident, it was found that the tail rotor drive belt had failed and caused the loss of control during transitioning phase.
- 2.2.13. The tail rotor drive belt was recovered from the wreckage. Pictures were taken and used to determine the cause of failure. The investigation found that the tail rotor failure was not an isolated occurrence. The aircraft manufacturer had published Airworthiness Directives and Service Bulletins to inform operators of the potential tail rotor dangers.

- 2.2.14. One particular Service Bulletin referred to the failure of tail rotor drive belts (part numbers E18-1150 and E18-1160) manufactured by Gates. The investigation into the belts industry revealed that Gates had changed its manufacturing facilities and processes and that users of Gates belts in other applications have also experienced premature belt wear and failure. Based on the findings of the manufacturer's investigation, it was recommended that these belts should not be used as they fail before they reach their time limit of 250 hours.

- 2.2.15. It was found that the accident aircraft still had the Gates belts installed. The Service Bulletin had, therefore, not been complied with. The result was as stated by the manufacturer: "Loss of tail rotor most likely resulted in significant aircraft damage".

4.1.2 It is recommended that the aircraft manufacturer provides training to registered owners and operators to appropriately make use of the tail rotor drive belt tension testing equipment and effective visual inspection techniques so that they are equipped with the necessary skills to identify potential problems with the tail rotor transmission system.
