AIRCRAFT ACCIDENT REPORT AND EXECUTIVE SUMMARY

Reference:		CA18/2/3/10062	
Aircraft Registration	ZS-PMT	Date of Accident	30 October 2021		Time of Accident	0800Z	
Type of Aircraft	Cessna 182P			Type of Operation	Private (Part 91)		
Pilot-in-command Licence Type	Private Pilot Licence (PPL)		Age	32	Licence Valid	Yes	
Pilot-in-command Flying Experience	Total Flying Hours		125.6	Hours on Type	52.8		
Last Point of Departure	Lanseria International Airport (FALA), Gauteng Province						
Next Point of Intended Landing	Rand Airport (FAGM), Gauteng Province						
Damage to Aircraft	Destroyed						
Location of the accident site with reference to easily defined geographical points (GPS readings if possible)							
Approximately 1.2 nautical miles (nm) west of FAGM at the following GPS co-ordinates: S 26° 14' 44.8" E 28° 07' 04.7", at an elevation of 5 139ft							
Meteorological Information	Surface wind 260°, 11 knots; Temperature: 20°C; Dew point: 09°C; CAVOK; QNH: 1021hPa

Probable Cause

The throttle cable separated from the throttle lever control in-flight because of the missing cotter pin on the castellated nut, which caused the engine to run at idle. The pilot was unable to maintain the

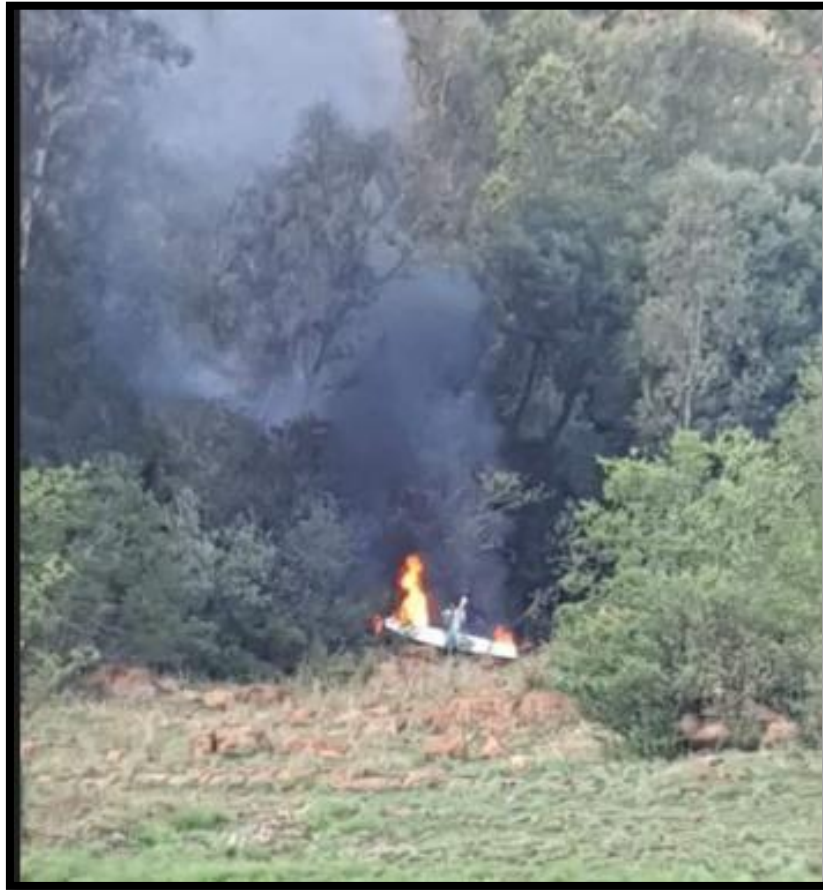
1.3.1. The aircraft was destroyed by post-impact fire.

Figure 2: ZS-PMT engulfed in flames immediately after coming to a stop. (Source: Facebook)

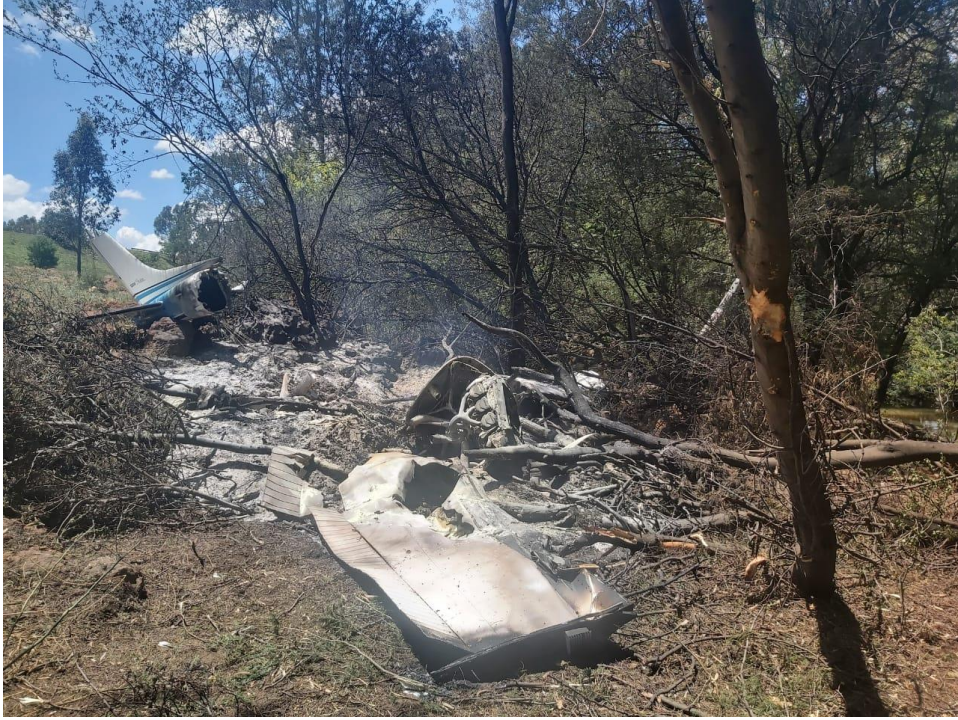
Figure 5: The aircraft burned beyond recognition. (Source: University of Pretoria)

1.12.4 The fire consumed most of the aircraft except for the engine, both outboard wings and the tail section of the empennage. The aircraft came to a stop facing south.

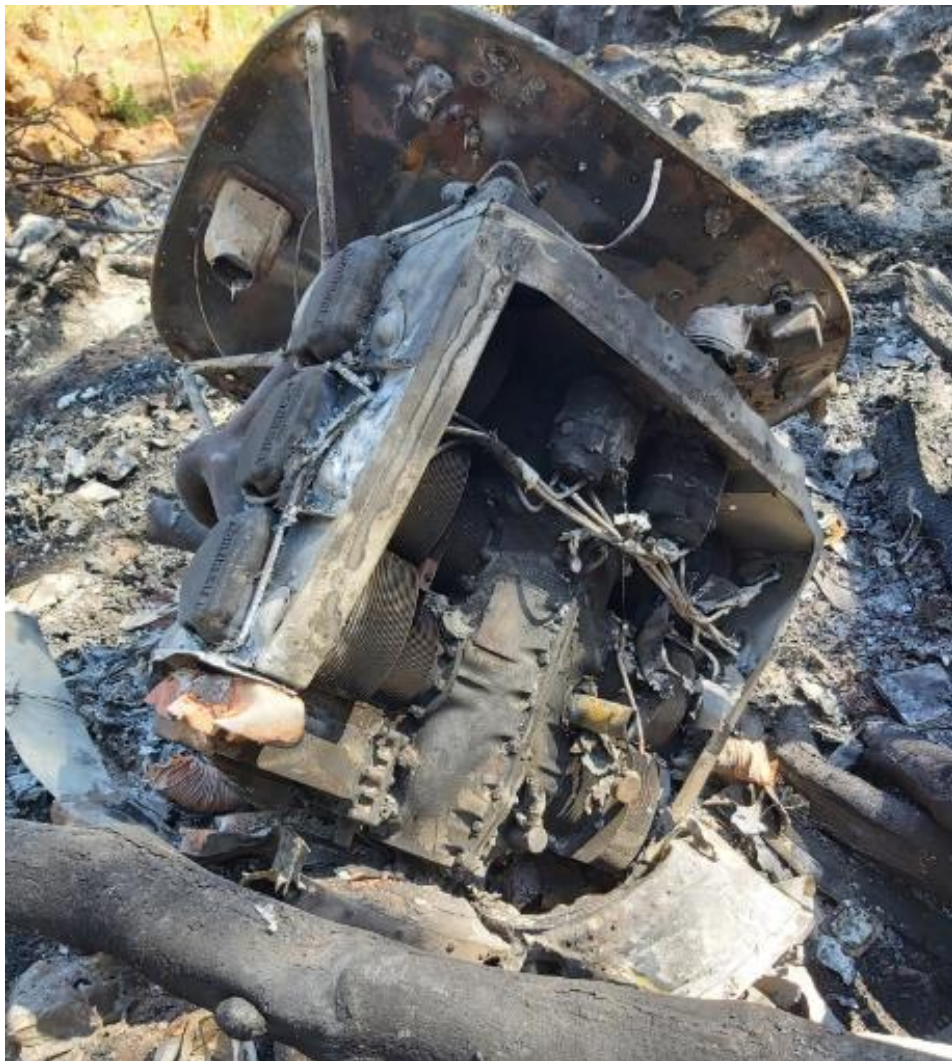
- 1.12.3 The engine was still attached to the cradle. The extension leads were scorched. Both propeller blades suffered impact damage and were still attached to the flange. Both blade tips were showing signs of damage consistent with low revolutions per minute (RPM) on impact. The engine turned satisfactorily when it was rotated by hand. It was noted that the throttle cable had detached from the attachment point where it connects to the lever (see Figure 7). The position of the lever indicated an engine in idle position as found at the accident site.

Figure 6: The engine and propeller blades post-accident. (Source: University of Pretoria)

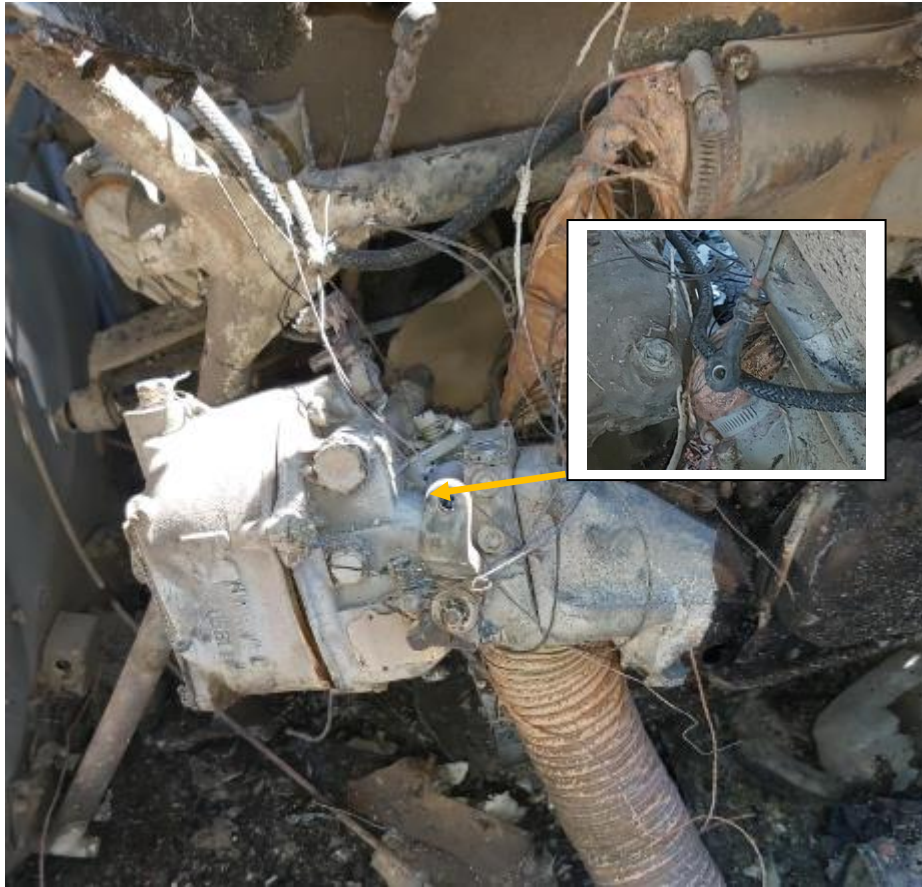
Figure 7: The separated cabrettor throttle control lever and (inset) throttle control cable.
(Source: University of Pretoria)

1.16.1. During the recovery stage, one of the technicians found that the carburettor throttle control lever had separated from the throttle control cable. The search for the attaching bolt and castellated nut proved unfruitful. The remaining eye end of the throttle cable was sent for testing analysis in a laboratory to determine the mode of failure.

- 3.2.9. The status report indicated that the carburettor was due for overhaul on 8 February 2026.
- 3.2.10. It was found that the throttle cable had separated from the throttle lever and only the eye end of the cable was found; it was then sent for testing and analysis. The bolt, castellated nut and the split pin were not recovered.

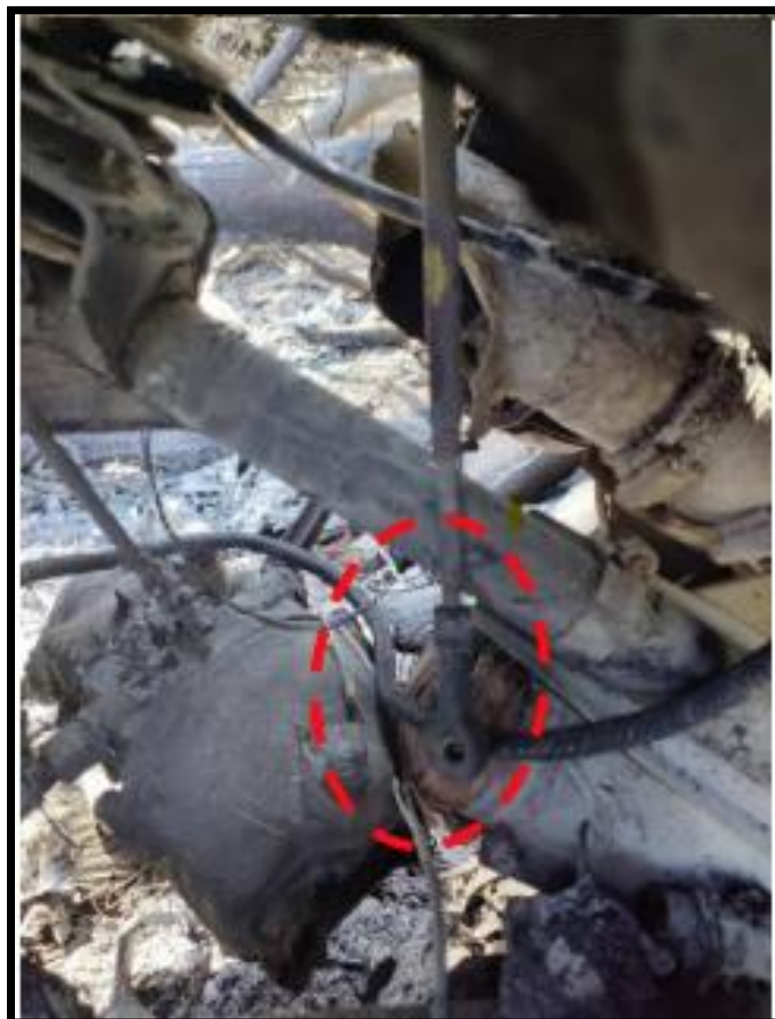
1.16.2. *Throttle Cable Assembly (Part no 565-549-031; no serial) The visual inspection revealed extensive post-impact fire damages to the throttle cable assembly (Photo 2).*

Figure 8: Throttle cable as found at the accident site. (Source: University of Pretoria)

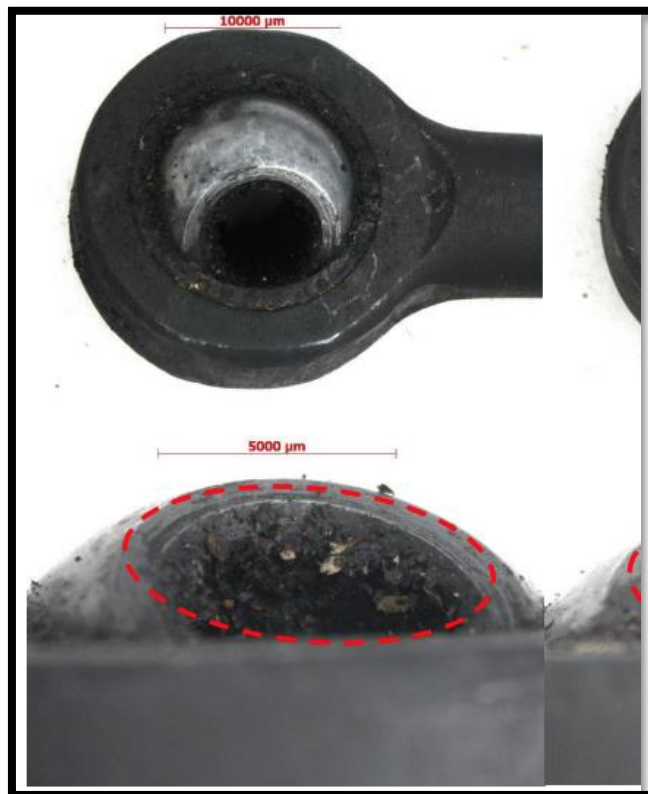
1.16.3. *The bending damage corresponded with the support bracket- and fire-wall positions when fitted. The inner area of the throttle cable ball-eye end revealed extensive build-up of foreign material.*

Figure 10: Ball-eye end and affected cable. (Source: University of Pretoria)

1.16.4. *At higher magnifications the foreign material particulate morphologies conformed to high temperature generated metallic residue and remnants of burnt-out oil and/or fuel. The EDS MAP analysis revealed the foreign particles compositions to conform to Iron-oxides (Fe, O)*

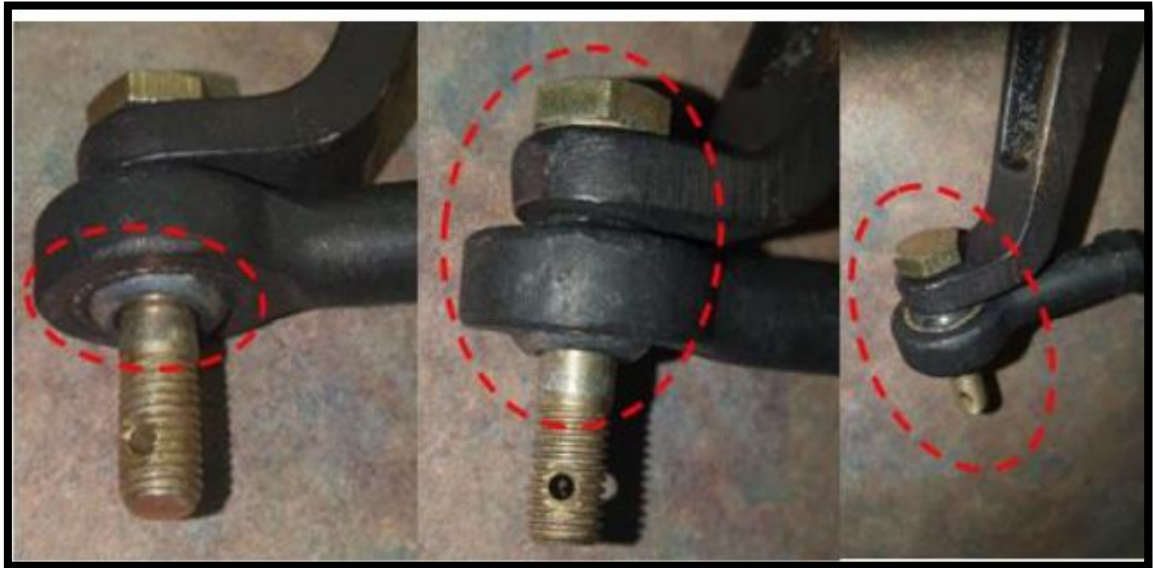
Figure 11: Simulated attachment bolt. (Source: University of Pretoria)

1.16.6. A new attachment bolt was fitted to the assembly to simulate an assembled unit for reference purposes (Figure 10). The noted close tolerances (Figure 11, red dashed circles) between the bolt outer surface and both the carburettor control arm and the throttle cable ball-eye end, support the notion that the level of foreign particles ingestion at these areas as noted would be highly unlikely with the bolt/nut/washers/cotter-pin fitted in position. It may therefore be concluded that the bolt/nut/washers/cotter-pin assembly was not in the depicted position at the time of the initiation of, and during, the post-impact fire
