**AIRCRAFT ACCIDENT REPORT AND EXECUTIVE SUMMARY**

<b>Reference:</b>		CA18/2/3/10064	
<b>Helicopter Registration</b>		ZS-HDX	<b>Date of Accident</b>		2 November 2021	<b>Time of Accident</b>	1012Z
<b>Type of Helicopter</b>		Bell 206L Jet ranger		<b>Type of Operation</b>		Commercial Helicopter Operations (Part 127)	
<b>Pilot-in-command Licence Type</b>		Airline Transport Pilot Licence (H)		<b>Age</b>	44	<b>Licence Valid</b>	Yes
<b>Pilot-in-command Flying Experience</b>		<b>Total Flying Hours</b>		4423.3		<b>Hours on Type</b>	164
<b>Last Point of Departure</b>		Rand Airport (FAGM), Gauteng Province					
<b>Next Point of Intended Landing</b>		Buffels Mine, North West Province					
<b>Damage to Helicopter</b>		Substantial					
<b>Location of the accident site with reference to easily defined geographical points (GPS readings if possible)</b>							
On a private farm, 16nm south-west of Fochville at Global Positioning System (GPS) determined to be 26°40'10.6680"S 027°16'14.6640"E, at an elevation of 4602 feet (ft)

**Synopsis**

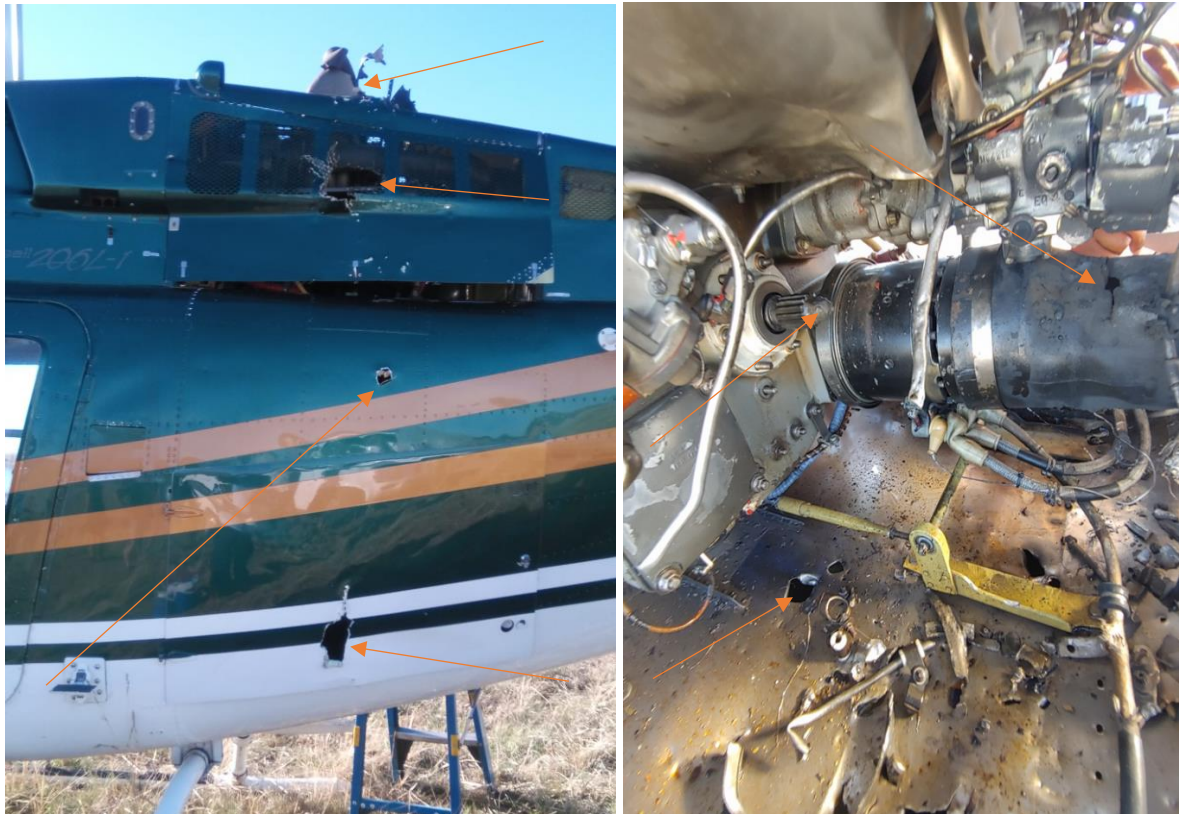
1.3.1. The helicopter sustained damage to the turbine section, fuselage, tail rotor drive shaft and main rotor blade. The engine sustained severe damage to the power turbine and gas producer supports. The tail rotor drive shaft was severed below the turbine section.

1.3.2. There was debris damage in the baggage compartment.

Figures 2 and 3: Damage to the fuselage and engine bay.

1.12.1. The pilot executed a successful forced landing following an engine failure approximately 35 minutes into the flight at a private farm. A post-landing fire erupted after a successful forced landing. The engine remained within the engine bay with heavy damage to the power turbine and gas producer supports. There was notable engine debris in the engine bay. The tail rotor drive shaft was sheared off, rendering the tail rotor pedals inoperative. Debris also damaged the main rotor blade and punctured the baggage compartment door (Figures 2 and 3).

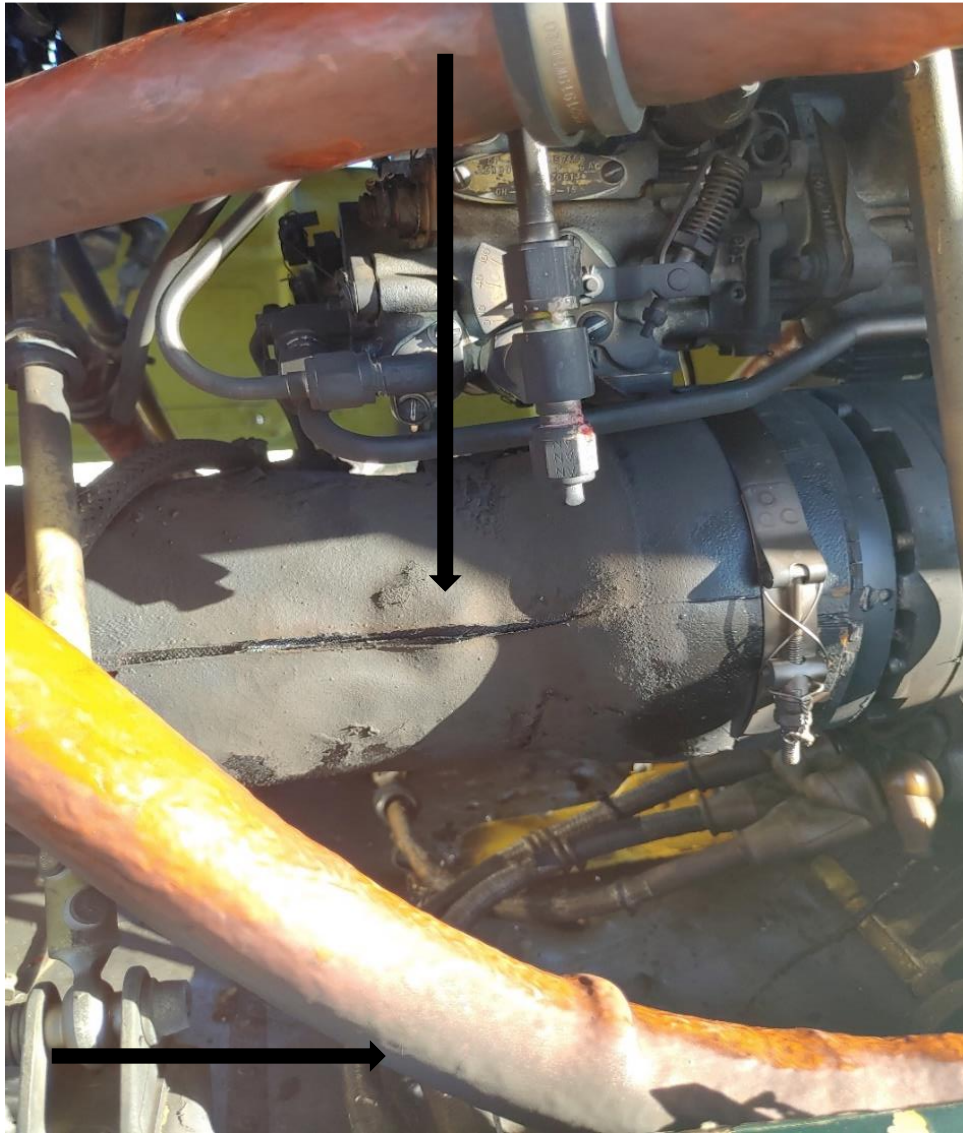
1.14.1. A fuel-fed fire erupted in the engine compartment after the forced landing. The pilot put out the fire using the fire extinguisher on-board the helicopter.

**Figure 4:** Fire damage on the engine tubing.

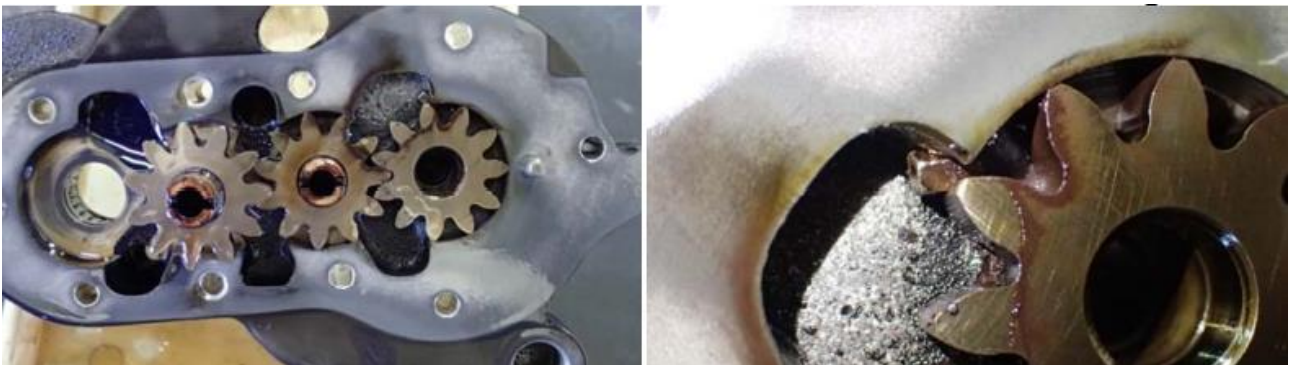
1.16.1. *On 8 November 2021, the engine was removed from the helicopter by an approved engine shop for further inspection. On 9 November 2021, an engine strip was carried out in the presence of an AIID investigator and the representative from Rolls Royce. During the preliminary findings, it was discovered that a small piece of metal was stuck in the gear in the scavenge side of the oil pump, causing it to stop and, thus, not allowing oil to flow into the engine.*

**Figures 5 and 6:** The oil pump scavenge gears with a tab lodged on the left gear. (Source: Rolls Royce)

- 2.2.6. A small metal piece got stuck in a gear in the scavenge side of the oil pump, causing it to stop, and thus, preventing oil flow to the engine.

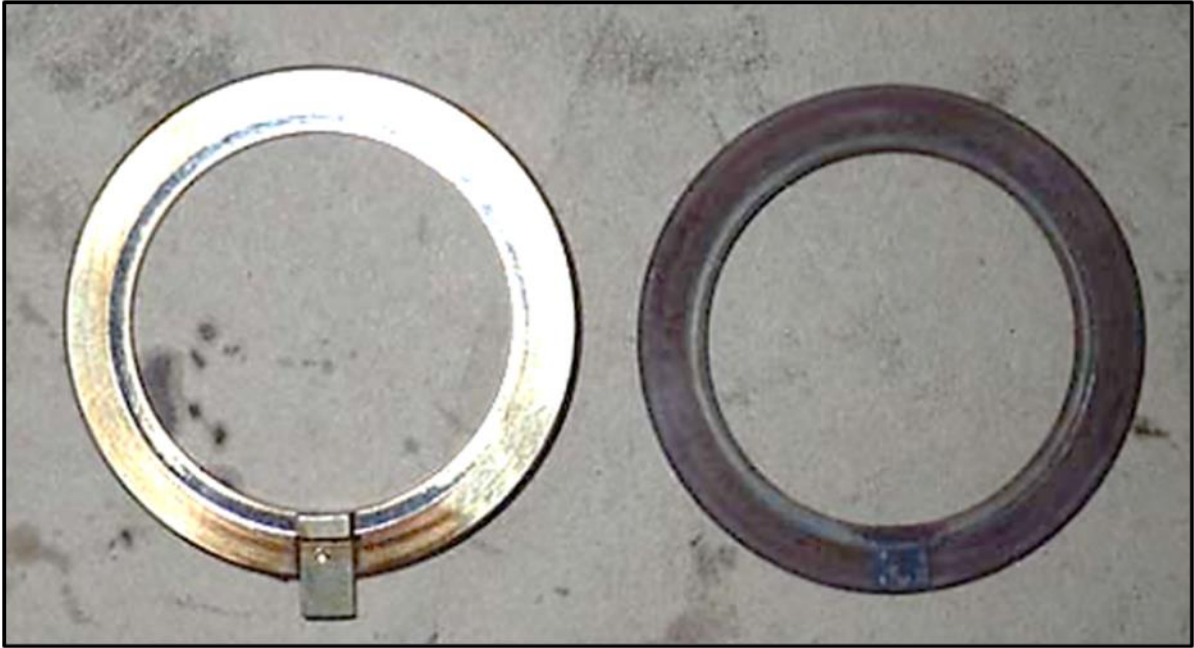
- 1.16.2. *An engine component was taken to the engine manufacturer for metallurgical examination and analysis. The piece of debris discovered in the oil pump is consistent in chemistry and morphology with the outboard portion of the anti-rotation tab of a bearing thrust plate. The anti-rotation tab was missing from the gas producer bearing thrust plate installed in the engine. The inboard portion of the tab was not recovered.*

- 1.16.3. *Semi-quantitative EDS analysis and metallography of the outboard portion of the thrust plate forward face revealed the presence of braze material over the joint surface and the evidence of a braze fillet at the joint extremities. Overall braze coverage could not be determined due to obliteration of the braze on the inboard portion of the thrust plate and the missing inboard portion of the tab. The outer diameter surface exhibits no evidence of fillets on the extremities and approximately 29% braze coverage in the internal braze joint, which did not meet the component definition requirements.*

**Figure 7:** New thrust plate (left) and accident thrust plate (right) with a missing tab. (Source: Rolls Royce)

- 3.4.1. Sheared off gas producer bearing thrust plate anti-rotation tab.

1.16.8. The engine manufacturer issued a Commercial Engine Bulletin CEB-72-3309 dated 16 December 2022 which stipulated the replacement of the number 8 bearing thrust plate to prevent domestic debris in the engine. The number 8 bearing thrust plate was redesigned.

- 4.2.1. Following the accident, the engine manufacturer issued a Commercial Engine Bulletin on 16 December 2022 which stipulated the replacement of the number 8 gas producer bearing thrust plate with a redesigned thrust plate.

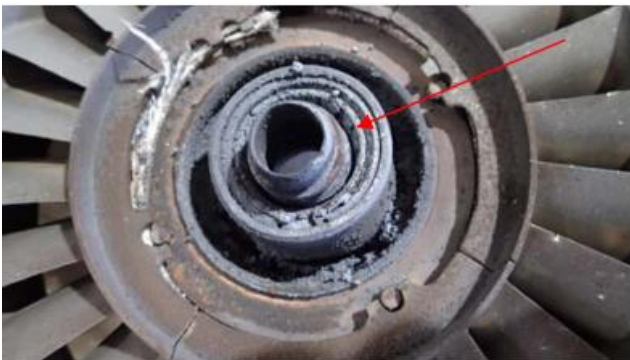
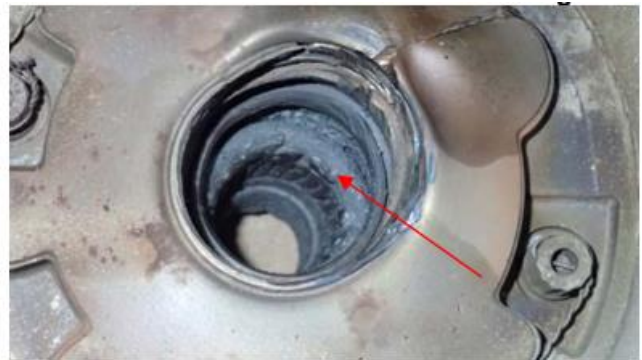
- 1.16.5. *The No. 8 bearing rotated freely, and the anti-rotation slot on the outer ring exhibited no apparent damage. The microstructure of the No 8 bearing subcomponents were consistent with the component definition requirements and revealed no evidence of thermally distressed material. All other damage was considered secondary to the loss of lubrication to the #6 and #7 bearings.*

**Figures 8 and 9:** Thermal damage on the number 6 and 7 bearings. (Source: Rolls Royce)

- 3.3.1. Engine failure due to loss of lubrication to the number 6 and 7 bearings caused by a separated thrust plate anti-rotation tab which lodged between the engine oil scavenge gear and the wall of the oil pump, preventing adequate flow of engine oil.
