AIRCRAFT ACCIDENT REPORT AND EXECUTIVE SUMMARY

Reference:	CA18/2/3/10070		
Aircraft Registration	ZU-EIJ	Date of Accident	7 December 2021		Time of Accident	1520Z	
Type of Aircraft	Evektor SportStar		Type of Operation	Private NTCA (Part 94)			
Pilot-in-command Licence Type	National Pilot Licence		Age	49	Licence Valid	Yes	
Pilot-in-command Flying Experience	Total Flying Hours		333.8	Hours on Type	48.1		
Last Point of Departure	Springs Aerodrome (FASI), Gauteng Province						
Next Point of Intended Landing	Springs Aerodrome (FASI), Gauteng Province						
Damage to Aircraft	Destroyed						
Location of the accident site with reference to easily defined geographical points (GPS readings if possible)							
Bajadam Resort (GPS position: 25°53'52.44" South, 028°42'38.00" East), at an elevation of 4 740 feet (ft)							
Meteorological Information	Strong winds were encountered while flying over the Bronkhorstspruit Dam						
Number of People On-board	1 + 0	Number of People Injured	0	Number of People Killed	1	Other (On Ground)	0

The pilot lost control of the aircraft following the structural failure of the outer left-wing main spar, located 125 centimetres (cm) from the wing tip. The failure

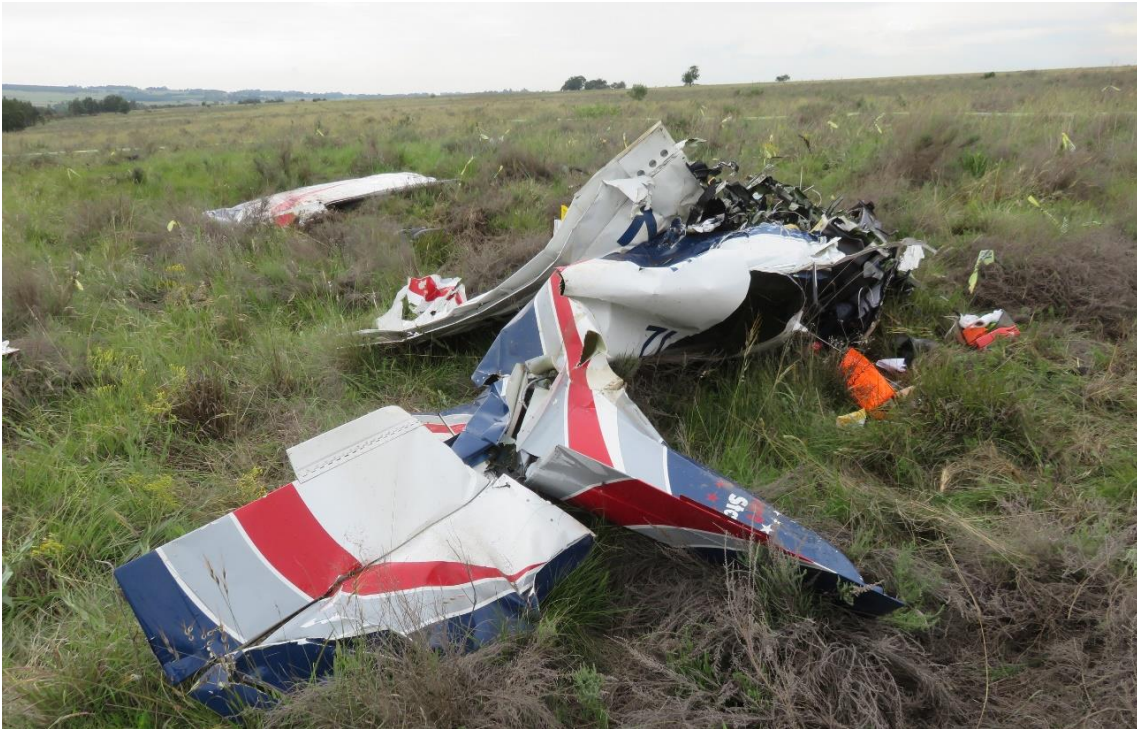
1.3.1 The aircraft was destroyed during the accident sequence.

Figure 3: The main wreckage post-accident. (Source: IIC on site)

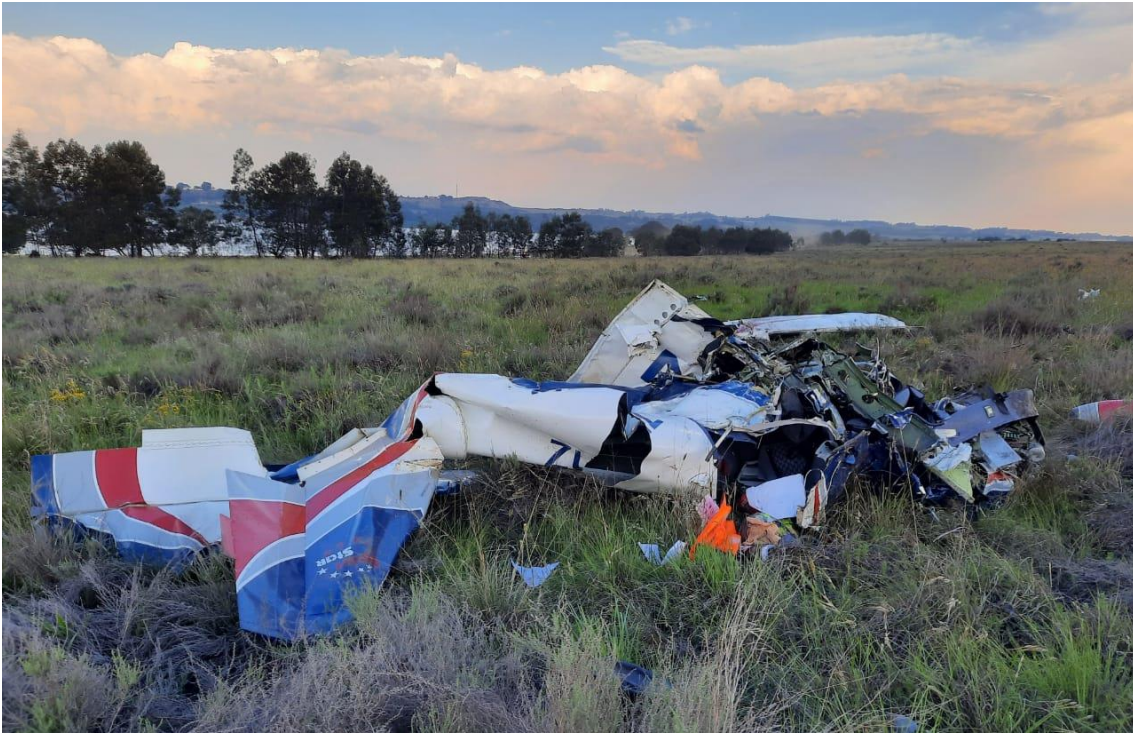
1.12.1 The aircraft impacted the ground on an open field in a westerly direction (255° Magnetic). The aircraft was in a nose-down attitude during ground impact and was described by one of the eyewitnesses as twirling in the air once the outer section of the left wing failed. It was evident from the first ground impact marking and the destruction of the wreckage that the aircraft was out of control during impact. The right-wing assembly was found fractured and was one of the first major components found along the impact line. The inner section of the left-wing remained attached to the fuselage, but was destroyed. The entire propeller hub assembly, including the propeller gearbox, had sheared from the engine. The three wooden propeller blades were severed at the hub assembly, which is an indication that the engine was delivering power to the engine on impact with the terrain. The cockpit area was mangled, and all the flight instruments were ripped out of the instrument panel. The fuel tank selector indicated that the left tank was selected at the time of the accident.

Figure 13: A view of the main wreckage.

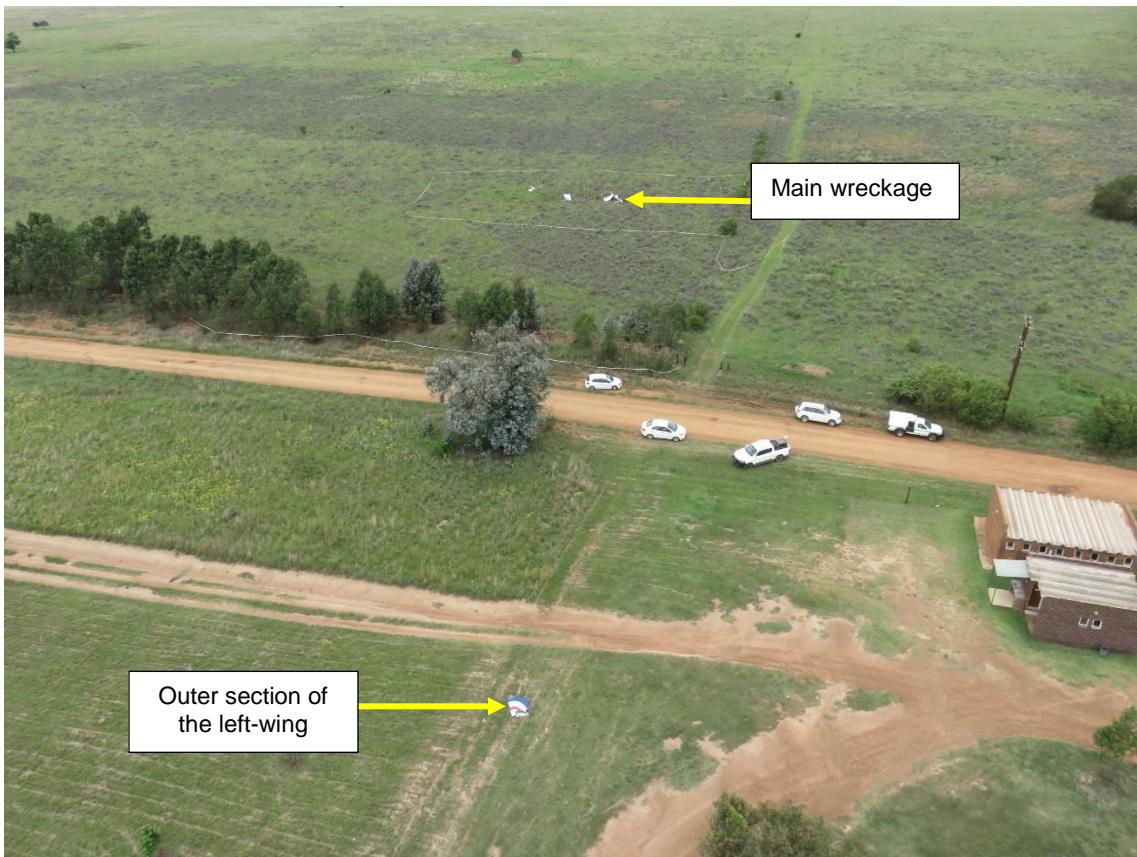
Figure 14: The aerial view showing the main wreckage and the outer section of the left-wing.

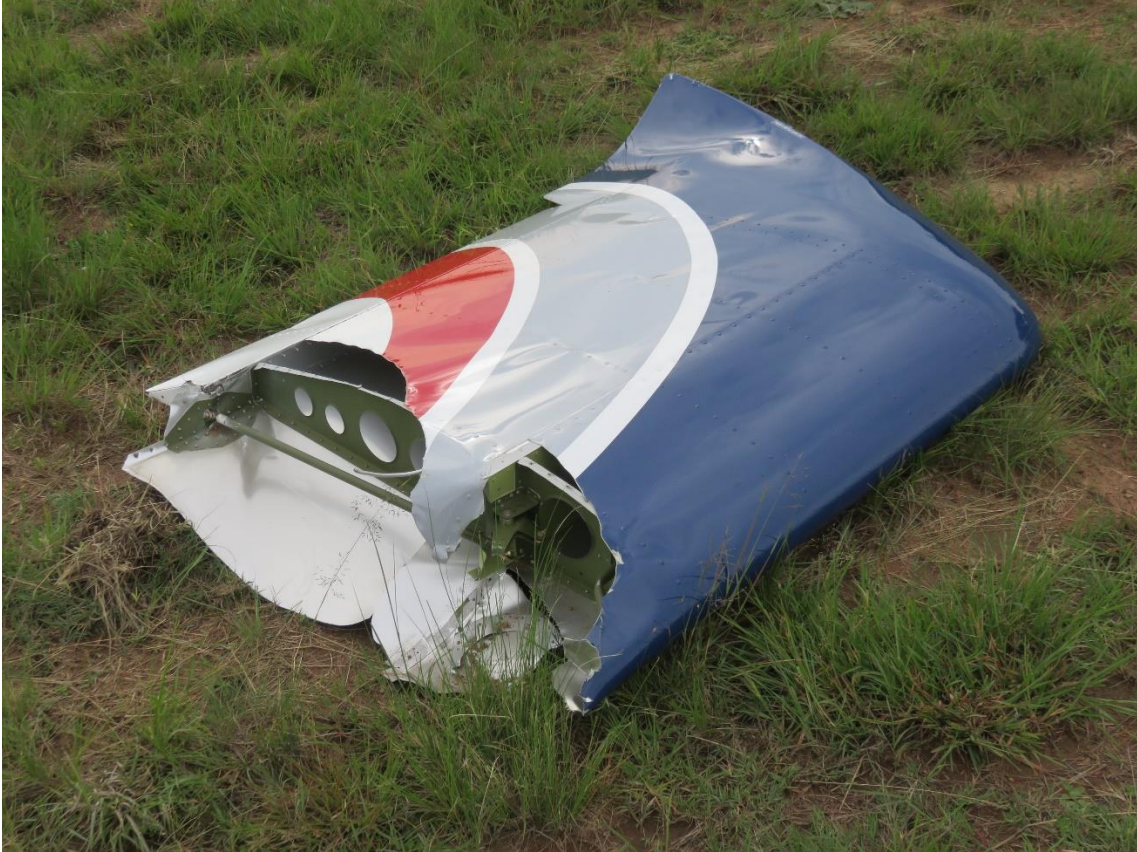
Figure 15: The outer section of the left-wing.

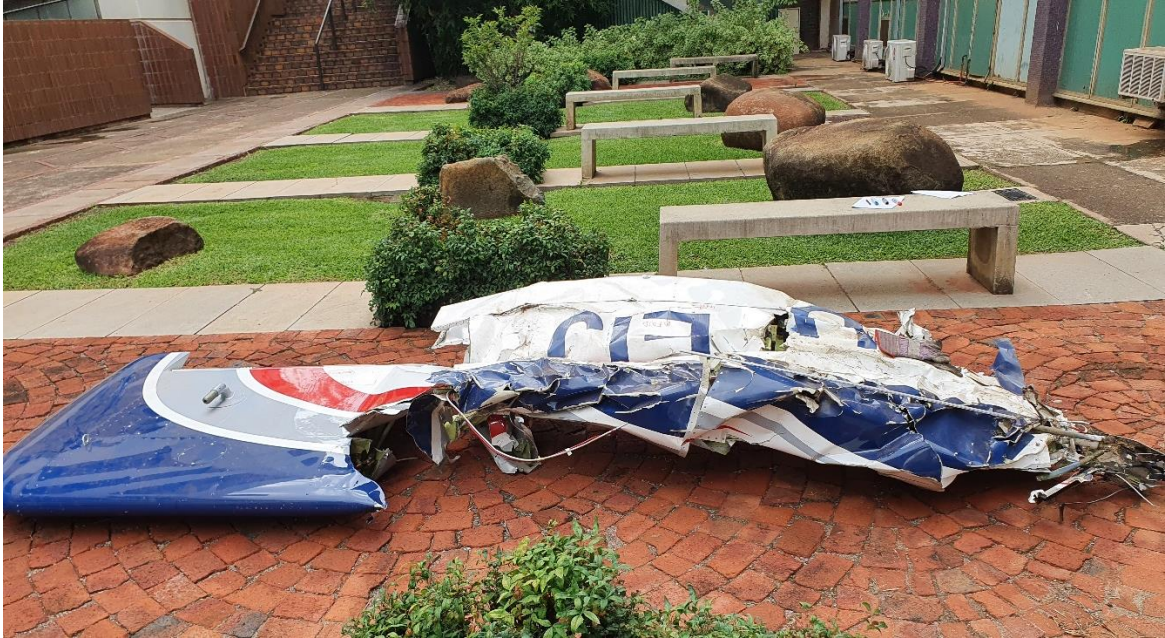
1.16.1 The entire left wing (both sections) as well as the main wing spar centre section were recovered from the accident site and were sent for metallurgical examination. The laboratory report is attached to this report as Appendix B.

Figure 16: The left wing (both sections) positioned upside down.

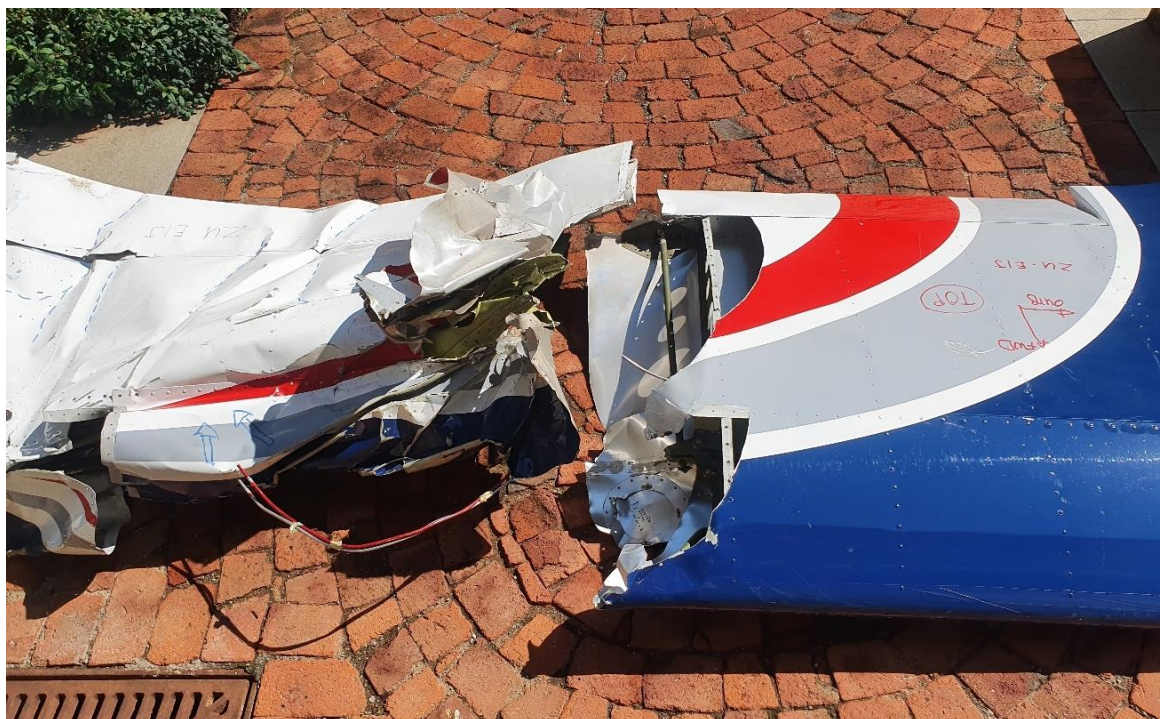
Figure 17: The area where the left wing failed is between ribs 8 and 9.

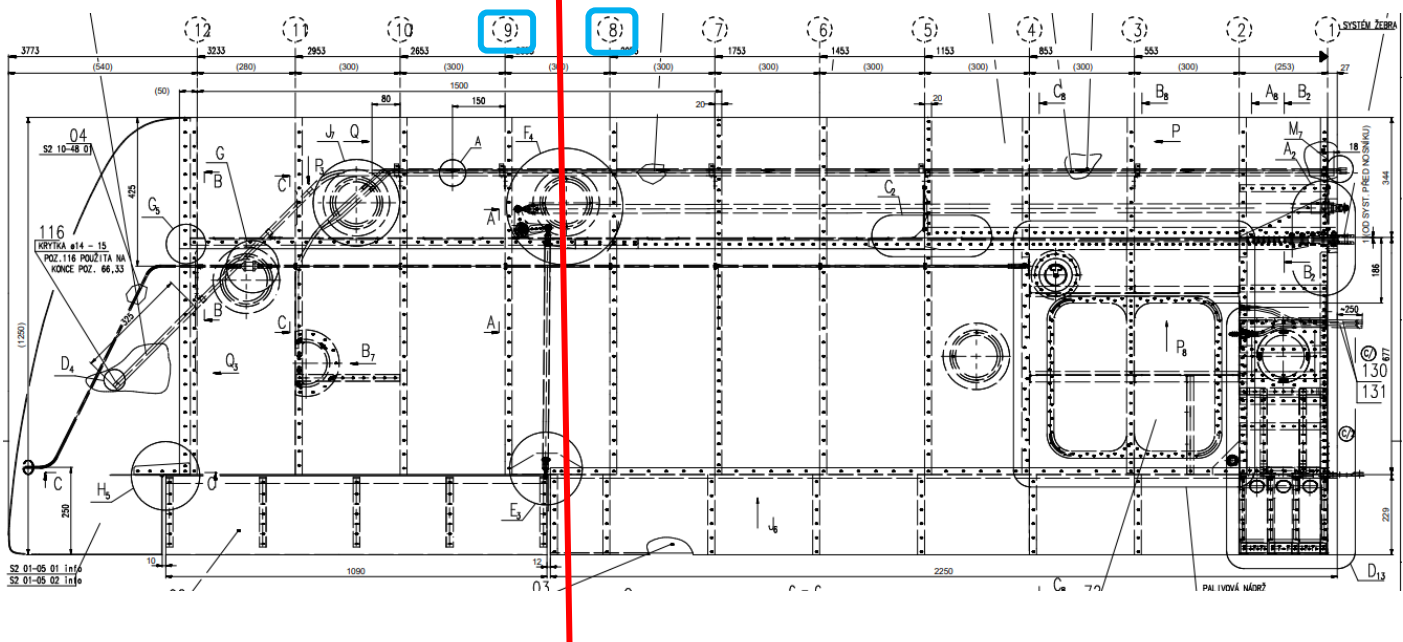
Diagram 1: The red line indicates the area of failure between ribs 8 and 9, looking at the wing from above.

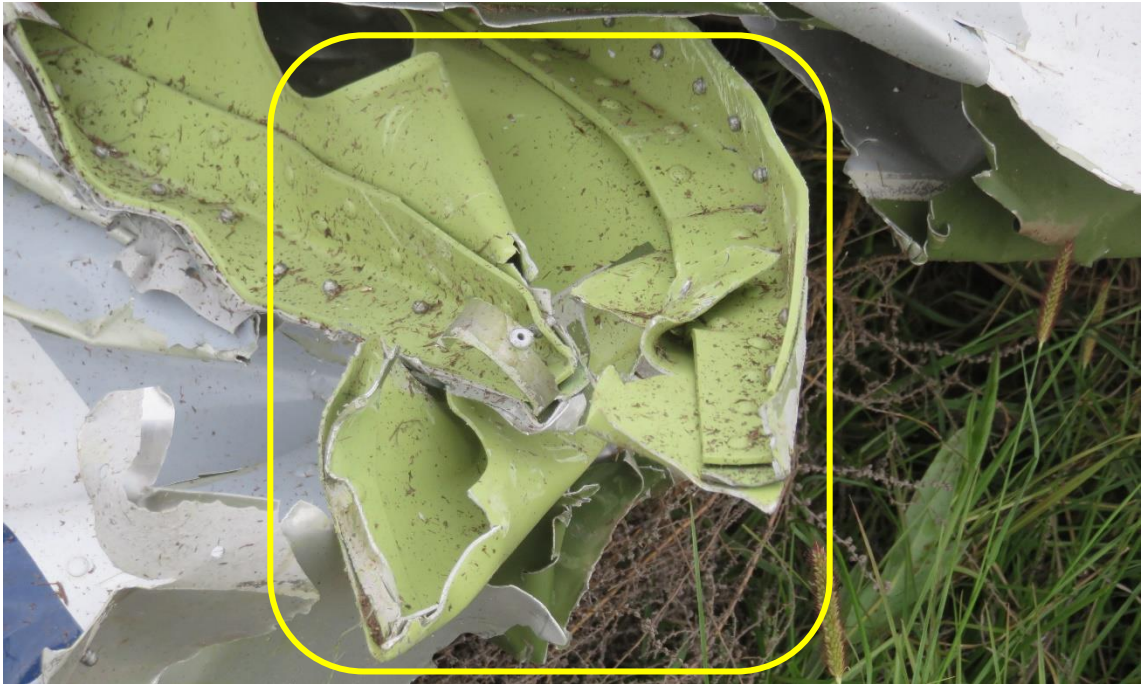
Figure 20: A view of the failed main spar on the left wing.

Although the aircraft was destructed during the accident sequence, it was established that apart from the outer section of the left wing that failed in-flight, the integrity of the aircraft was not compromised. It was also evident that the engine was delivering power on impact as all three propeller blades were severed at their respective roots (flash with the propeller spinner). The right wing had separated from the fuselage during the impact sequence and did not display any structural deformation, which is an indication that the wing loading at the time of the failure of the outer section of the left wing was of a much higher +G load than what was experienced on the right wing. It was further noted that the wing failure occurred at the weakest part of the wing spar design, where only a single right angle stiffener bar was present (see Figures 20 and 21).

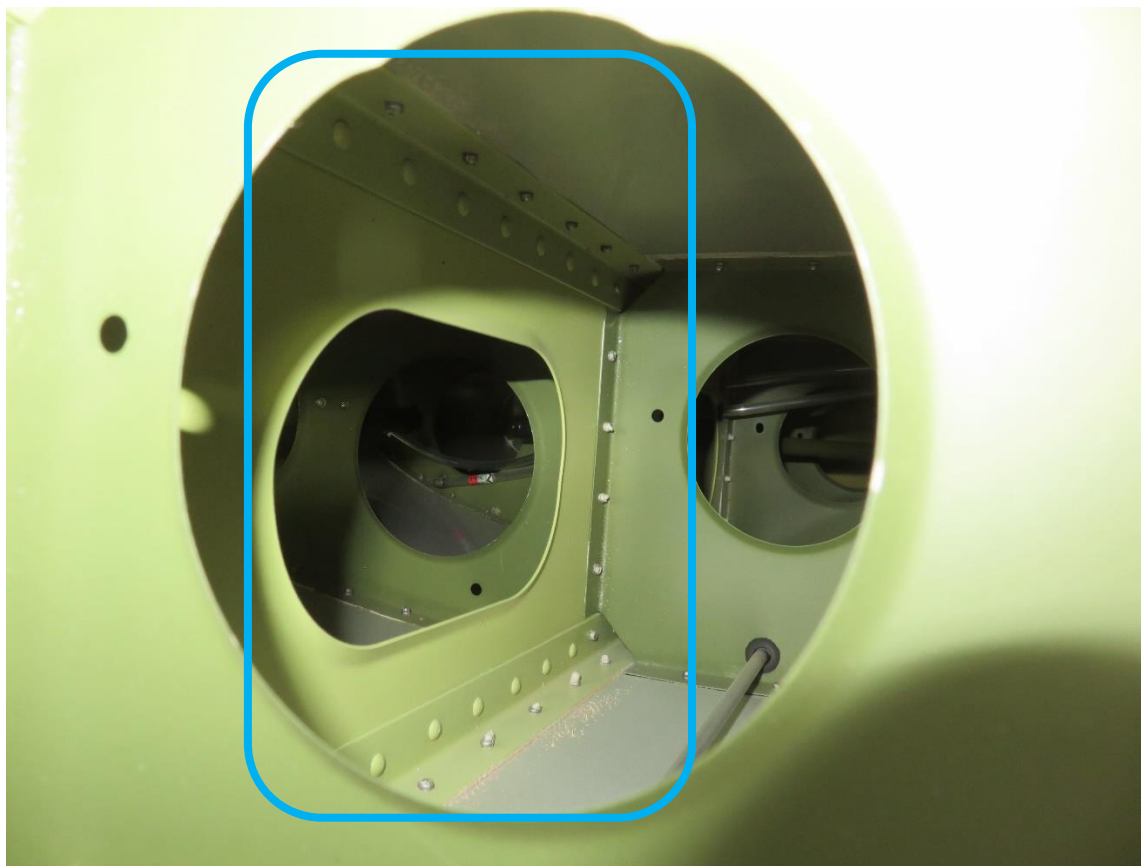
Figure 21: A view of the main spar inside the outer section of the left-wing which failed in-flight.

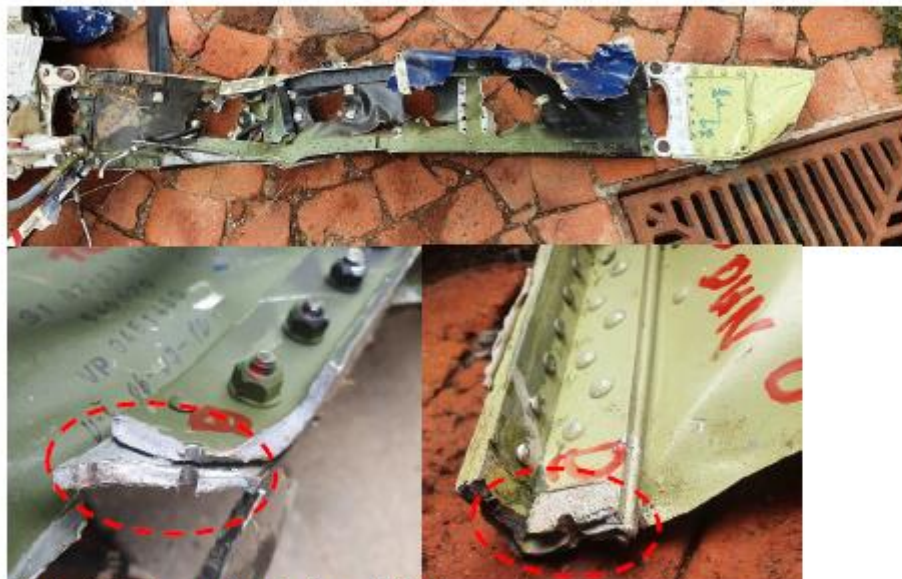
Photo 4: Centre section fractures (digital)

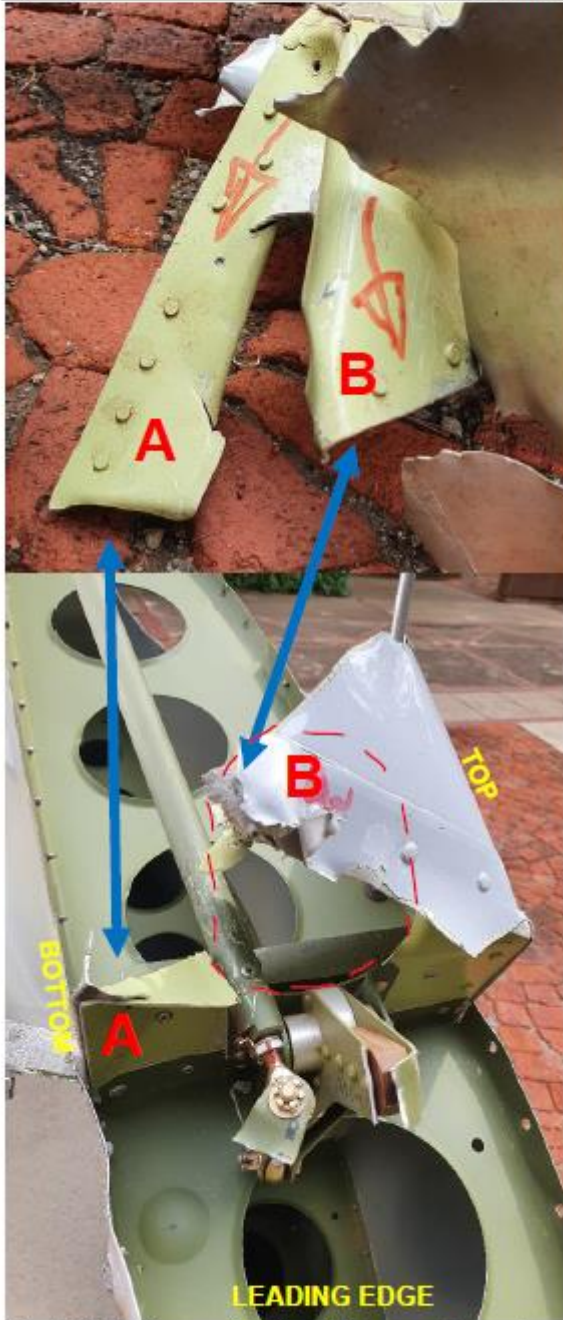
Photo 5: Fracture points A and B, separated outboard section, LH wing assembly (digital)

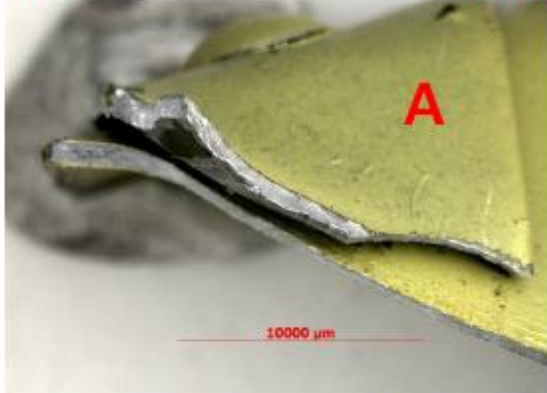
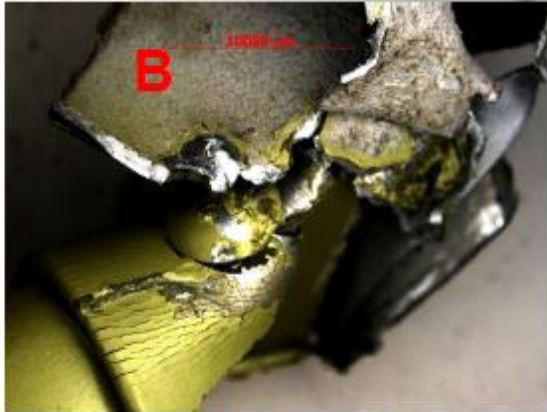
Photo 8: Sectioned fracture locations, inboard section (Stereo)

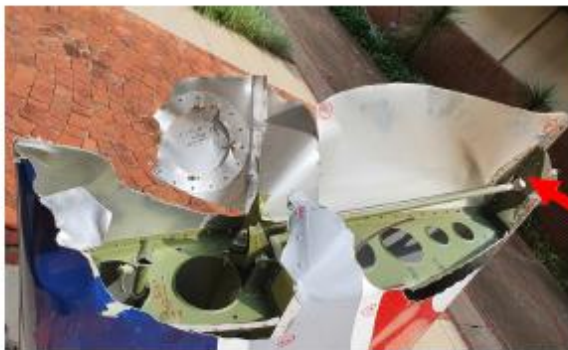
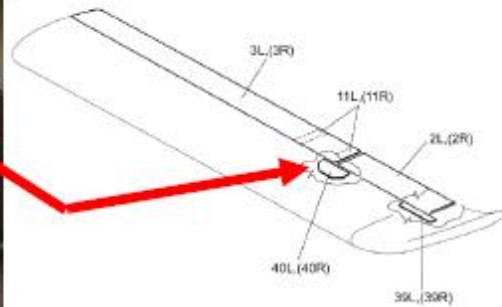
Photo 9: Fracture progression versus stiffener position (digital)

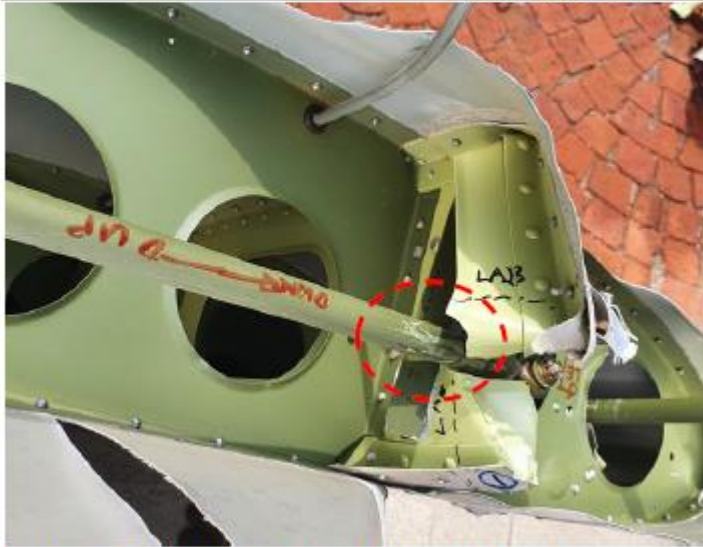
Photo 10: Aileron pushrod impact damages (digital)

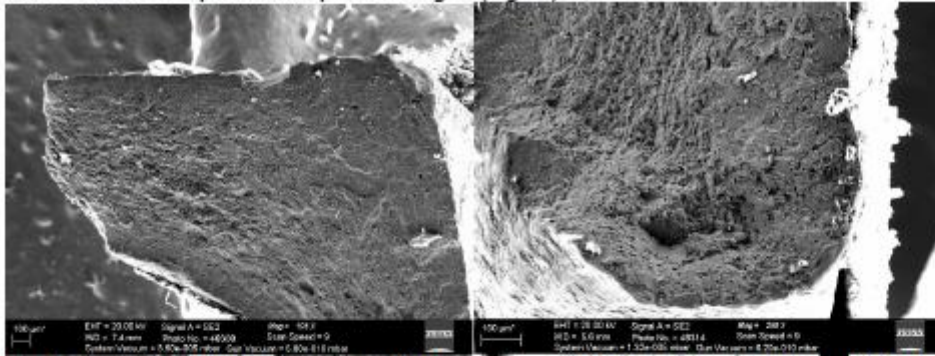
Fractograph 1: Fracture surface morphology showing no clear pre-existing fracture initiation/s (105-250X, 20kV, SE, FEGSEM)

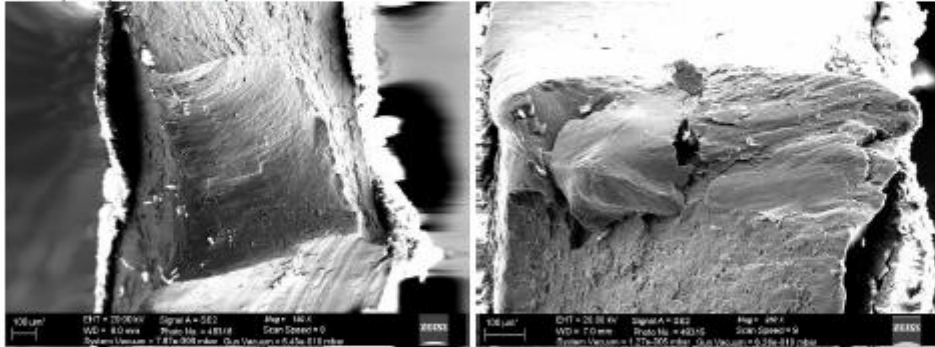
Fractograph 2: Fracture surface morphology showing secondary damages (105-250X, 20kV, SE, FEGSEM)

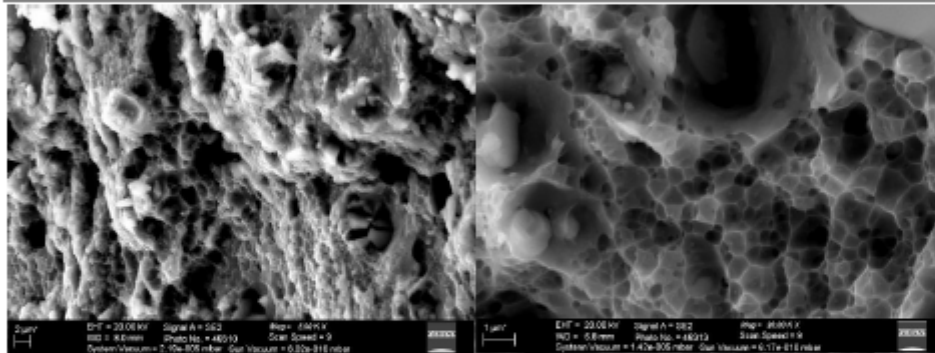
Fracture surface morphology showing ductile overload (5000-20000X, 20kV, SE, FEGSEM)

7.3. The results suggest that the LH outboard wing area was exposed to an exceedingly high load condition in the +g region during flight that resulted in the failure of the LH main wing spar assembly as the first in the sequence of events.

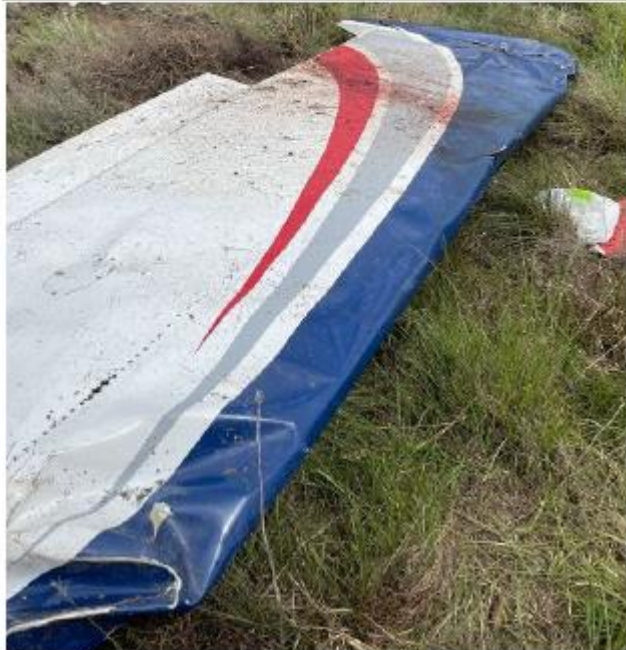
Photo 11: RH wing condition, as found⁶
