<b>AIRCRAFT ACCIDENT REPORT AND EXECUTIVE SUMMARY</b>
---

<b>Reference:</b>	<b>CA18/2/3/10072</b>			
<b>Aircraft Registration</b>	ZU-EHW	<b>Date of Accident</b>	10 November 2021		<b>Time of Accident</b>	1735Z		
<b>Type of Aircraft</b>	ELA-08 Gyrocopter		<b>Type of Operation</b>		Training (Part 141)			
<b>Pilot-in-command Licence Type</b>	Private Pilot Licence (PPL)		<b>Age</b>	46		<b>Licence Valid</b>	Yes	
<b>Pilot-in-command Flying Experience</b>	<b>Total Flying Hours</b>		215		<b>Hours on Type</b>	20.9		
<b>Last Point of Departure</b>	Overulate Airstrip, Musina, Limpopo Province							
<b>Next Point of Intended Landing</b>	Overulate Airstrip, Musina, Limpopo Province							
<b>Damage to Aircraft</b>	Destroyed							
<b>Location of the accident site with reference to easily defined geographical points (GPS readings if possible)</b>								
Five hundred (500m) metres from Overulate Airstrip threshold at Global Positioning System (GPS) co-ordinates 22° 8'38.42" South, 029°38'20.14" East, and at a field elevation of 1623ft

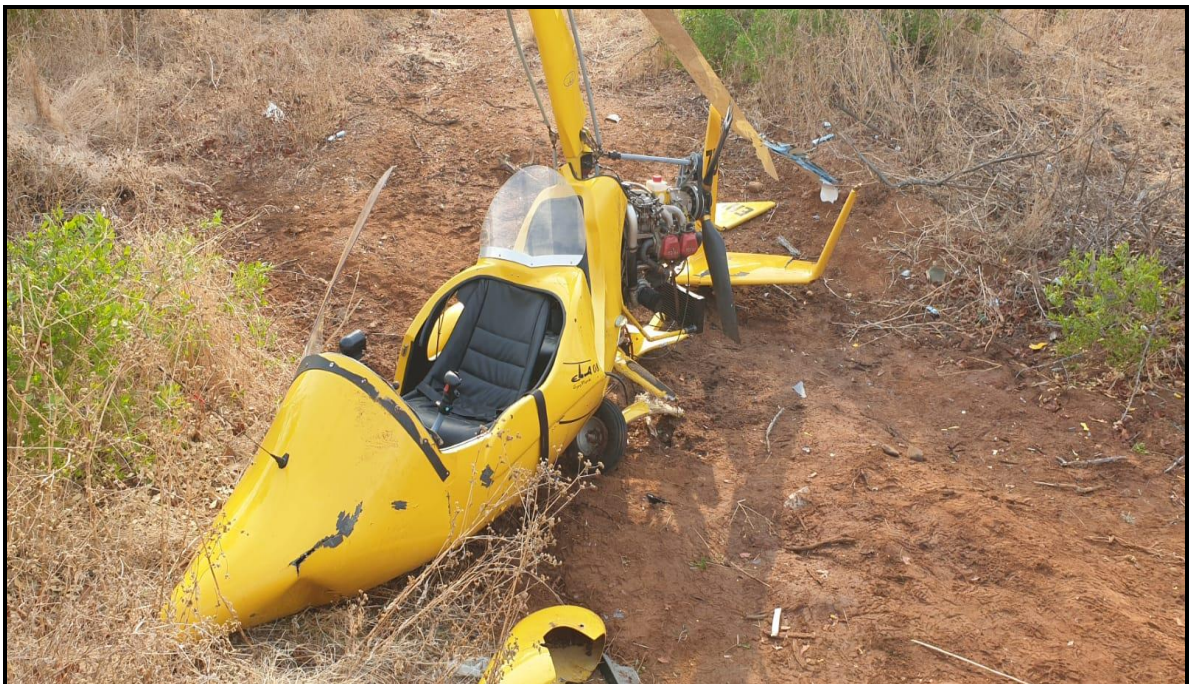
1.3.1 The gyrocopter was substantially damaged.

Figure 2: The damage sustained by the gyrocopter.

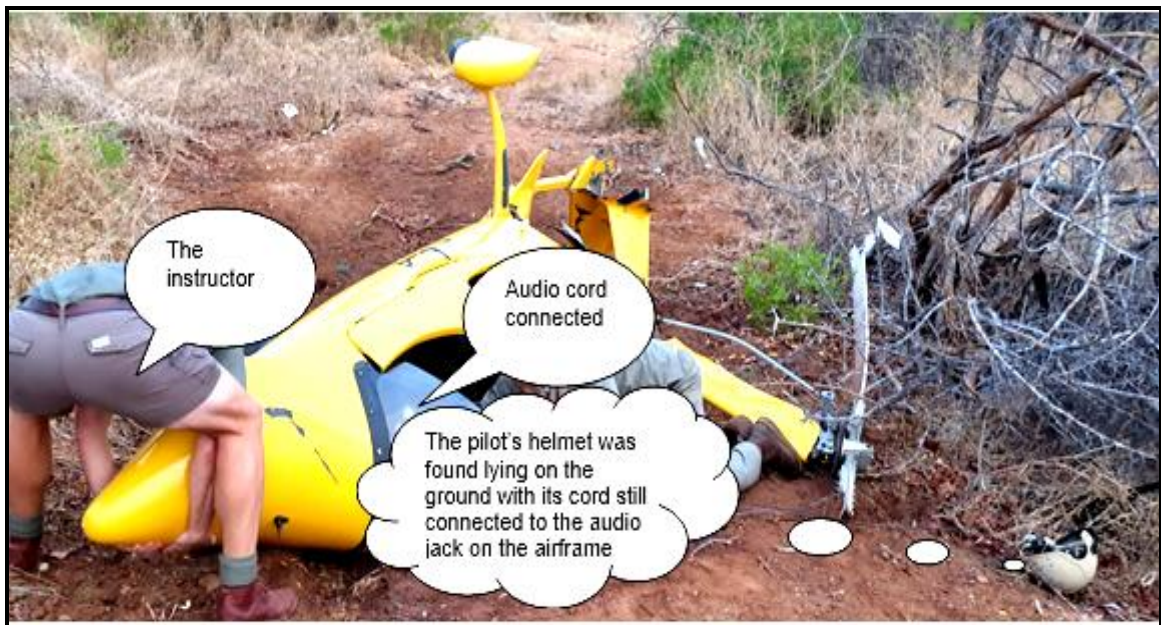
**Figure 4:** The aircraft immediately after the accident. (Source: Instructor)

The pilot's helmet was found about a metre from the gyrocopter, just above the main rotor head. Figure 4 picture was taken by the first responders, it shows the helmet's audio headset connecting cable (cord) still connected to the front cockpit audio jack instrument panel. The gyrocopter position was disturbed during an attempt to rescue the pilot from the wreckage (see Figure 4).

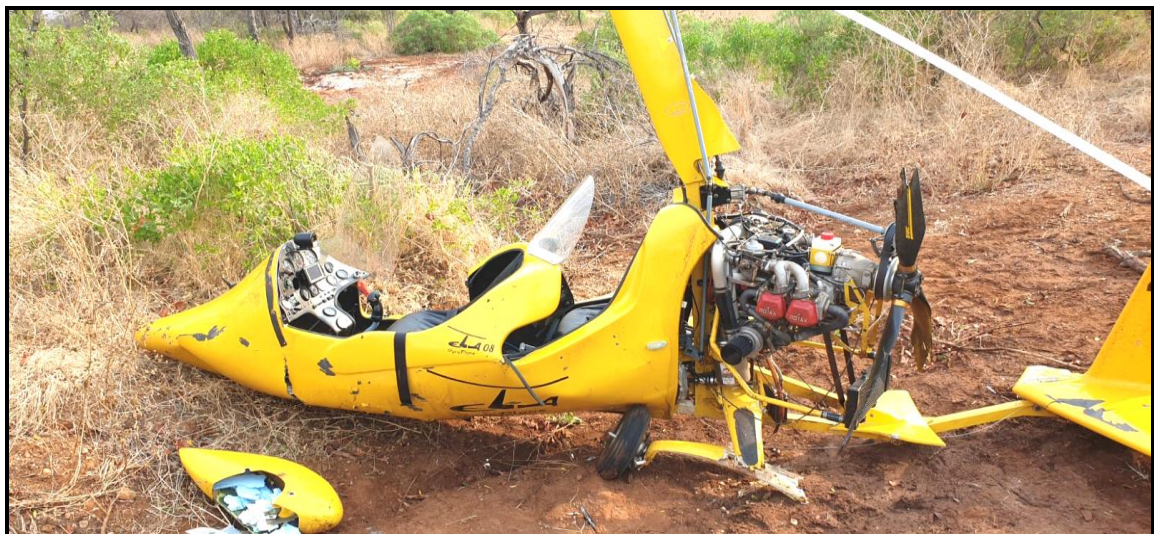
**Figure 5:** The damage sustained by the gyrocopter.

1.12.2 The left main landing gear had broken off, and the nose gear had folded under the bottom part of the fuselage. The left-side of the gyrocopter impacted the ground hard, resulting in multiple fuselage structure damage. The nose section was found slightly pointing towards the right, and had scratches sustained during impact. The engine mounting was found bent and facing left, which indicated inertia force at the time of impact. All engine control cables were still connected; they had continuity after being inspected. The engine turned without restrictions. The carbon fibre three-bladed propeller was still attached to the gyrocopter; all blades had sustained impact damage and were destroyed. The damage on the propeller indicated high-speed rotation under power at the time of impact or contact with the ground.

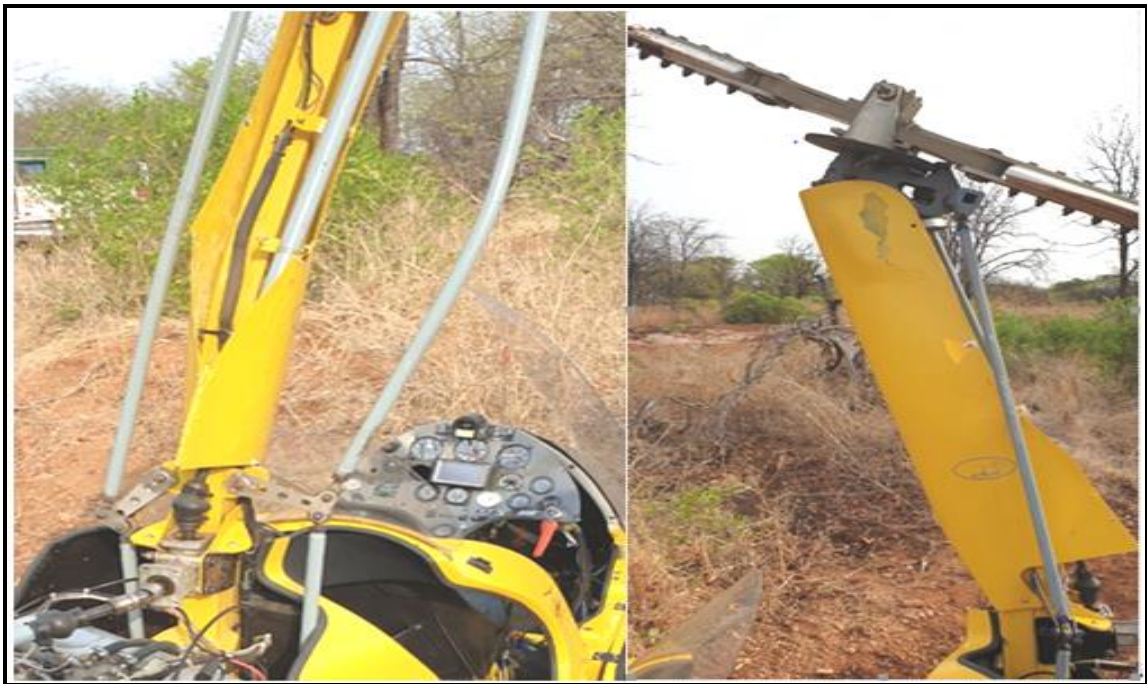
**Figure 6:** Damage on the main rotor hub.

1.12.3 The main rotor hub was found slightly bent; however, it was still intact. Both main rotor blades impacted the ground at high rotational speed. The first blade that impacted the ground disintegrated and broke off; it was flung approximately 20m from the main wreckage. The blade caused damage to some trees due to inertia. The second blade which was still attached to the rotor hub sustained damage to its outer section towards the tip; this is likely to be associated with the propeller and vertical stabiliser strike (impact). The two main rotor blade control links were found bent (see Figure 6).

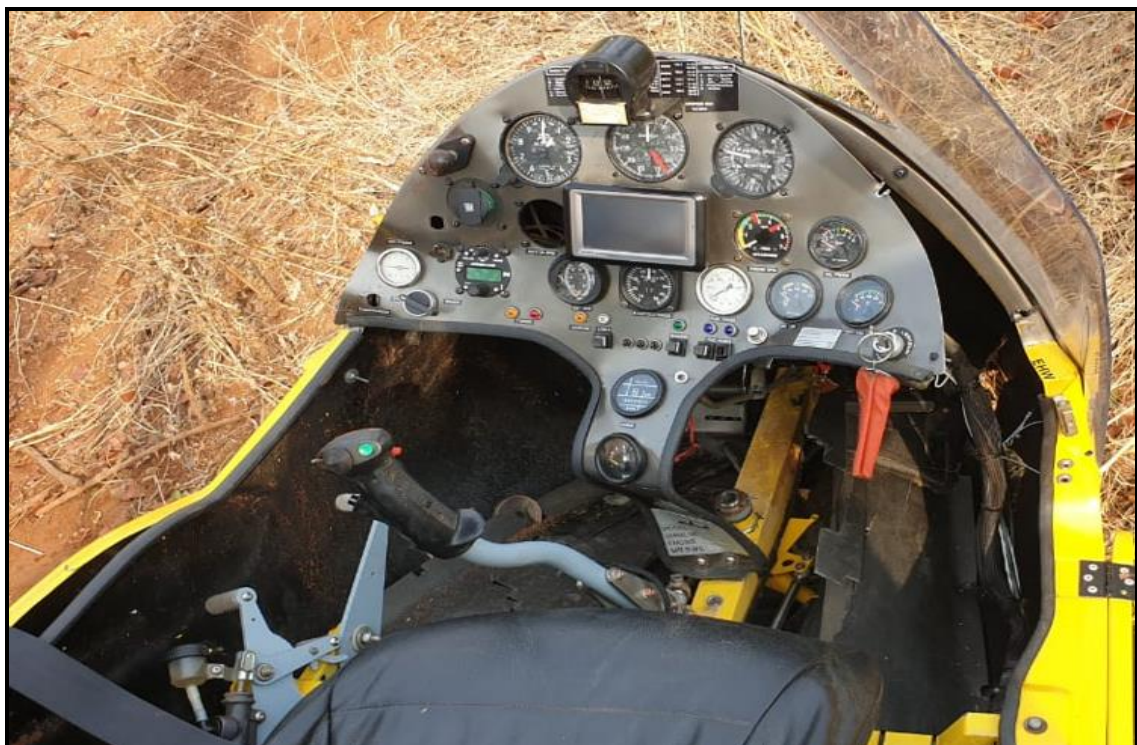
**Figure 7:** The damage on the front cockpit instrument panel.

1.12.4 The front cockpit windshield was destroyed during the impact sequence. The front cockpit instrument panel was found bent; the damage was likely to have been caused by compression forces during the accident sequence. The cyclic control assembly unit had damage on the front attachment. The right-side rudder control paddle link was found detached and damaged.

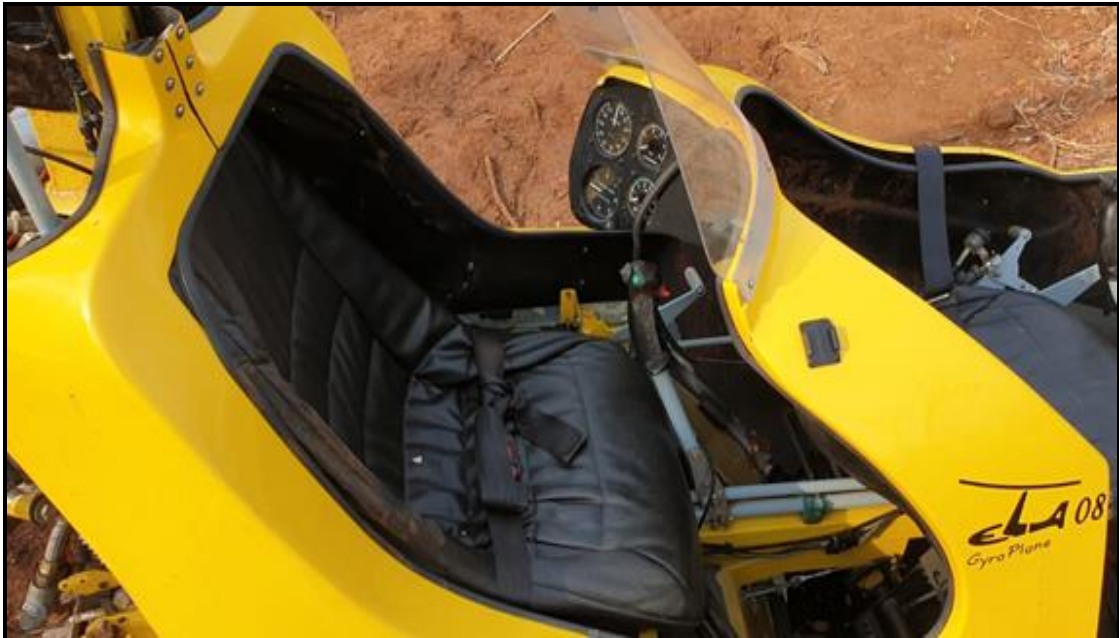
**Figure 8:** The rear cockpit seat was configured securely for a solo flight.

1.12.5 The rear cockpit seat was safely secured for a solo configuration flight. The rear cockpit instrument panel was found still intact.

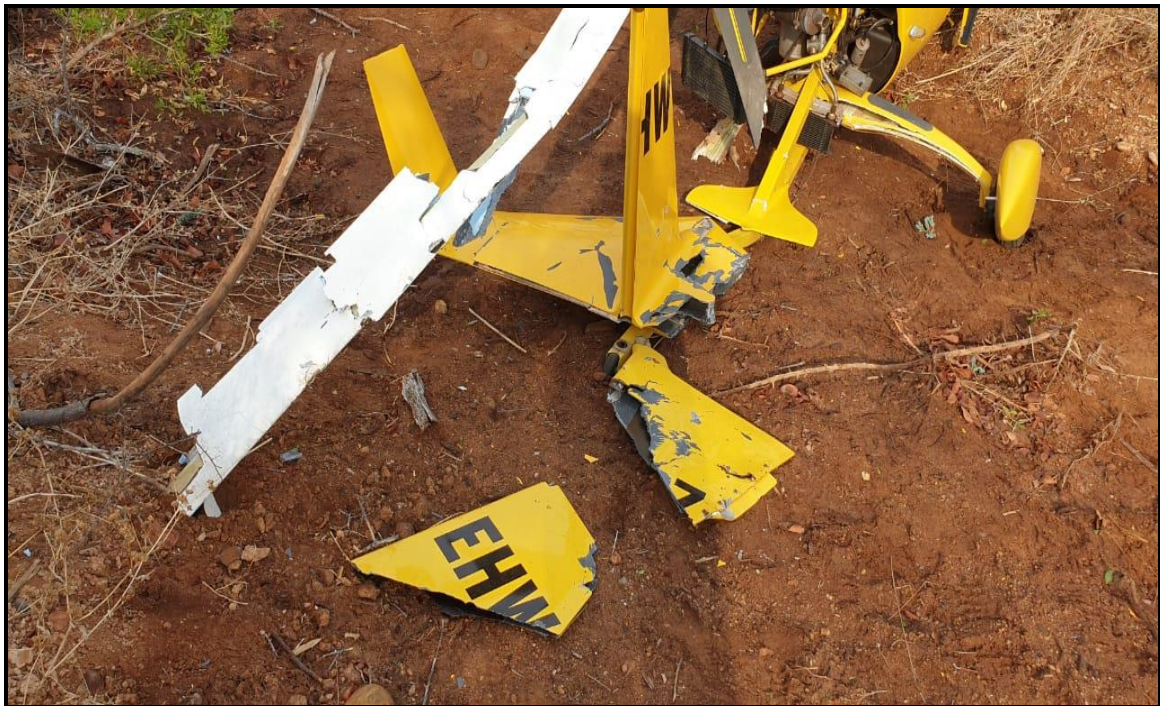
**Figure 9:** The severed vertical stabiliser.

1.12.6 The right-side winglet and the rudder were severed. It is likely that they were severed by the flapping main rotor blades during the accident sequence. The main vertical stabiliser fin rudder had detached during the impact sequence.

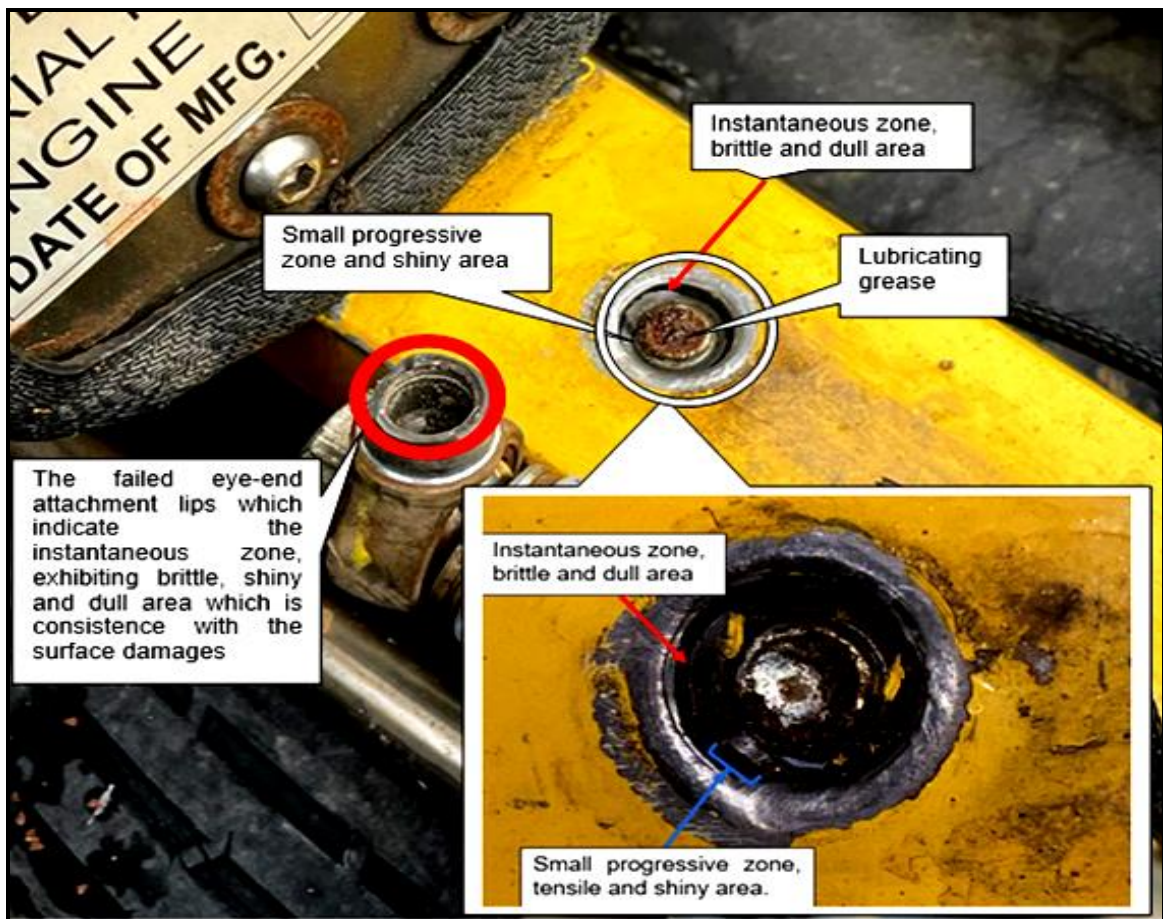
**Figure 10:** The failed attachment link. (Source: Instructor)

- 1.12.7 The control column mounting assembly sustained damage on the front eye-end attachment link bolt. The damage indicated a clear break (failure) caused by high load, which was likely to be acting sideways due to the main rotor flapping, resulting in great feedback forces on the control column during the accident sequence. The damage exhibits instantaneous zone, brittle and dull with a progressive zone with tensile and shiny area (refer to Annexure A for tests results).

*The rod end with its internal female thread clearly failed by abnormal bending, which introduced an overload induced shear failure. The failure of this rod end did not cause the accident. It failed during, and because of, the accident.*

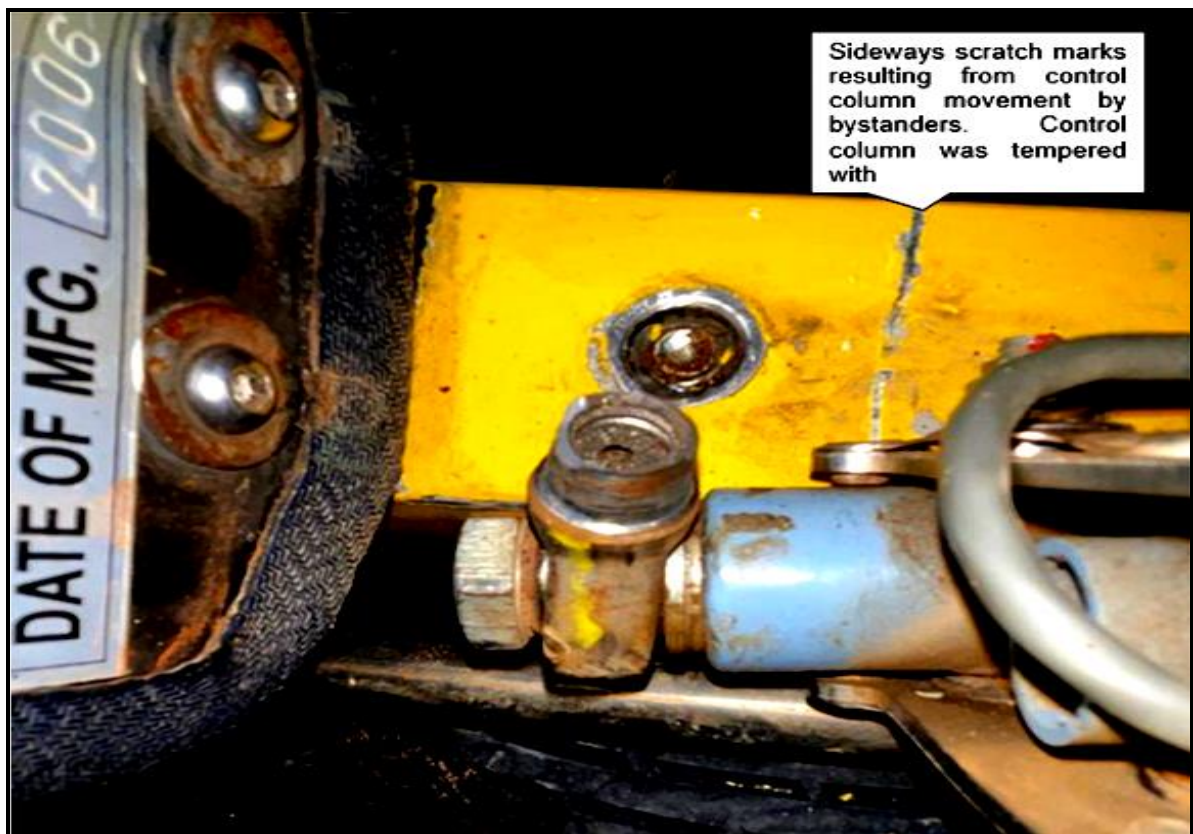
**Figure 11:** The scratch marks left by the control column following the accident as it was tempered with by the recovery team. (Source: Recovery Team)

The recovery team tampered with (moved side) the control column, evidenced by scratch marks (see Figure 11).

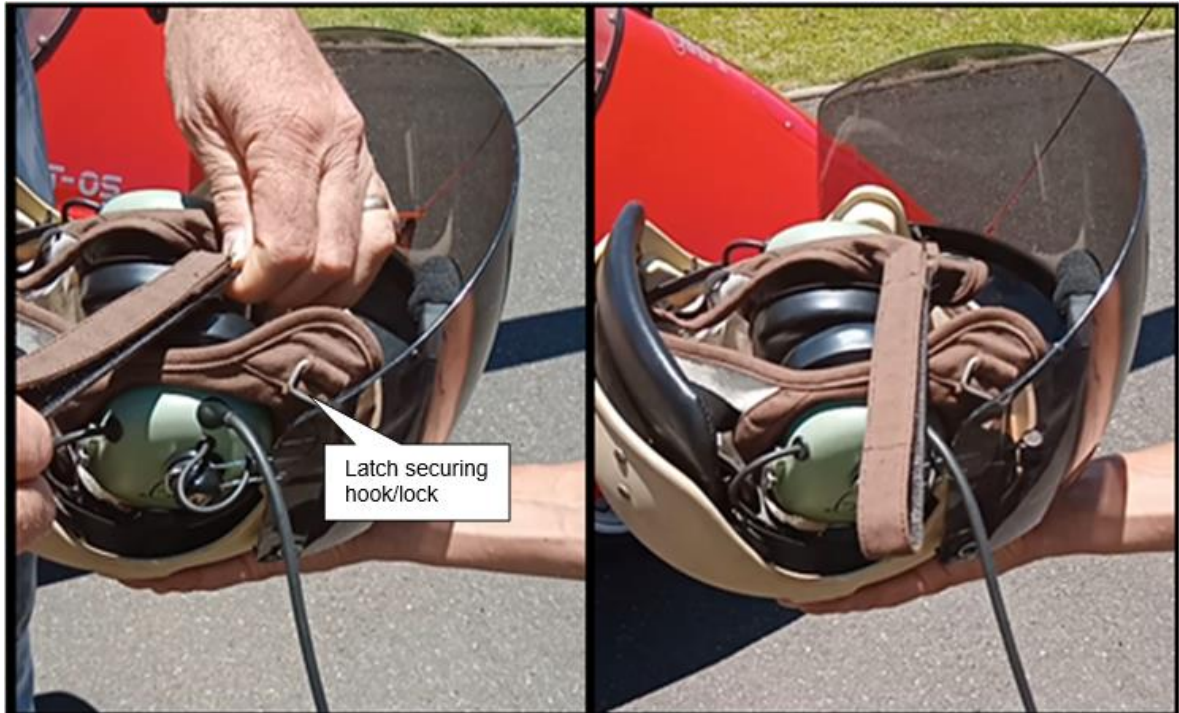
- 1.18.1 The pilot's helmet was found on the ground with its audio connecting cable attached to the airframe audio jack. According to the instructor, the pilot's helmet was not secured properly. The helmet provides a secure latching mechanism when engaged and worn correctly. The pilot's helmet was found latched without the strap feeding through the securing hook/lock.

**Figure 12:** (Left) A demonstration of the helmet latching (securing) mechanism similar to that of the pilot in this accident. (Right) The manner in which the pilot's helmet was found post-accident.

- 3.2.10 The pilot's helmet was found on the ground just above the main rotor head with its cable still connected to the headset audio jack. Its securing latch was found engaged but the strap was not fed through the lock/hook.

- 4.1.1 The Gyrocopter Operational Manual does not prescribe that a helmet should be worn during operation, but only the headset. Therefore, it is recommended that the manufacturer includes the wearing of the helmet during operation.

4.1.2 **Safety Message:** The Gyrocopter Operational Manual does not prescribe that a helmet should be worn during operation, but only the headset. Pilots are urged to wear and properly secure their helmets during operation to prevent or minimise the possibility of injuries should an accident occur.

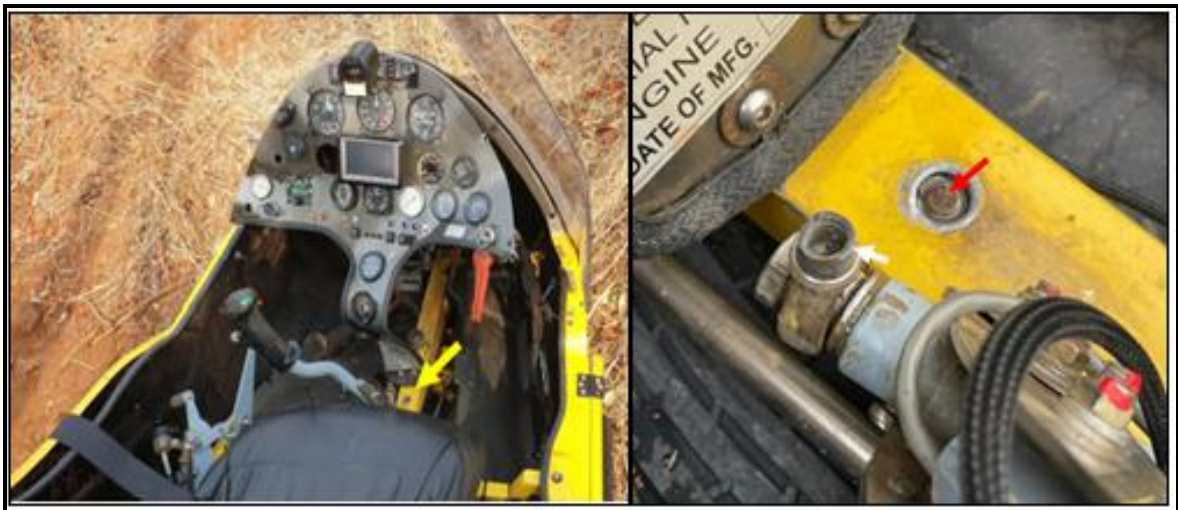
**Annexure Figure 12 :** Shows the failed eye-end bolt mounting section.

*Photographs taken shortly after the accident and provided to the Writer. The arrows were added by the Writer. The red arrow in the bottom image shows a brownish substance on the bottom end of a bolt that was screwed into the rod end with its internal female screw thread. The rod end was at the bottom of the front control stick. The white arrow in the bottom image shows the fracture surface of the rod end. This fracture surface was not corroded and is therefore indicative of a fresh fracture surface. The matching fracture surface at the red arrow was also not corroded.*

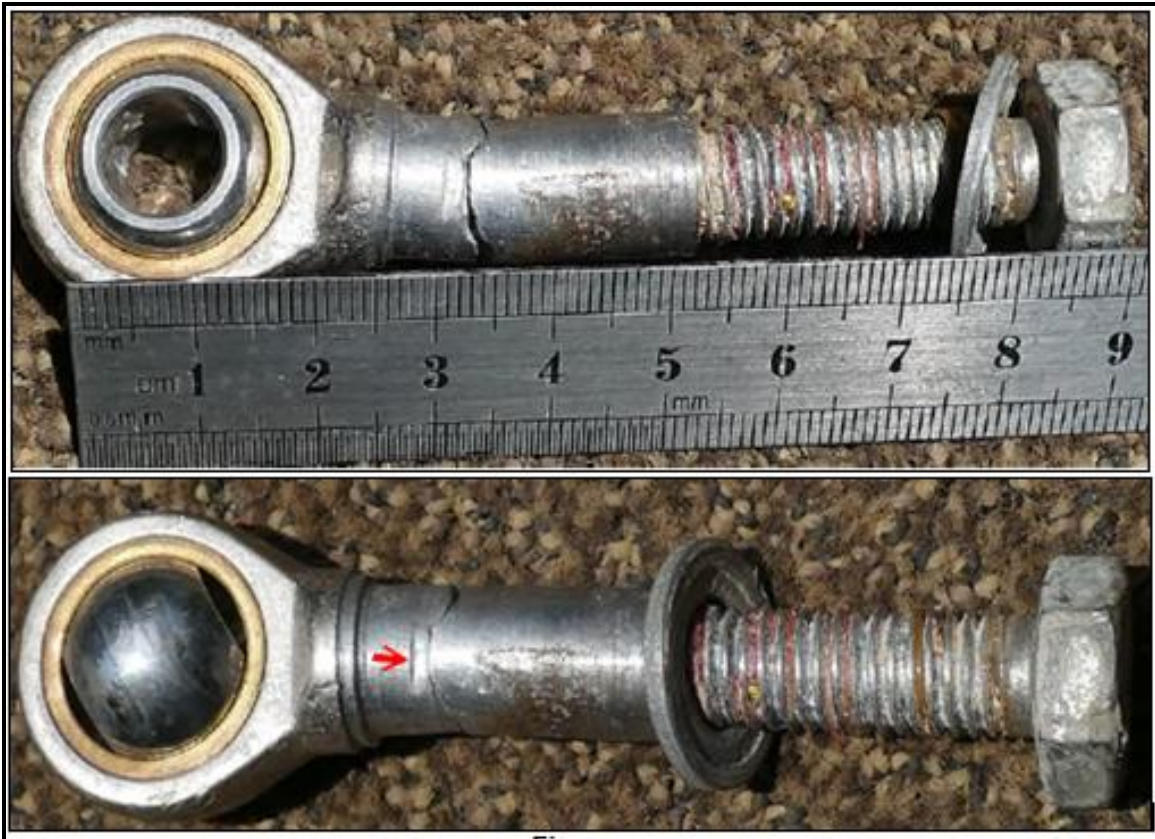
**Annexure Figure13:** Shows the failed eye-end bolt

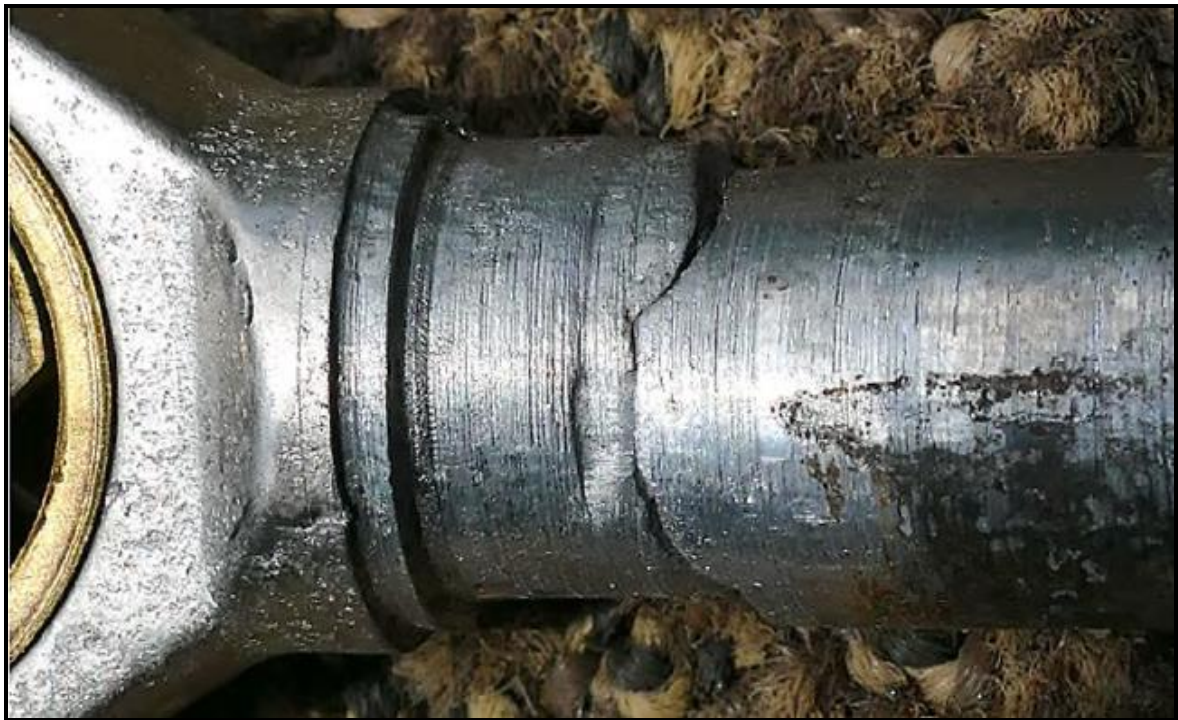
**Annexure Figure 14:** Shows the failed part of the eye-end bolt

*The indentation on the one side of the hollow end portion of the rod end, with female screw thread identified with the red arrow, and the morphology of the failure along the circumference of the rod end, especially along this side of the component, indicate that the rod end was subjected to abnormal bending. The side identified with the red arrow was subjected to compression. The opposite side was subjected to tension during the bending action. Also refer to the following figure.*

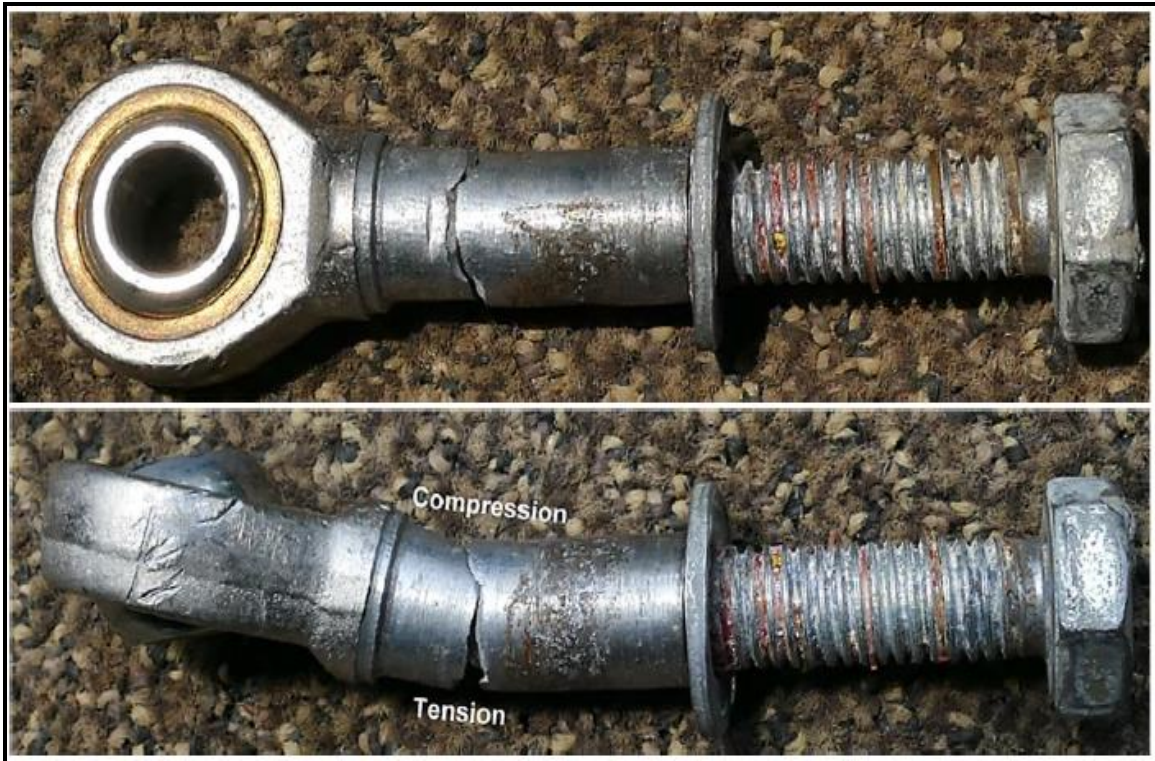
**Annexure Figure 15:** Demonstration of forces that caused the bolt to fail

*The rod end with internal female thread was subjected to bending, which produced an overload shear failure from the internal screw thread at the end of the bolt that was screwed into the threaded end portion of the rod end (following image)*

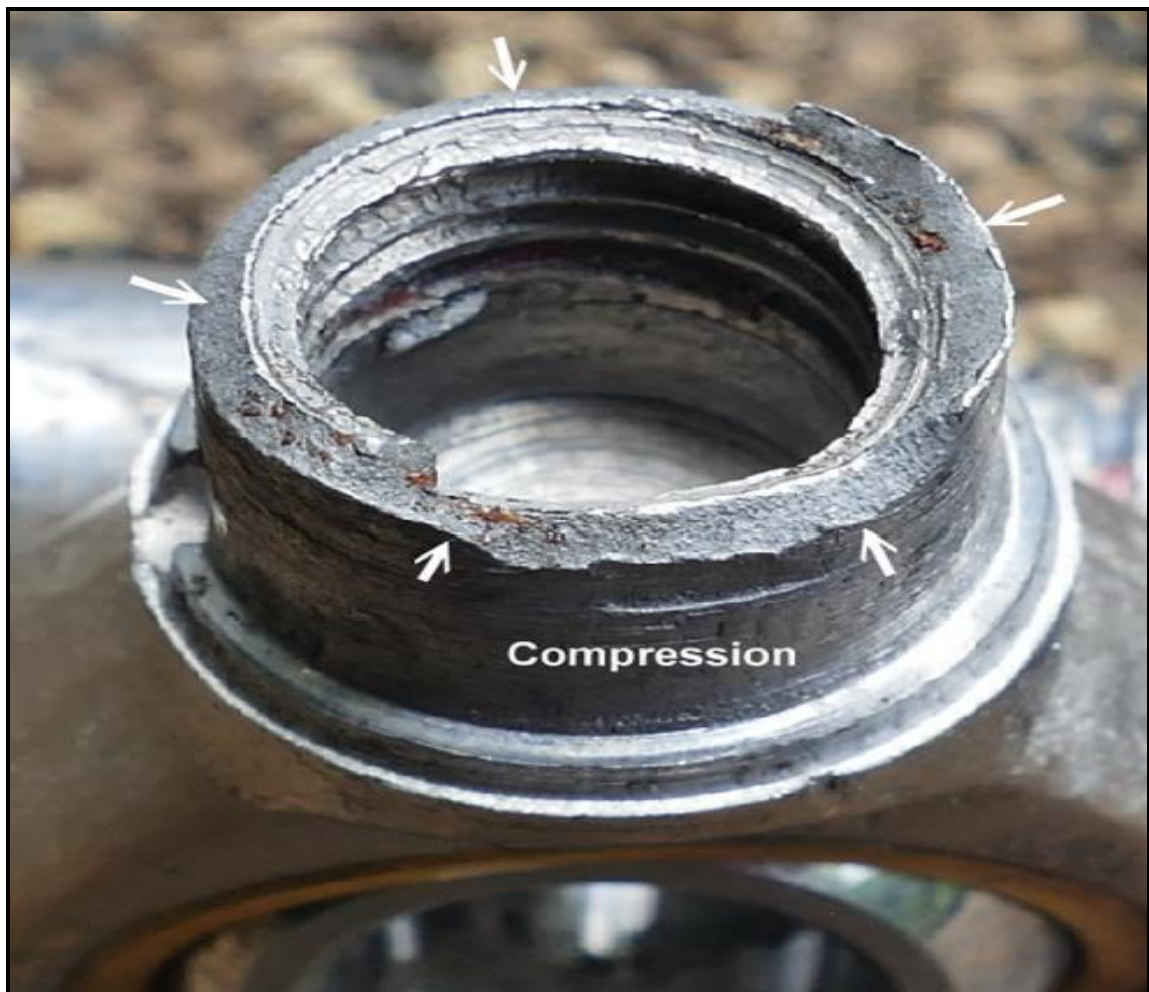
**Annexure Figure 16:** Demonstration of shear failure on the bolt circumference

The arrows identify an approximately 45° shear failure along the entire circumference of the threaded end portion of the rod end. This failure surface did not exhibit any evidence of fatigue cracking, i.e., the threaded end portion of the rod end failed during a single overload (bending).

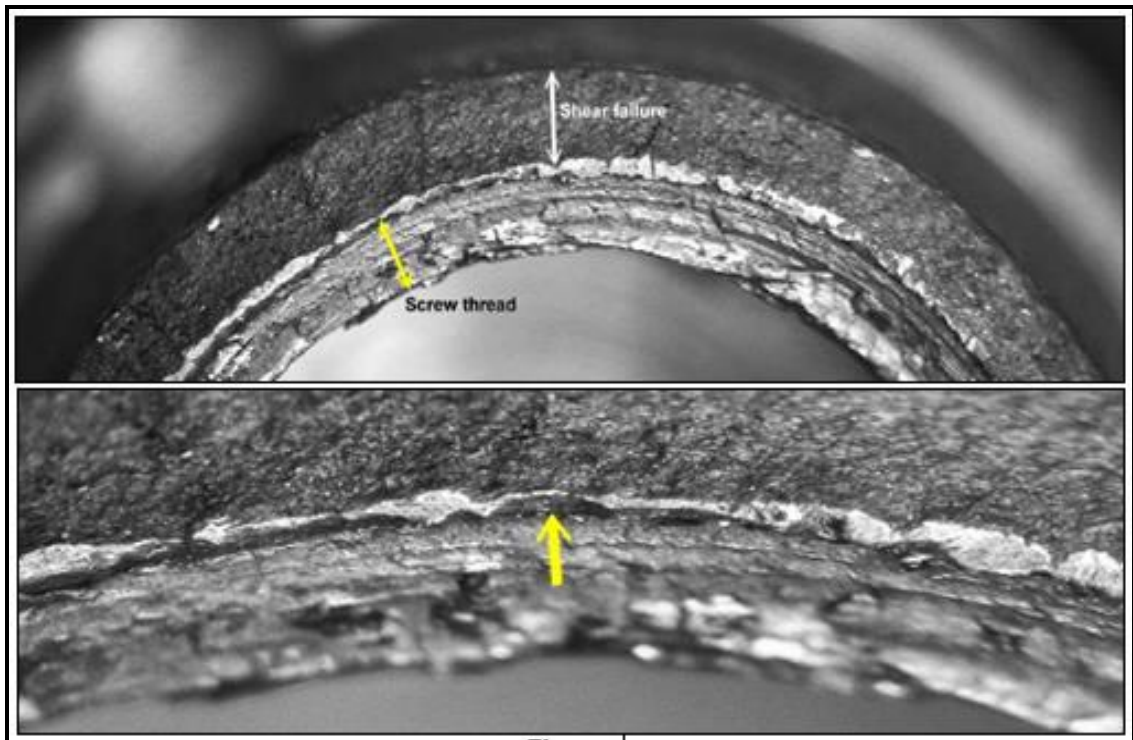
**Annexure Figure 17:** Shows the stereomicroscopic image of the failure portion

*Stereomicroscopic images of a portion of the failure surface of the rod end in the previous figure. The arrow in the bottom image identifies the original position of the screw thread root. When a fatigue crack develops it usually develops from this location from inside the screw thread. The failure surface at the screw thread did not exhibit any evidence of even a shallow fatigue crack.*

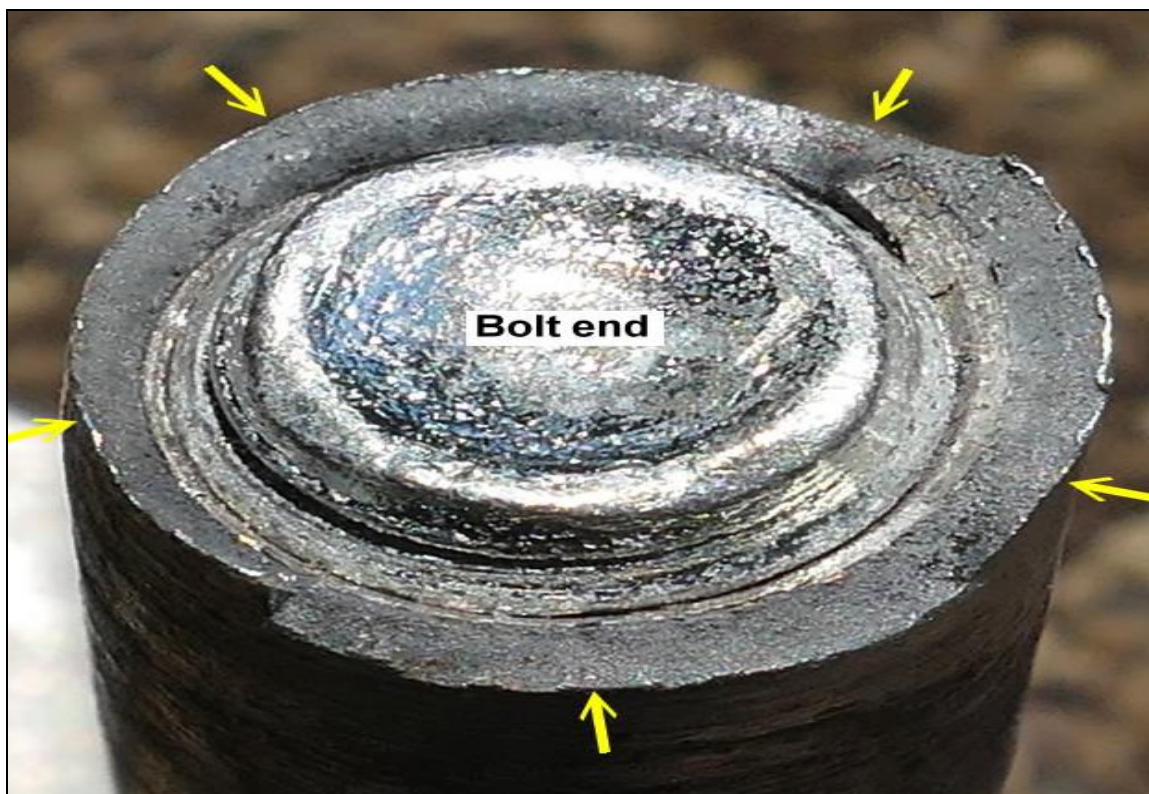
**Annexure Figure 18:** Shows the matching analysis of the failure surface

Matching failure surface of the rod end for the failure surface in Figure 3a. The threaded end portion of the rod end failed at a substantial stiffness transition, with the maximum bending stress in the rod end at the end of the bolt that was partially screwed into the rod end. The internal screw thread of the rod end offered a severe stress concentration, producing a shear failure along the entire circumference of the rod end. The unaffected electroplated end of the bolt indicates that the brownish substance observed on the bolt end immediately after the accident was dirt and not a corrosion product from the bolt

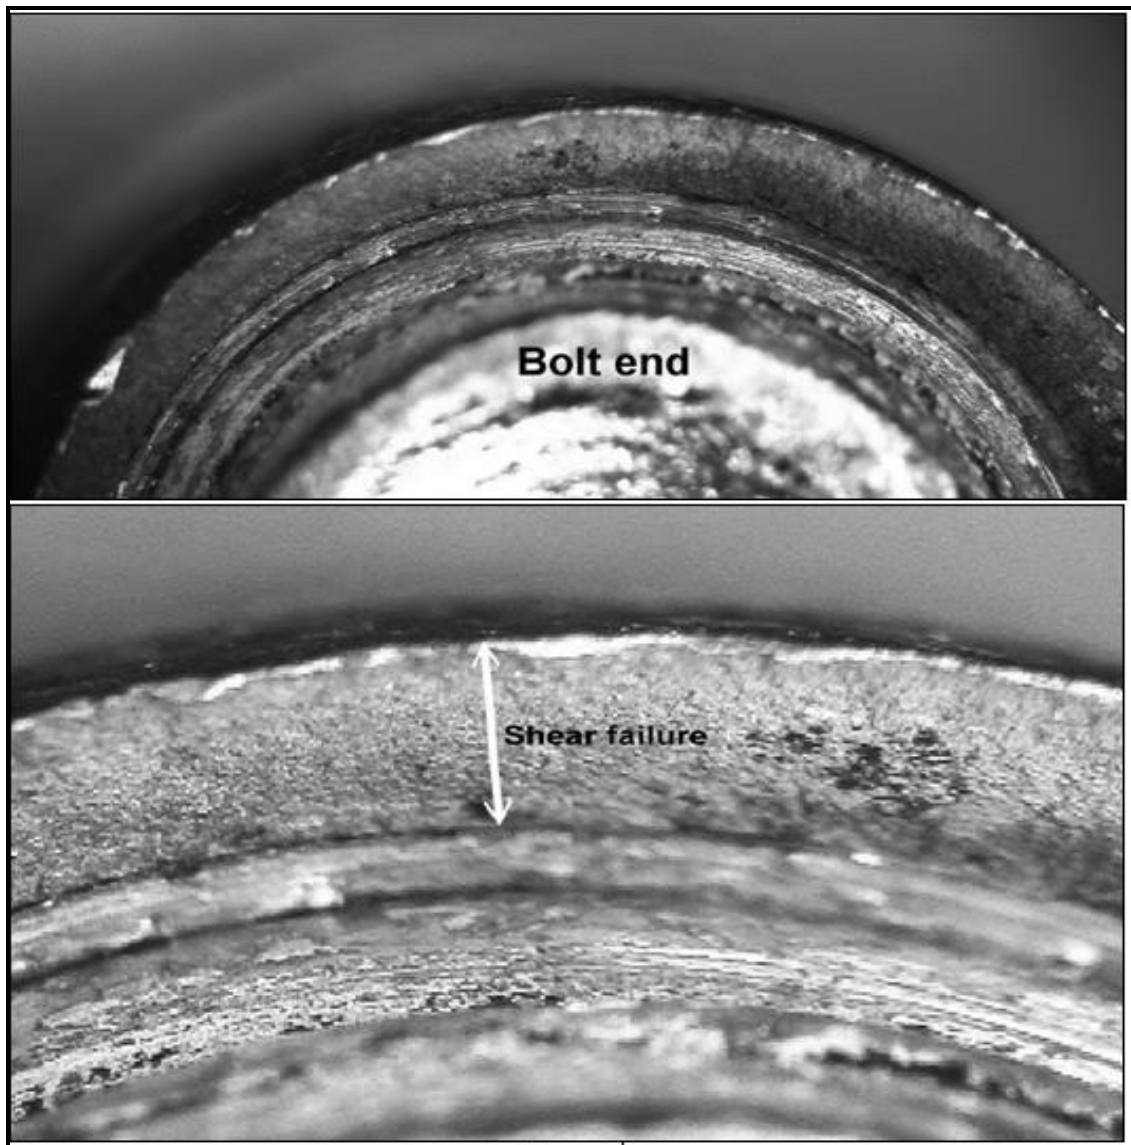
**Annexure Figure 19:** Stereomicroscopic image of the shear failure on the rod surface

*Stereomicroscopic images of a portion of the failure surface of the rod end in the previous figure.*
