AIRCRAFT ACCIDENT REPORT AND EXECUTIVE SUMMARY

Reference:		CA18/2/3/10075		
Helicopter Registration		ZS-REH	Date of Accident		13 November 2021		Time of Accident	1445Z
Type of Helicopter		Robinson 22			Type of Operation		Training (Part 141)	
Pilot-in-command Licence Type		Student Pilot Licence (SPL)		Age	35	Licence Valid	Yes	
Pilot-in-command Flying Experience			Total Flying Hours		36.4		Hours on Type	36.4
Last Point of Departure		Virginia Aerodrome (FAVG), KwaZulu-Natal Province						
Next Point of Intended Landing		Virginia Aerodrome (FAVG), KwaZulu-Natal Province						
Damage to Helicopter		Substantial						
Location of the accident site with reference to easily defined geographical points (GPS readings if possible)								
On the flat top of Maphephetha Mountain at Inanda GFA (GPS position: 29°38'16.37" South 030°51'22.28" East), at an elevation of 2192 feet (ft).								
Meteorological Information		Surface wind: 070°/11 kts, temperature: 27°C; dew point: 17°C; CAVOK QNH: 1010hPa

Probable Cause								
It is likely that the heel of the right skid got stuck in the soft soil, which led to loss of control and a dynamic roll over.								
SRP Date		13 December 2022			Publication D

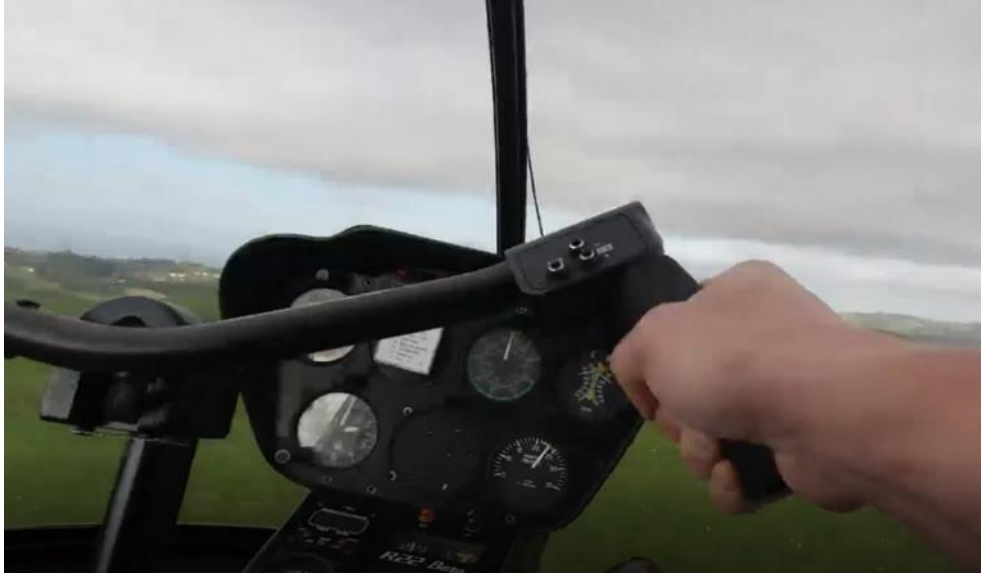
- 1.1.4. The student pilot was wearing an action camera on his chest during the accident flight. The investigators replayed the video footage frame-by-frame to analyse the sequence of events. On the video footage, *the helicopter becomes lighter on the skids at 18 inches manifold pressure (MP) as it starts to yaw to the right with the nose in a pitch-up attitude and without any intervention/input from the student pilot on the controls. The student pilot then makes an abrupt left cyclic input which results in the helicopter swinging to the left-side first, and then to the right-side until the helicopter is greater than 45° angle of bank. This was evidenced by the instrument panel cutting through the horizon at an angle. The student pilot's inputs to correct the helicopter angle are all in vain. Thereafter, the helicopter completes a full 360° roll to the right-side before it comes to a stop on its skids in an upright position. During loss of control, there are no visible warning lights on the instrument panel and the MP is at 25 inches. The engine and the rotor revolutions per minute (RPM) are in sync at the time of loss*

of control. After impact, the sound of the engine running at high rpm is heard. Post-accident, the student pilot walks away from the helicopter; and the video ends.

Figure 1: A still picture of the video footage during the accident. (Source: Pilot)

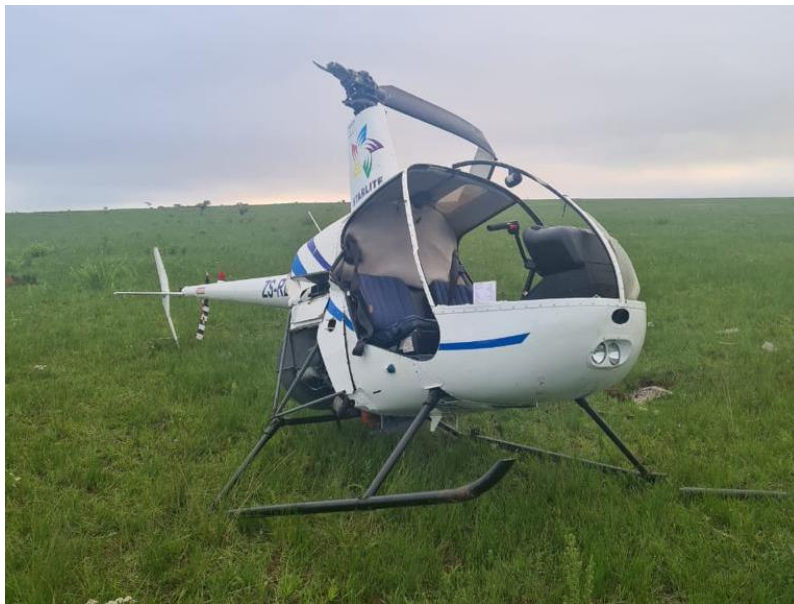
1.3.1. The aircraft sustained substantial damage during the accident sequence.

Figure 3: The helicopter as it came to rest at the accident site.

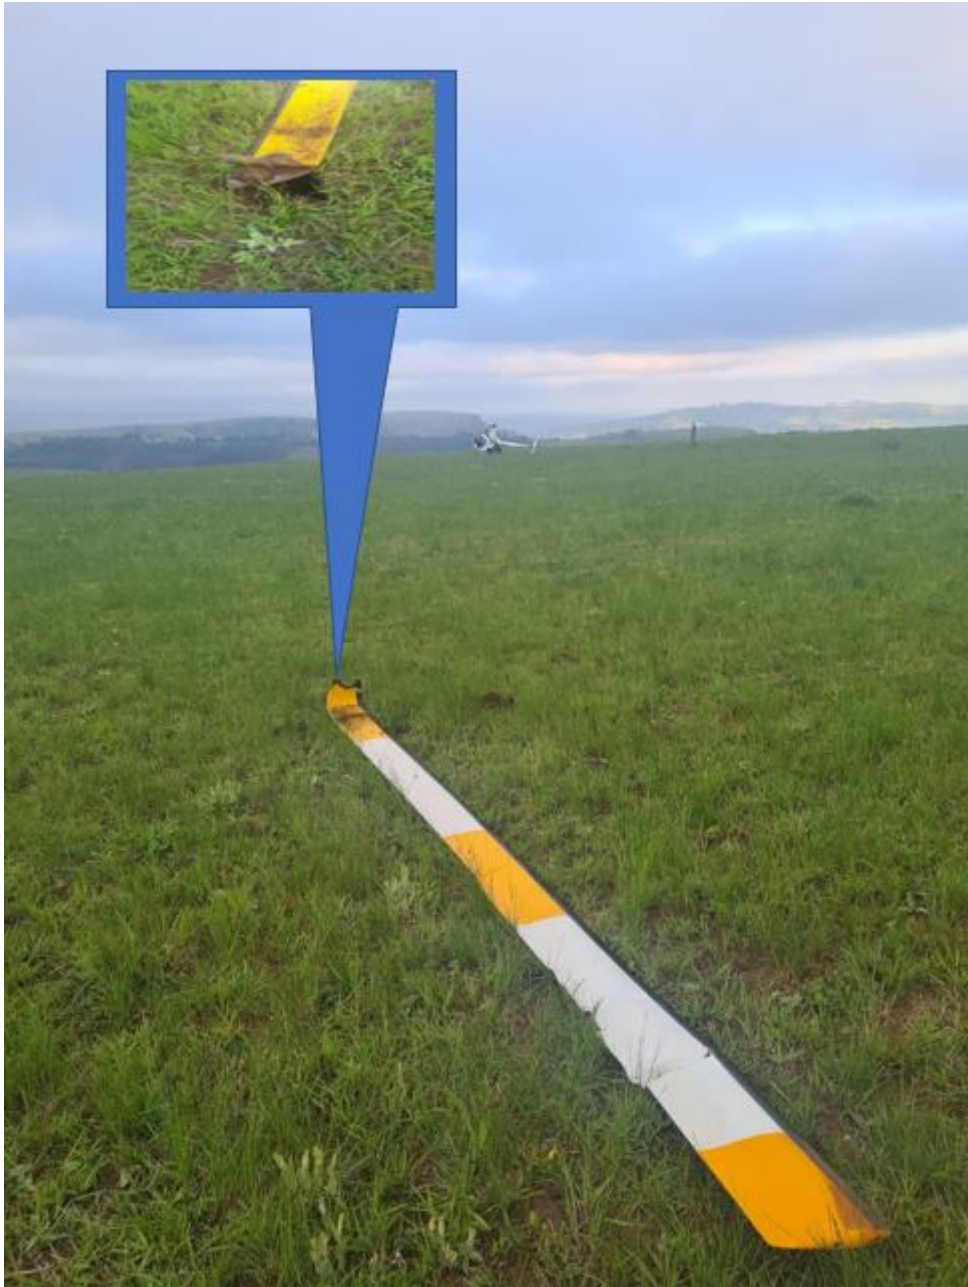
1.12.2. The main rotor blade that had detached from the helicopter was located 70.9 metres (m) from the helicopter (Figure 5). The other main rotor blade was found wrapped around the helicopter anti-clockwise (direction). The main rotor hub was still intact; however, the bumpers had sheared off in the middle, indicative of excessive mast bumping. The swashplate was still intact, whilst the scissor link sustained damage on its attachment point. The pitch link of the detached blade was still intact; however, the pitch link of the other blade had sheared off at the upper rod end; it was found hanging loose on the lower rod end. The attachment hardware of the upper rod end was not located at the accident site. The mast was still attached, and the main rotor gearbox exhibited damage on the attachment points. The control tubes were still intact with the middle tube slightly bent. The continuity of the control tubes was not verified due to the jammed flight controls bell crank. The position of the collective control stick was in a raised position almost three-quarters ($\frac{3}{4}$) of full travel (from the video footage), and was jammed in that position. The throttle was also stuck in position, and it was hard to rotate. Both anti-torque pedals were still in position and were not damaged.

Figure 5: The detached main rotor blade. (Source: AMO)

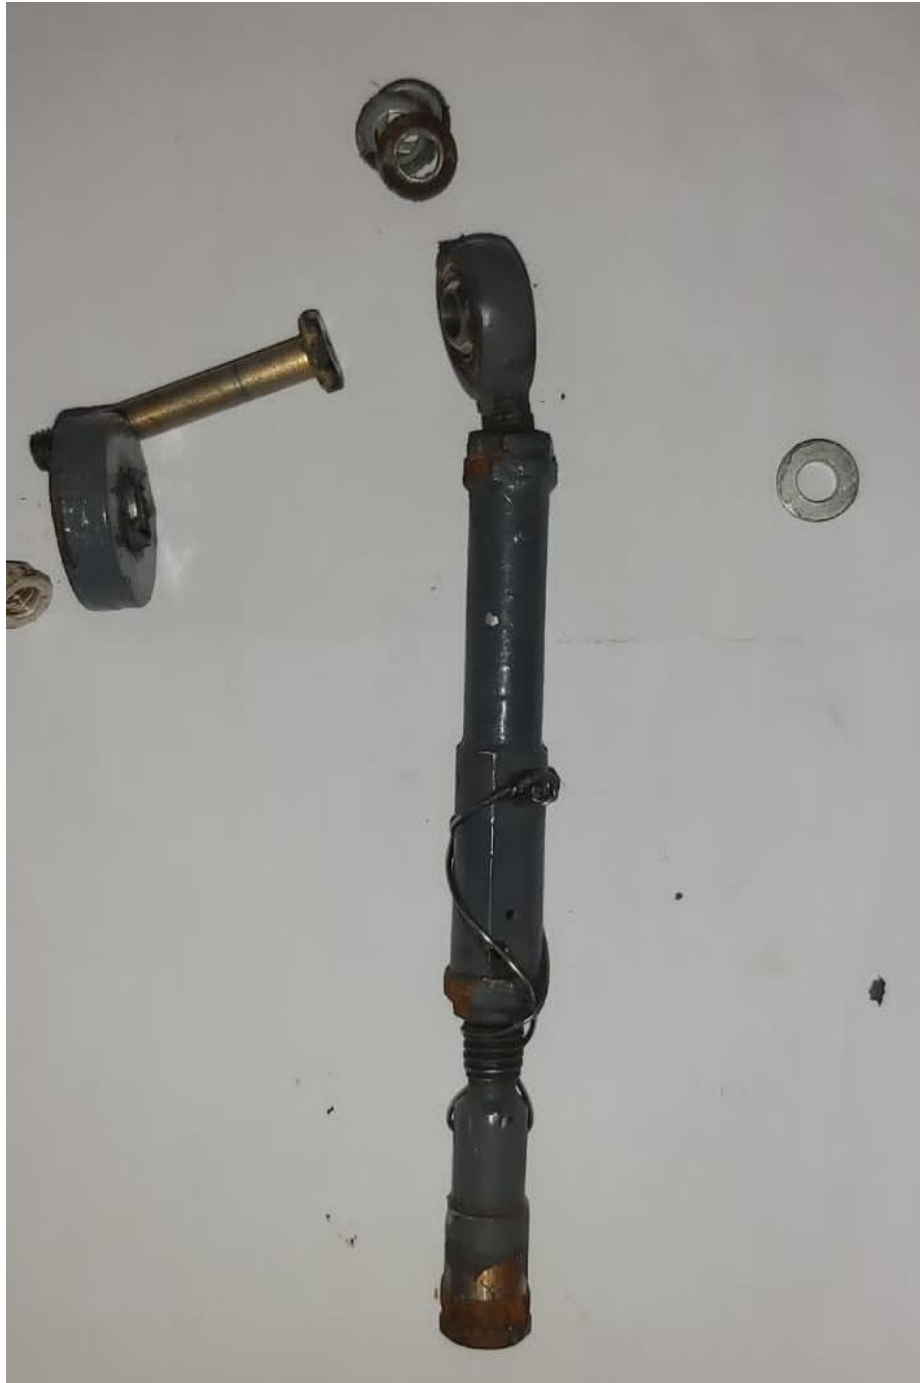
Figure 6: The broken pitch change link.

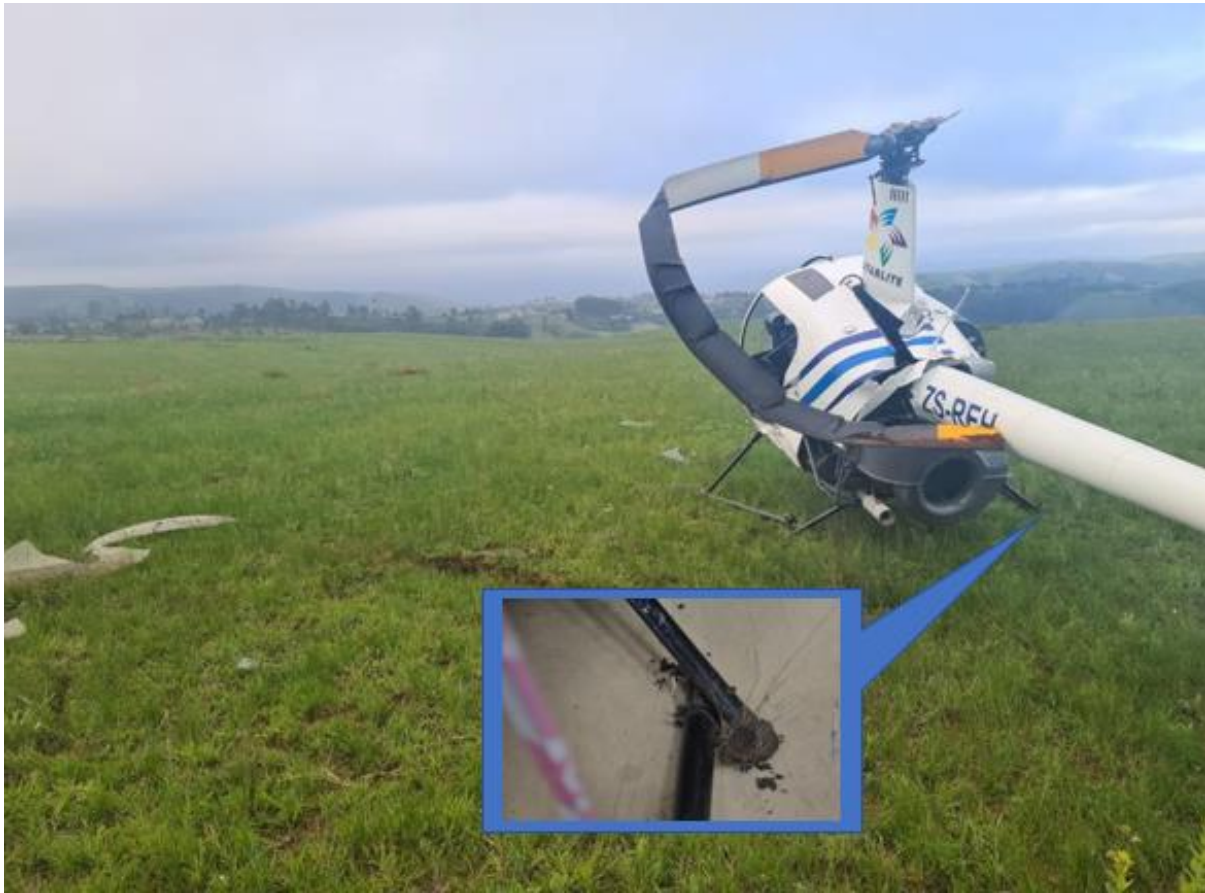
1.12.3 The tail boom section was still attached to the mountings with evidence of compression load and buckling on the left-side; a puncture on the skin surface indicated tail rotor blade impact. One of the tail rotor blades broke off at the root as a result of impact. The tail gearbox was still intact, and the 90° drive was still positive. The tail rotor pitch was checked, and the pitch link assemblies were found operational. The teller temperature indicator was at 66°C, indicative of normal operation; the oil level was full. The vertical fin was still intact except for the compression damage (which had bent) towards the bottom end. The vertical fin had traces of blades of grass and dirt at the top, an indication of contact with the ground, whilst the lower fin had a 90° bend to the left. The tail rotor guard had dirt and blades of grass, indicative of contact with the ground. The tail drive shaft was still attached to its bearings, but

the flex plate had fractured. The shaft was broken and had disconnected from the yoke assembly.

Figure 7: Damage sustained by the tail boom and the right skid. (Source: ATO)

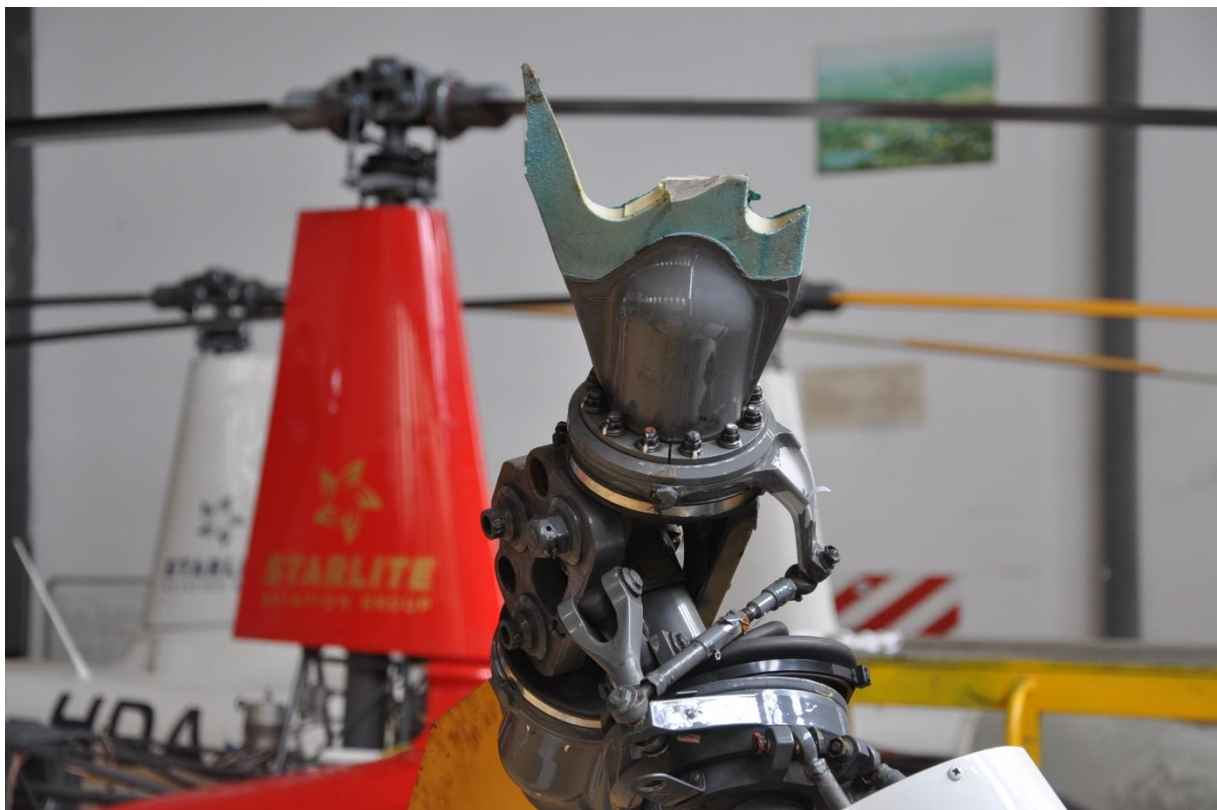
Figure 8: The sleeve showing where the blade had detached.

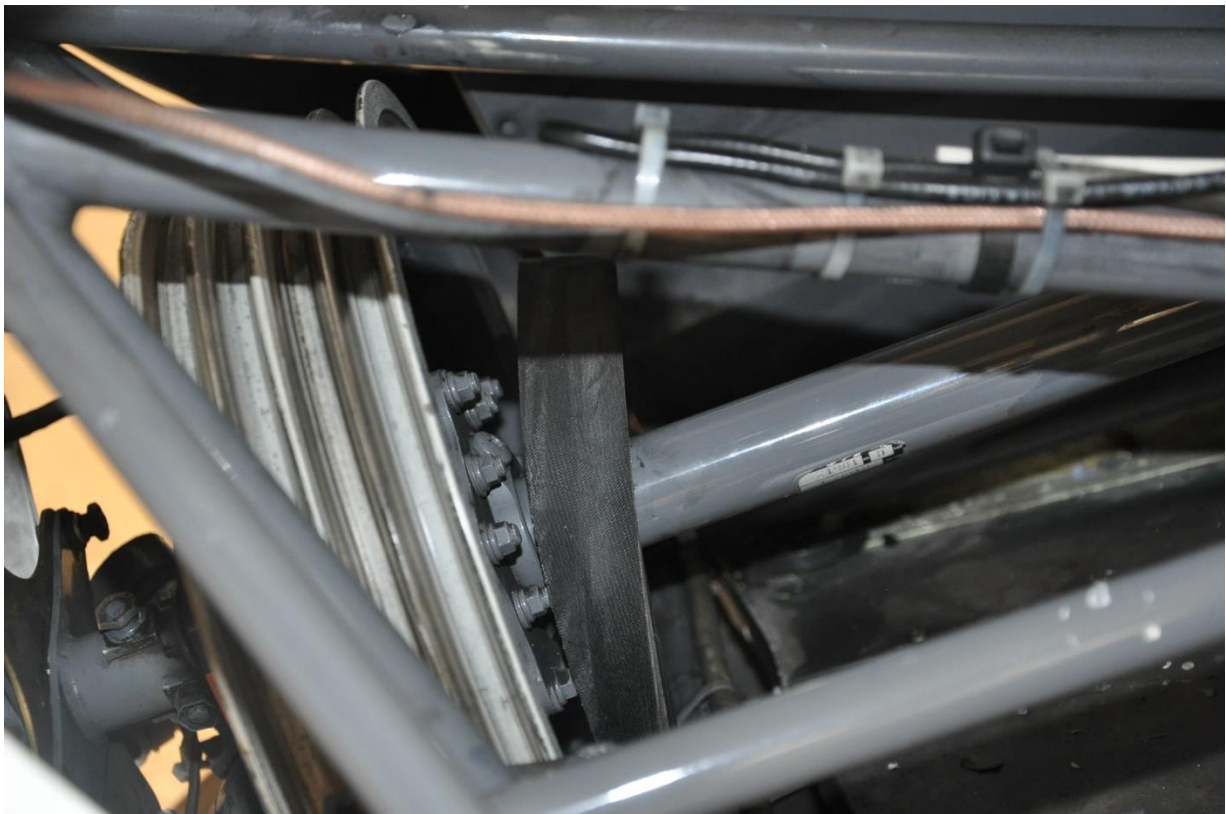
1.12.4 The engine was still secured in the cradle, although damage was seen on the left lower side of it (cradle). The oil level indicated five (5) quarts; no oil leak was visible. The throttle tube was wedged into the skin surface and movement could not be confirmed. The V-belts had detached from the sheath and one of the belts was not accounted for. The tele-temperature of the lower bearing indicated 56°C, which is normal operation. The nut securing the cooling fan to the engine was misaligned, indicative of the engine producing power at impact. The alternator belt was still connected to the alternator. The firewall had buckling damage. Battery attachment points and terminals were found broken as a result of the impact.

Figure 9: The upper sheath and belt.

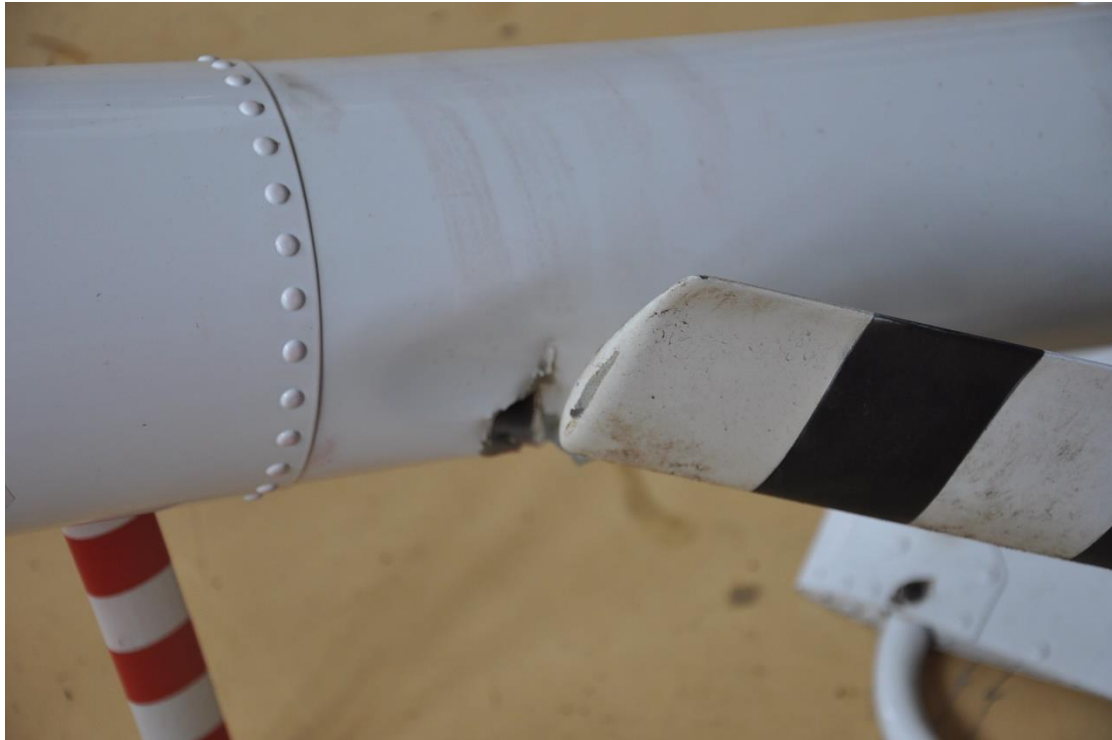
Figure 10: The punctured boom.

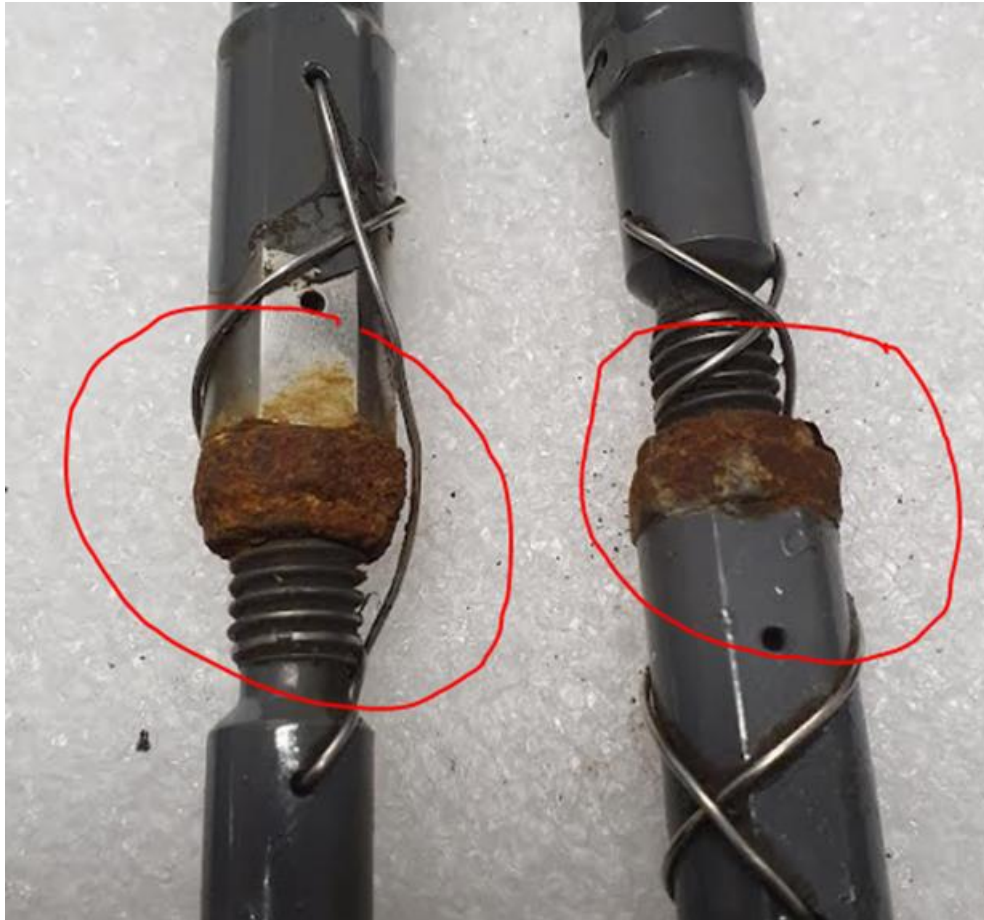
1.16.1. The lock nuts on the control pitch change links revealed extensive corrosion damage. The failed components were recovered and sent to the University of Pretoria for metallurgical analysis. The cause of this corrosion was due to the breakdown of the painted protective layer coating which exposed the steel-based nuts to the operation environment, as well as the galvanic action between the nut and the more inert steel adjuster body. The evidence suggested that the corrosion damage was present for a long time and should have been detected during the walk-around inspections, the mandatory periodic inspections (MPI) and the pre-flight checks.

Figure 11: Corroded pitch change links. (Source: University of Pretoria)

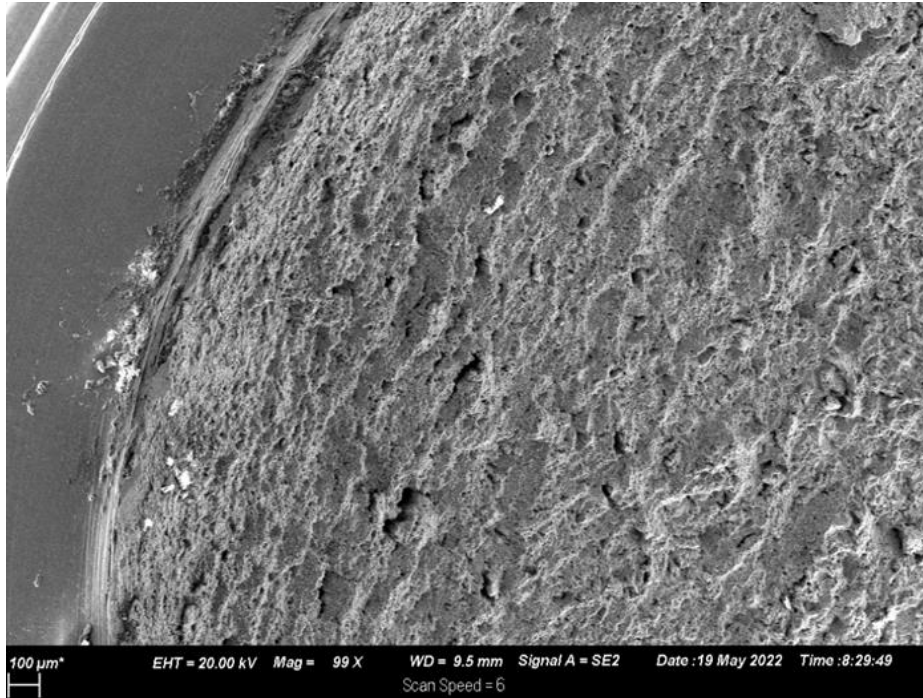
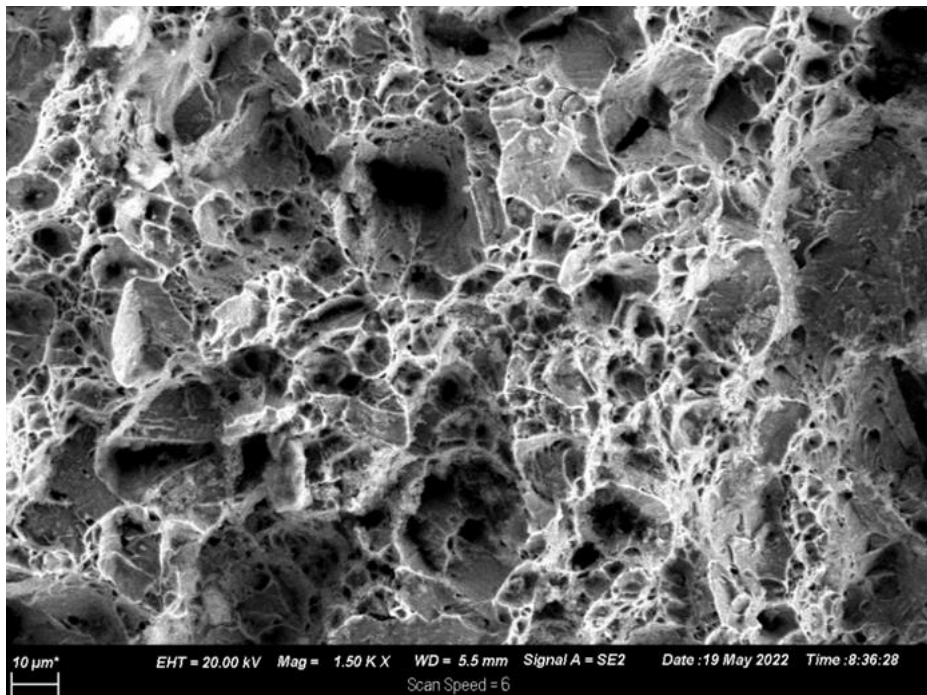
1.16.2 The threaded section of the eye-end revealed some bending deformation at the vicinity of the primary fracture. No clear indication of a pre-existing fracture was noticed at the initiation point, i.e. fatigue, corrosion or other material discrepancies. The fractured surface morphology corresponded with a steel-based exposure to an overload condition which showed ductile, microvoid coalescence features with indications of shear. (Figures 12 and 13).

Figure 12: Sheered bolt under microscope. (Source: University of Pretoria)

Figure 13: Magnified sheered bolt. (Source: University of Pretoria)

1.16.3 Considering the above, the fractured surface morphology corresponded with the steel-based wrought alloy exposed to a single overload operation.

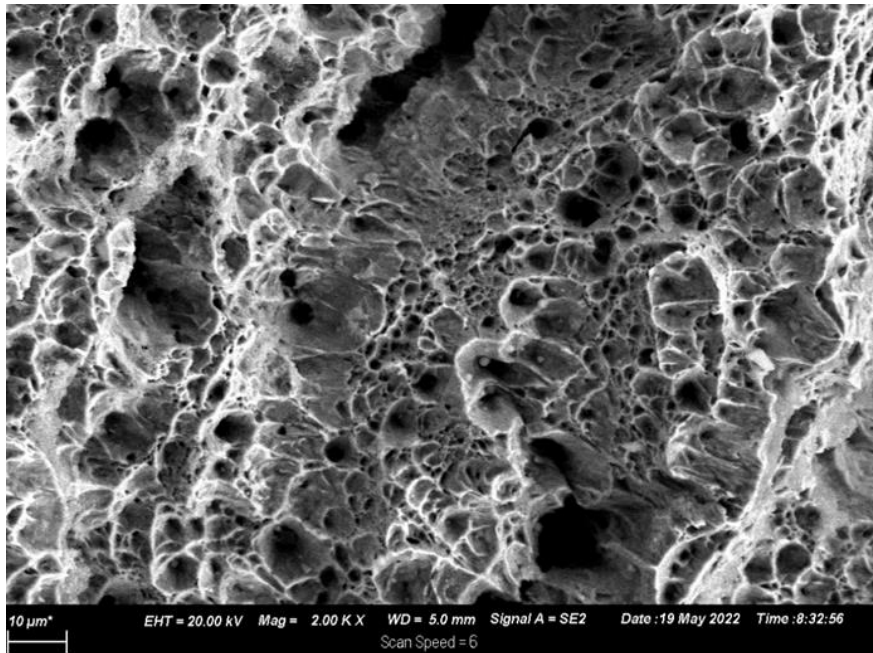
Figure 14: Enlarged magnified sheered bolt. (Source: University of Pretoria)

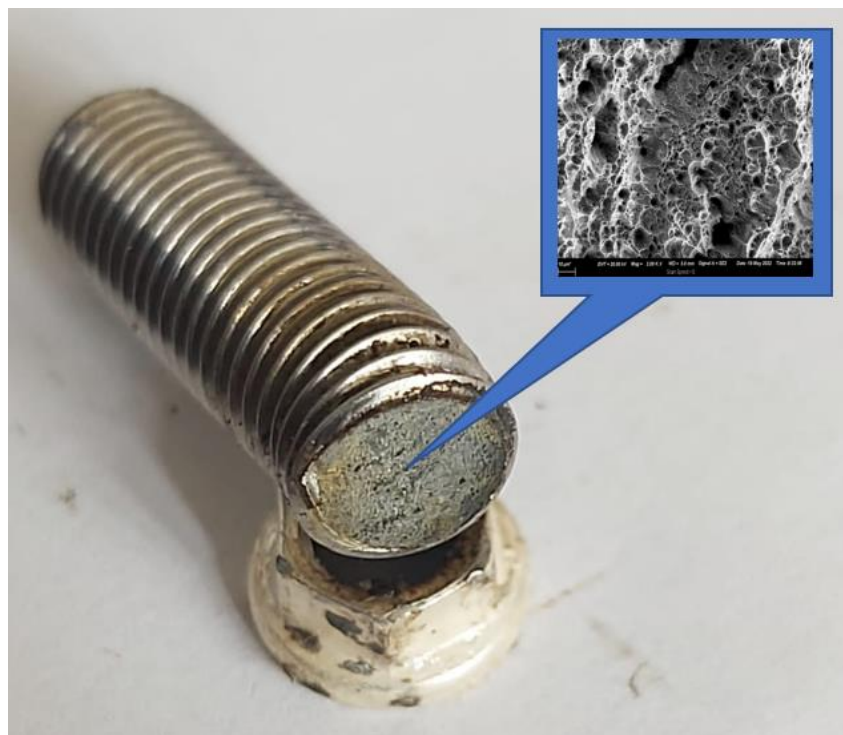
Figure 15: Sheered bolt. (Source: University of Pretoria)
