LIMITED OCCURRENCE INVESTIGATION REPORT – FINAL

Reference Number	CA18/2/3/10082						
Classification	Accident	Date	9 October 2022		Time	1015Z	
Type of Operation	Private (Part 94)						
Location							
Place of Departure	Wonderboom Aerodrome (FAWB), Gauteng Province		Place of Intended Landing	Kitty Hawk Aerodrome (FAKT), Gauteng Province			
Place of Occurrence	Right-side of Runway 01 at Kitty Hawk Aerodrome						
GPS Co-ordinates	Latitude	25° 51' 36.27" S	Longitude	028° 27' 1.61" E	Elevation	4586ft	
Aircraft Information							
Registration	ZU-IBE						
Make; Model; S/N	Jabiru J170 (Serial Number: 358)						
Damage to Aircraft	Substantial		Total Aircraft Hours	2898			
Pilot-in-command							
Licence Type	Private Pilot Licence (PPL)		Gender	Male		Age	21
Licence Valid	Yes	Total Hours	126.8		Total Hours on Type	1.4	
Total Hours 30 Days	0.8		Total Flying on Type Past 90 Days	0.6			
People On-board	1 + 1	Injuries	0	Fatalities	0	Other (on ground)	0
What Happened

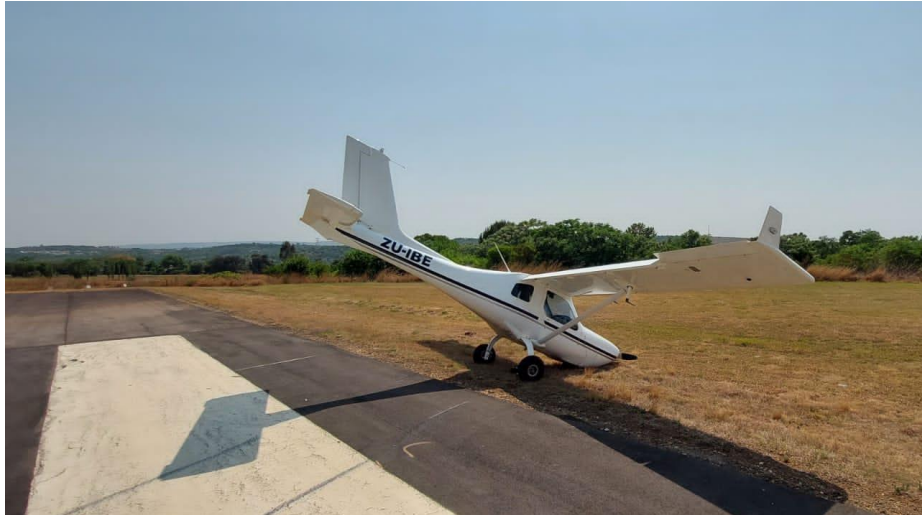
further slowdown the aircraft by steering the aircraft over to the grass area next to the runway. The pilot turned the aircraft to the right to avoid rolling into trees. However, the nose landing gear broke off upon touching the grass surface and the aircraft came to a full stop approximately 1m from the right of Runway 01. The pilot shut down the engine and exited the aircraft unassisted together with the passenger. They were both not injured.

Figure1: The aircraft at the accident site. (Source: Pilot)

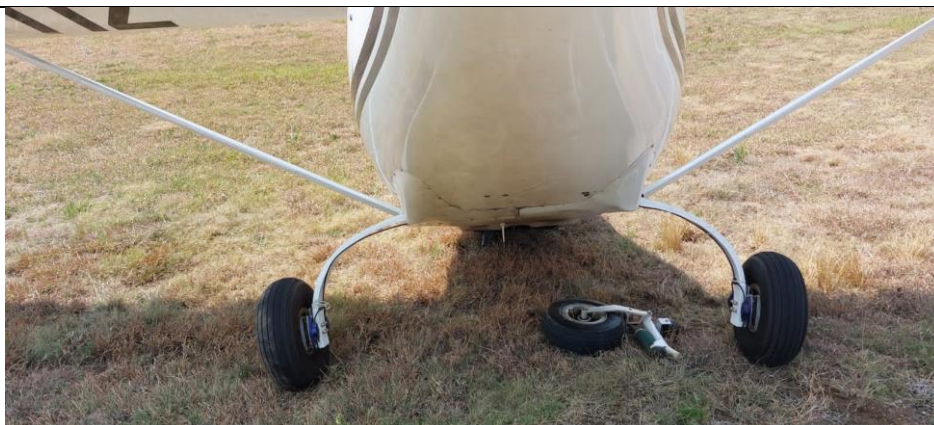
Figure 2: Damage to the aircraft. (Source: Pilot)

The pilot landed deep, which resulted in the pilot steering the aircraft onto the grass area; the nose gear broke off in the process.

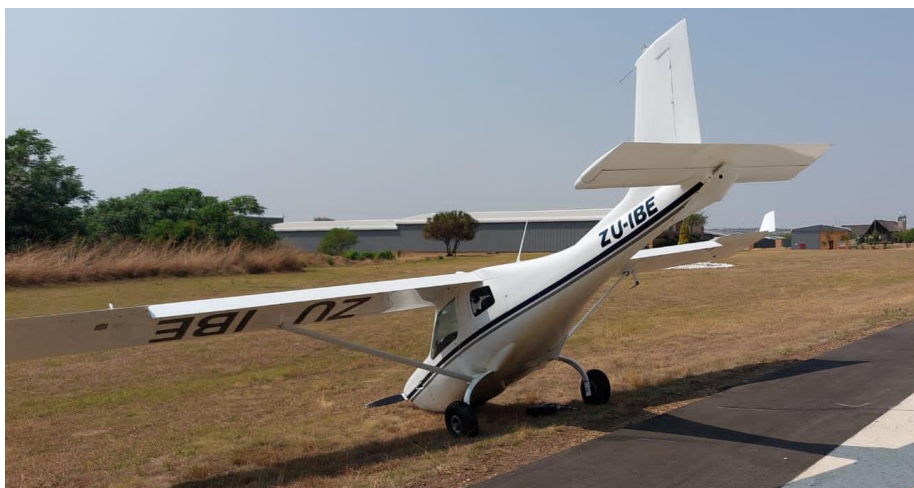
Figure 3: The aircraft as it came to rest. (Source: Pilot)

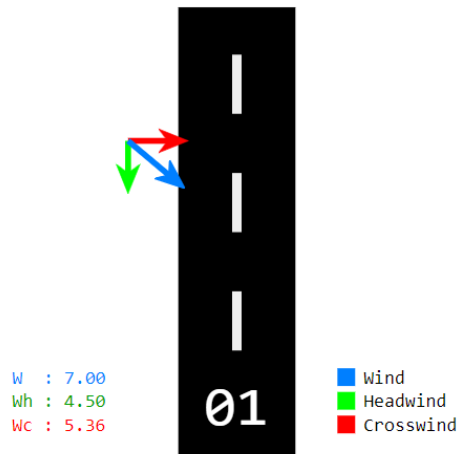
- The maximum allowable crosswind velocity is 14kts according to the POH. The crosswind was approximately 5.36kts, which meant that the wind conditions were within the capabilities of the aircraft.

Figure 4: Wind components on the day. (Source: e6bx.com/wind-components/)
