AIRCRAFT ACCIDENT REPORT AND EXECUTIVE SUMMARY

Reference:		CA18/2/3/10087	
Aircraft Registration	ZS-EZM	Date of Accident	7 December 2021		Time of Accident	0635Z	
Type of Aircraft	Cessna 177 Cardinal		Type of Operation		Private (Part 91)		
Pilot-in-command Licence Type	CPL (A)		Age	23	Licence Valid	Yes	
Pilot-in-command Flying Experience	Total Flying Hours		724.1		Hours on Type	36.4	
Last Point of Departure	Grand Central Airport (FAGC), Gauteng Province						
Next Point of Intended Landing	Grand Central Airport (FAGC), Gauteng Province						
Damage to Aircraft	Substantial						
Location of the accident site with reference to easily defined geographical points (GPS readings if possible)							
Approximately 300 metres from the threshold of RWY 31 at Baragwanath Aerodrome (FASY), at GPS co-ordinates determined to be 26°21'05.2" South 027°47'10.8" East at 5439 ft AMSL							
Meteorological Information	Surface wind: 360°/10kt; temperature: 21°C; dew Point: 15°C; CAVOK; visibility: 9999m; QNH: 1025hPA

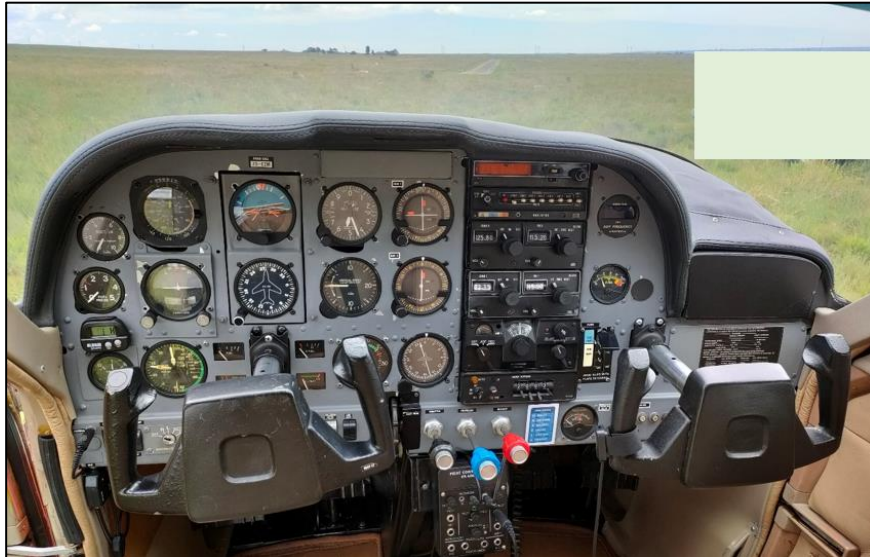
- 1.1.7. The pilot then glided the aircraft towards Baragwanath Aerodrome (FASY); however, it lost height rapidly, resulting in the aircraft undershooting RWY 31 by approximately 300 metres (m). During touchdown, the nose landing gear collapsed, and the aircraft came to an abrupt stop. The aircraft was substantially damaged; however, the occupants did not sustain any injuries; they disembarked from the aircraft unassisted.

Figure 1: A view from inside the cockpit with the runway visible in the 12 o'clock position. (Source: Accident Claim Accessor)

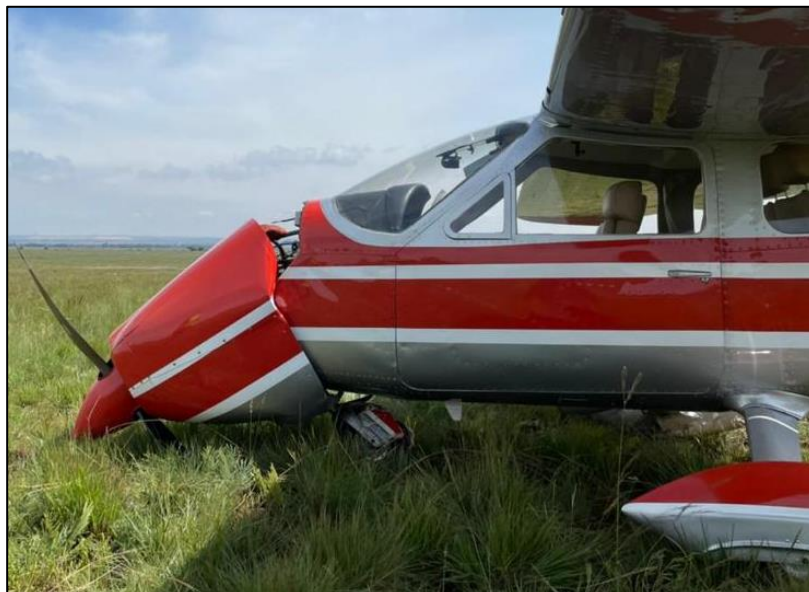
1.3.1. The aircraft was substantially damaged.

Figure 2: The aircraft post-accident. (Source: Pilot)

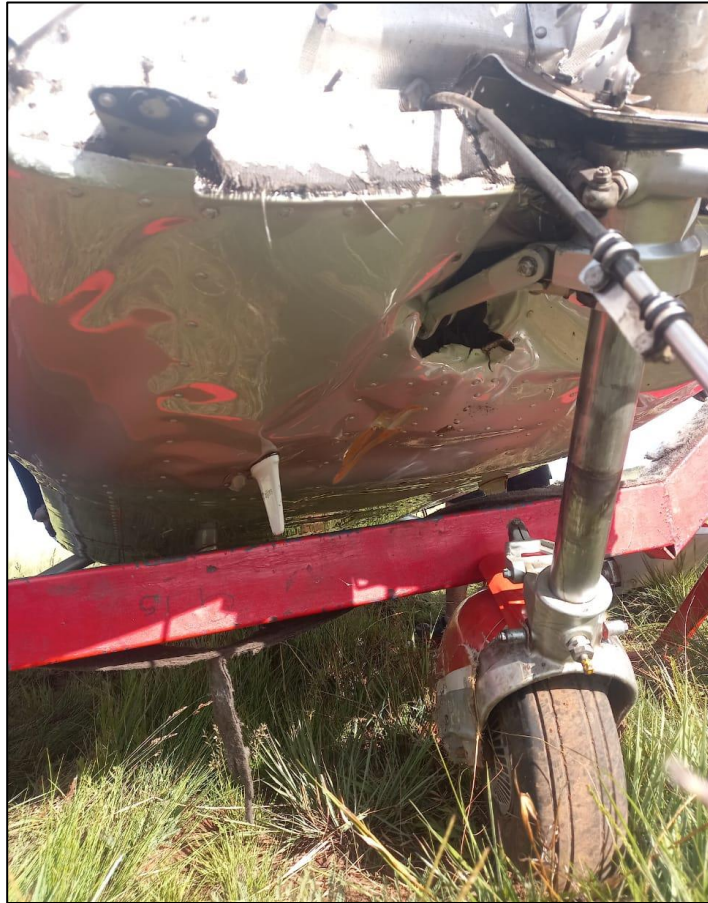
1.12.3. The engine separated from the cradle and firewall. The firewall was damaged, whilst the nose

landing gear strut collapsed backwards.

Figure 3: The nose landing gear strut that collapsed.
(Source: Pilot)

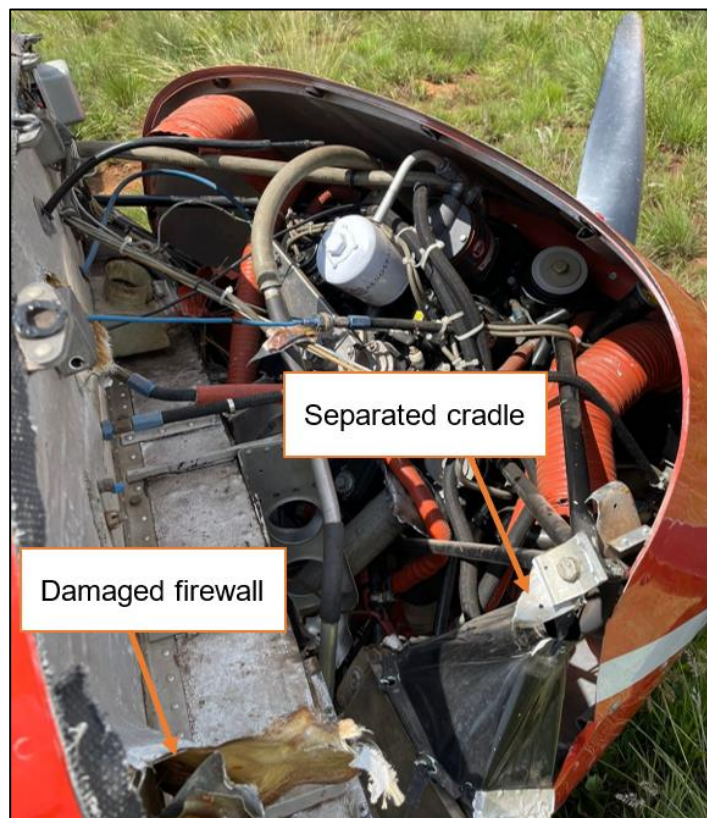
Figure 4: Damaged firewall and separated engine cradle.
(Source: AMO)

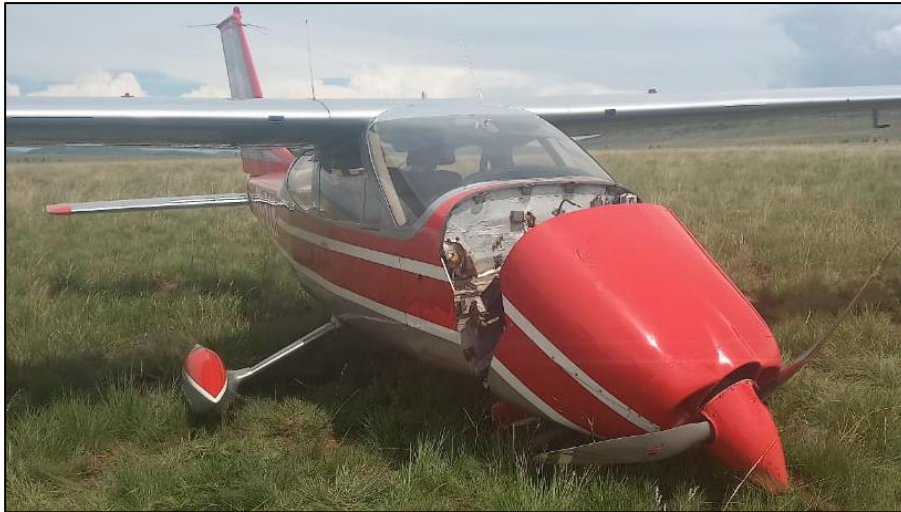
1.12.4. Based on the appearance of the propeller blade in Figure 5, the lack of visible damage or twisting is consistent with the engine not producing power at impact.

Figure 5: Appearance of propeller blades post the accident. (Source: Pilot)

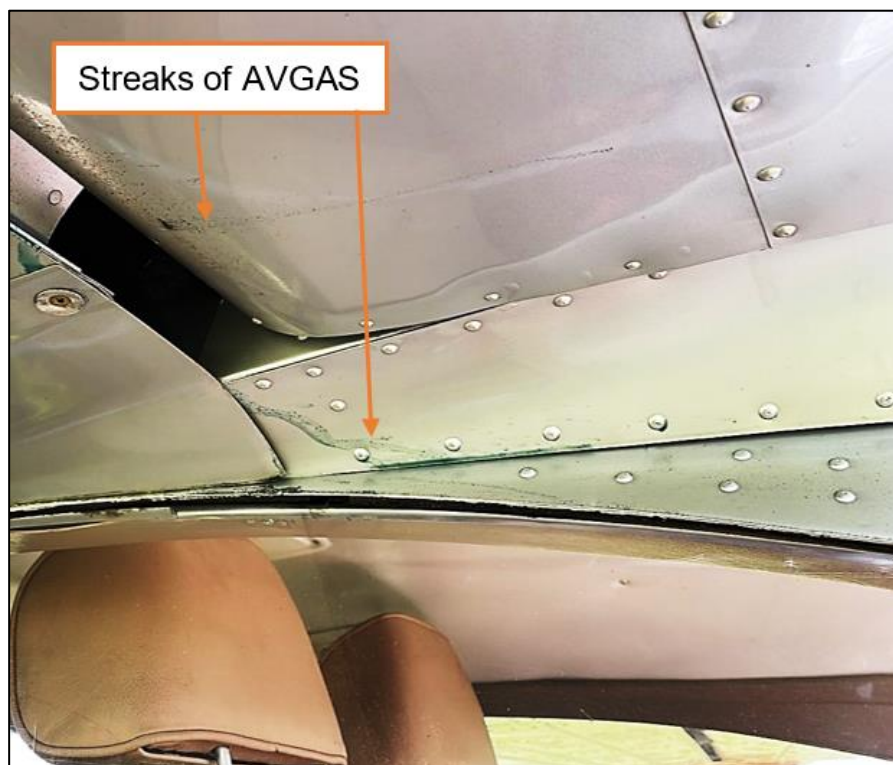
1.12.5. Post-accident, the pilot noticed fuel residue, characterised by its blue colour, underneath the left-wing fuel tank and along the roof of the cabin.

Figure 6: Streaks of AVGAS underneath the left fuel tank (left image) and along the roof of the cabin (right image). (Source: Pilot)

2.1.19. Post-accident, the pilot found both fuel tanks empty and noticed fuel residue underneath the left fuel tank and along the roof of the cabin. According to the pilot, this suggested that some fuel had leaked out from the left fuel tank. However, the two occupants did not smell the fuel running along the cabin roof.

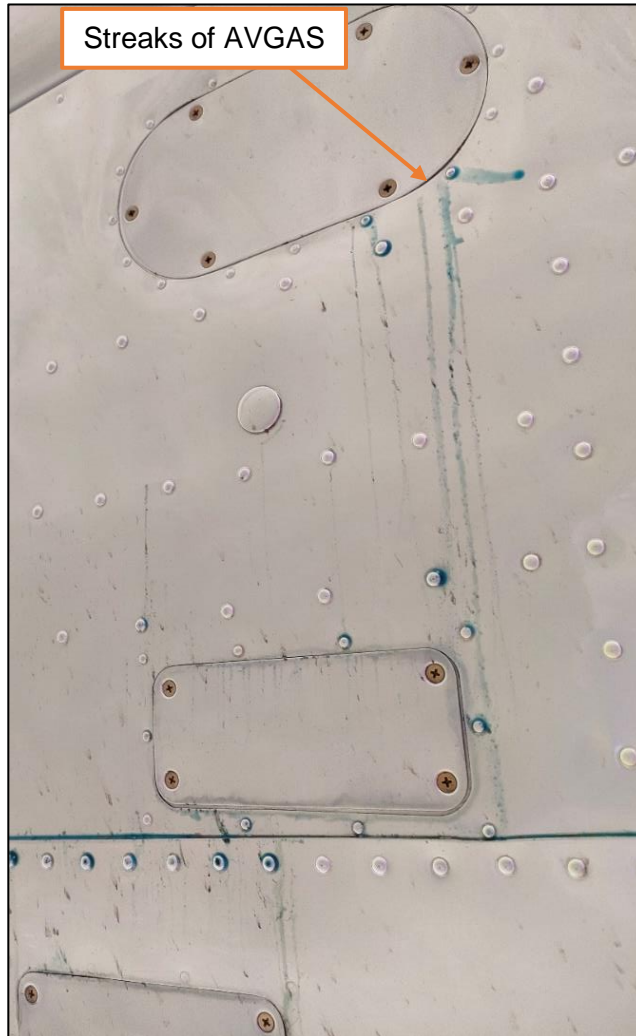
Figure 7: The photograph was taken on site of the lower left wing. (Source: Pilot)

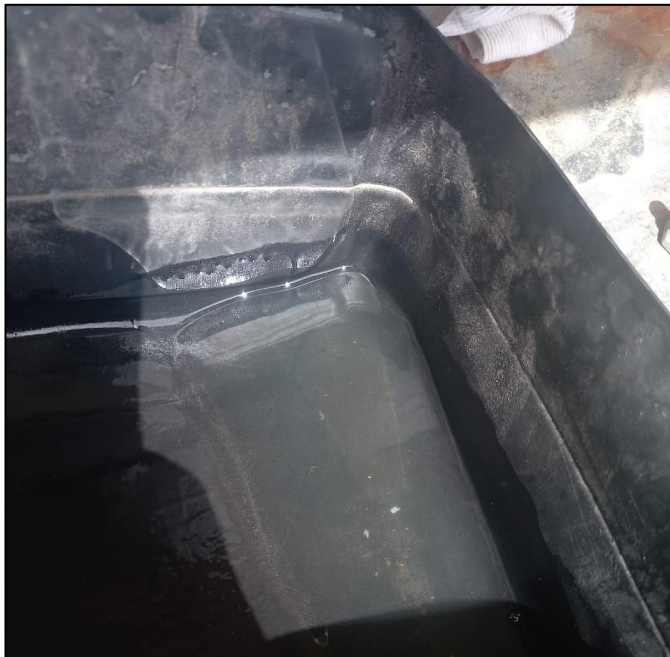
- A 5-litre container was used to drain the remaining fuel in the fuel tanks before the wings of the aircraft were removed for transportation. Approximately 200 millilitres (ml) of fuel was drained from both the left- and the right-wing tanks, of which 50ml was water sediment.

Figure 8: Fuel drained from wing tanks during recovery.
(Source: AME)
