**AIRCRAFT ACCIDENT REPORT AND EXECUTIVE SUMMARY**

<b>Reference:</b>		CA18/2/3/10091		
<b>Aircraft Registration</b>	ZU-MDA	<b>Date of Accident</b>	11 December 2021		<b>Time of Accident</b>	0930Z	
<b>Type of Aircraft</b>	Slick-360		<b>Type of Operation</b>		Private (Part 94)		
<b>Pilot-in-command Licence Type</b>		ATPL (Aeroplane)	<b>Age</b>	66	<b>Licence Valid</b>	Yes	
<b>Pilot-in-command Flying Experience</b>		<b>Total Flying Hours</b>	± 16 300		<b>Hours on Type</b>	± 170	
<b>Last Point of Departure</b>		Baragwanath Aerodrome (FASY), Johannesburg, Gauteng Province					
<b>Next Point of Intended Landing</b>		Baragwanath Aerodrome (FASY), Johannesburg, Gauteng Province					
<b>Damage to Aircraft</b>		Destroyed					
<b>Location of the accident site with reference to easily defined geographical points (GPS readings if possible)</b>							
Open area adjacent the taxiway at FASY at GPS co-ordinates: 26°20'56.1" South 027°46'37.7" East, at an elevation of 5 426 feet (ft)

<b>Reference Number</b>	: CA18/2/3/10091
<b>Occurrence Category</b>	: Accident (Category 2)
<b>Type of Operation</b>	: Private (Part 94)
<b>Operator Type</b>	: Private
<b>Aircraft Registration</b>	: ZU-MDA
<b>Aircraft

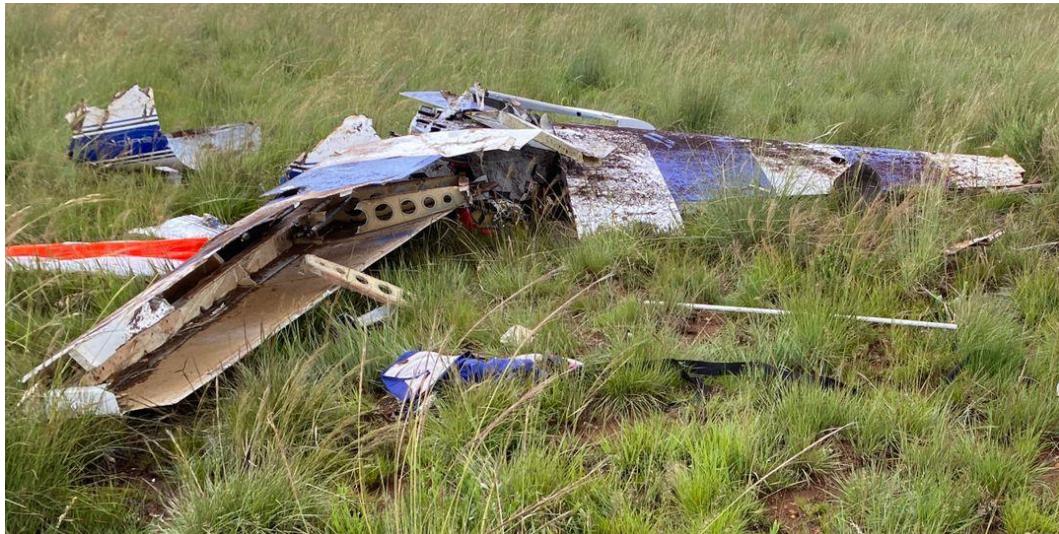
**Figure 2:** The wreckage post-accident.

### 1.3.1. The aircraft was destroyed.

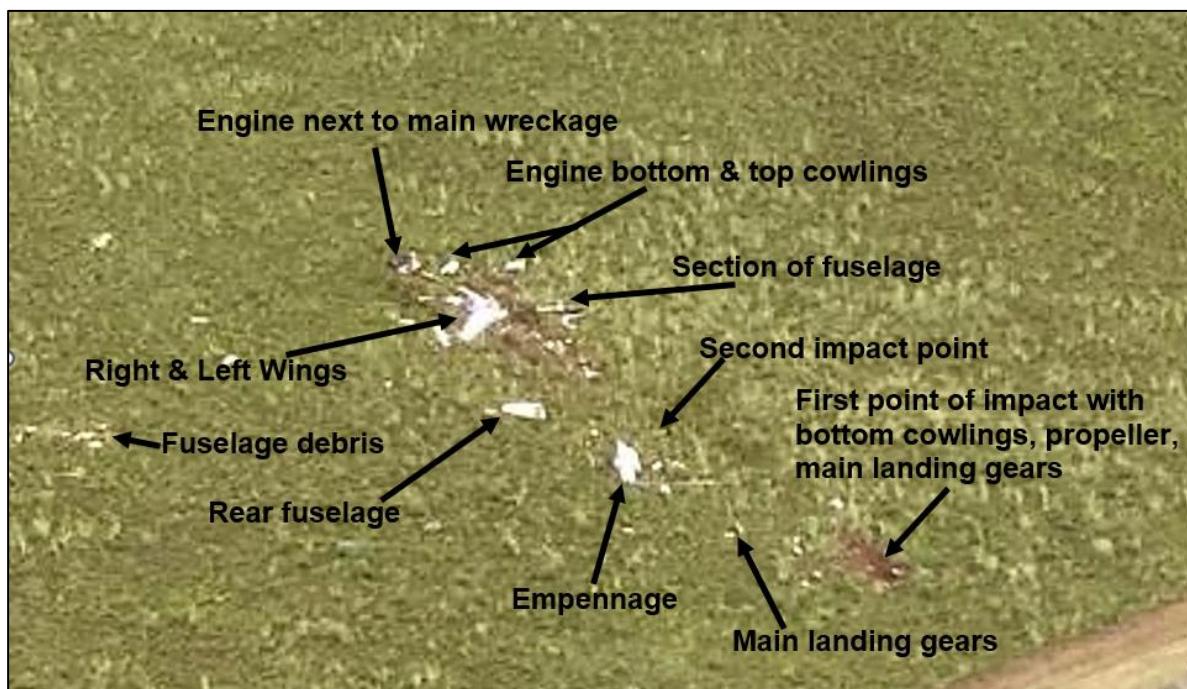
**Figure 6:** Wreckage distribution. (Source: Insurance Assessor)

1.12.2. The ground scars showed that the aircraft cartwheeled and bounced on its nose about 15m high before it came to rest approximately 40m from the initial point of impact. The wreckage distribution consisted of numerous fragments of the wings and fuselage (Figure 6) in a 40m radius of the main wreckage, indicative of the aircraft disintegrating after impacting the ground at high speed.

1.12.3. The aircraft's fuselage, canopy, propeller, undercarriage, wings and engine were extensively damaged during impact. The examination revealed that the entire structure of the aircraft sustained impact damage. The aircraft crashed on a grass-covered terrain about 15m south of the taxiway at FASY.

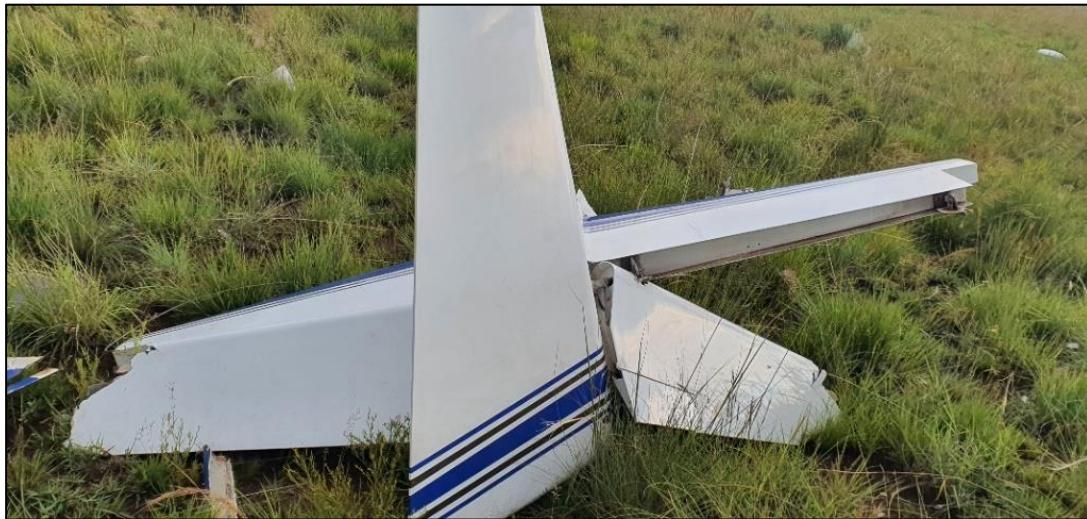
**Figure 7:** The empennage at the accident site.

1.12.4. Although the control surfaces had been destroyed, the rudder and elevator on the empennage were found still attached; they moved without obstruction when examined at the accident site. Due to the extensively damaged wings, aileron continuity could not be established.

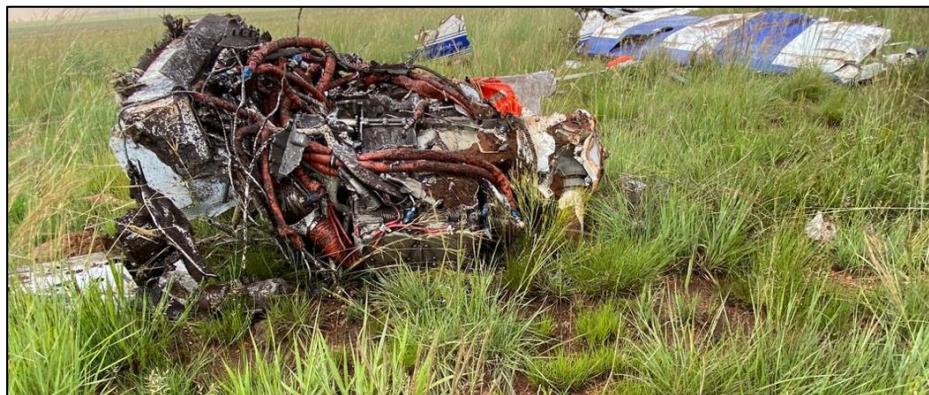
**Figure 8:** The condition of the engine and its proximity to the wreckage.

1.12.5. The engine had dislodged from its mounting point and the impact mark on the ground indicated that it had separated before it bounced. It was found 3m from the main wreckage. The inspection of the engine on site indicated that it was running at a high-power setting at the time of impact; this was verified by the destruction of all three composite propeller blades at the roots.

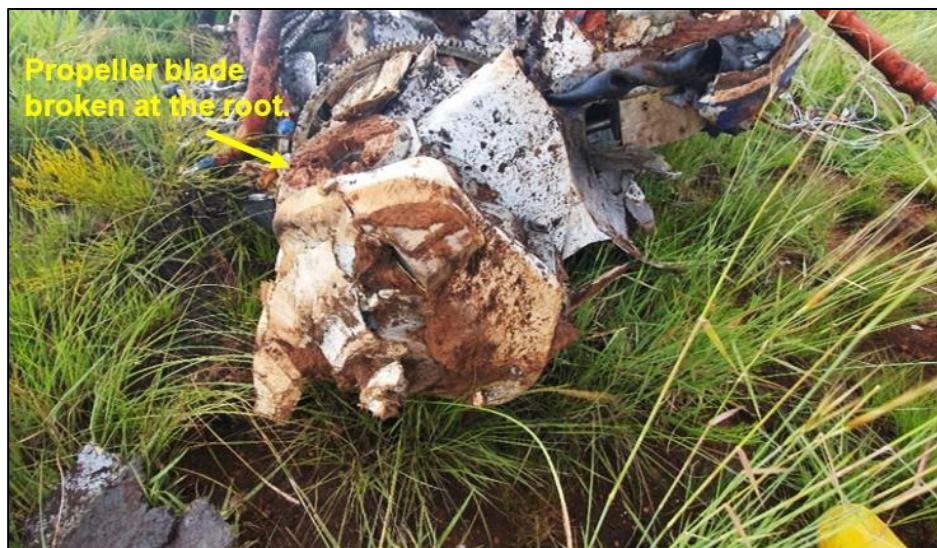
**Figure 9:** The propeller hub assembly.

- 2.2.16. Based on the engine and propeller damage, it was determined that the engine was running at high power. This resulted in the destruction of the propeller blades on impact with the ground.

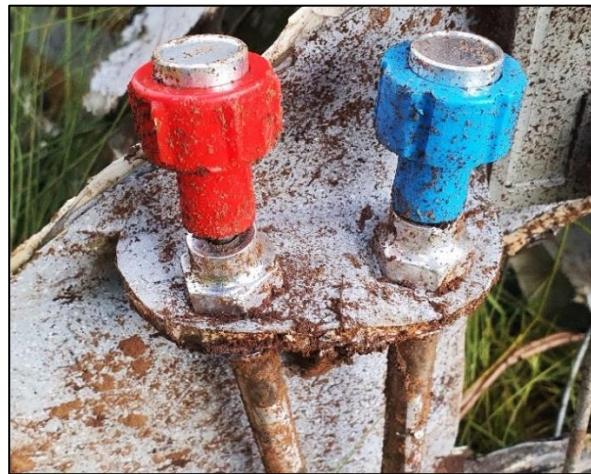
**Figure 10:** The throttle and mixture control/selector levers.

1.12.6. The fuel selector was found selected to the main tank. The fuel amount could not be established as the fuel tanks had ruptured due to impact forces; however, there was still a small amount of Avgas LL100 fuel in the carburettor fuel bowls. The throttle and mixture control levers were found in the fully in/forward (open) position.

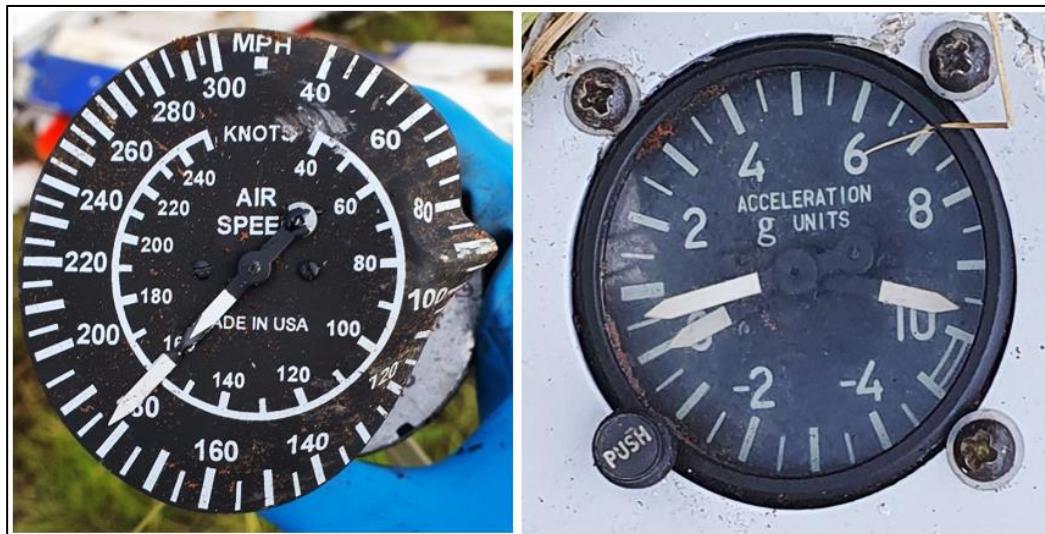
**Figure 11:** Airspeed indicator (left) and accelerometer (right).

1.12.7. Most of the aircraft's instruments and avionics were not found as they had dislodged from their mounting brackets. The aircraft's rudder pedals were found 4m from the main wreckage. The pilot's helmet was found under the aircraft's wings. The airspeed indicator was found intact and stuck at 180 miles per hour (mph), which is equivalent to 160 knots.

- 2.2.13. After the accident, the AIID investigators examined the aircraft's construction and the components of the control system, but the aircraft was extensively destroyed, and no useful information could be recovered. However, the airspeed indicator dial was found, and its examination thereof showed that the speed was about 160 knots at the time of impact.
