LIMITED ACCIDENT INVESTIGATION REPORT

Reference Number		CA18/2/3/10095					
Classification	Accident	Date	15 December 2021	Time	1520Z		
Type of Operation		Training (Part 141)					
Location							
Place of Departure		Wonderboom Aerodrome (FAWB), Gauteng Province		Place of Intended Landing		Wonderboom Aerodrome (FAWB), Gauteng Province	
Place of Accident		Approximately 2.2nm Northeast of FAWB, Gauteng Province					
GPS Co-ordinates	Latitude	25°38'29" S	Longitude	028°15'43.6" E	Elevation	4110ft	
Aircraft Information							
Registration		ZU-WMM					
Model/Make		Sling 2 (Serial number: 144)					
Damage to Aircraft		Destroyed		Total Aircraft Hours		2477.9	
Pilot-in-command							
Licence Valid		Yes		Gender		Male	
						Age 37	
Licence Type		Airline Transportation Pilot Licence (ATPL) Aeroplane					
Total Hours on Type		±26.5		Total Flying Hours		10 209.5	
People On-board	2+0	Injuries	0	Fatalities	0	Other (on ground)	0
What Happened							
<p>On Saturday afternoon, 15 December 2021 at approximately 1520Z, a flight instructor and a student pilot on-board a Sling 2 aircraft with registration ZU-WMM took off on a training flight from Runway 06 at Wonderboom Aerodrome (FAWB) in Gauteng provin

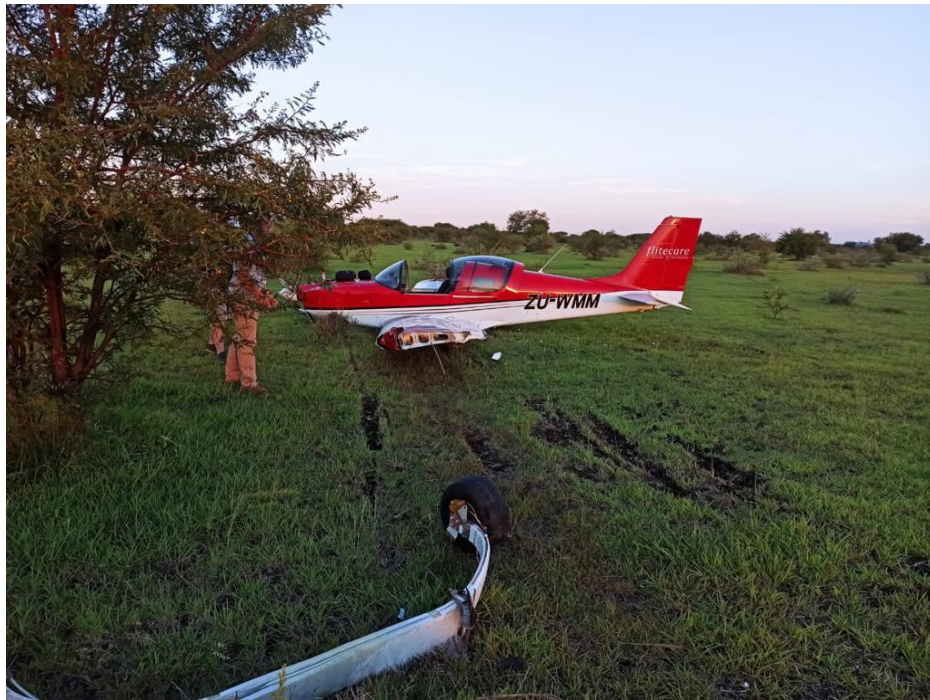
Figure 1: The aircraft at the accident site and the main landing gear strut (Source: pilot)

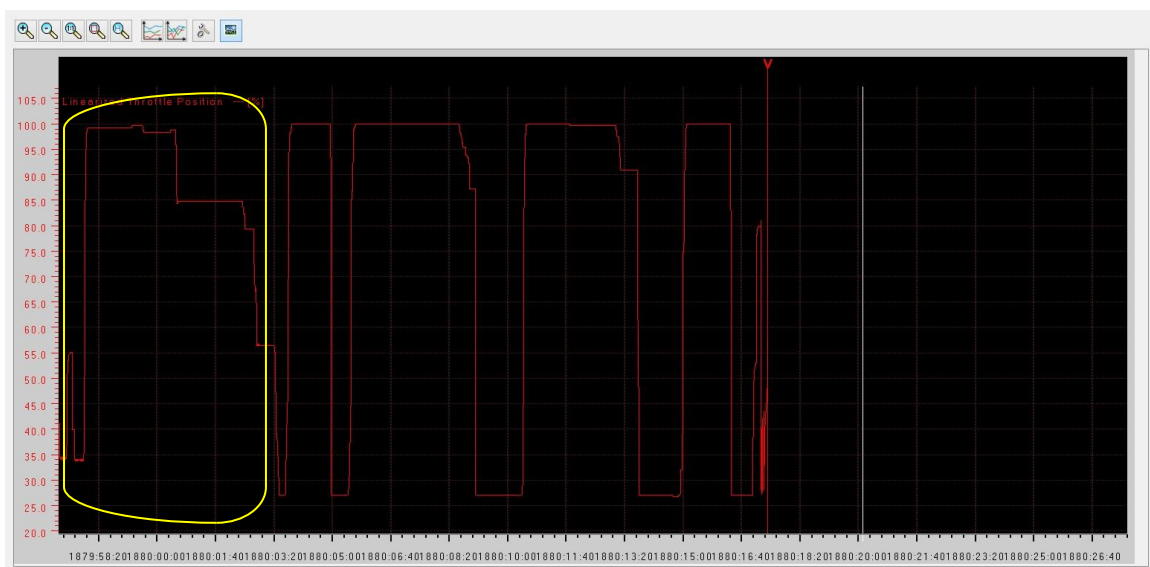
- The engine was running as normal throughout the flight with no abnormal indication parameters being recorded except for the indications of the throttle position sensor which contradict the throttle position as described by both pilots.

Figure 2: The throttle position sensor recordings

- The throttle sensor position varied between 28% and a max of 50% up until the time the aircraft was landed the above was a clear indication of a loss of engine power control attributed to an unresponsive throttle movement.
- The accident aircraft model had the Service Bulletin (SB)19--01102021 installed on 2 November 2021 at 48.9 hours prior to the accident it was is meant to prevent the possible loss of engine power control.

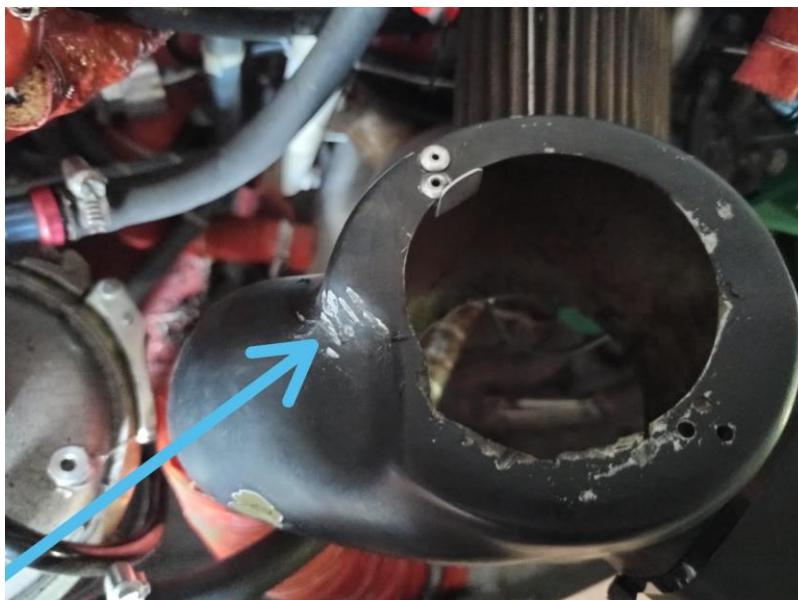
- The AMO stated that: further investigation of the throttle system on the accident aircraft throughout the entire range of travel showed the following: The air filter housing had witness marks from the throttle lever cable (see figure 3). During the investigation, the throttle lever was recycled, and it revealed that during flight the air filter housing is pushed back by the high airflow and as a result, it limits the movement of the throttle lever into a full forward position. The throttle cable attachment bolt does not swivel, the lock nut is used as a result the cable tends to bend when the throttle lever is pushed forward and as a result, the flexible cable does not reach a full position when the throttle lever is pushed forward.

Figure 3: Witness marks left on the air filter housing

- It was not the throttle arm itself, but the section of throttle cable which was left extending beyond the throttle arm attachment bolt that interfered with the air filter housing box.

- The throttle cable is flexible and not solid it is possible for it kink, and there was a section of the throttle cable that was left extending beyond the throttle arm attachment bolt that interfered with the air filter housing box, it did not advance as needed because of some interference of the system with the air filter housing box.

- The section of the throttle cable that was left extending beyond the throttle arm attachment bolt should have been bend back and, if necessary, tie off the end to prevent interference.

- The air filter housing box should be effectively secured to prevent it from obstructing the throttle cable.

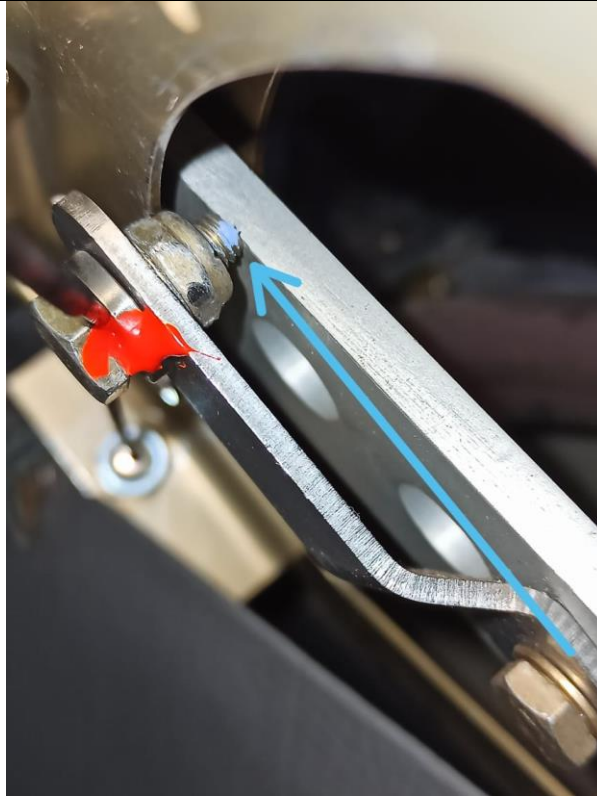
Figure 4: Throttle cable attachment bolt that was torque sealed

- SB 19 was not done properly as the cable retaining bolt on the throttle quadrant lever side was torque sealed see figure 4 above in such a way that it prevents free rotation as required by the SB.
- The air filter housing was not tied back and limited the movement of the throttle lever into a full forward position.
- There was a section of throttle cable which was left extending beyond the throttle arm attachment bolt which was interfering with air filter housing.
- The SB was done by an unapproved person under the aircraft maintenance organization (AMO) company authorization.
- The chief quality inspector then did SB 19 on ZU-LZR and ZU-FCT to ensure that a similar accident does not happen again on the operator's aircraft.

- The interference between the sprung engine throttle arm side of the throttle system and the air filter housing box was aggravated by the fact that the cable retaining bolt on the throttle quadrant lever side had been torque-sealed in such a manner as to prevent its free rotation, in direct contradiction of the requirements of the Service Bulletin (see Clause 3.2(c) of SB0019).

- The SB was done by an unapproved person under the aircraft maintenance organization (AMO) company authorization. The SB was dual inspected by two approved people of the AMO. This is allowed as per Civil Aviation Regulations Part 44.01.4(1) (b) below. Both APs did not see that the cable retaining bolt was not supposed to be torque sealed and should be free swivelling as specified in the SB
