AIRCRAFT ACCIDENT REPORT AND EXECUTIVE SUMMARY

Reference:		CA18/2/3/10100	
Aircraft Registration	ZS-XPC	Date of Accident	8 January 2022		Time of Accident	0730Z	
Type of Aircraft	Air Tractor AT-502A			Type of Operation	Aerial Work (Part 137)		
Pilot-in-command Licence Type	Commercial Pilot Licence		Age	61	Licence Valid	Yes	
Pilot-in-command Flying Experience	Total Flying Hours		13 314.7		Hours on Type	2 887.4	
Last Point of Departure	Farm Elandsfontein, Fochville District, Gauteng Province						
Next Point of Intended Landing	Farm Elandsfontein, Fochville District, Gauteng Province						
Damage to Aircraft	Minor						
Location of the accident site with reference to easily defined geographical points (GPS readings if possible)							
Farm Elandsfontein (GPS co-ordinates: 26°36'18.35" South 027°33'54.22" East), elevation 5 015 feet (ft)							
Meteorological Information	Surface wind; 090°/8 knots, temperature; 17°C, visibility; CAVOK						
Number of People On-board	1 + 0	Number of People Injured	0	Number of People Killed	0	Other (On Ground)	1

Probable Cause							
<p>During a low-level turn to the left whilst the pilot was manoeuvring the aircraft for the next spray run, the left-wi

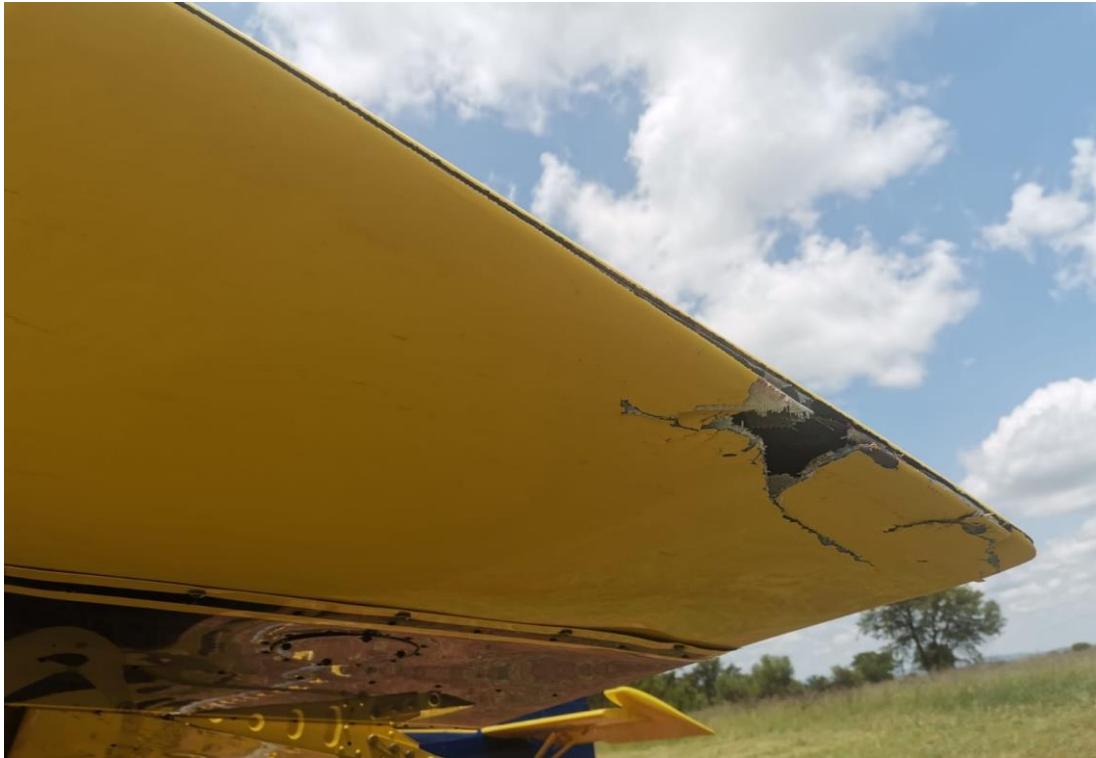
1.3.1 There aircraft sustained damage to the left-wing tip.

Figure 2: Damage to the left-wing tip of the aircraft.

1.12.1 The left-wing tip fairing, which is manufactured from fibreglass, had minor damage when the wing tip struck the left leg of the person on the ground. The person was positioned approximately 100 to 130m from the end of the maize field that was being sprayed. The vegetation consisted of different types of grass, which varied in height from the ground (level) to approximately 80 centimetres (cm) in height. Figure 13 shows the height in relation to a four-wheel drive vehicle. In the same figure, the maize field that was being sprayed is visible beyond the vehicle.

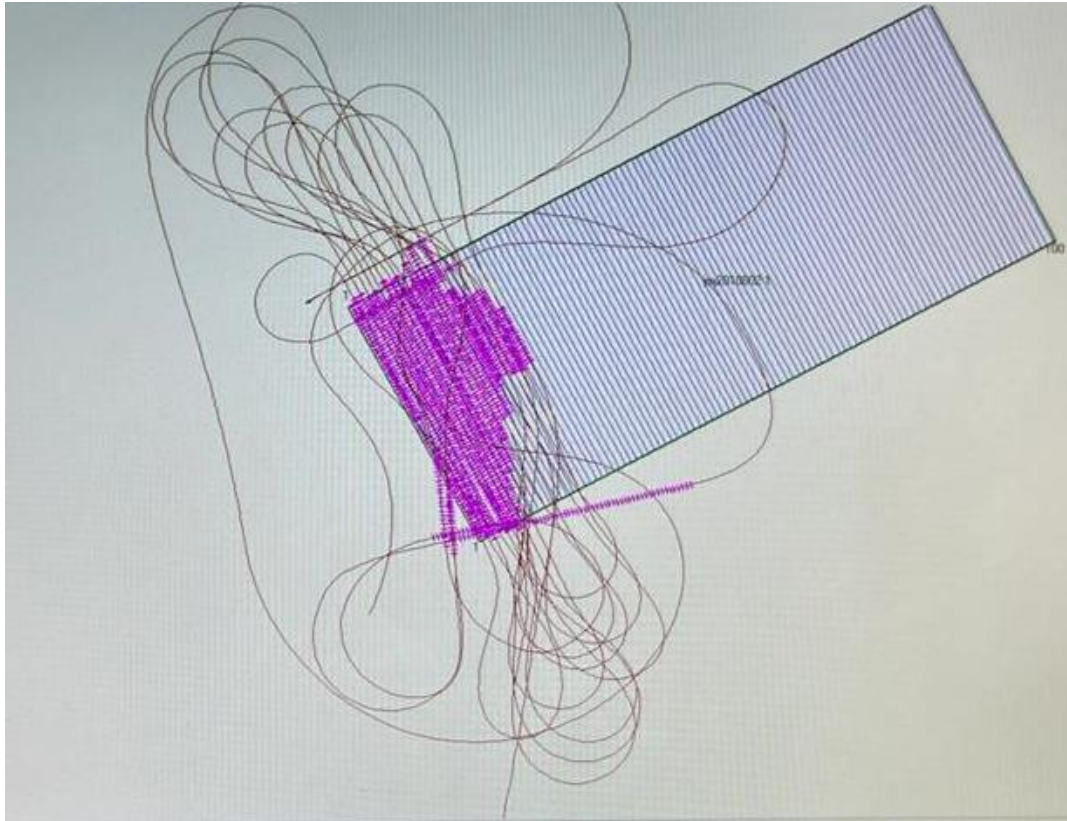
1.11.4 The Ag-Nav spray pattern in Figure 6 shows the first field that was sprayed (referenced in 1.11.3).

Figure 6: The flight profile from the Ag-Nav system that was flown when the accident occurred.

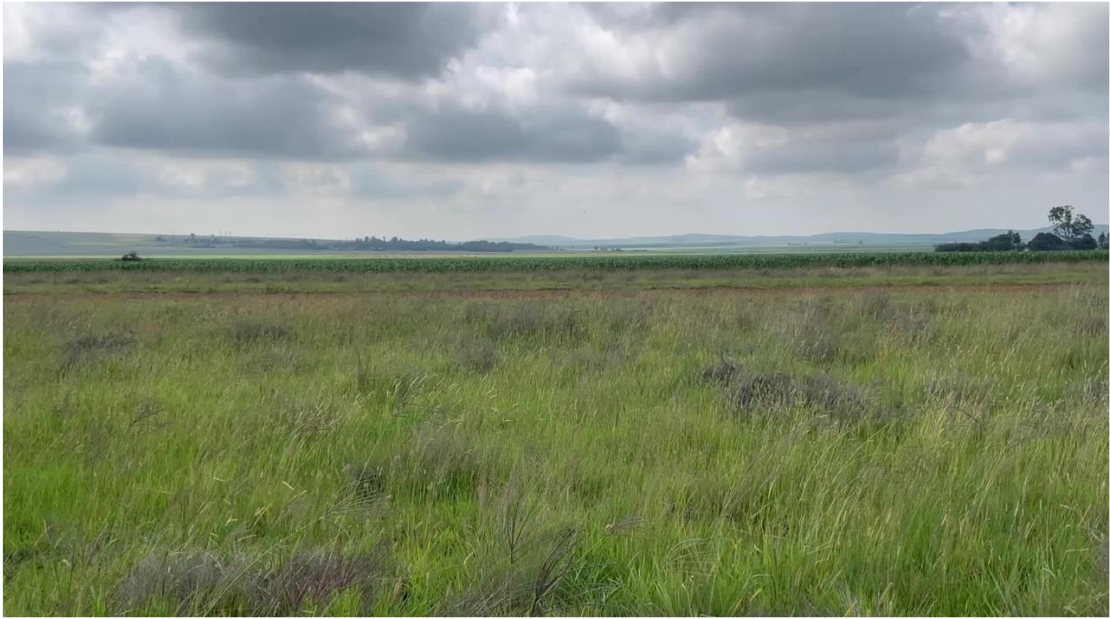
Figure 7: The position where the two people were standing when filming the flight.

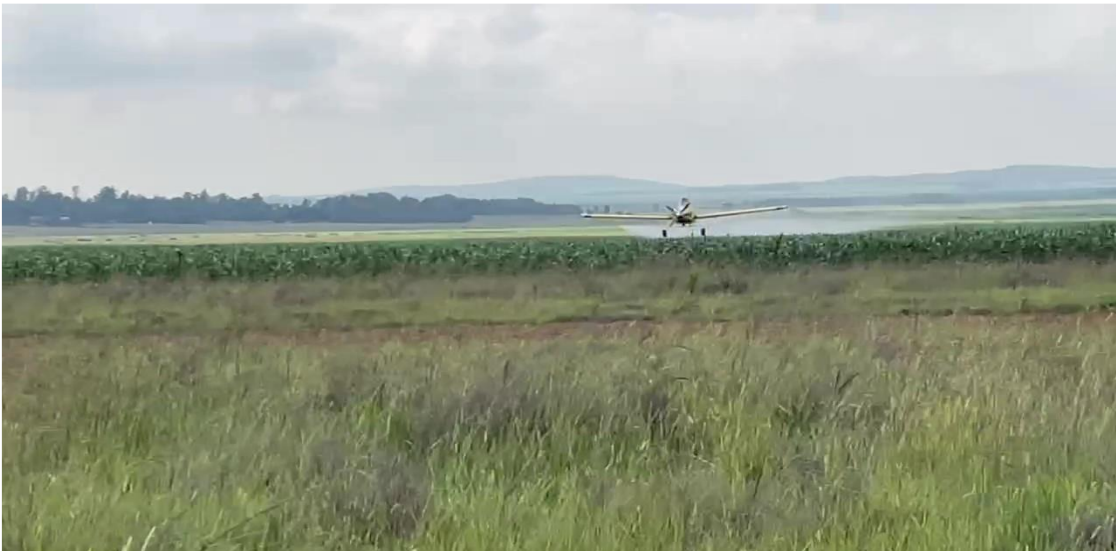
Figure 8: The enlarged view of the aircraft from the video footage taken by the person whilst in an upright position.

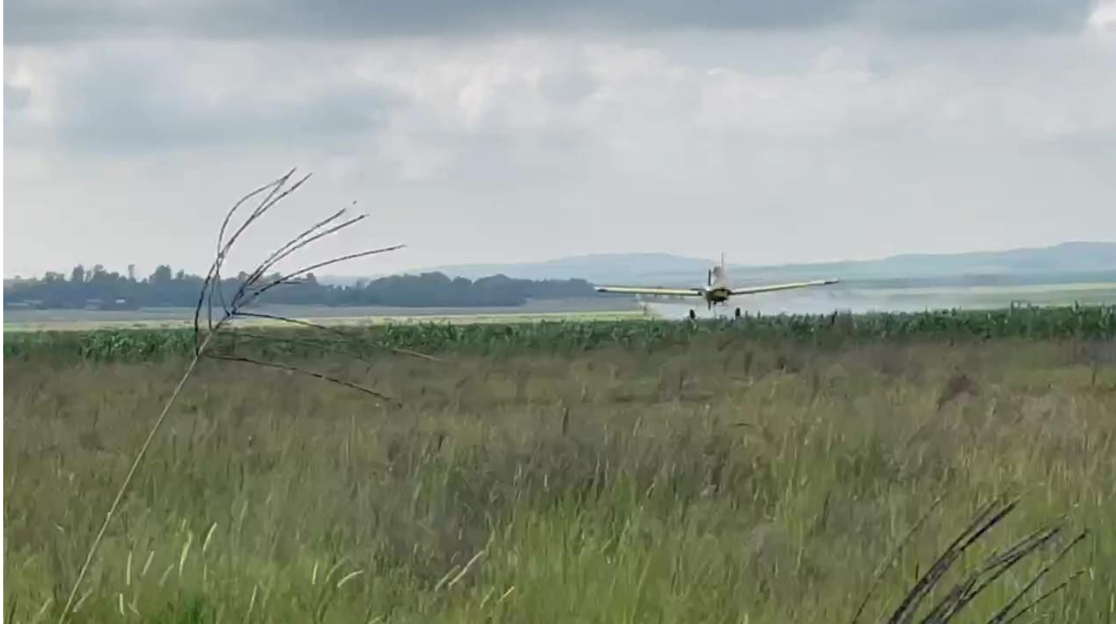
Figure 9: In this frame, the person filming is bending forward.

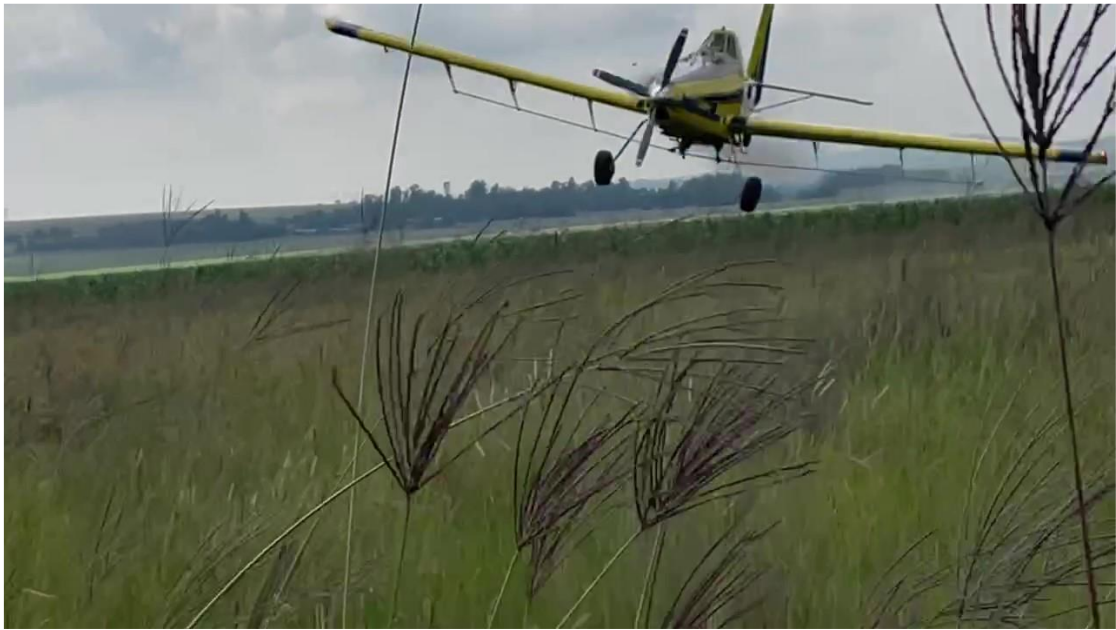
Figure 10: In this frame, the person is on his haunches.

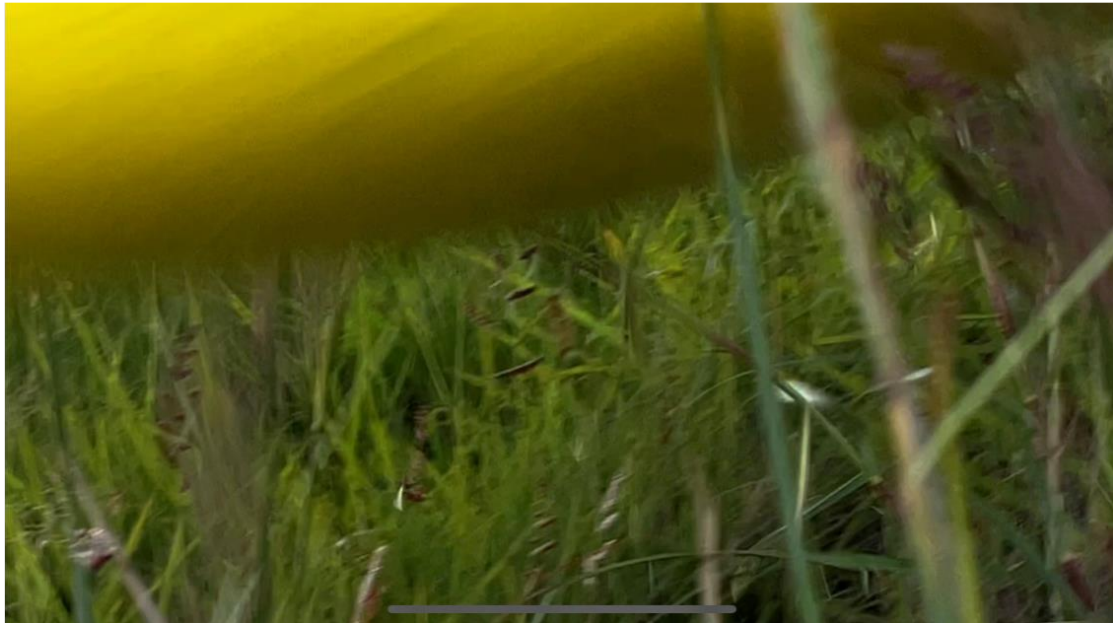
Figure 11: In this frame, the wing of the aircraft is visible with the person laying on his back.

- (viii) While manoeuvring the aircraft for the next spray run, the pilot executed a left turn, which caused the left-wing tip of the aircraft to be close to the ground. Due to lack of video footage evidence, it could not be determined if this type of manoeuvre was the norm for the pilot on the day or if it was a once-off turn close to the ground.

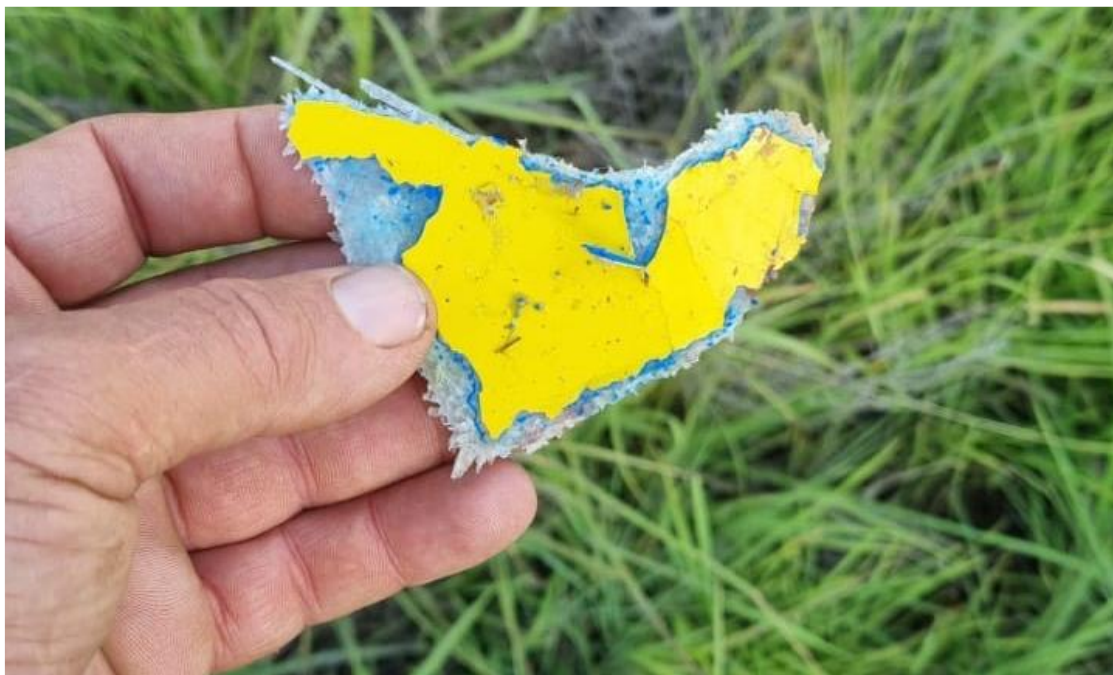
Figure 12: A small piece of fibreglass from the left-wing tip fairing found at the scene.

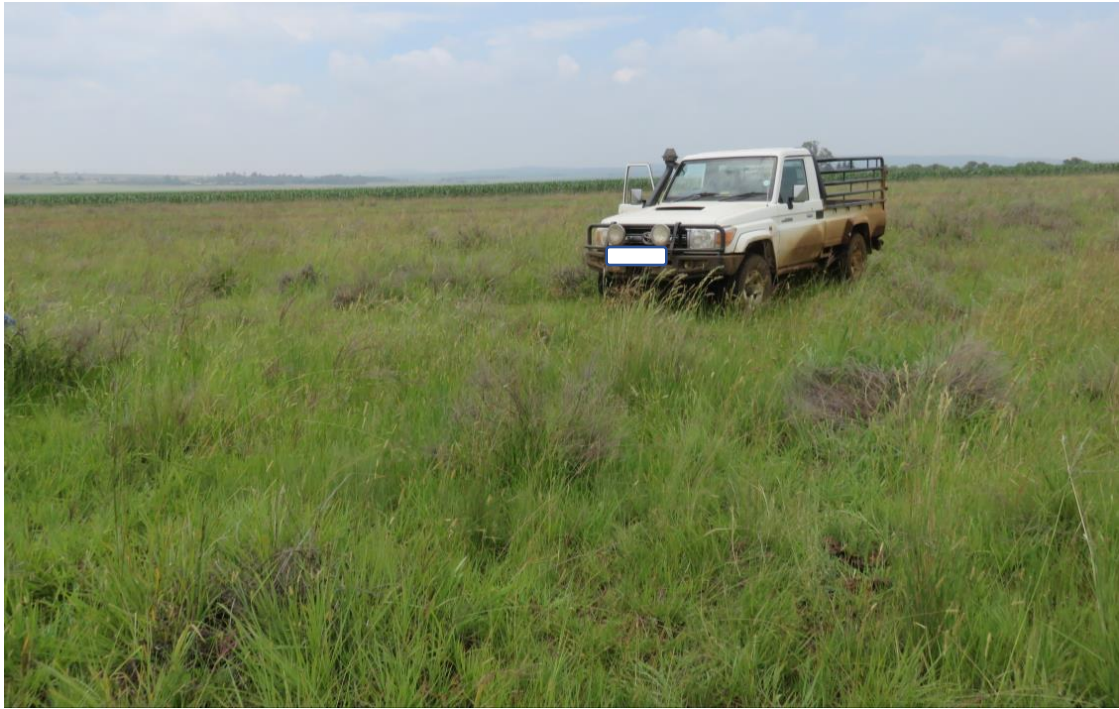
Figure 13: The view of the grassland. This is where the person was standing when filming the aircraft.

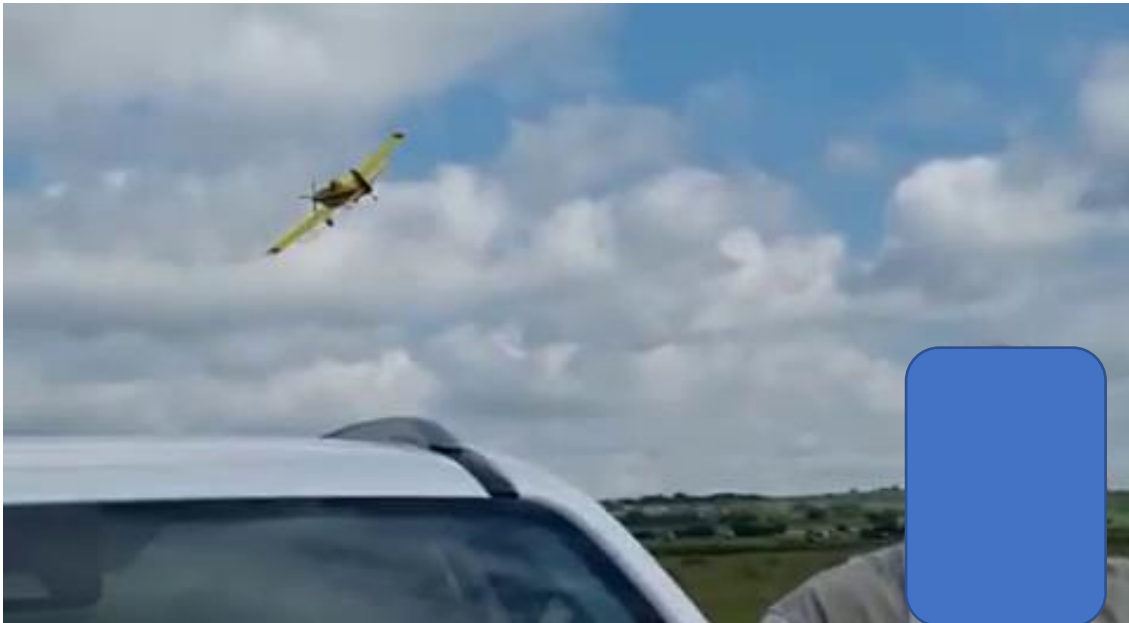
Figure 17: The still video footage shows the aircraft, vehicle and farmer.

- (ii) From the video clips that were made available to the investigator, it was evident that the farmer and his family were standing next to a white vehicle, which made the location of the people on the ground much easier for the pilot to see whilst manoeuvring the aircraft.
