LIMITED ACCIDENT INVESTIGATION REPORT

Reference Number	CA18/2/3/10110						
Classification	Accident	Date	31 January 2022	Time	1400Z		
Type of Operation	Training (Part 141)						
Location							
Place of Departure	Port Alfred (FAPA), Eastern Cape Province		Place of Intended Landing		Port Alfred (FAPA), Eastern Cape Province		
Place of Accident	A grass field 44 Nautical Miles north-east of FAPA						
GPS Co-ordinates	Longitude	S 33°11'46.0"	Latitude	E 027°35'35.6"	Elevation	450 feet	
Aircraft Information							
Registration	ZS-SYJ						
Model/Make	Piper Archer PA 28 R (S/N:28-43208)						
Damage to Aircraft	Substantial		Total Aircraft Hours		19157		
Pilot-in-command							
Licence Type	Student Pilot Licence (Aeroplane)		Gender	Male	Age	29	
Licence Valid	Yes						
Total Hours on Type	16.6		Total Flying Hours		101.3		
People On-board	1 + 0	Injuries	0	Fatalities	0	Other (on ground)	0
What Happened							
<p>On Tuesday, 31 January 2022, a student pilot on-board a Piper Archer with registration ZS-SYJ was conducting a solo navigation training flight from Port Alfred Airport (FAPA) to Mazeppa Bay, and then back to FAPA. The flight was conducted under visual meteorological conditions by da

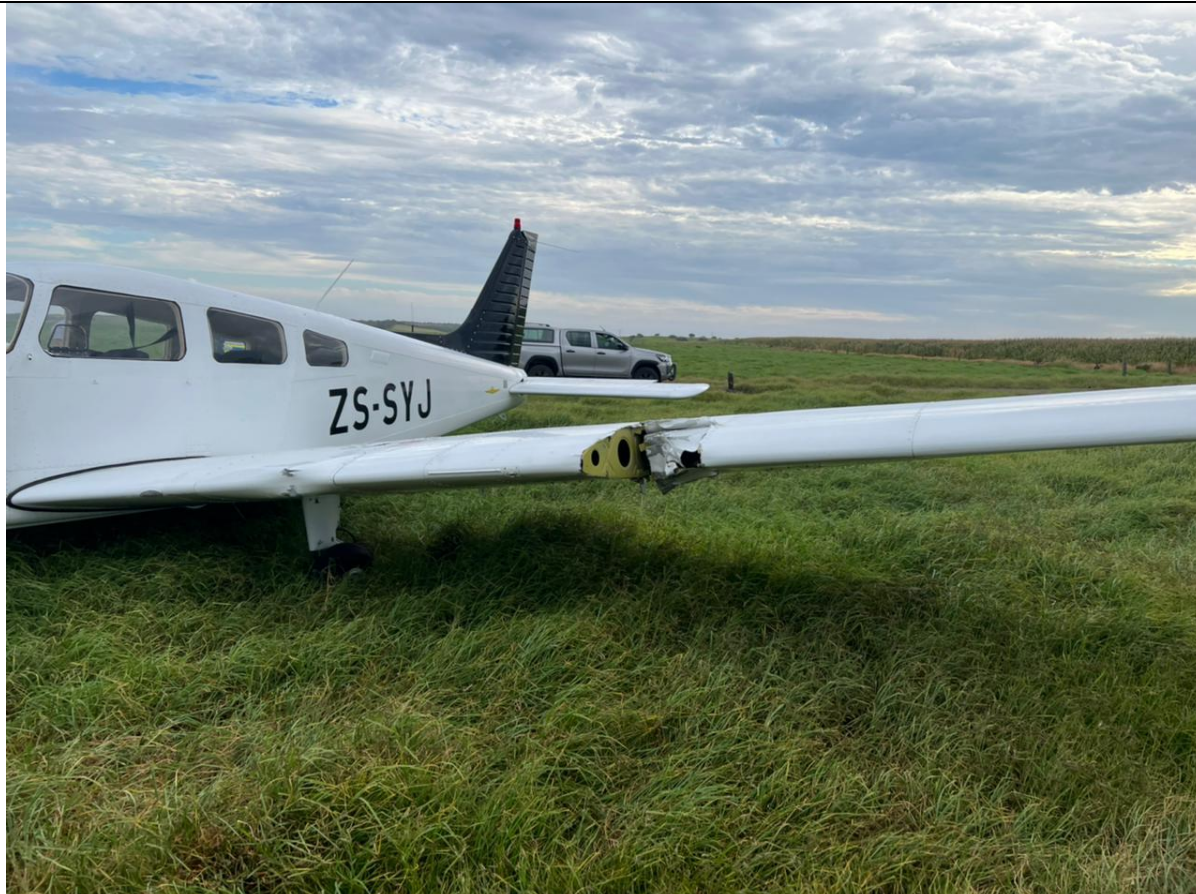
4. During the landing roll, the aircraft's left wing leading edge collided with a fence pole before the aircraft came to a stop. The pilot did not sustain any injuries; the aircraft sustained damage to the left wing.

5. Post-flight inspection revealed that the alternator had failed due to a broken cooling fan, which led to the instrumentation switching off in-flight.

Figure 1: Picture of ZS-SYJ aircraft. (Source: 43 Air school)

Electrical failure in-flight due to alternator failure, followed by an unsuccessful precautionary landing.
