AIRCRAFT ACCIDENT REPORT AND EXECUTIVE SUMMARY

Reference:		CA18/2/3/10116	
Aircraft Registration	ZU-IKI	Date of Accident	10 February 2022		Time of Accident	1110Z	
Type of Aircraft	Jabiru 430		Type of Operation		Private (Part 94)		
Pilot-in-command Licence Type	Private Pilot Licence (Aeroplane)		Age	64	Licence Valid	Yes	
Pilot-in-command Flying Experience	Total Flying Hours		647.5	Hours on Type	59		
Last Point of Departure	Robertson Aerodrome (FARS), Western Cape Province						
Next Point of Intended Landing	Morning Star Aerodrome, Western Cape Province						
Damage to Aircraft	Substantial						
Location of the accident site with reference to easily defined geographical points (GPS readings if possible)							
Cape Point Nature Reserve Road, at Global Positioning System (GPS) co-ordinates determined to be 34°21'02.72"S 018°29'06.23"E at an elevation of 416 feet							
Meteorological Information	Wind velocity: 290° at 9kt; Temperature: 25°C; Dew Point: 16°C; Visibility: ≥10000m; Cloud: SCT 3500 ft; QNH: 1014 hPa

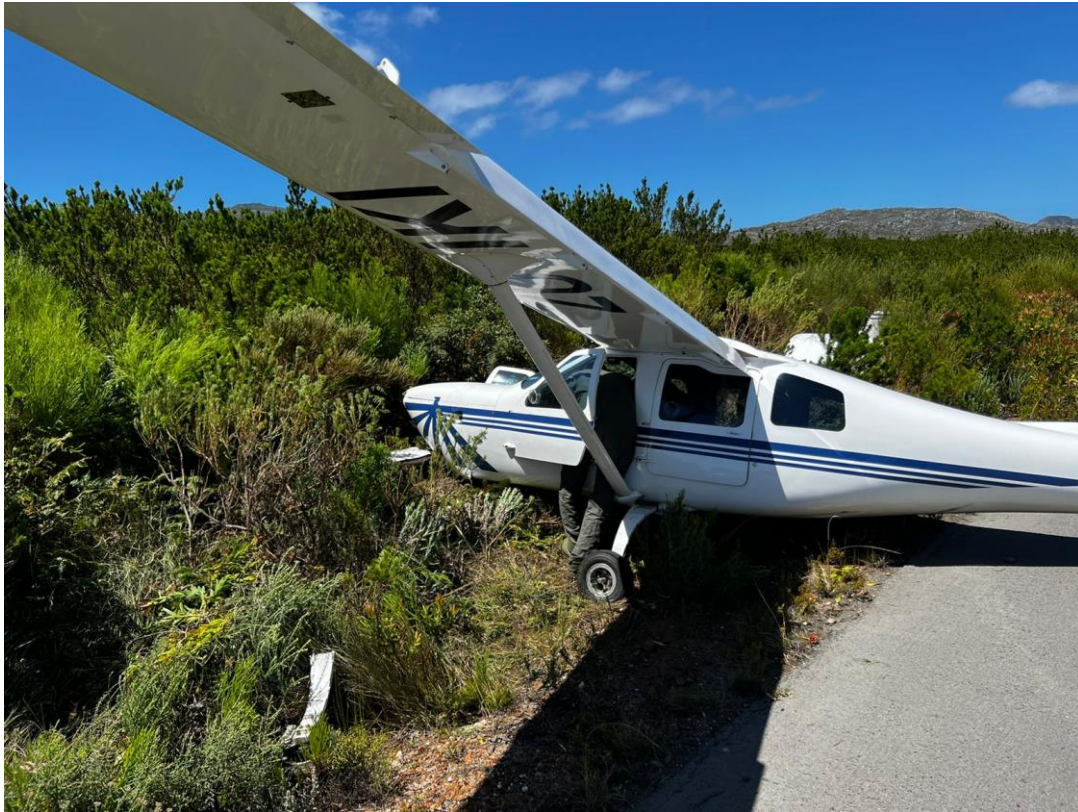
1.3.1. The aircraft was substantially damaged during the accident sequence.

Figure 2: The aircraft as it came to rest in the fynbos. (Source: EMS)

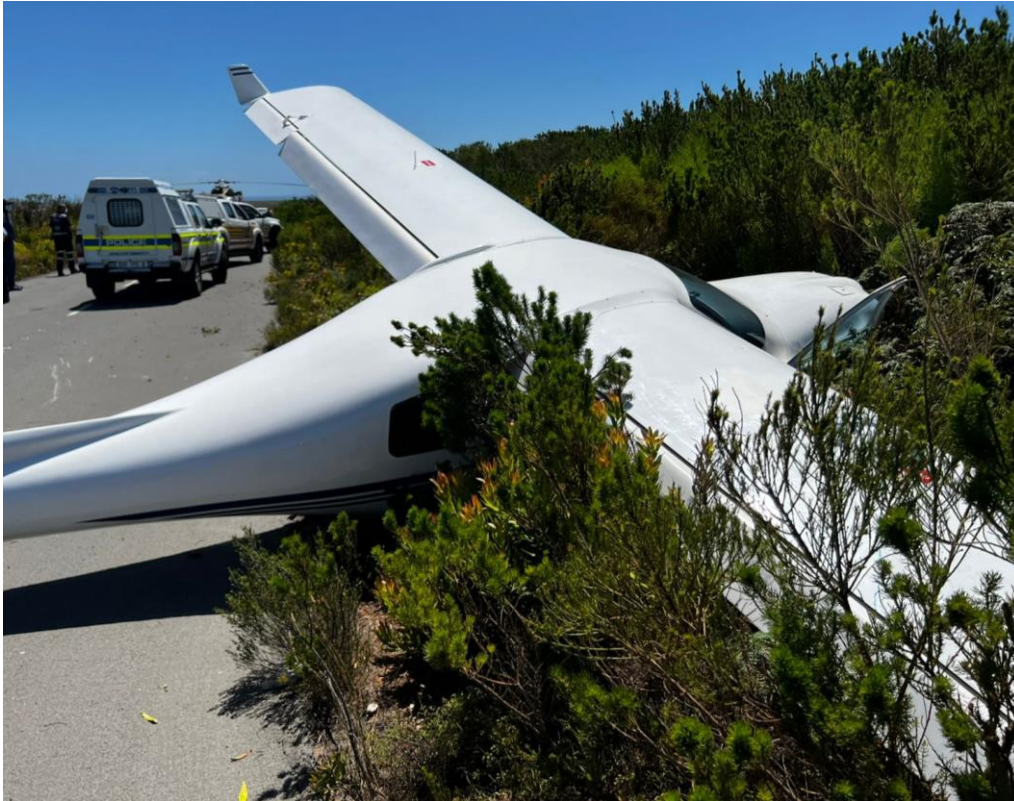
1.12.1. The aircraft landed on the road in the Cape Point Nature Reserve. The left wing contacted the fynbos on the left side of the road and the aircraft ground-looped counter-clockwise and

came to rest 90° across the road. It sustained damage to the right wing, horizontal stabiliser, undercarriage, nose wheel and fuselage. The propeller was missing from the accident scene and was not recovered.

Figure 3: The aircraft post-accident. (Source: EMS)

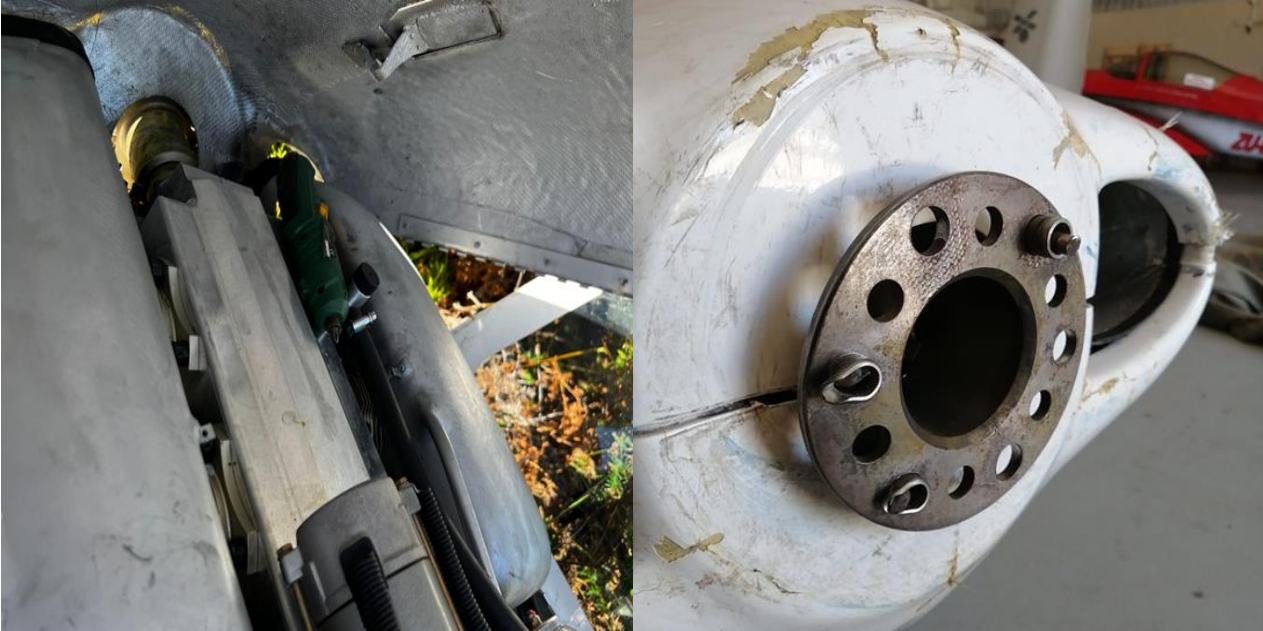
Figures 4 and 5: The aircraft post-accident. (Source: Jabiru)

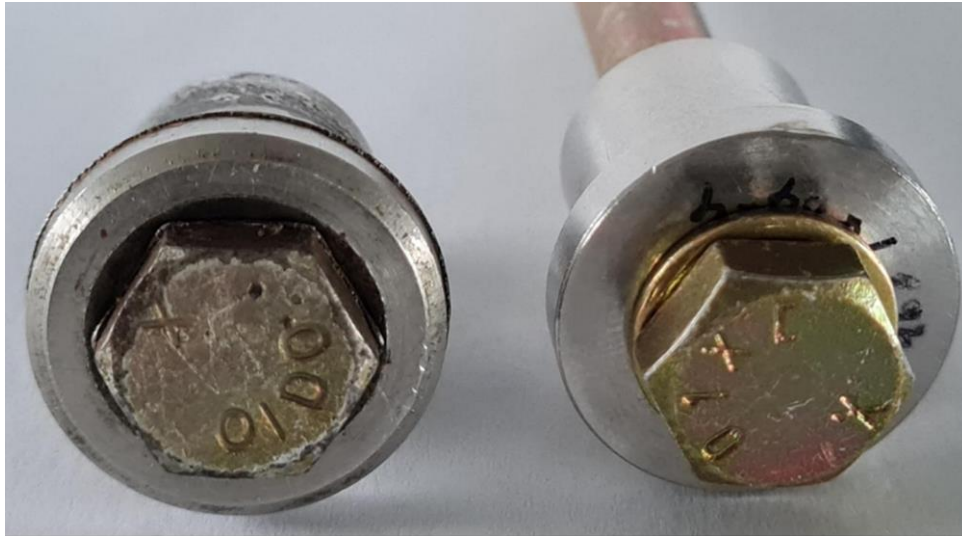
The propeller was not available to access. The only items accessed were the single prop bolt which had sheared and the propeller guide. There is evidence which can clearly be seen that the propeller bolt AN5-42 was loose and worn and this can also be seen in the propeller Bush. For reference of the two items refer to attached appendix E the Scimitar propeller installation diagram the AN5-42 propeller bolt would be number 6 and the propeller Bush would be number 14 on the diagram.

Figure 6: The AN5-42 bolt and the propeller bush from ZU-IKI (left), the new bolt and propeller bush (right).

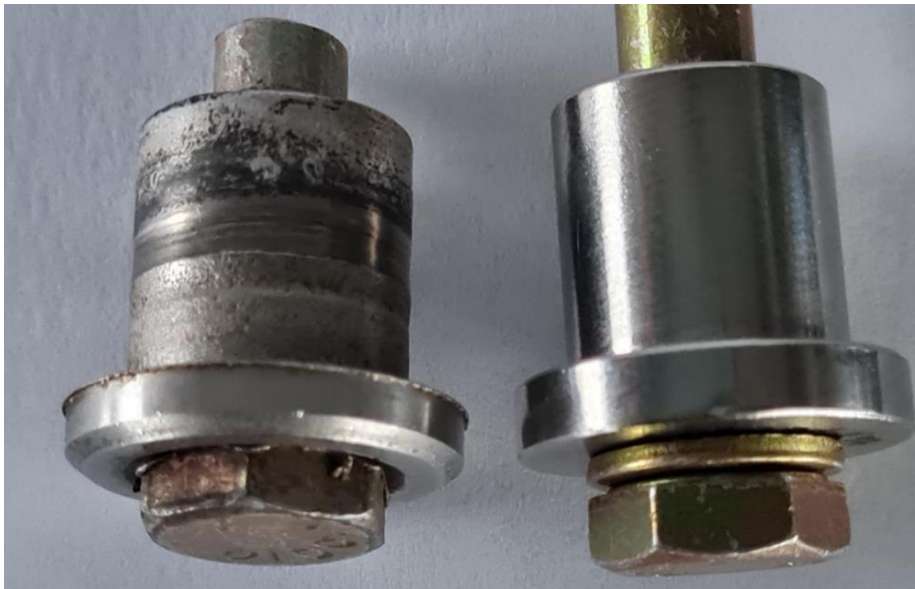
Figure 7: The head of the AN5-42 bolt from ZU-IKI (left) and the new item (right).

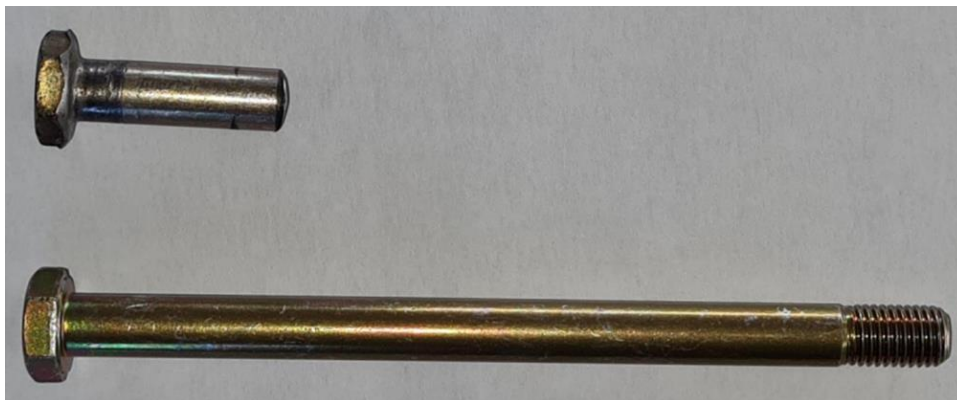
Figure 8: the AN5-42 bolt that was recovered (top) in comparison to the new bolt below (left).

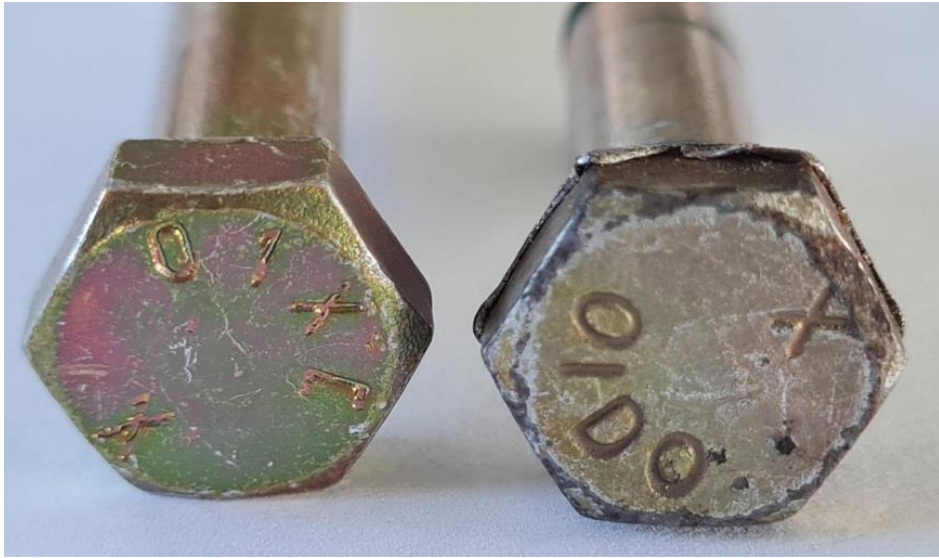
Figure 9: The heads of the AN5-42 bolt. The sheared bolt from ZU-IKI is on the right, showing the worn head.

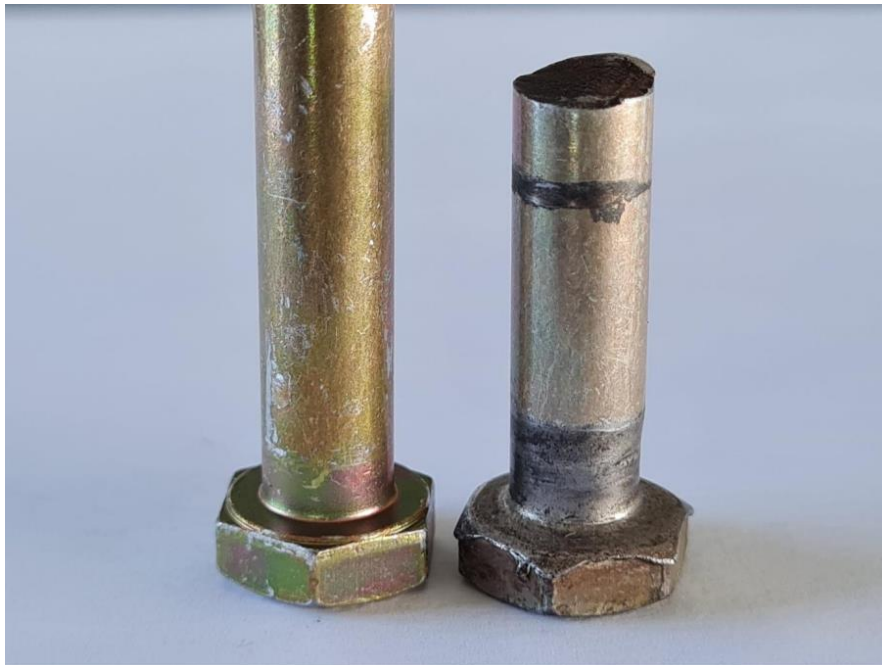
Figure 10: The AN5-42 bolt that had worn on the shank of the bolt as well as the head of the bolt which indicates movement.

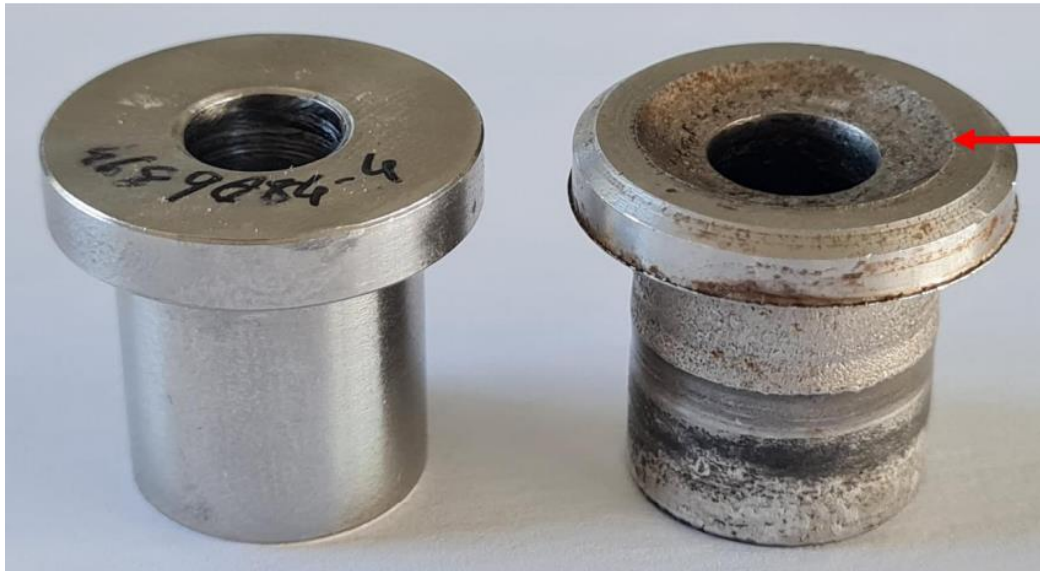
Figure 11: The pictures above were taken from the top and side angle. The new propeller bush is on the left and the bush from ZU-IKI is on the right. The wear on the bush from the AN5-42 bolt movement is clearly visible.

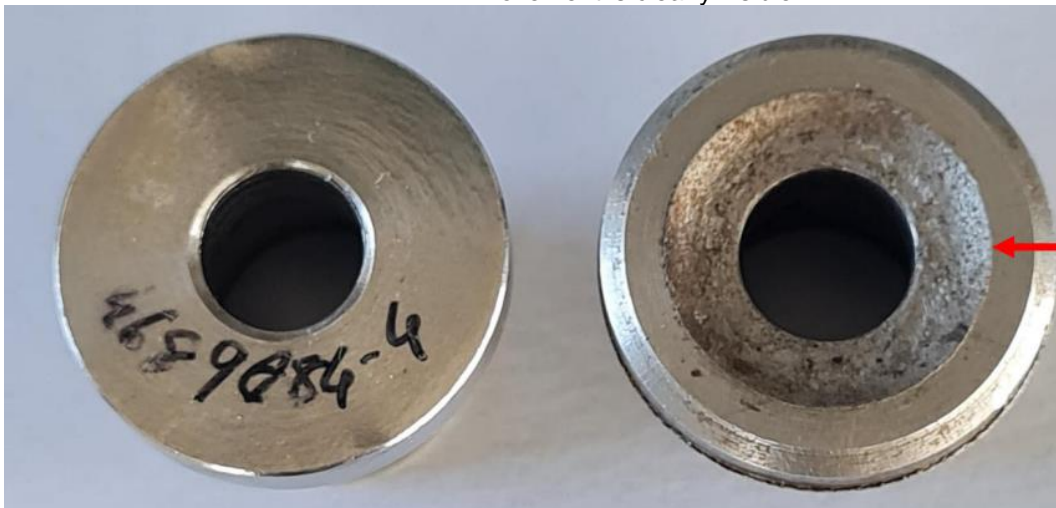
Figure 12: The two pictures show the propeller bush shaft taken from the side profile. The new propeller bush is on the left and the bush from ZU-IKI is on the right. The bush has been moving in the propeller hub as indicated by the striations on the bush shank.

- 3.3.1. The propeller detached from the engine in-flight, which caused the engine to rev excessively; this led to the pilot executing an unsuccessful forced landing on the road. The cause of the propeller detaching could be likely attributed to loss of tension in the bolts.

- 4.2.1. Operators and AMO/APs are encouraged to ensure that they check torque of the propeller bolts during the 100 hours in service in accordance with the requirements of maintenance inspections and in line with the manufacturers' manuals.

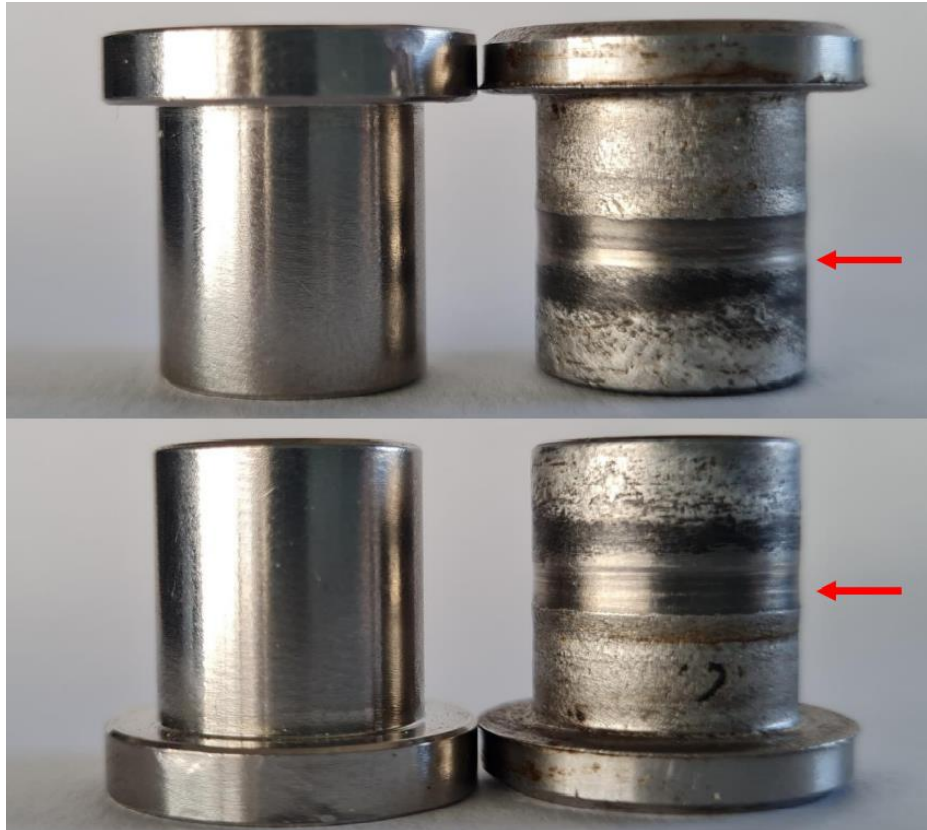
Figure 13: The two pictures show the propeller bush shaft taken from the side profile. The new propeller bush is on the left and the bush from ZU-IKI is on the right. It clear that the bush has been moving in the propeller hub as indicated by the striations on the bush shank.
