AIRCRAFT ACCIDENT REPORT AND EXECUTIVE SUMMARY

Reference:		CA18/2/3/10130		
Helicopter Registration		ZS-RVP	Date of Accident		2 March 2022	Time of Accident		0740Z
Type of Helicopter		Agusta-Bell 206A			Type of Operation		Private (Part 91)	
Pilot-in-command Licence Type		Private Pilot Licence (PPL)		Age	54	Licence Valid	Yes	
Pilot-in-command Flying Experience		Total Flying Hours		475.9		Hours on Type	0	
Last Point of Departure		Virginia Aerodrome (FAVG), Kwazulu-Natal Province						
Next Point of Intended Landing		Virginia Aerodrome (FAVG), Kwazulu-Natal Province						
Damage to Helicopter		Substantial						
Location of the accident site with reference to easily defined geographical points (GPS readings if possible)								
On the grass, 3 metres (m) west of Runway 05 at FAVG at Global Positioning System (GPS) co-ordinates determined to be 29° 46' 14" South 031°03'30" East, at an elevation of 20 feet								
Meteorological Information		Wind: 060°at 14kt, temperature: 30°C, Dew point: 21°C, Visibility: 9999m, QNH: 1011hPa

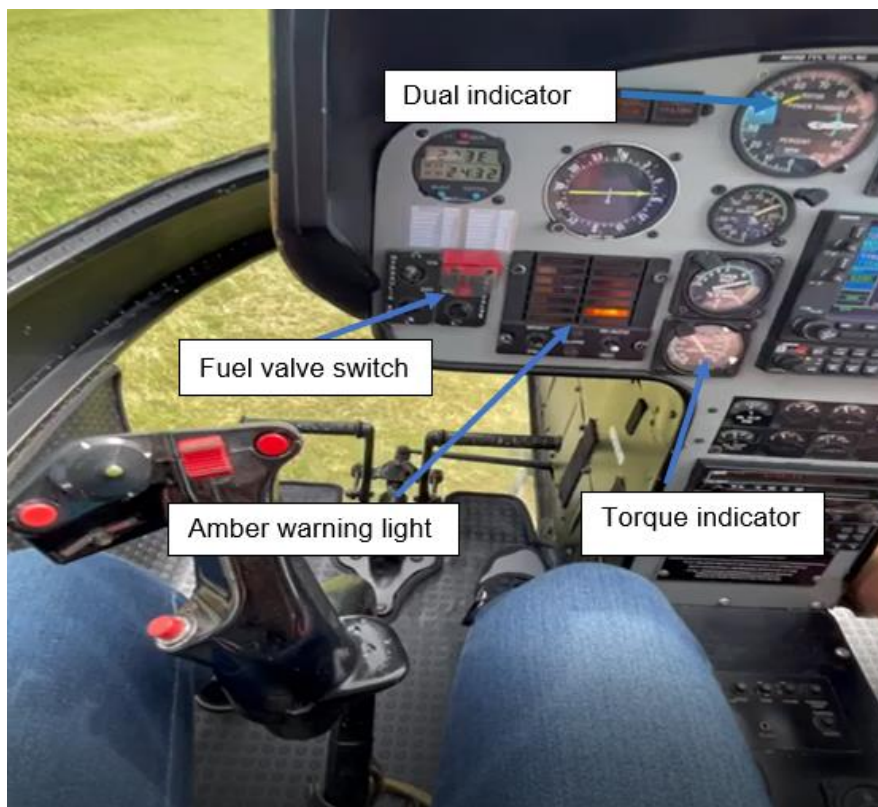
Figure 1: A video still showing arrows indicating positions of the fuel valve in the off position, torque indicator and dual gauge. (Source: Video footage from the passenger)

manual. It is evident that when the helicopter engine was started for the second time, the shutoff valve was in the off position, according to the video. As a result, the engine continued to run for a few seconds using residual fuel (upstream of the fuel system) until there was none remaining, which caused the engine to starve during the lift-off phase. This was evidenced by a decrease (spooling down noise) in engine RPM. There was no Quick Reference Handbook that was found in the cockpit as required by the Regulation (Part 91.03.3[2]). The Airframe Flight Manual for the helicopter was in the baggage compartment at the time of the accident. It is likely that the pre-start checks were completed without referencing any material and this led to a human factor element playing a role. Although the pilot had prior experience flying the Bell 206 helicopter, it is worth noting that he was flying the Agusta-Bell 206A for the first time, which had a different instrument panel compared to the Bell 206. The position/location and design of the shutoff valve switch is different between the two aircraft types. No familiarisation or difference in training was conducted with the ATO or qualified flight instructor. There were no records found on the pilot's logbook that this type of training was conducted. This was not in line with the CAR Part 61.09.8.

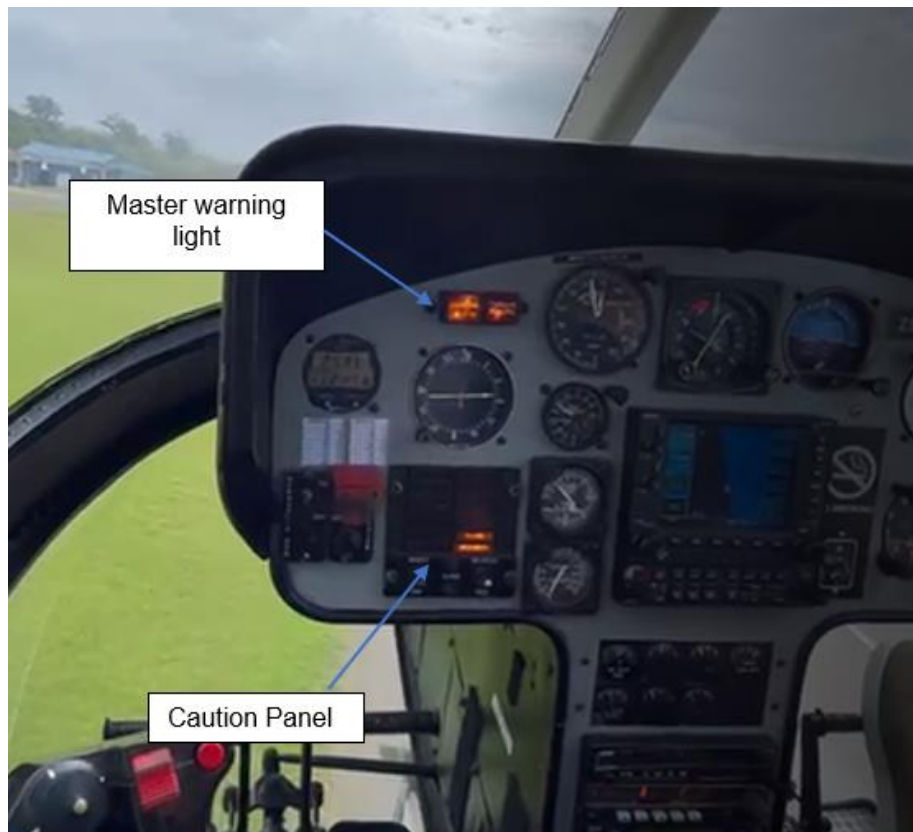
Figure 2: A video still showing master warning and caution as well as an additional caution message on the caution panel. (Source: Video footage from the passenger)

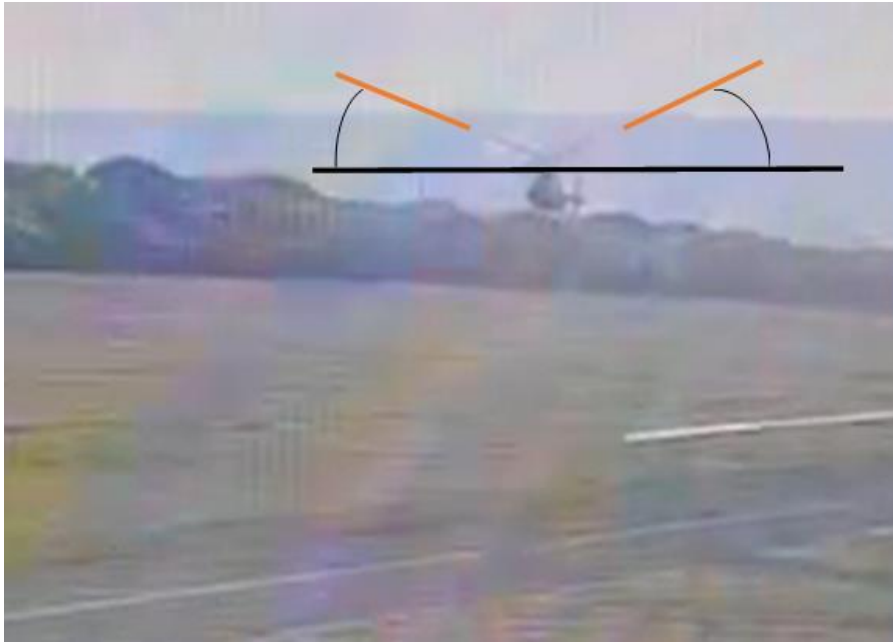
Figure 3: Coning angle of the main rotor blades. (Source: CCTV camera still image)

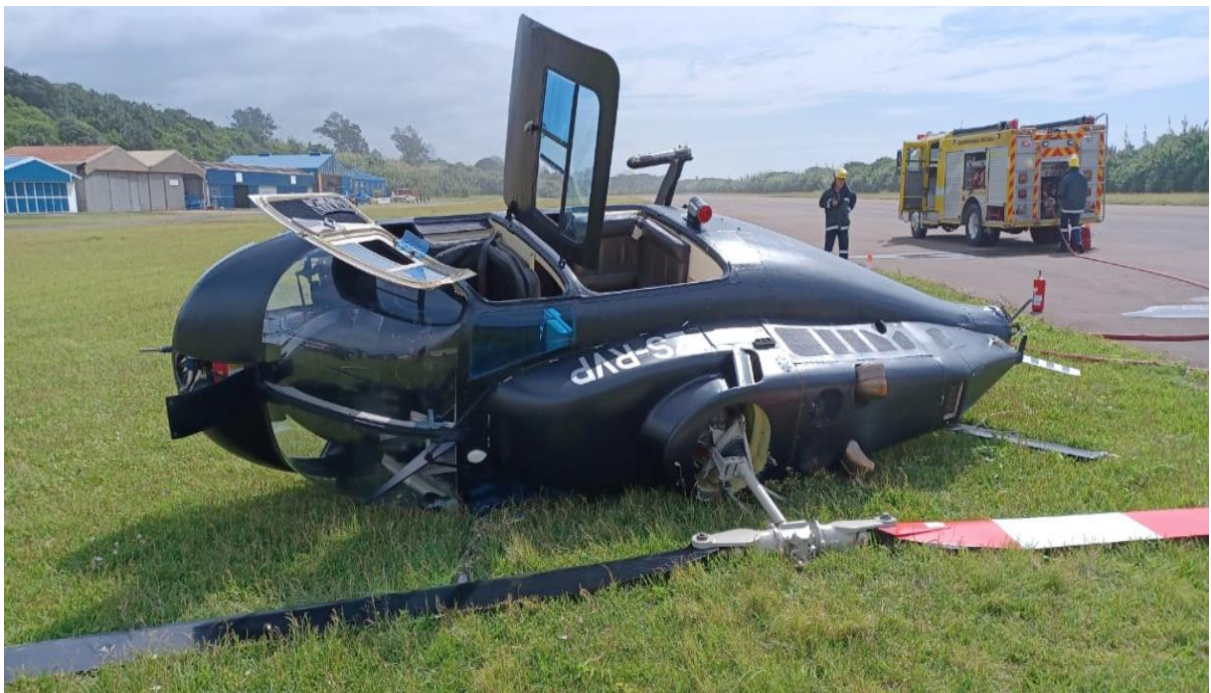
- 1.3.1. The helicopter was substantially damaged.

Figure 5: The helicopter as it came to rest. (Source: Johan Hattingh)

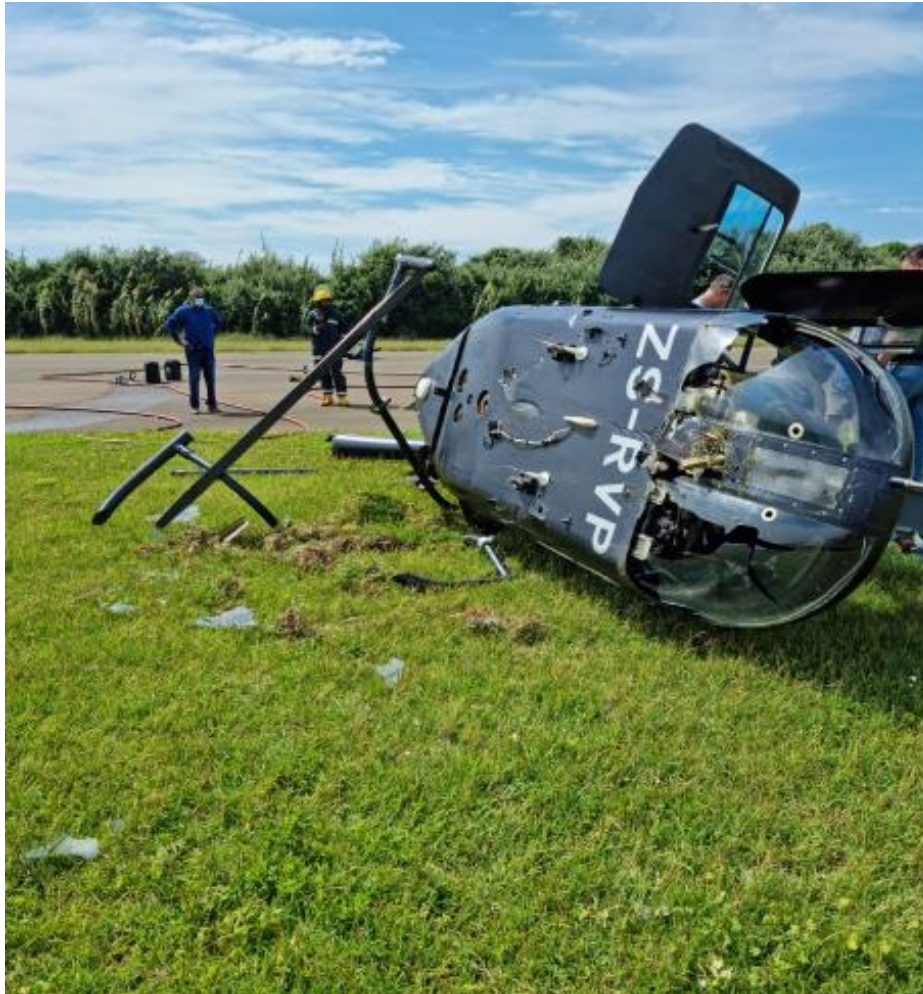
1.12.1. During transition, the engine experienced uncommanded shutdown and the helicopter lost height and crashed on the ground (grass), 3m west of Runway 05. The helicopter touched down hard with the skid gears first in a near level orientation. After impact, the helicopter rolled over to the left with the nose section pointing to a heading of 260°. Both skid gears broke off and the front cross tube separated. The main rotor blades severed the tail boom in three parts and the tail boom separated from its attachment points. The tail cone, tail gearbox and tail rotor blades were still attached and were found near the fuselage. The main rotor blades were still attached to the main rotor hub.

Figure 6: Main wreckage post-accident. (Source: Ronald Collyer)

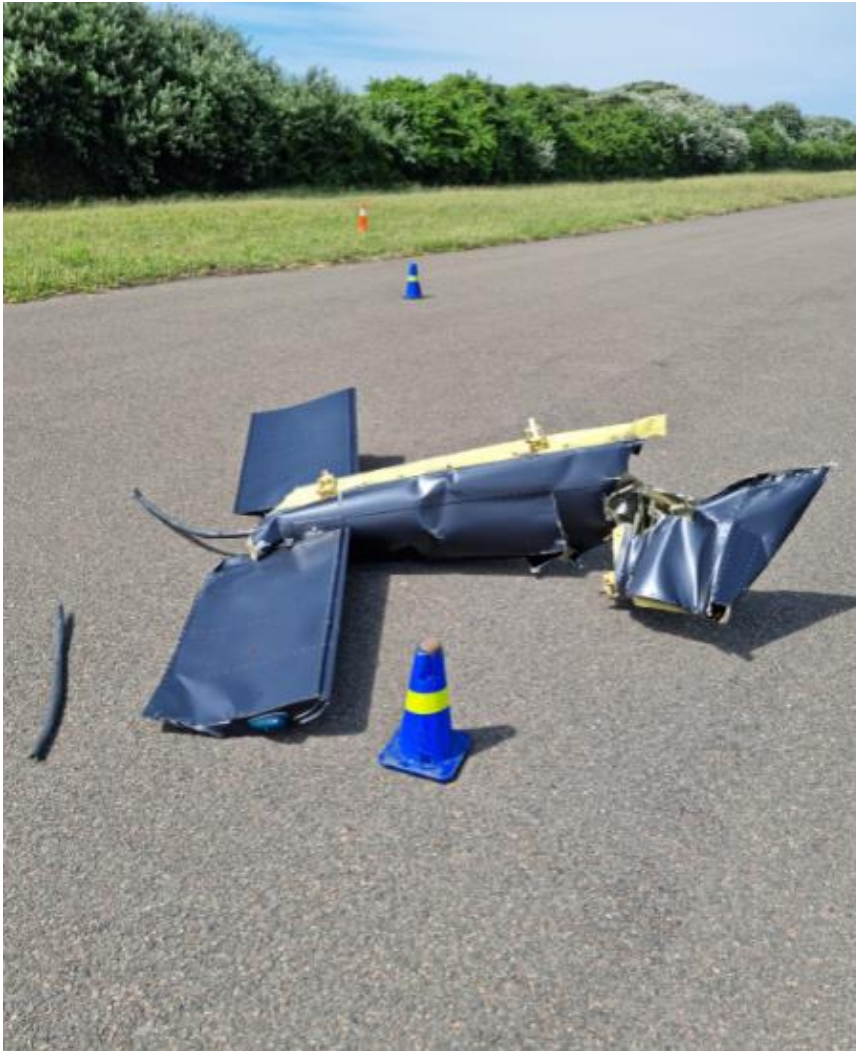
Figure 7: Horizontal stabiliser and control tube. (Source: Ronald Collyer)

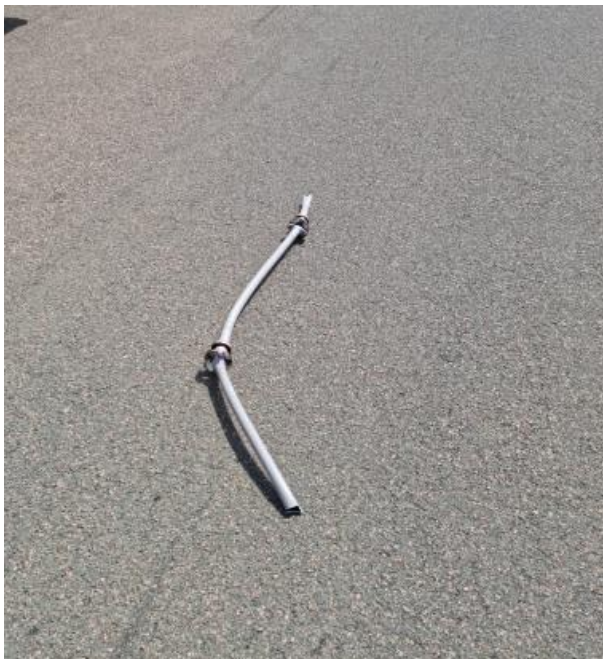
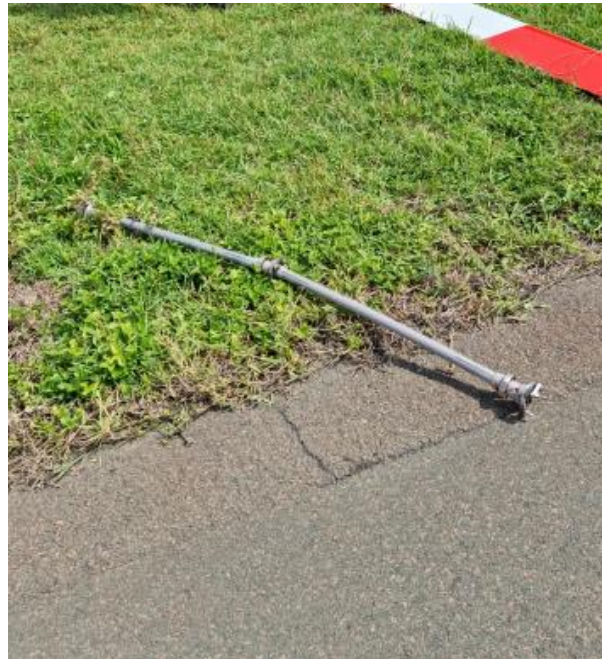
When the main rotor blades severed the tail boom, the tail drive shaft separated and broke into pieces which scattered in different directions. The damage on the fractured skin indicated that the main rotor blades made contact with the tail boom before it separated from the fuselage. The piece that was furthest was found approximately 20m east of the runway edge. The horizontal stabiliser and pieces of the control tail rotor tubes were found in the middle of the runway, east of the main wreckage.

Figures 8 and 9: Tail rotor shaft assemblies. (Source: Ronald Collyer)

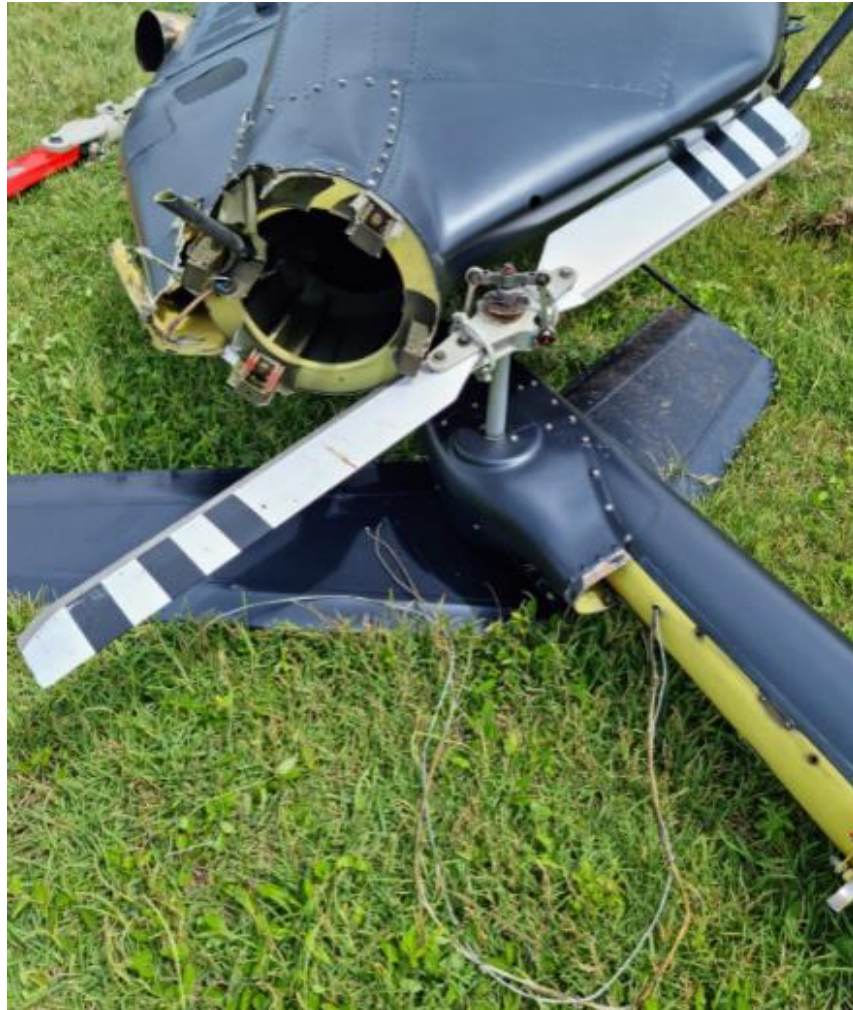
Figure 10: Tail cone with tail rotor blade attached. (Source: Ronald Collyer)

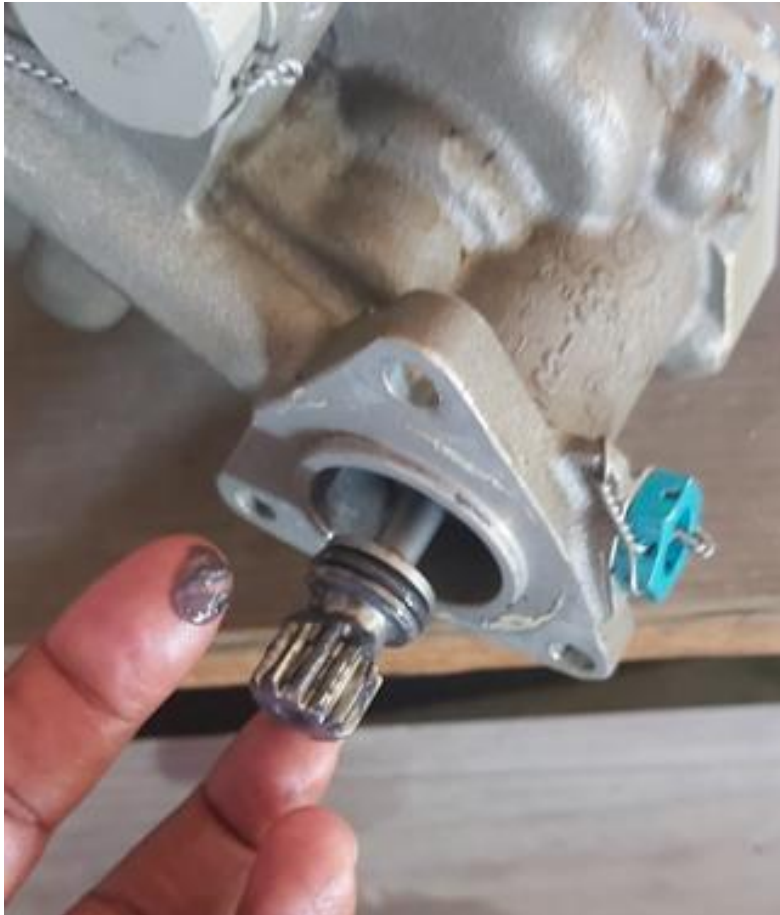
- The fuel pump filter was removed and checked for sediment, and it was found to be clean.
- The splines and shaft were checked, and the overall condition was good with no missing splines or visible wear, the shaft did not shear off.
- The shaft was rotated freely without any difficulties.

Figure 11: The shaft and the splines of the fuel pump.

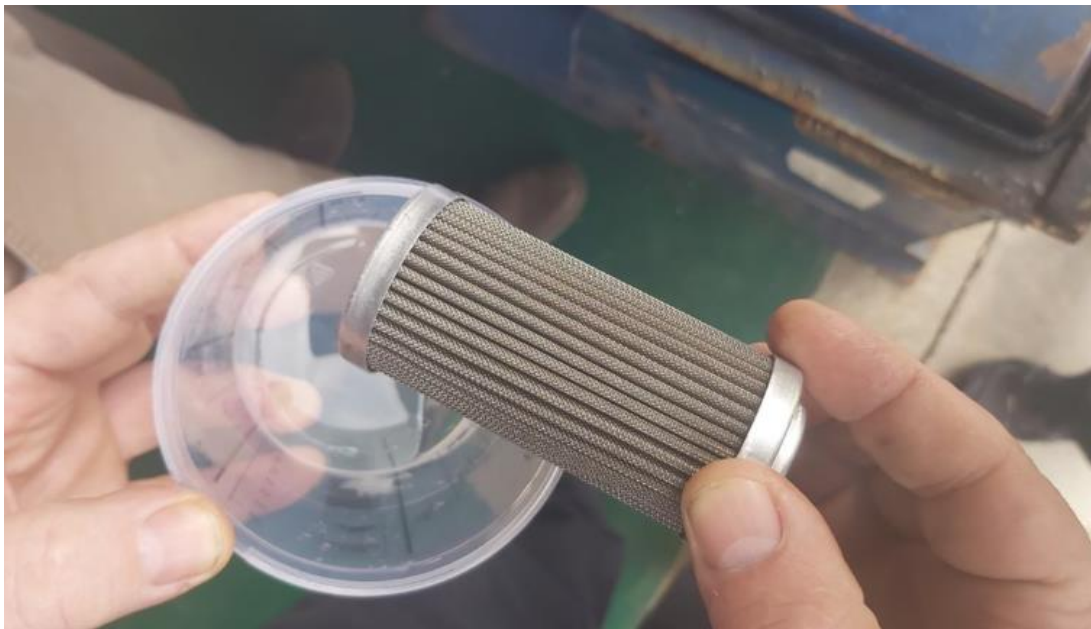
Figure 12: The condition of the fuel pump strainer after being removed from the pump assembly at the testing facility.

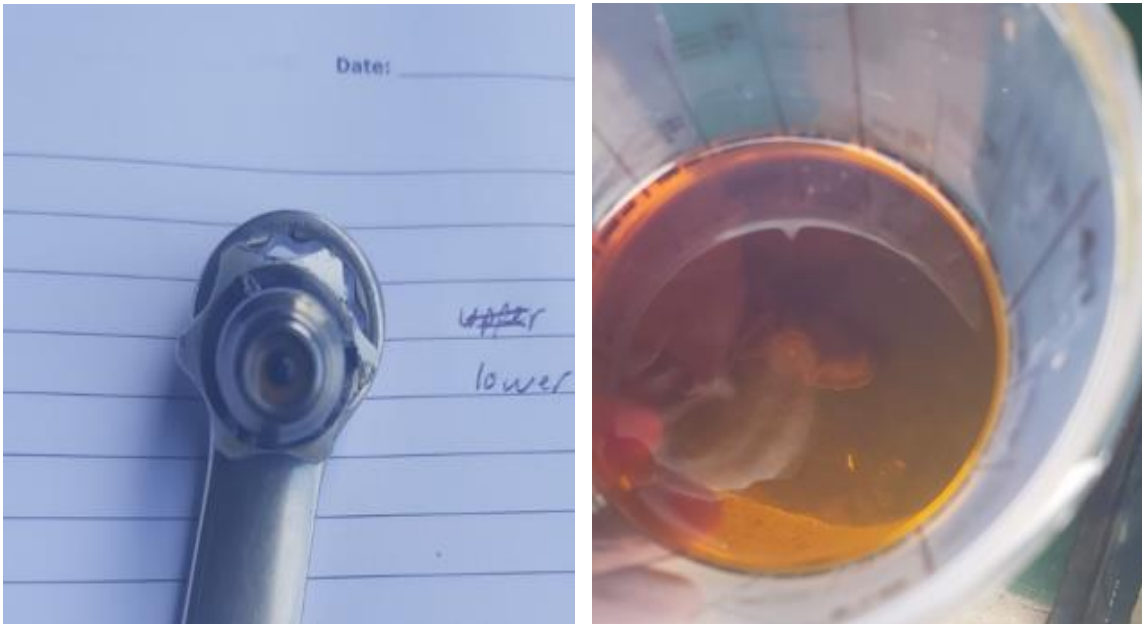
1.16.4 The engine oil was drained from the accessory gearbox and the oil was found to be clean with no sediment. The engine electrical and mechanical chip detectors were removed and checked; no filings/chips were visible at the tips.

Figure 13&14: The chip detector (left) and drained oil from the accessory gearbox (right) at the testing facility.

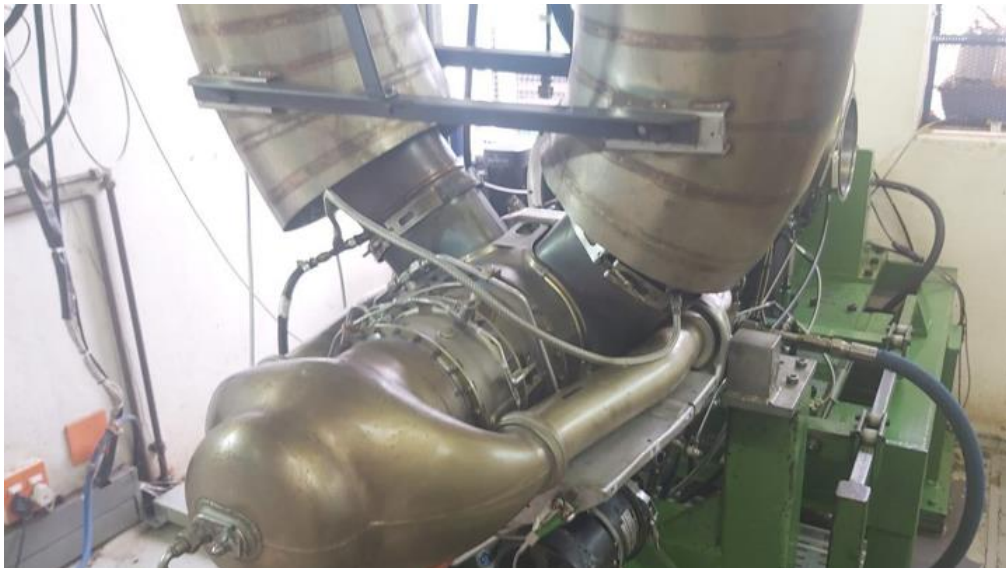
Summary: The engine started, idled, and accelerated as designed during the testing with no flame outs or uncommanded power fluctuations noted. No anomalies were observed during the exam or testing which would have caused the reported sudden power loss during the event.

Figure 15: Accident engine fitted on a test bench.

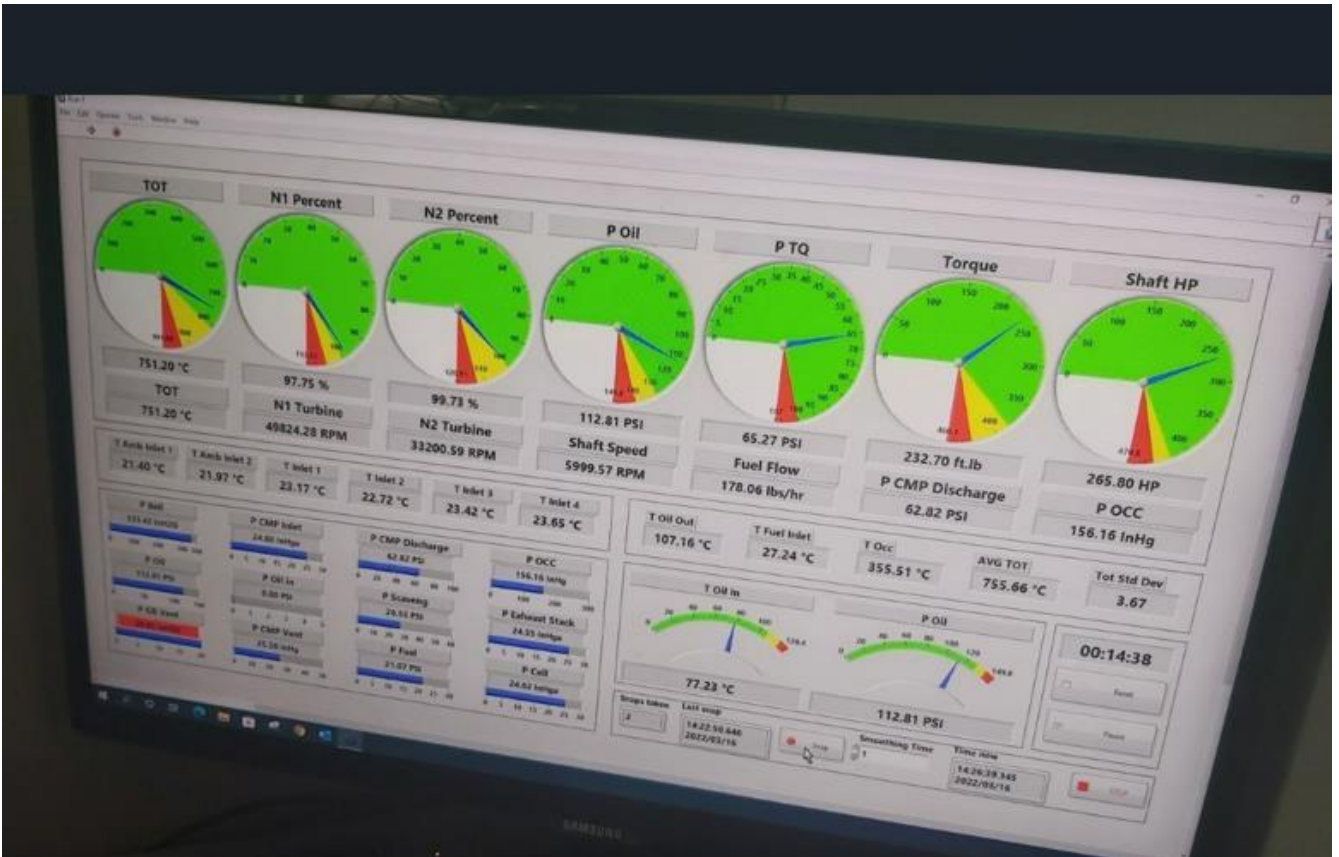
the first attempt and stabilized at ground idle (~65%) within 20 seconds. As the engine was accelerated to 100% N2 speed condition, some speed oscillations were observed. The cause of the oscillations was not conclusively determined, but the test stand operator stated that this condition had been observed in the past and was previously attributed to the dynamometer sensitivity. The oscillations did not repeat after several more accelerations. Several power calibration points were recorded and the engine reached a maximum observed output power of 363 shp (corrected). Due to software issues, standard day predicted data was unavailable.

Figure 16: Screenshot of the engine parameters during bench testing.

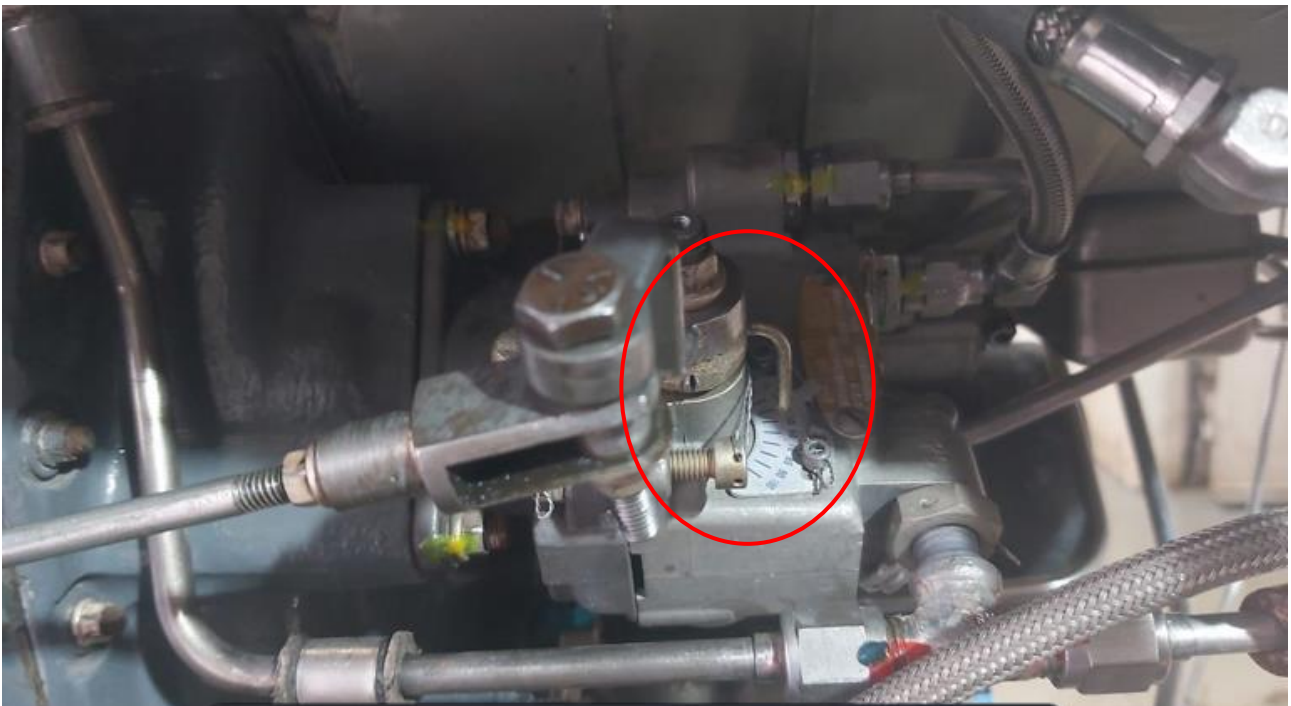
Figure 17: Needle position during ground idle.

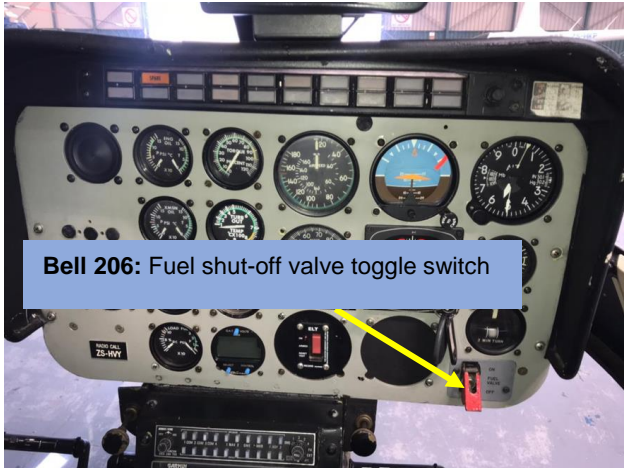
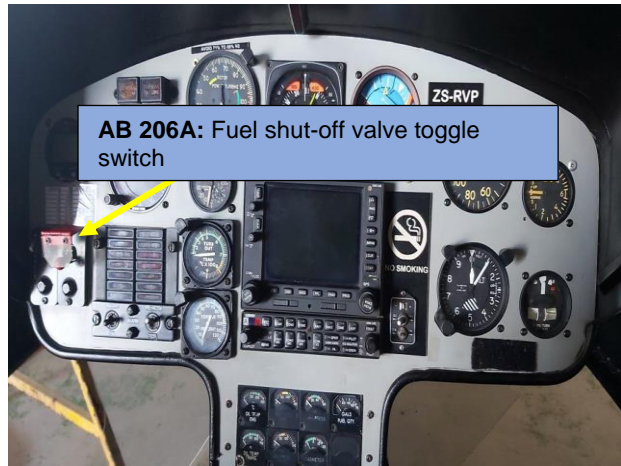
Figures 18 and 19: The position of fuel shutoff valve differences between Bell 206 and Agusta-Bell 206A helicopters.
