AIRCRAFT ACCIDENT REPORT AND EXECUTIVE SUMMARY

Reference:		CA18/2/3/10147	
Aircraft Registration	ZU-CIA	Date of Accident	27 April 2022		Time of Accident	0748Z	
Type of Aircraft	Jabiru SP			Type of Operation	Private NTCA (Part 94)		
Pilot-in-command Licence Type	National Pilot Licence		Age	44	Licence Valid	Yes	
Pilot-in-command Flying Experience	Total Flying Hours		116.3		Hours on Type	47.7	
Last Point of Departure	Rhino Park Aerodrome, Gauteng Province						
Next Point of Intended Landing	Witbank Aerodrome (FAWI), Mpumalanga Province						
Damage to Aircraft	Substantial						
Location of the accident site with reference to easily defined geographical points (GPS readings if possible)							
On R104 provincial road (GPS co-ordinates: 25°51'45.54" South 028°55'06.24" East)							
Meteorological Information	Surface wind, 090°/8 knots; temperature, 13°C; scattered clouds at 6 500 feet						
Number of People On-board	1 + 1	Number of People Injured	0	Number of People Killed	0	Other (On Ground)	0

ITEM: CRANKSHAFT GEAR ASSEMBLY, JABIRU 2200 ENGINE, JABIRU SP, AIRCRAFT ZU-CIA		
<p>1. BACKGROUND INFORMATION</p> <p>1.1. The fractured Crankshaft Gear assembly (Diagram 1, no 2; Part No 464308

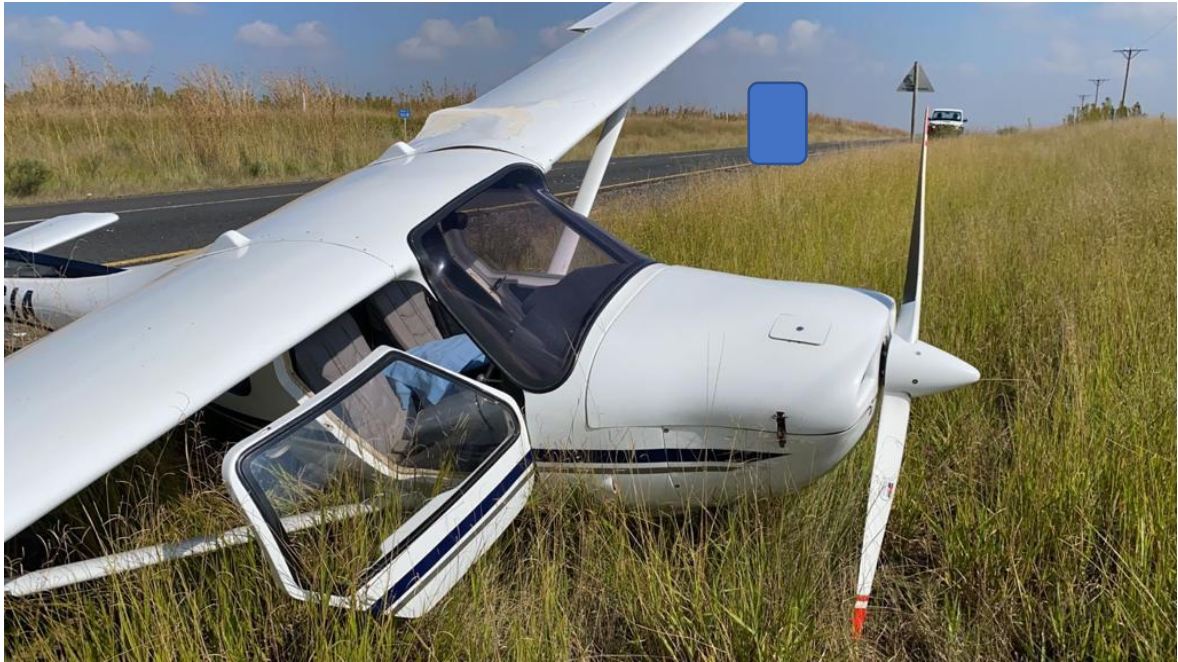
1.3.1 The aircraft sustained substantial damage during the accident sequence.

Figure 2: The aircraft as it came to rest next to the R104 roadway.

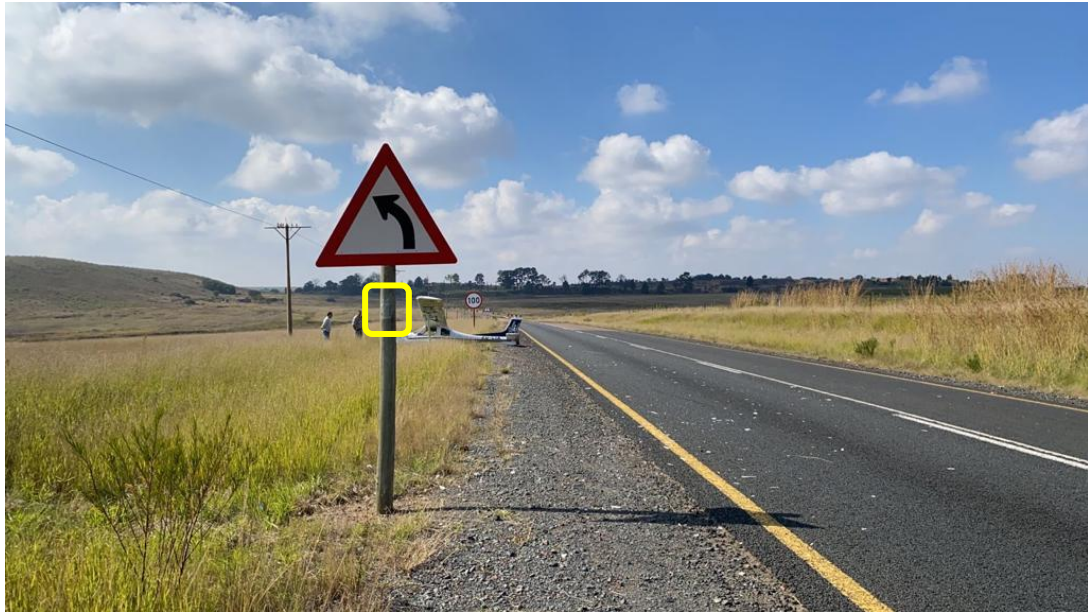
1.12.1 The pilot landed on the R104 roadway in an easterly direction. During the landing roll, the outer section of the left wing collided with a road sign pole (see Figure 4), causing the aircraft to veer off to the left-side and depart the roadway. As the aircraft left the asphalt surface, the right main landing gear strut broke off approximately midspan, which caused the right wing to make contact with the ground. The aircraft came to rest in a right-wing low attitude.

Figure 4: The road sign pole with which the aircraft's left wing collided, leaving a mark on it (see yellow block).

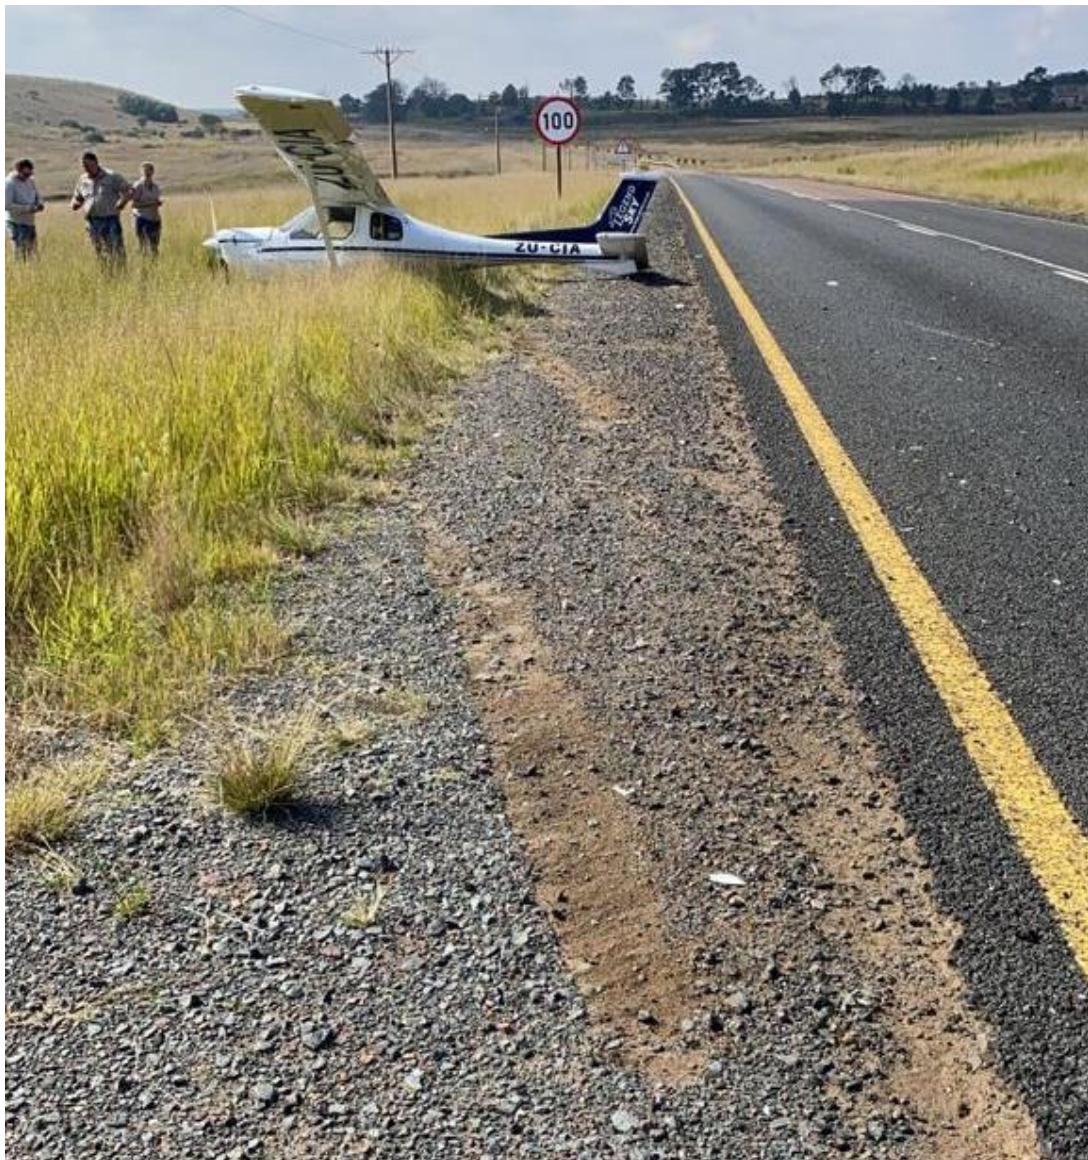
Figure 5: The tyre markings of the main wheels (both sides) as the aircraft veered off the roadway.

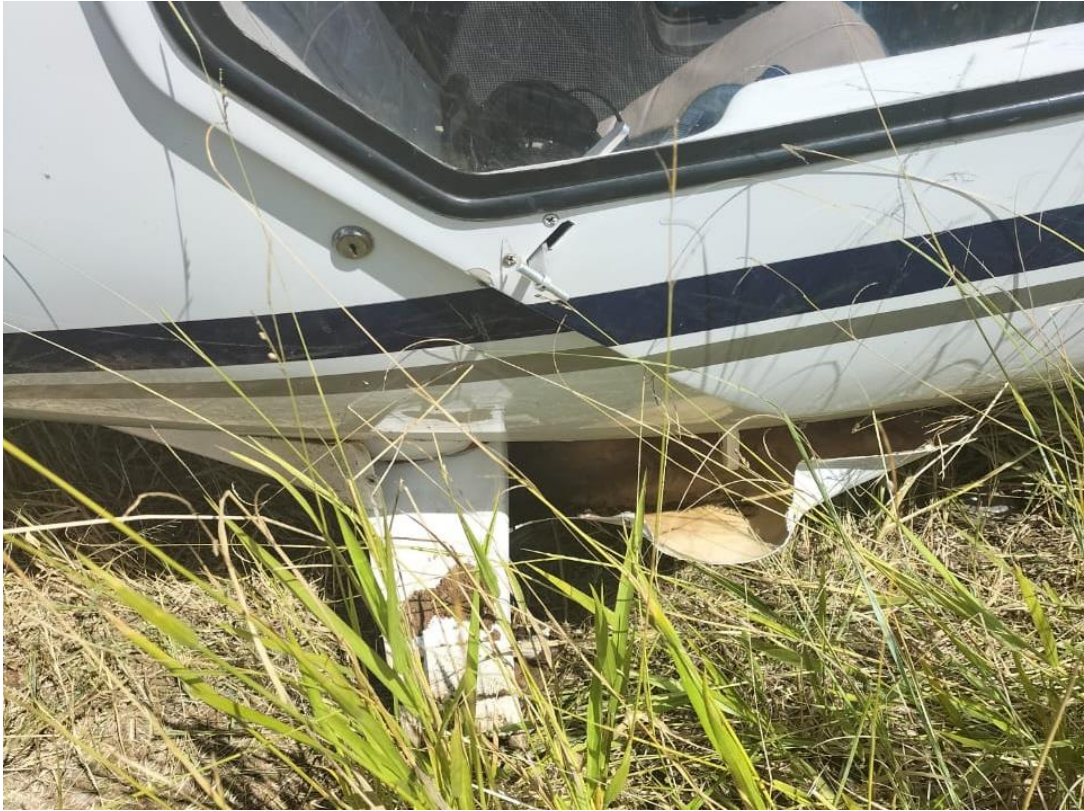
Figure 6: The right main gear strut broke off approximately midspan.

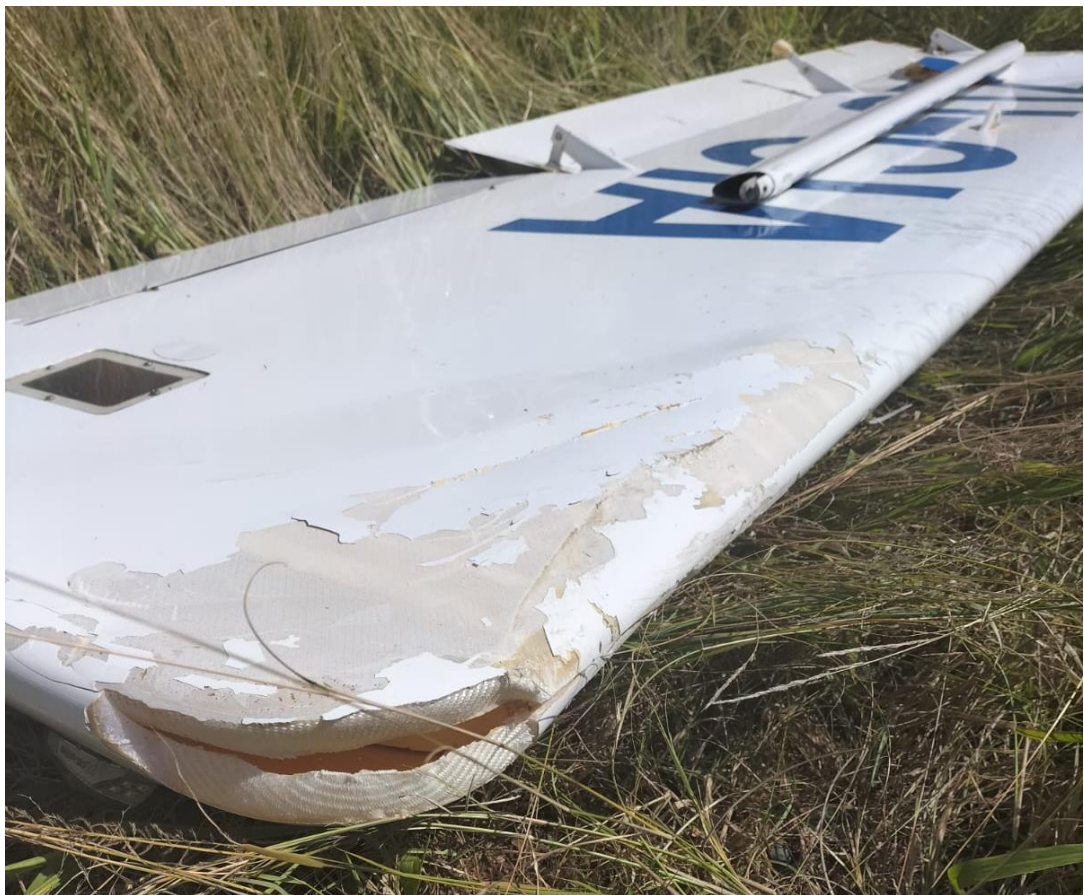
Figure 7: The damage to the left wing following impact with the road sign pole.

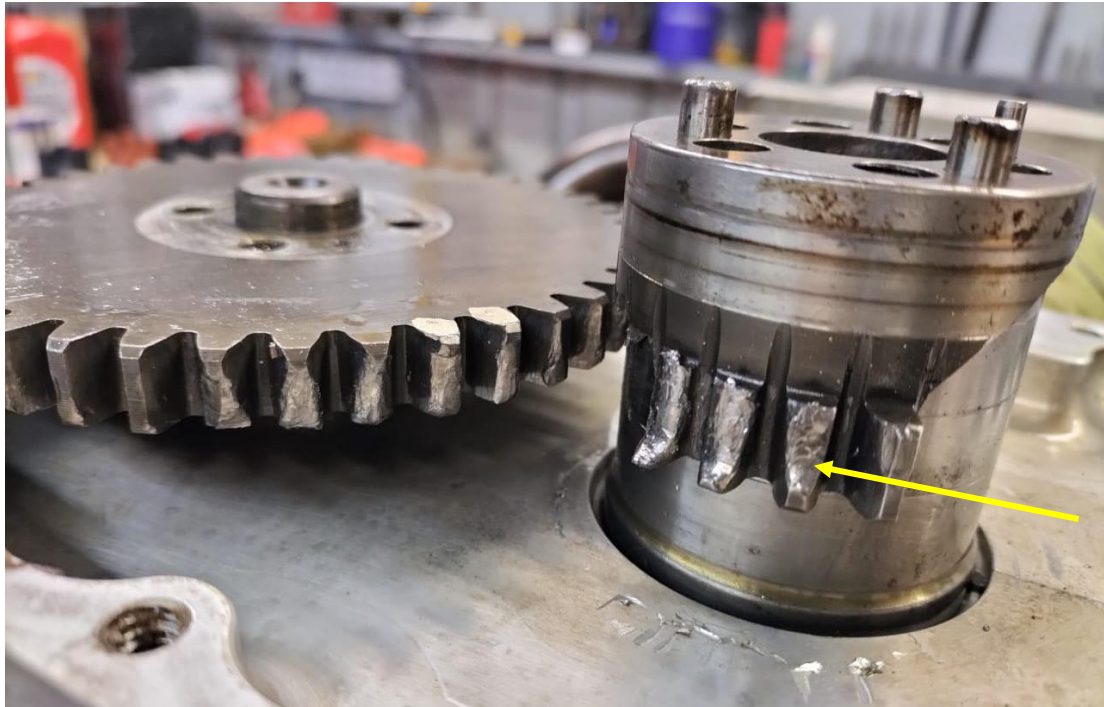
The Jabiru 2200 engine with serial number 22A3244 was removed from the wreckage and was later subjected to a teardown inspection. It was found that the crankshaft gear assembly with part number 4643084 had failed in operation. The failed component was subjected to a metallurgical analysis. The metallurgical report is attached to this report as Appendix A.

The investigation results revealed the primary contributing factor towards the failure of the crankshaft gear was hydrogen embrittlement. The exact cause/s towards the hydrogen induced cracking (HIC) could not be determined by this investigation – the original equipment manufacturer's (OEM's) manufacturing process is proprietary information.

Figure 8: The crankshaft gear assembly that failed, indicated by the yellow arrow.

During the engine teardown inspection, it was found that the crankshaft gear had failed, and was subjected to a laboratory examination. The engine stoppage was attributed to the failure of the crankshaft gear that was determined to have been caused by hydrogen embrittlement (HE) which most probably manifested during the manufacturing process of the gear assembly. The exact cause/s to the hydrogen induced cracking (HIC) could not be determined.

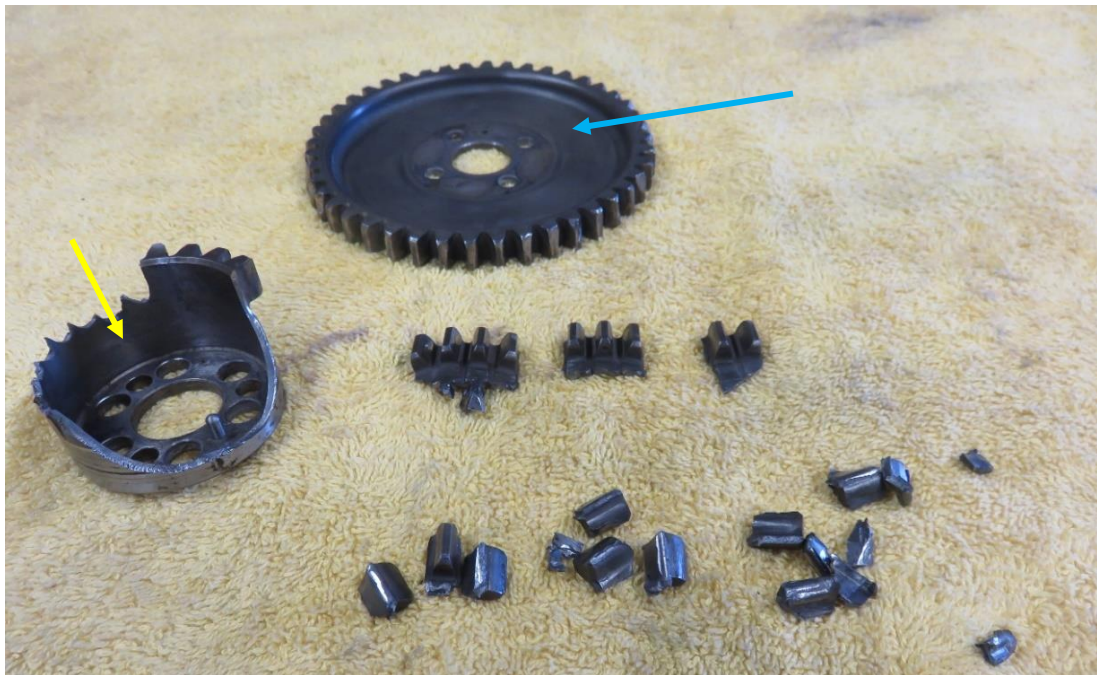
Figure 9: Fractured pieces from the crankshaft gear assembly and the flywheel (blue arrow).

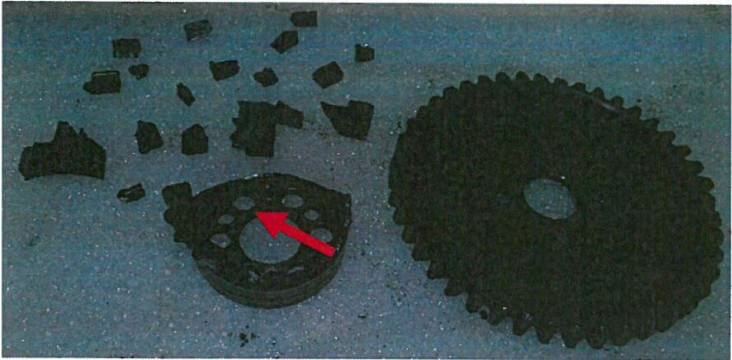
<p>Photo 2: Fractured Crankshaft Gear assembly, as supplied (digital)</p>		
<p>¹ SACAA/AIID ² Courtesy AIRPORTDATA.com</p>

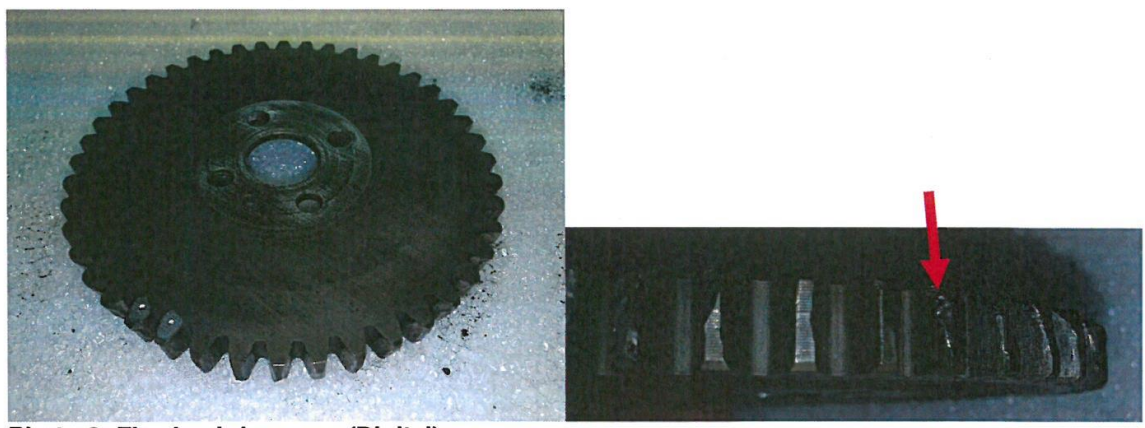
Photo 3: Flywheel damages (Digital)

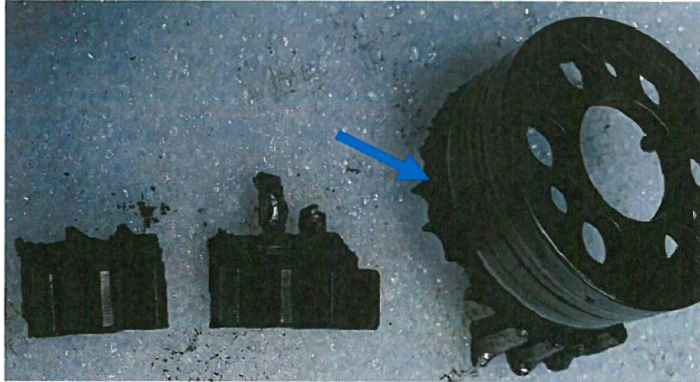
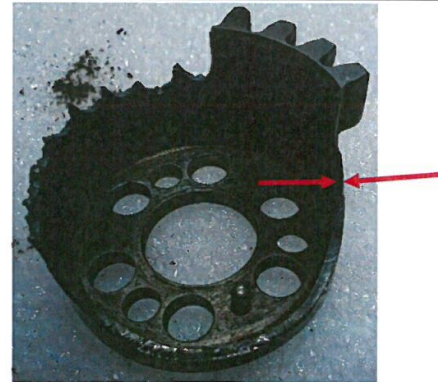
Photo 4: Fractured Crankshaft Gear (Digital)

- 7.1. The investigation results revealed the primary contributing factor towards the failure of the Crankshaft Gear is Hydrogen Embrittlement. The exact cause/s towards the HIC could not be determined by this investigation – *the OEM manufacturing process is proprietary information.*

- 7.2. HIC is predominantly introduced by the manufacturing processes, particularly during plating/hardening where the component surface might be exposed to higher-than-normal ionised hydrogen (H+) concentration/s. Failing to remove the absorbed hydrogen by proper heat treatment, will result in HE and a loss in ductility with subsequent brittle behaviour of the metal. *However, HIC usually manifests itself within a relative short period of time (not operational time) following the exposure while in this case the part remained intact for an extended period. It can be hypothesized that the HIC was magnified during the engine impact loading/s (ref.p. 1.4.) thus contributing to the timing of the final fracture.*

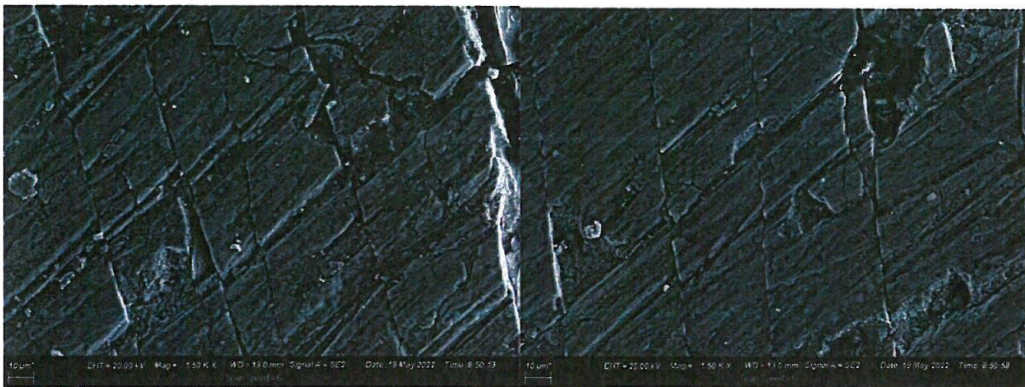
Fractograph 1: Outer surface morphology (1500X, 20kV, SE, FEGSEM)

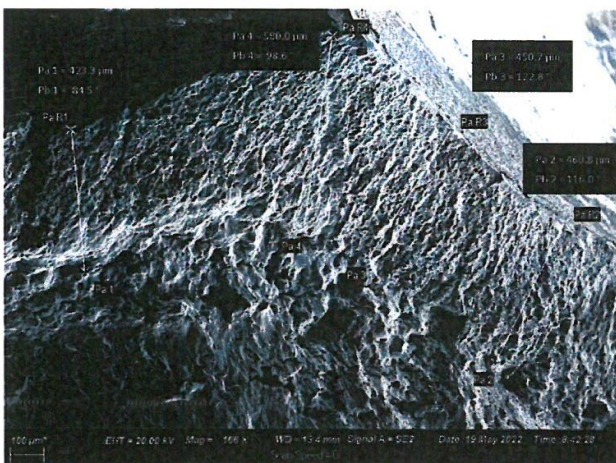
Fractograph 2: Fracture surface morphology (166X, 20kV, SE, FEGSEM)

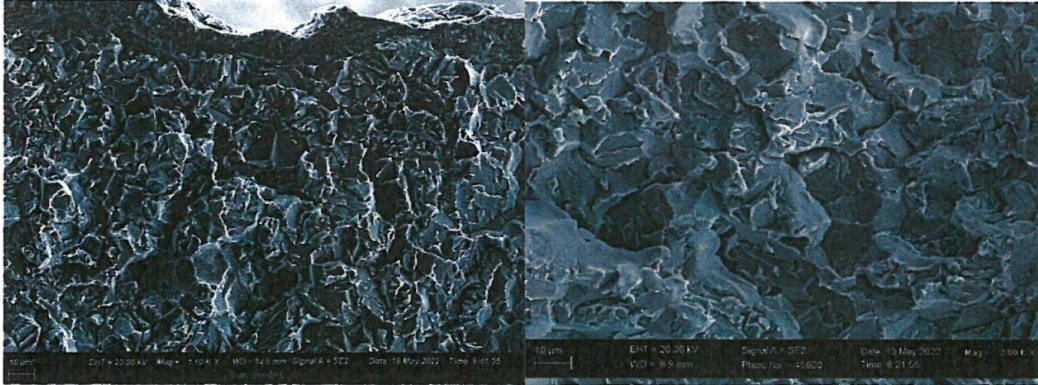
Fractograph 3: Fracture surface morphology (1500-2000X, 20kV, SE, FEGSEM)
