**AIRCRAFT ACCIDENT REPORT AND EXECUTIVE SUMMARY**

<b>Reference:</b>		<b>CA18/2/3/10152</b>	
<b>Aircraft Registration</b>	<b>ZS-AWX</b>	<b>Date of Accident</b>	3 May 2022		<b>Time of Accident</b>	0647Z	
<b>Type of Aircraft</b>	Piper PA-25-235		<b>Type of Operation</b>		Agricultural (Part 137)		
<b>Pilot-in-command Licence Type</b>	Commercial Pilot Licence (CPL)		<b>Age</b>	25	<b>Licence Valid</b>	Yes	
<b>Pilot-in-command Flying Experience</b>	<b>Total Flying Hours</b>		1232.9		<b>Hours on Type</b>	288.0	
<b>Last Point of Departure</b>	Clan Airfield, KwaZulu-Natal Province						
<b>Next Point of Intended Landing</b>	Clan Airfield, KwaZulu-Natal Province						
<b>Damage to Aircraft</b>	Substantial						
<b>Location of the accident site with reference to easily defined geographical points (GPS readings if possible)</b>							
Open field at Global Positioning System (GPS) co-ordinates determined to be 29°26'9.90" South, 030°27'15.16" East, at an elevation of 2132ft

**Reference Number** : CA18/2/3/10152  
**Occurrence Category** : Category 1  
**Type of Operation** : Aerial Work Operations (Part 137)  
**Name of Operator** : Natal Aerial Spray (PTY) LTD  
**Aircraft Make and Model** :

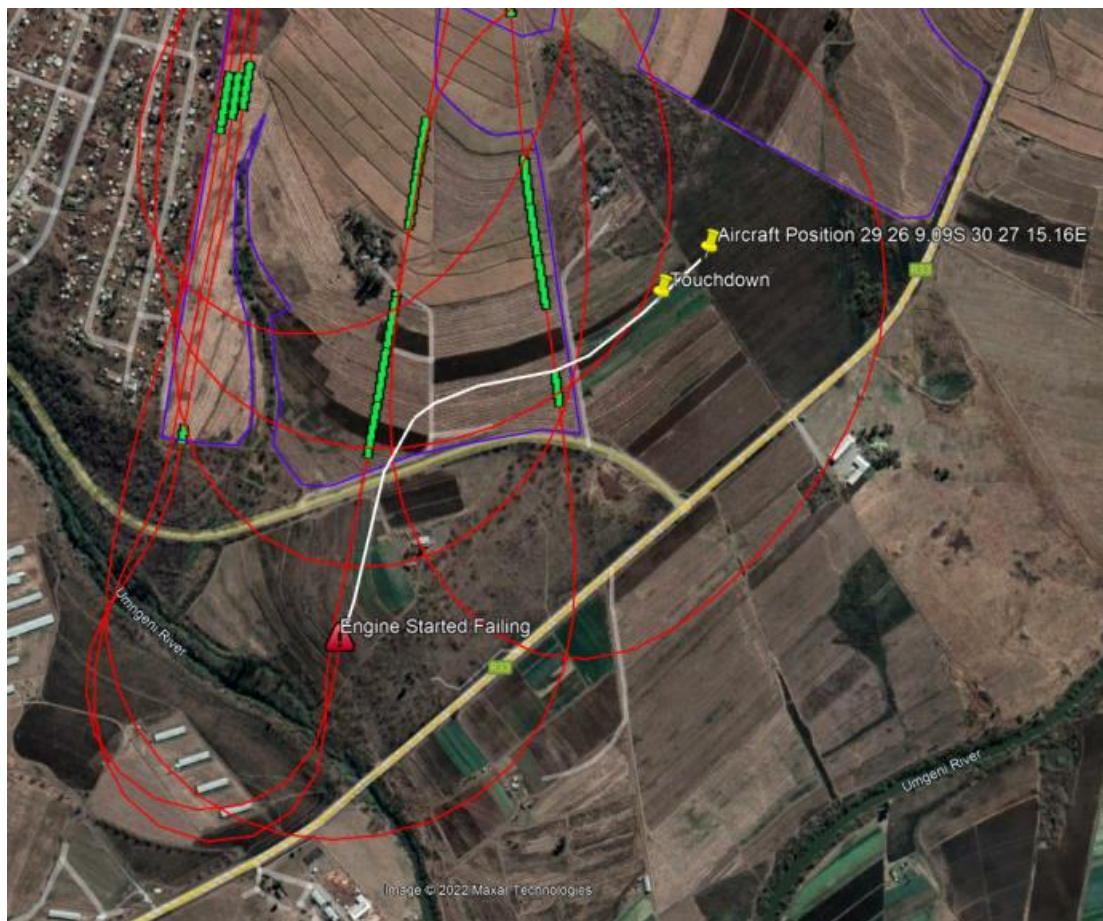
**Figure 1:** The red lines indicate the completed swath lines. The white line shows the flight path of the aircraft from the point the engine started to run rough to the point it came to a stop on the ground. (Source: Pilot)

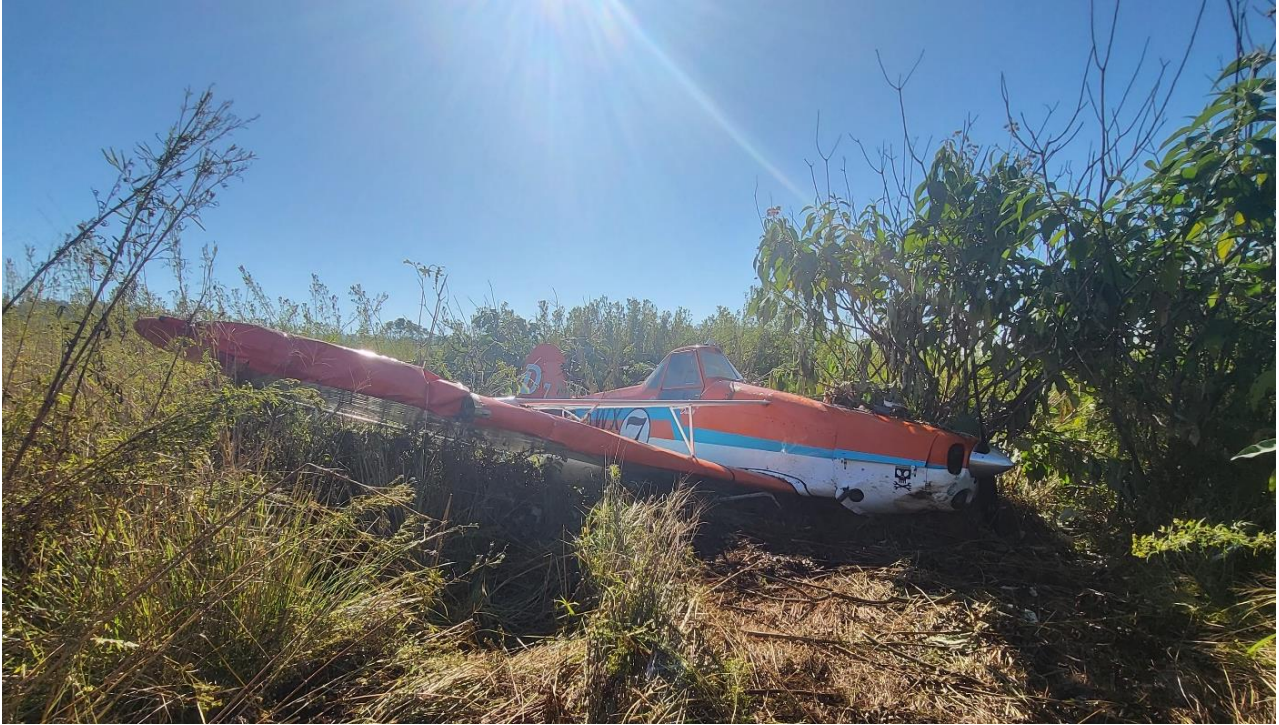
- 1.3.1. The aircraft sustained damage to the propeller, undercarriage, leading edge on both wings, left elevator, spinner and the spray system equipment.

**Figure 2:** The aircraft at the accident site.

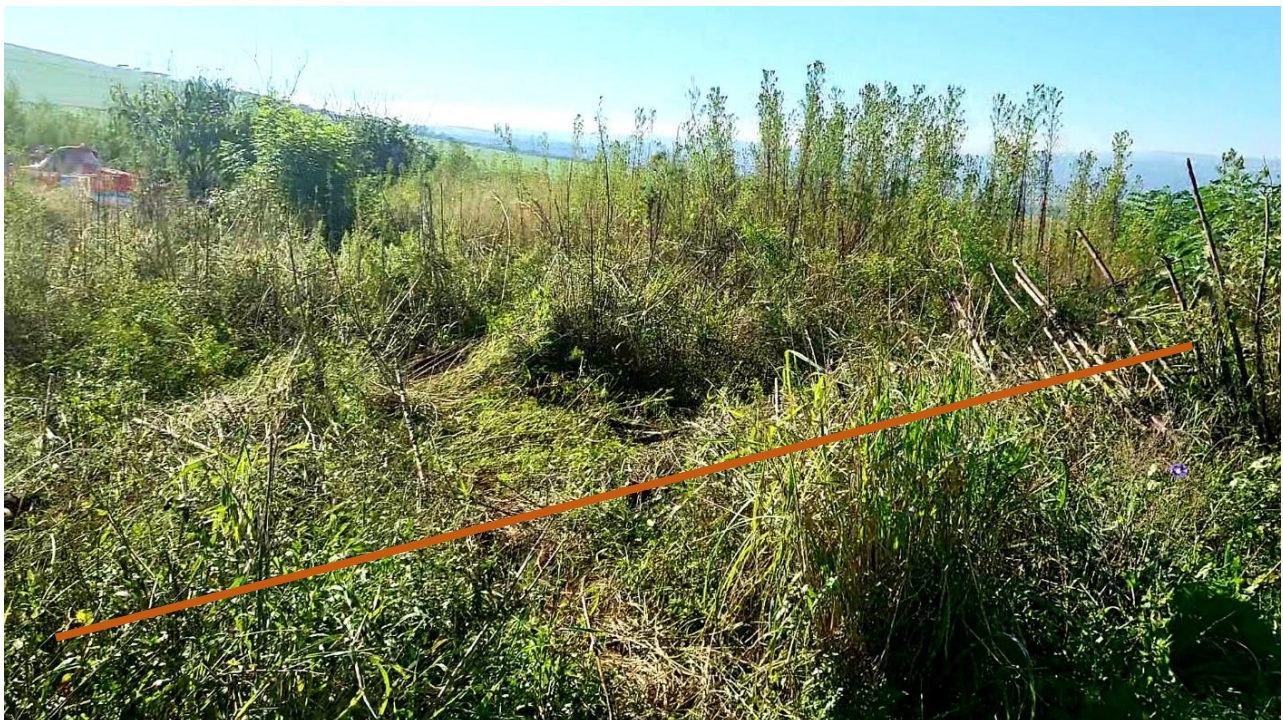
1.4.1. The aircraft impacted a perimeter fence and flattened it.

**Figure 3:** The perimeter fence (brown line) constructed from wood poles and barbed wire with the aircraft on the top-left corner of the picture.

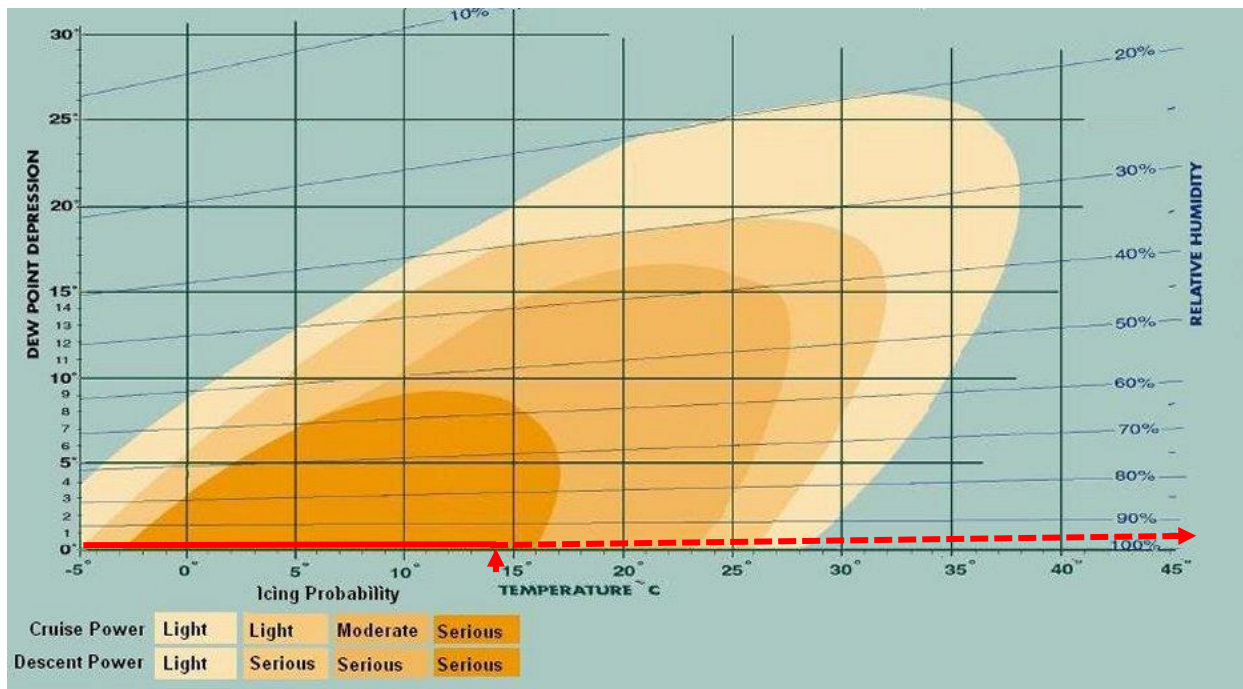
1.7.2. In the table above, the temperature is 14°C and dew point is also 14°C, equating to a dew point depression of 0° and a relative humidity of 97%. Mapping these values on the carb-icing chart resulted in a serious probability icing at both cruise and descent powers.

**Figure 4:** The carb-icing probability chart indicating weather conditions at the time of the accident.

Fine weather conditions prevailed at the time of the flight; therefore, the weather was not a contributory factor to the accident. Even though the carb-icing chart indicated a probability of icing, carburettor icing could not be attributed to the accident as crop-spraying flights are normally conducted at high-power settings. The pilot also applied the carburettor heat to remedy the situation (if there was carburettor icing).

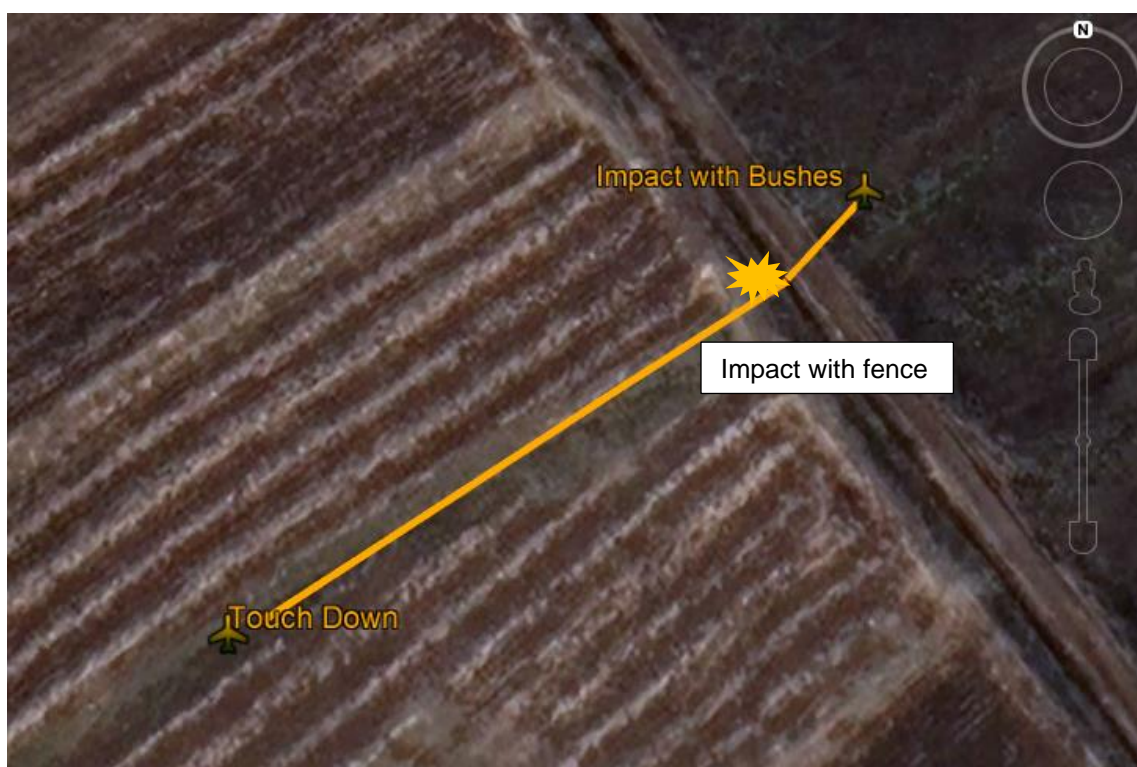
1.12.1. The aircraft touched down on an uneven terrain after the forced landing and rolled for approximately 60m before the propeller blades impacted a perimeter fence, followed by the aircraft flattening it. The aircraft continued to roll to the other side of the fence, ground-looped and made an approximate 90° turn. It then impacted some bushes before it came to a stop with the nose facing south-east.

**Figure 5:** The path of the aircraft after touchdown. (Source: Google Earth)

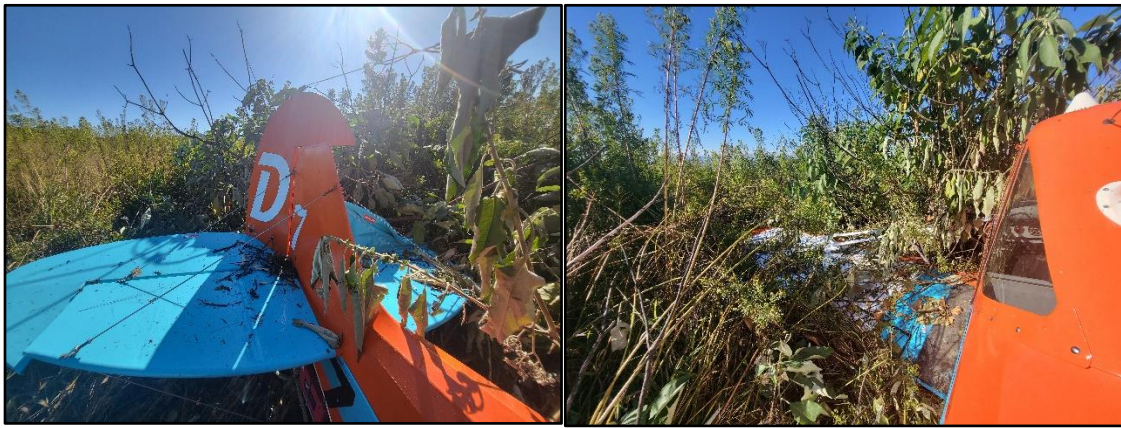
The fuselage was fairly intact with signs of damage on the leading edge of both wings after impacting the perimeter fence. The left elevator and left-wing leading edge sustained greater impact damage as the aircraft's left-side and the spray system equipment impacted the bushes.

**Figure 6 and 7:** Damage to the left elevator (left); and left-side wing tucked in the bushes (right).

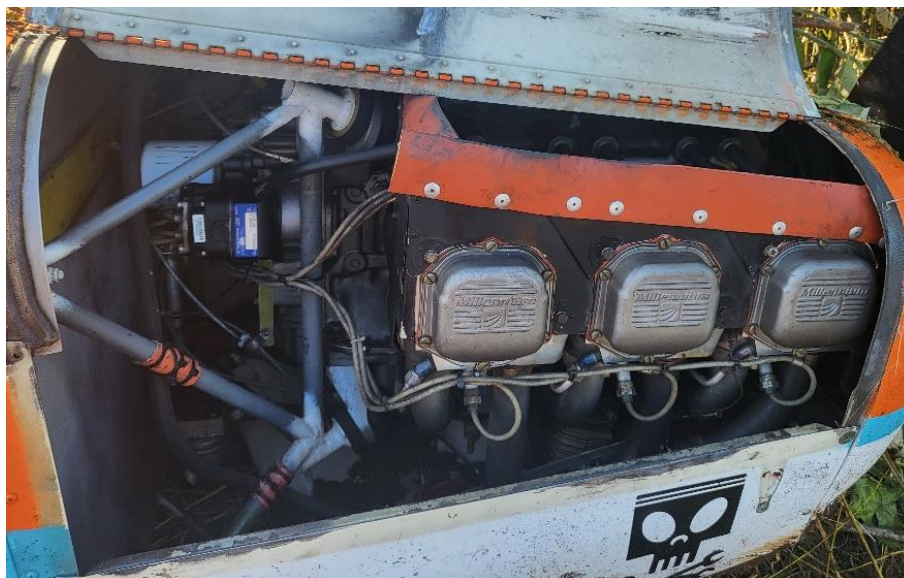
The engine was intact, it was found still attached to the cradle with no sign of oil or fuel spillage. Both propeller blades were still attached to the hub with no signs of rotational signatures. One blade was found lodged firmly into the ground.

**Figure 8:** The condition of the engine compartment as it was observed at the accident site.

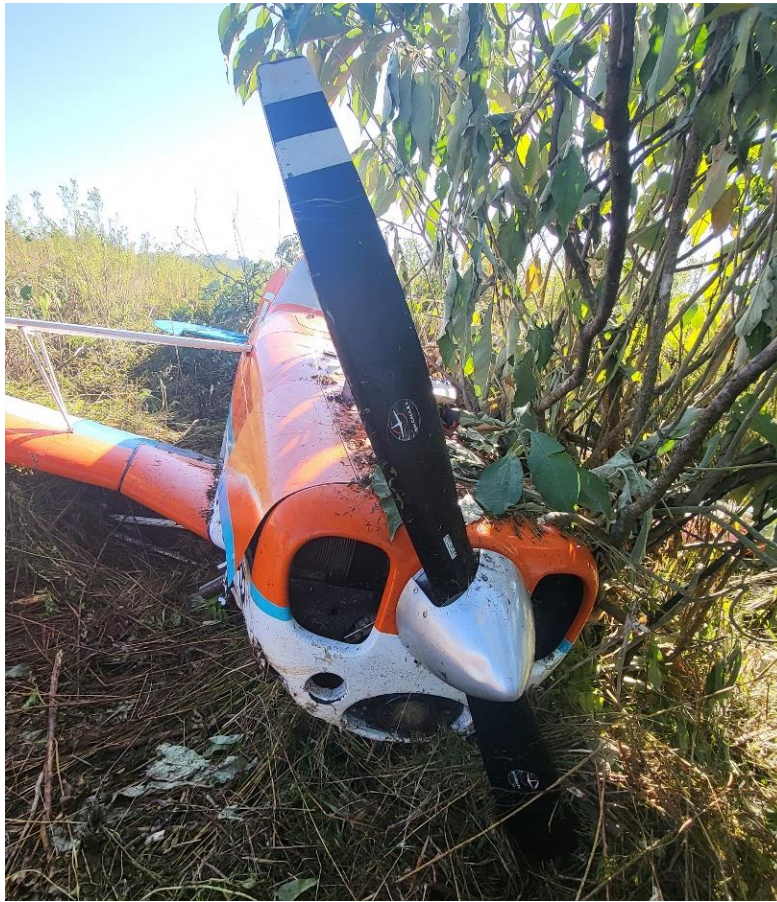
**Figure 9:** The final position of the propeller.

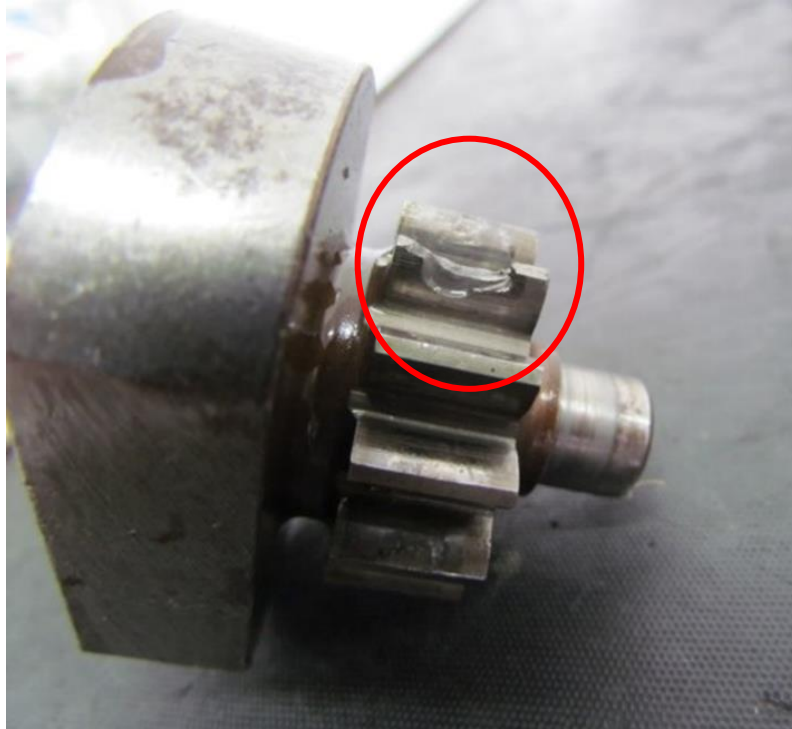
- One of the left magneto drive gear teeth was found broken (figure 9).
- The crankshaft idler gear was found damaged where the magneto drive gear meshes with it (Figure 10).

**Figure 10:** The left magneto drive gear indicating one of the broken teeth. (Source: AMO)

- *In conclusion, when the left magneto drive gear failed, it resulted on the internal timing to be shifted, this resulting in the engine misfiring and would have vibrated badly eventually ending with an engine power loss.*

- 3.3.1. In-flight engine power loss as a result of the left magneto drive gear failure due to a worn out drive gear shaft which led to the advanced engine timing and, hence, the subsequent forced landing.

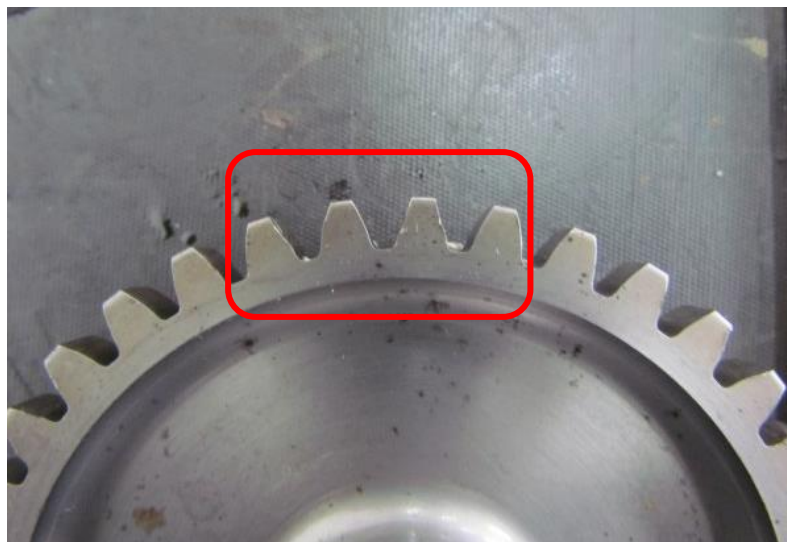
**Figure 11:** The crankshaft idler gear with wear on teeth. (Source: AMO)

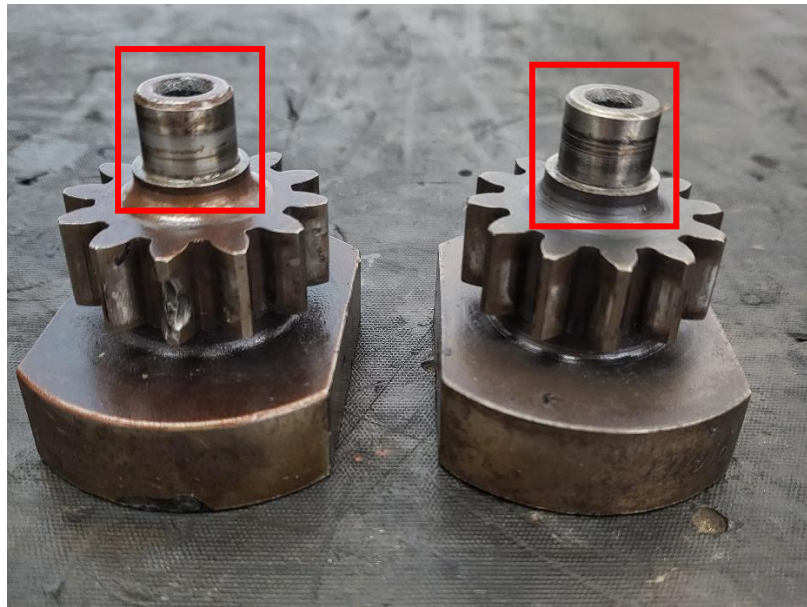
1.16.2 Further inspection of the left and right magneto drive gears indicated wear on the magneto drive gear shaft that is inserted into the engine via a bearing. It was also noted that during the engine strip, the magneto drive gear could easily be removed by hand from the bearing. The component is press-fit onto the engine and, therefore, should not be easily removed.

**Figure 12:** The left and right magneto drive gear shaft indicating wear on the shaft.

Further investigation of the left and right magneto drive gears indicated wear on the magneto drive gear shaft. The wear on the left magneto drive gear shaft was considerable enough that when the drive gear was removed from the point where it is flushed with the bearing, the removal could be carried out by hand. This component is press-fit into the engine and, therefore, it should not be easily removed by hand in a normal operation. This indicated that the drive gear was unserviceable and, during flight, caused some play between the drive gear and the crankshaft idler gear. These two gears should mash into each other and, if not, teeth will be knocked out as observed in the left magneto drive gear.

- 3.2.10. It is probable that the magneto drive gear shaft was worn (out of limit) and was refitted to the engine which resulted in damage to the magneto drive gear.

It is probable that after the last magneto inspection when the left and right magneto were refitted onto the engine, the condition of both magneto drive gears was not inspected. This component is on-condition, but it is recommended that in future it should be inspected when the magneto is removed or/and when it is refitted.

4.2.1. The AMOs and aircraft maintenance engineers (AMEs) are advised to inspect the fitment security of the magneto drive gear shaft and bearing before the magneto is refitted to the engine.

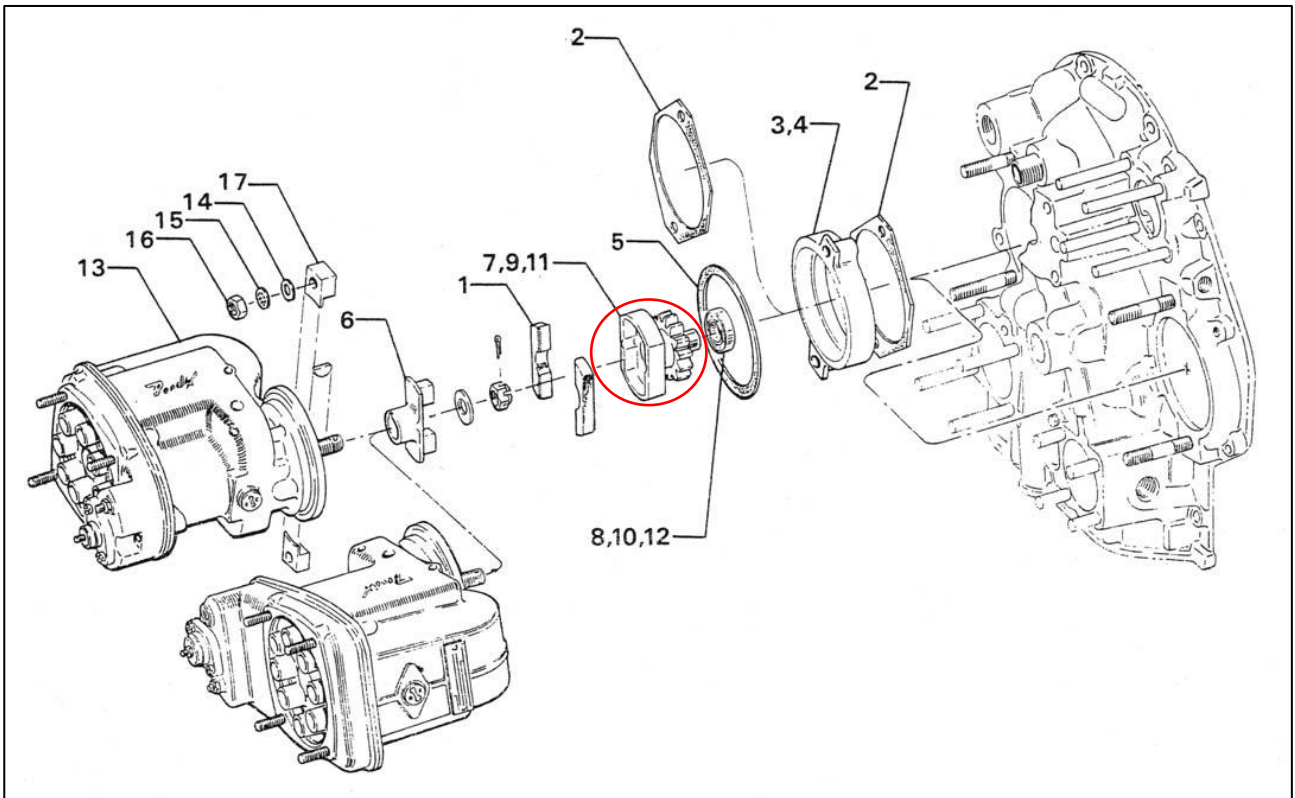
1.16.3 Illustration 1 below is an extract from the Lycoming O-540-B, -E and -G series parts catalogue. It indicates the ignition system in which the magneto drive gear assembly (7,9,11) is inserted into the bearing (8,10,12).

**Illustration 1:** The ignition system indicating the magneto drive gear (red circle).  
(Source: Lycoming O-540 Parts Catalogue)
