LIMITED ACCIDENT INVESTIGATION REPORT

Reference Number	CA18/2/3/10157						
Classification	Accident	Date	14 May 2022	Time	1530Z		
Type of Operation	Training (Part 141)						
Location							
Place of departure	Wonderboom Aerodrome (FAWB), Gauteng		Place of intended landing		Wonderboom Aerodrome (FAWB), Gauteng		
Place Accident	Middle of Runway 29 at FAWB						
GPS Co-ordinates	Latitude	S 25°39'12.7"	Longitude	E 028°13'16.5"	Altitude	3961.6 feet (ft)	
Aircraft Information							
Registration	ZS-PYT						
Model/Make	Cessna 172N Skyhawk (Serial Number: 172-72851)						
Damage to Aircraft	Substantial		Total Aircraft Hours		9058.2		
Pilot-in-command							
Licence Type	Student Pilot Licence (SPL)	Gender		Female	Age	36	
Licence Valid	Yes						
Total Hours on Type	49.6		Total Flying Hours		49.6		
People On-board	1+0	Injuries	0	Fatalities	0	Other (on ground)	0
What Happened							
<p>On 14 May 2022 at 1130Z, an instructor and a student pilot on-board a Cessna 172N Skyhawk aircraft with registration ZS-PYT were conducting circuit exercises on Runway (RWY) 29 at Wonderboom Aerodrome (FAWB), Gauteng province. The exercises were intended for the student pilot to progress to the solo consolidat

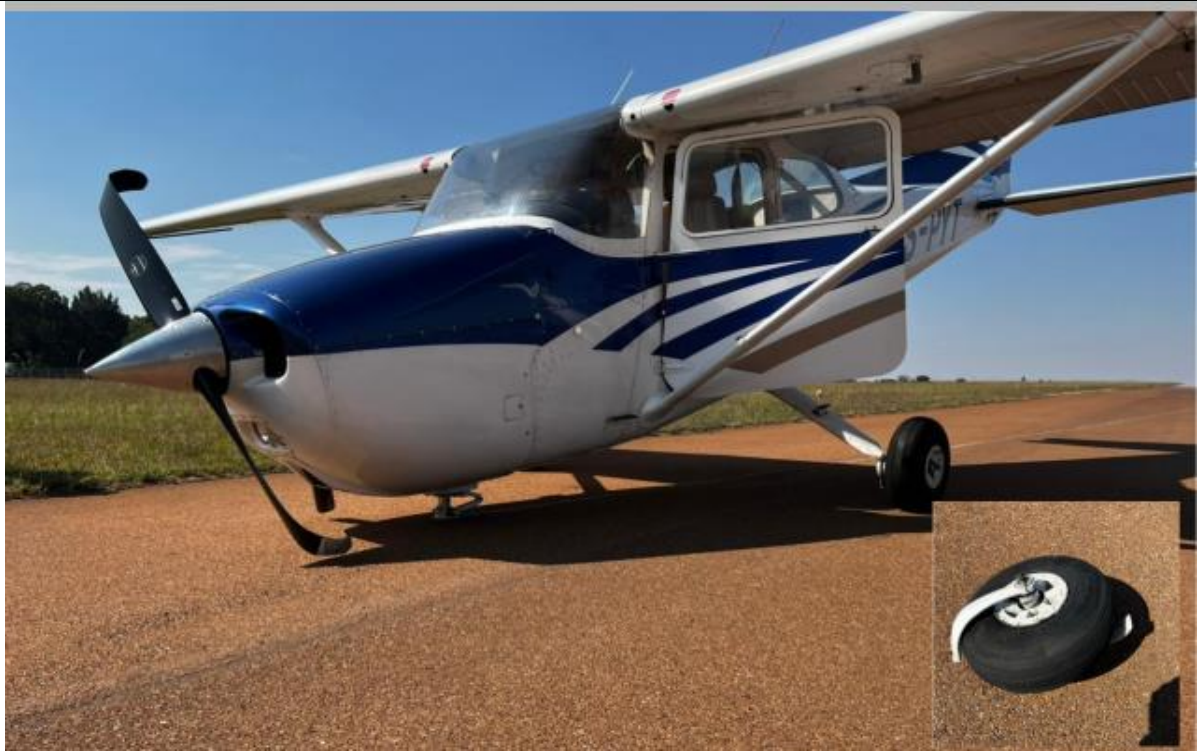
The student pilot conducted two circuits successfully. On the third and final circuit, she stated that her downwind checks were completed on time with the approach speed on the final leg between 65 and 70 knots (kts), which was within limits as prescribed in the Pilot's Operating Handbook (POH). She then touched down but when she tried to apply brakes, the nose gear broke off and the aircraft scrapped the runway surface with the end of the oleo strut, followed by the propeller strike on the runway several times before the aircraft came to a stop. The student pilot was not injured during the accident sequence; the aircraft sustained damage to the nose gear fork and the propeller.

Figure 1: The aircraft on the runway with the broken nose wheel. (Source: Operator)

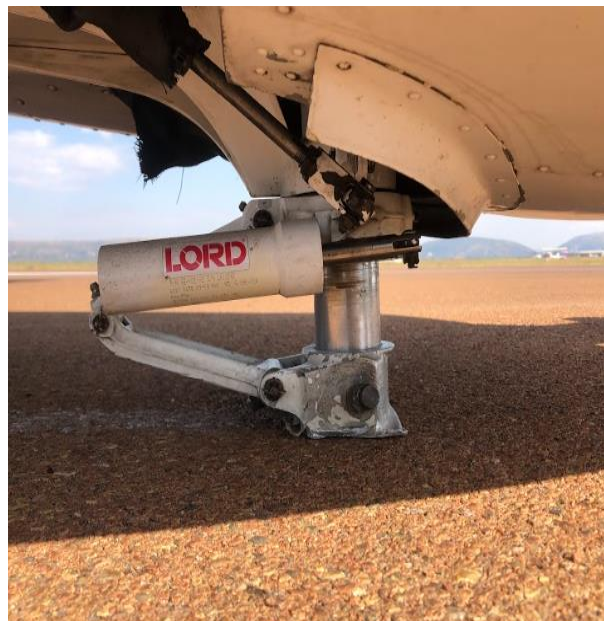
Figure 3 The break occurred above the nose wheel fork.

It is likely that the aircraft was flared too high, which resulted in the aircraft landing hard with the nose gear assembly, which subsequently failed.

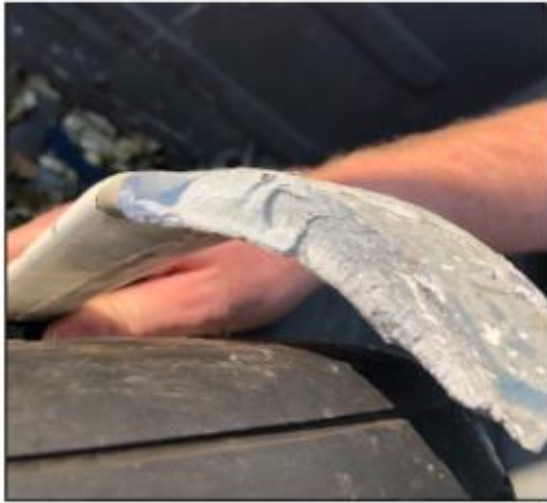
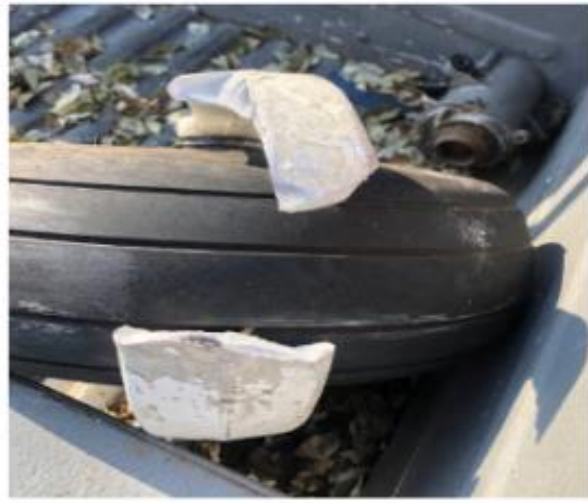
Figures 4 and 5: The clean breaks with no signs of pre-existing cracks. (Source: Operator)
