AIRCRAFT ACCIDENT REPORT AND EXECUTIVE SUMMARY

Reference:		CA18/2/3/10160	
Aircraft Registration	ZS-BTL	Date of Accident	18 May 2022		Time of Accident	0805Z	
Type of Aircraft	Piper PA-25-235D Pawnee		Type of Operation		Private (Part 91)		
Pilot-in-command Licence Type	PPL (A)	Age	52		Licence Valid	Yes	
Pilot-in-command Flying Experience	Total Flying Hours	1060.1	Total Hours on Type		17.6		
Last Point of Departure	Potchefstroom Aerodrome (FAPS), North West Province						
Next Point of Intended Landing	Bospan Airstrip, North West Province						
Damage to Aircraft	Substantial						
Location of the accident site with reference to easily defined geographical points (GPS readings if possible)							
± 910 metres from the threshold of Runway 21 at FAPS (GPS co-ordinates: 26°39'45.65" South 027°05'01.94" East) at an elevation of 4 459 feet (ft)							
Meteorological Information	Surface wind: 340°/06-10kt; temperature: 19.7°C; dew Point: 7°C; visibility: 9999m

Reference Number : CA18/2/3/10160
Occurrence Category : Accident (Category 2)
Type of Operation : Private (Part 91)
Operator Type : Private
Aircraft Registration : ZS-BTL
Aircraft Make and Model : Piper Aircraft Corporation, PA-25-2

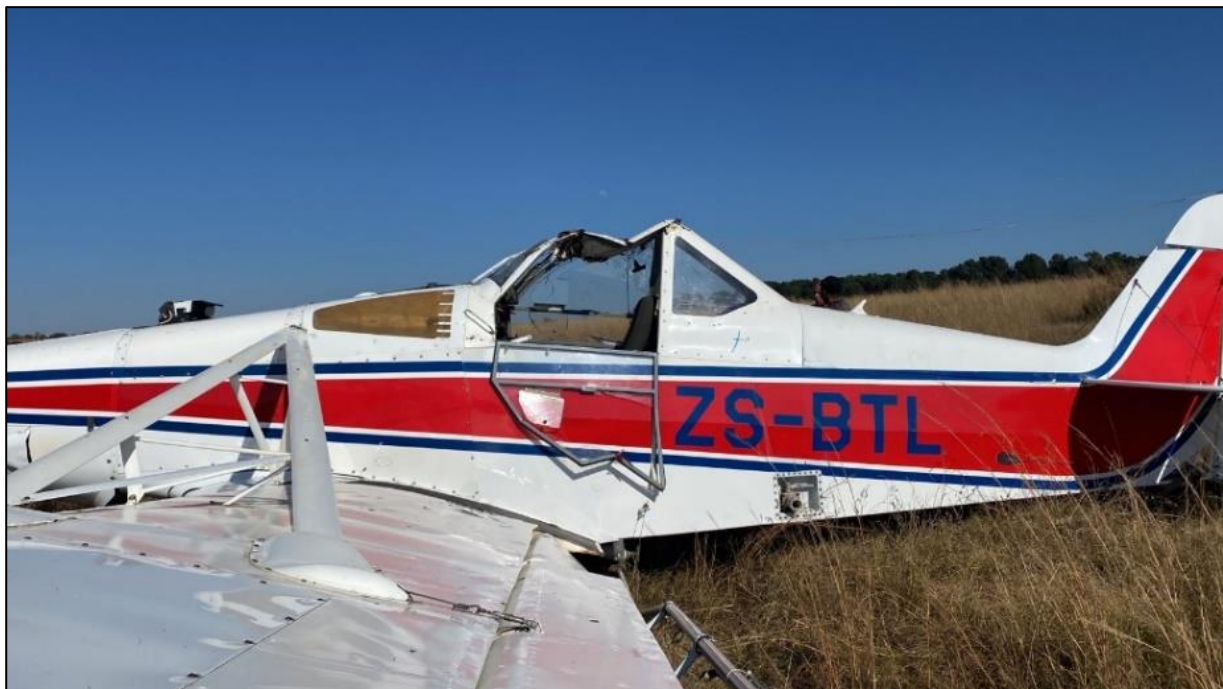
- 1.3.1. The aircraft sustained substantial damage.

Figure 2: The aircraft after being positioned upright. (Source: AMO)

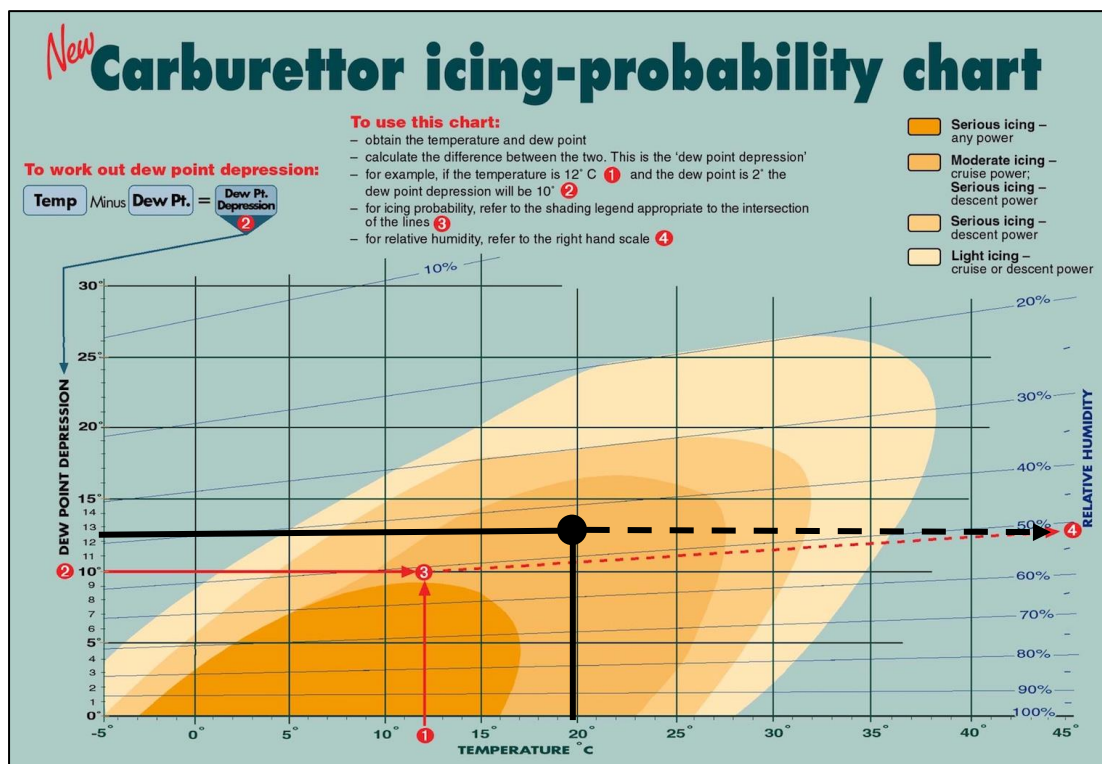
Graph 1: The Carburettor icing-probability chart.

1.7.3. The carburettor icing chart below shows that the weather conditions were conducive for moderate icing at cruise power or serious icing at descent power, and no probability of carburettor icing during climb power (refer to the black solid and dotted lines, as well as the round spot on the graph below).

2.2.4. The dew point calculation indicated that the weather conditions were conducive for the formation of moderate icing at cruise power or serious icing at descent power with 50% relative humidity. Accordingly, these conditions would have less likely resulted in the formation of carburettor icing during take-off (take-off power).

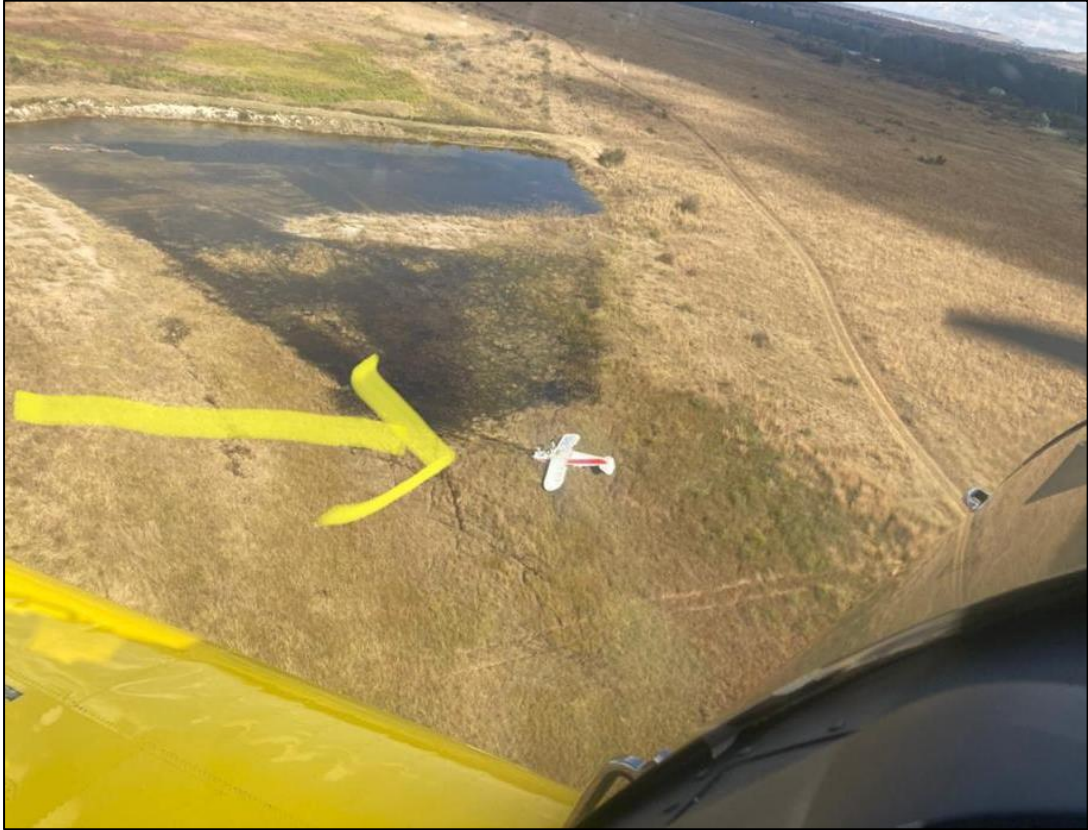
1.12.1. The aircraft landed on a waterbed after touchdown and rolled over a body of water which led to the main wheels sinking into the muddy soil and bringing the aircraft to an abrupt stop. The aircraft nosed over and came to rest in an inverted position, with the engine compartment resting in the waterbed.

Figure 3: The wreckage location. The picture was taken by a pilot on-board another aircraft. (Source: Pilot)

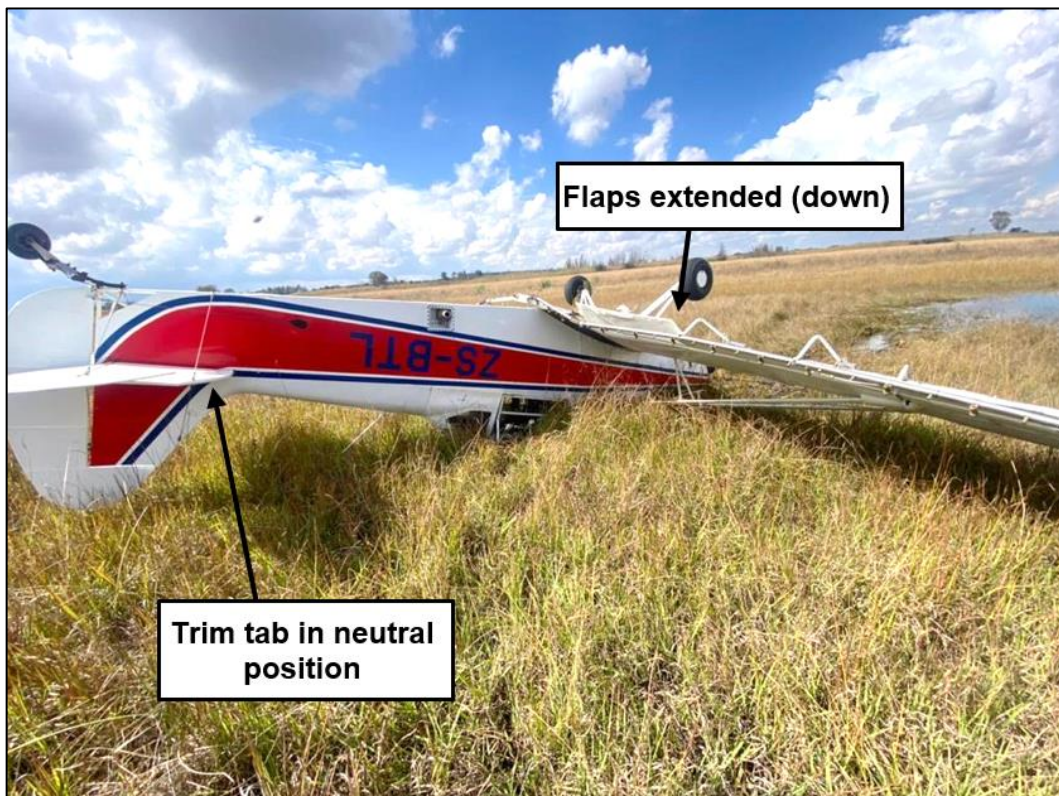
1.12.2. The aircraft's wings and vertical stabiliser were damaged.

Figure 4: The aircraft as it came to rest on the grass-covered field. (Source: Pilot)

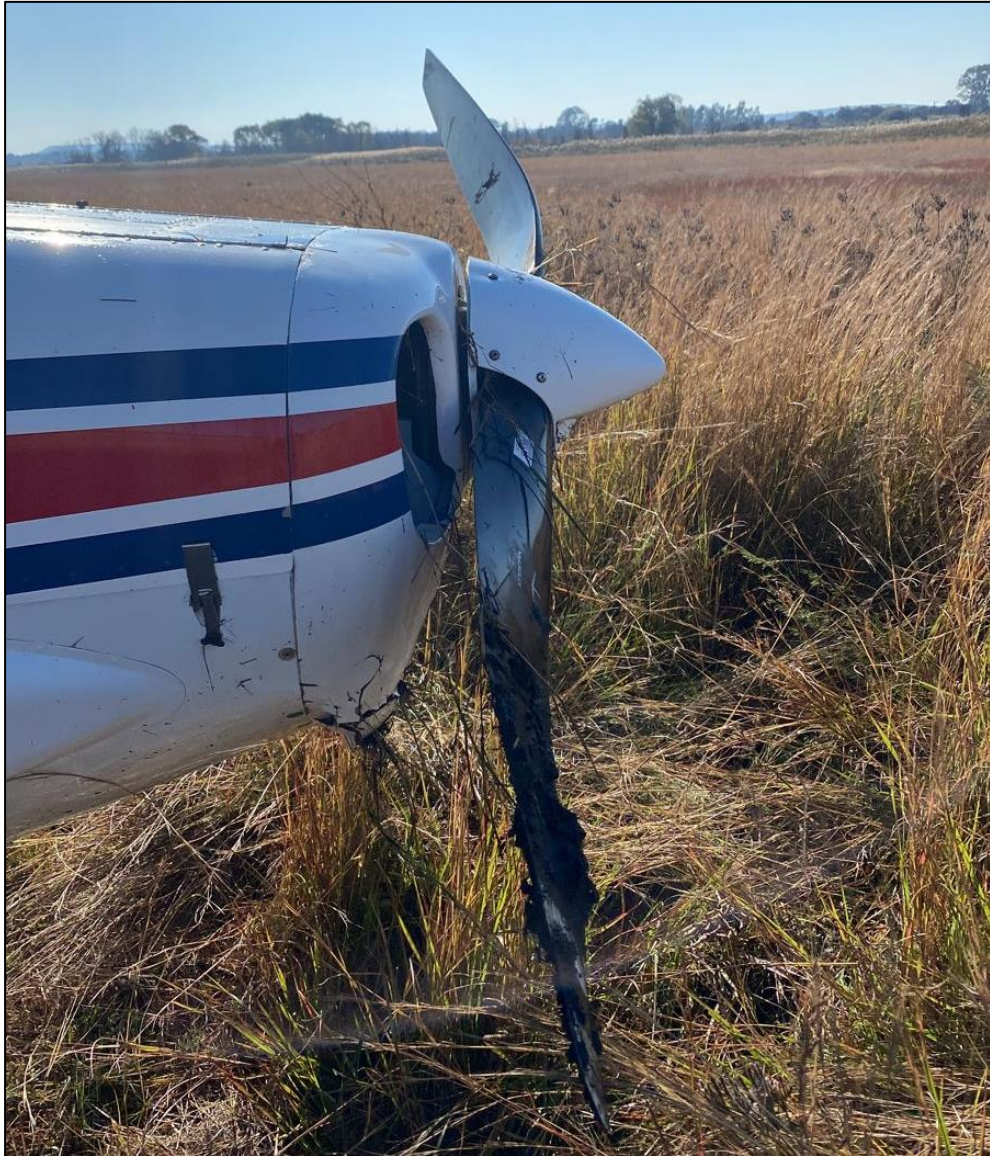
1.12.3. Damage observed on the propeller blades indicated that the engine was not producing power on impact and that the propeller blades were probably wind milling during the landing roll. One of the propeller blades was bent slightly backwards, whilst the other blade was deeply lodged into the soft ground with the third of its length above ground and still intact.

Figure 5: The propeller blades after the accident. (Source: AMO)

- 3.2.6. The aircraft was substantially damaged by impact forces; however, the pilot did not sustain any injuries during the accident.
- 3.2.7. Lack of visible damage and/or twisting of the propeller is consistent with the engine not producing power at impact.

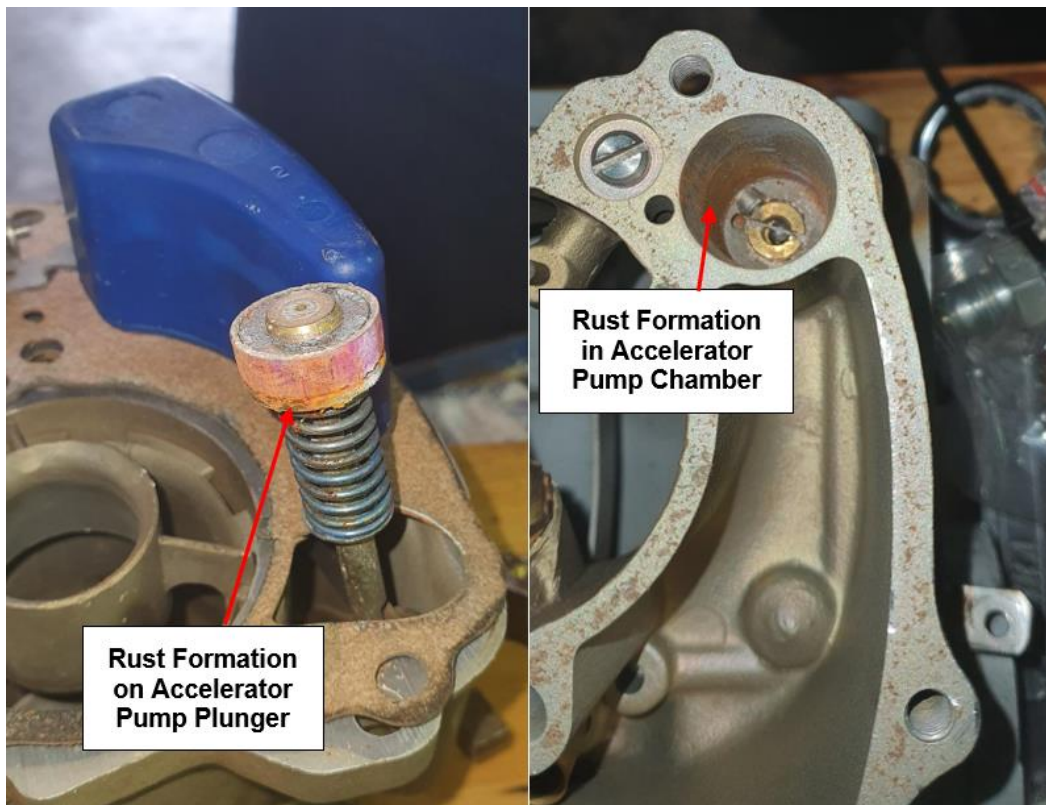
- 1.16.3.1. Disassembly and inspection of the carburettor bowl did not reveal any failure or blockage. Because the engine was stored in an inverted orientation for months before it could be subjected to a teardown inspection, there were very little remnants of fuel found in the carburettor bowl.
- 1.16.3.2. All seals were observed to be in good condition, which ruled out a possibility of an internal leak in the carburettor.
- 1.16.3.3. After disassembly, observation of discolouration due to rust was noted on the idle fuel tube vent, accelerator pump, pump plunger and the walls of the accelerator pump chamber.

Figure 6: Rusted accelerator pump plunger and chamber.

- 2.2.13. Disassembly and inspection carburettor bowl did not reveal any failure or blockage. Because the engine had been stored in an inverted orientation for months before it could be stripped, there were very little remnants of fuel found in the carburettor bowl. After disassembly, observation of discolouration due to rust was noted on the idle fuel tube vent, accelerator pump, pump plunger and the walls of the accelerator pump chamber of the carburettor.

- 3.2.12. After disassembly, discolouration due to rust was noted on the idle fuel tube vent, accelerator pump, pump plunger and the walls of the accelerator pump chamber of the carburettor. Water can only enter these sections of the carburettor during operation.

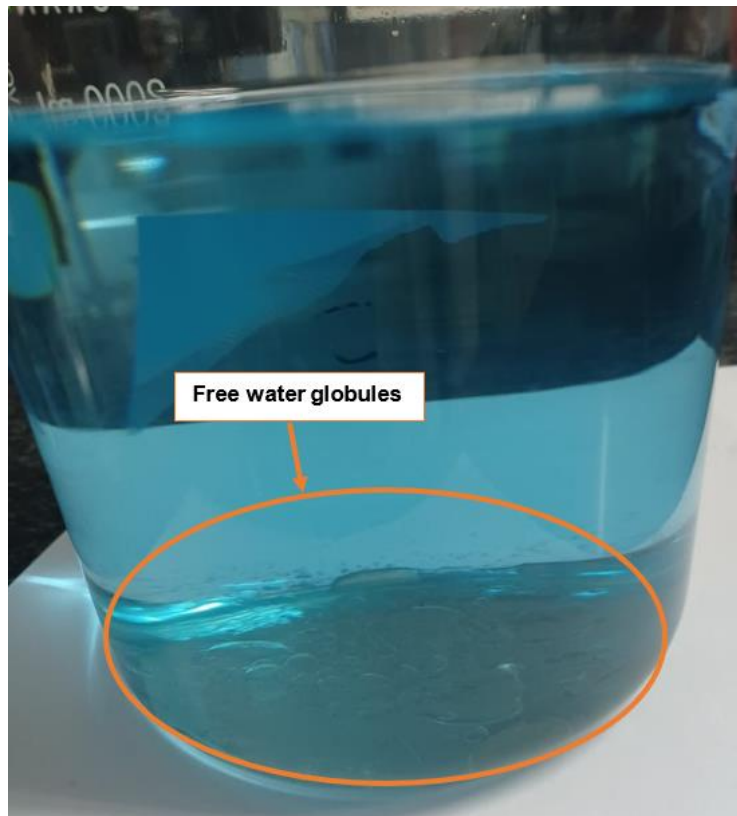
- *Aircraft registration (ZS-BTL) sample ex-aircraft fuel tank drain – enviro condition: clear; sample comment: sample fails on appearance (fine particles and free water present) and does not meet requirements for RVP (Reid Vapour Pressure) 22 kPa.*

Figure 3: First fuel sample of ZS-BTL taken after the accident shows free water globules. (Source: SGS)

- 2.2.17. On 27 May 2022, fuel samples from bowsers KMG 672 NW and KMG 698 NW from which the owner refuels were taken for analysis; the fuel samples from bowsers were found acceptable and met all specifications. However, according to the results given in 1.16.4.4., the fuel sample from ZS-BTL supplied by the owner failed on appearance as there were fine particles and free water globules visible; the sample did not meet the requirements for RVP.

- 2.2.20. Based on the significant quantity of water identified in the fuel sample taken after the accident and the absence of any other engine defect, the engine power loss was probably the result of water contamination. A possible source of water found in the fuel was considered to have seeped into the fuel tanks as the aircraft was submerged in a waterbed for a few days before the fuel sample was drawn.
