**AIRCRAFT ACCIDENT REPORT AND EXECUTIVE SUMMARY**

<b>Reference:</b>		CA18/2/3/10165	
<b>Aircraft Registration</b>	ZS-CSL	<b>Date of Accident</b>	26 May 2022		<b>Time of Accident</b>	1445Z	
<b>Type of Aircraft</b>	Piper PA-24-250			<b>Type of Operation</b>	Private (Part 91)		
<b>Pilot-in-command Licence Type</b>	Commercial Pilot Licence (CPL)		<b>Age</b>	34	<b>Licence Valid</b>	Yes	
<b>Pilot-in-command Flying Experience</b>	<b>Total Flying Hours</b>			1466.9	<b>Hours on Type</b>	3.9	
<b>Last Point of Departure</b>	Newcastle Aerodrome (FANC), KwaZulu-Natal Province						
<b>Next Point of Intended Landing</b>	Krugersdorp Aerodrome (FAKR), Gauteng Province						
<b>Damage to Aircraft</b>	Substantial						
<b>Location of the accident site with reference to easily defined geographical points (GPS readings if possible)</b>							
Panorama Airfield perimeter fence at GPS position: 26°19'31.06" South 028°4'1.90" East, at an elevation of 5020 feet (ft)

**Synopsis**

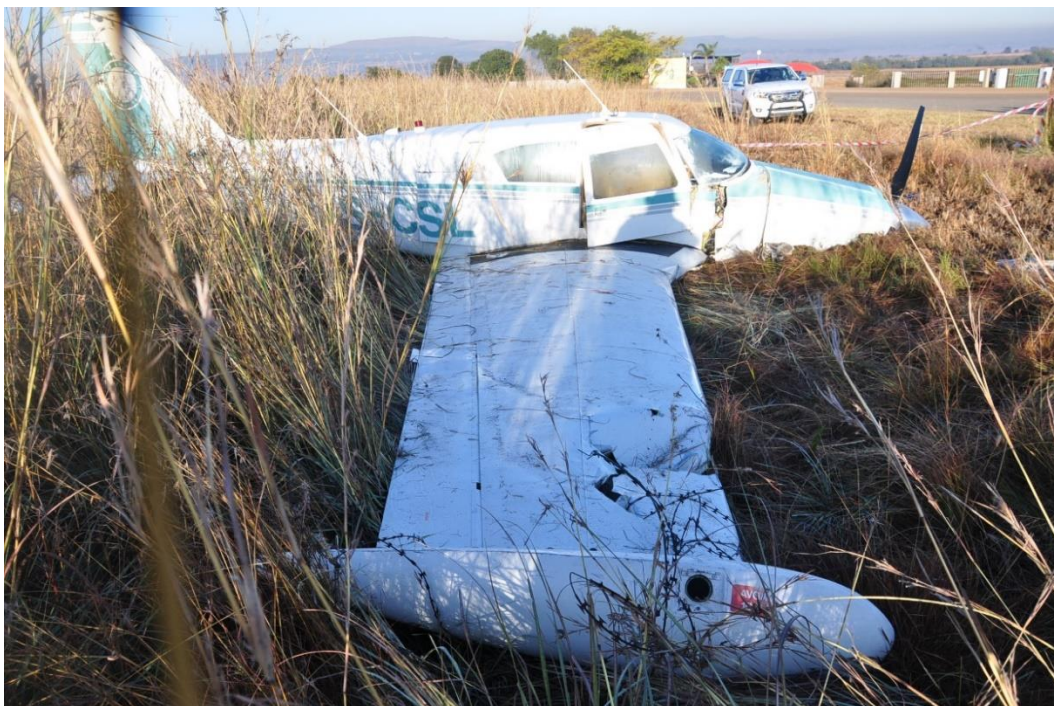
1.3.1. The aircraft sustained substantial damage to the propeller blades, both wings, underbelly, landing gear and the cockpit.

**Figure 2:** The aircraft at the scene post-accident.

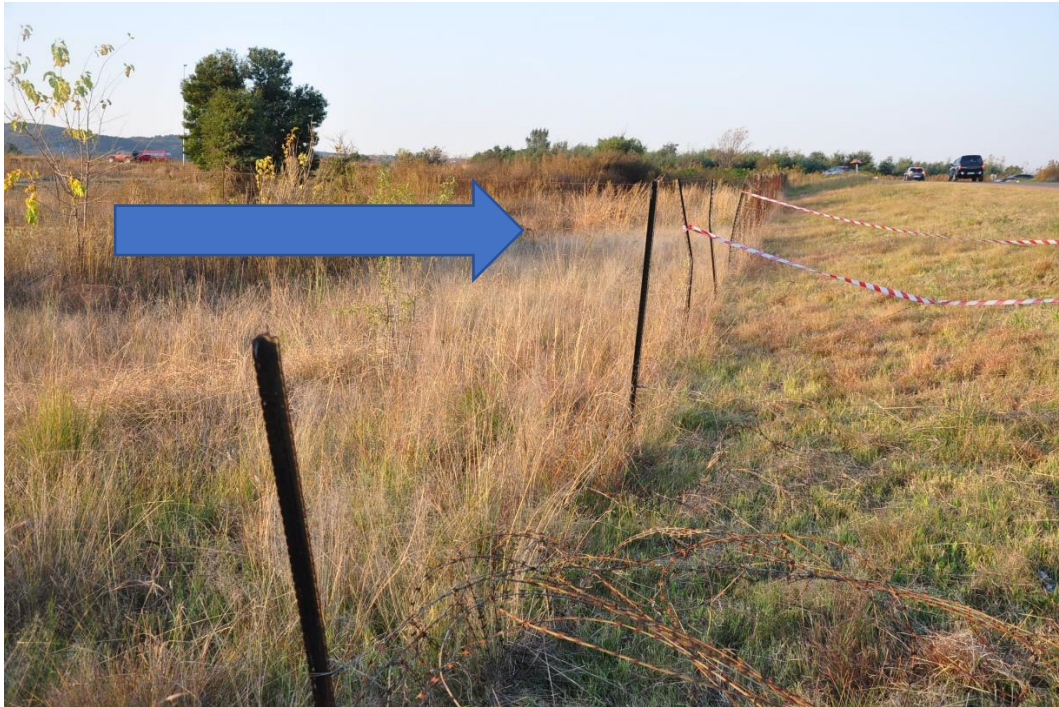
**Figure 3:** The perimeter fence that the main undercarriage got caught on.

1.4.1. The perimeter fence opposite the Panorama Airfield was damaged.

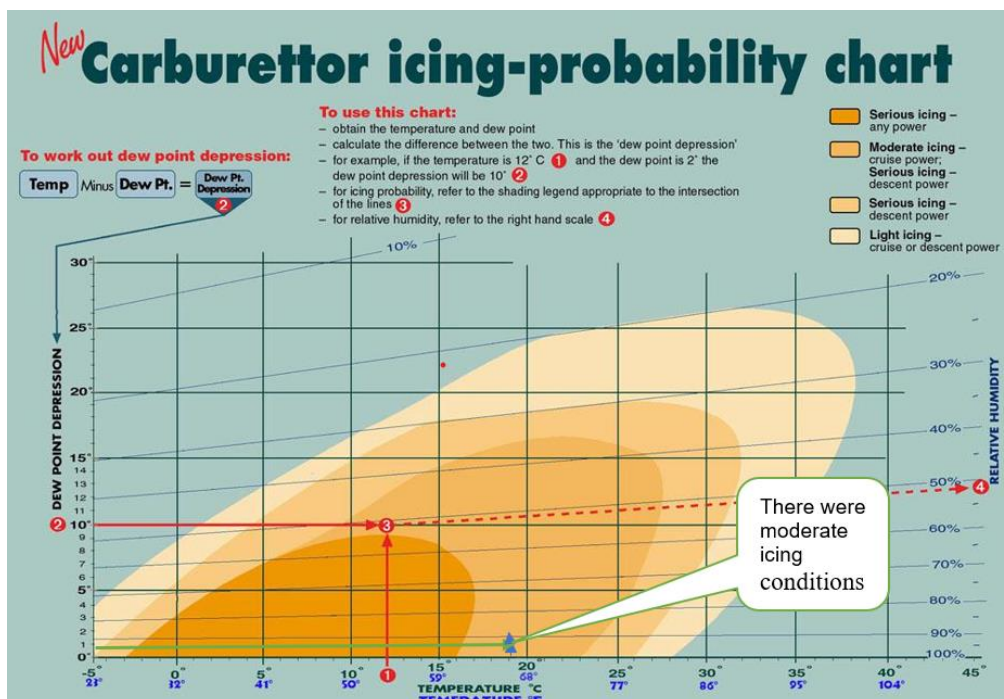
1.7.2 According to the carburettor icing chart, there was moderate icing conditions at the time of the accident.

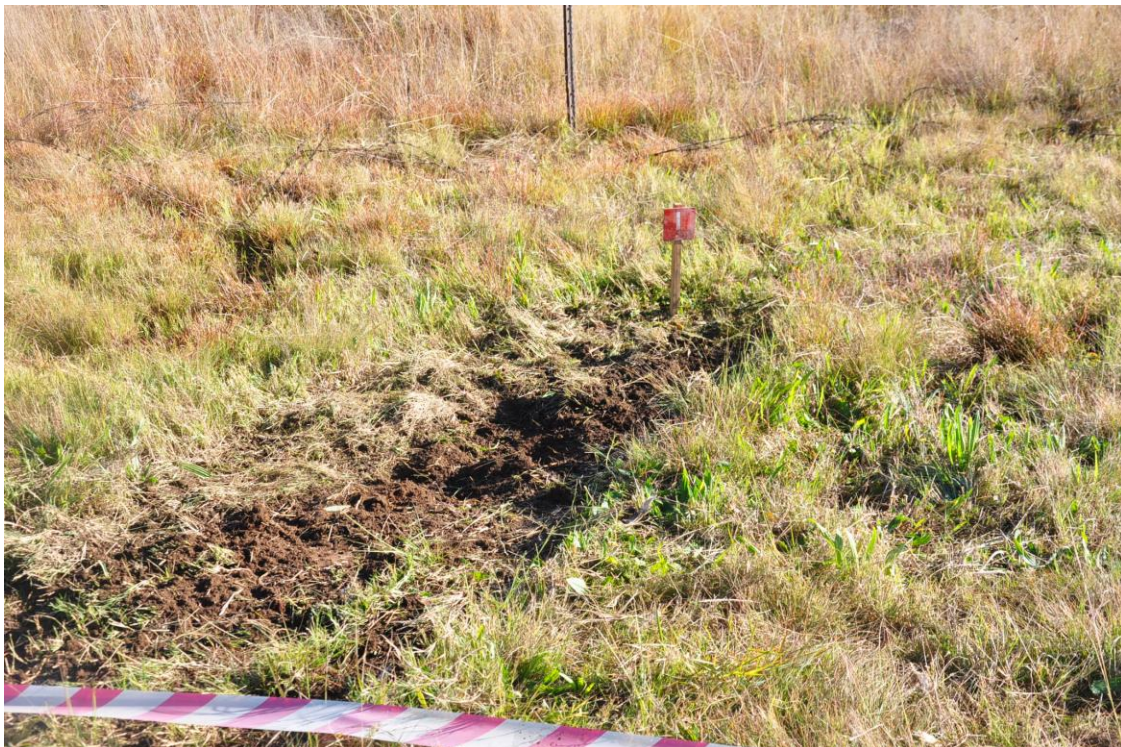
**Figure 4:** The first impact with the ground just beyond the barbed wire fence.

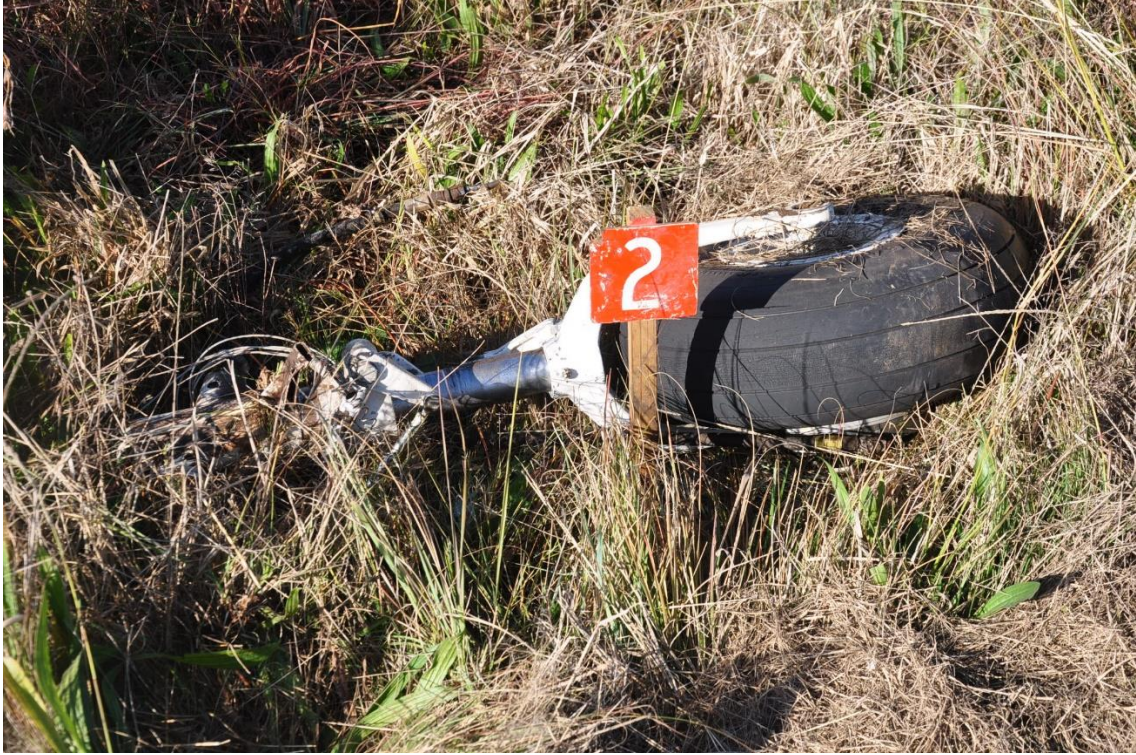
**Figure 5:** The main undercarriage strut and wheel that broke off.

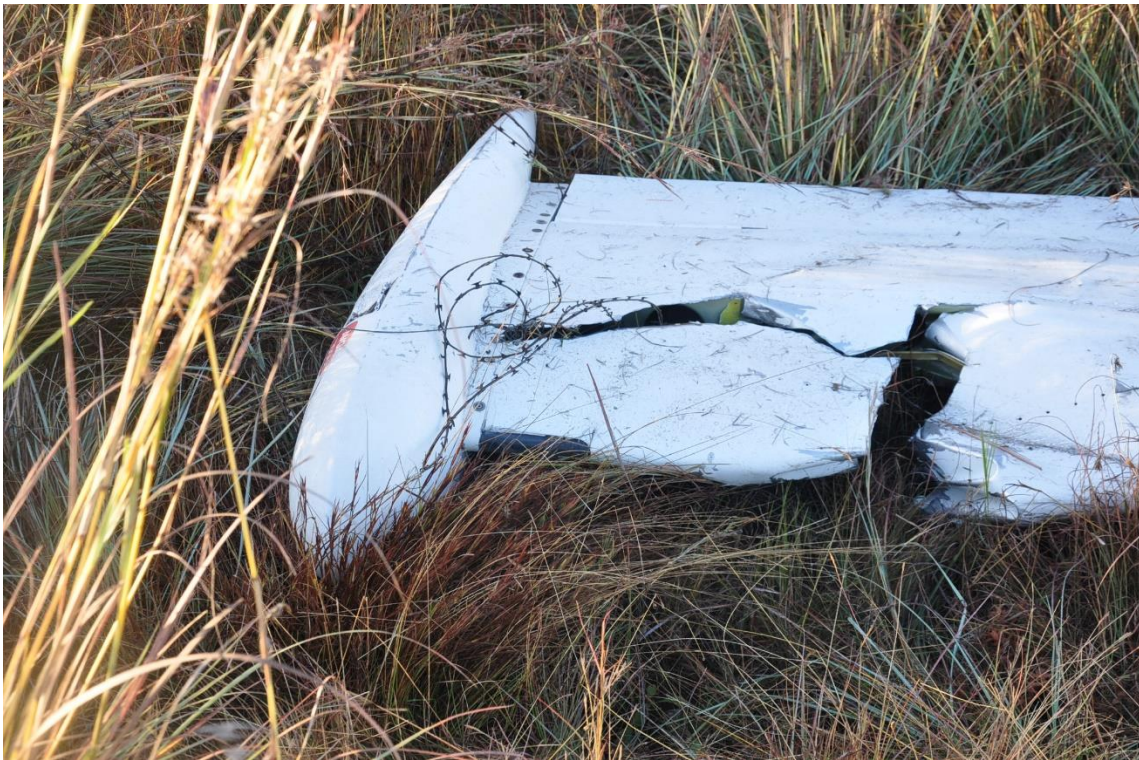
**Figure 6:** The right wing that impacted the fence post.

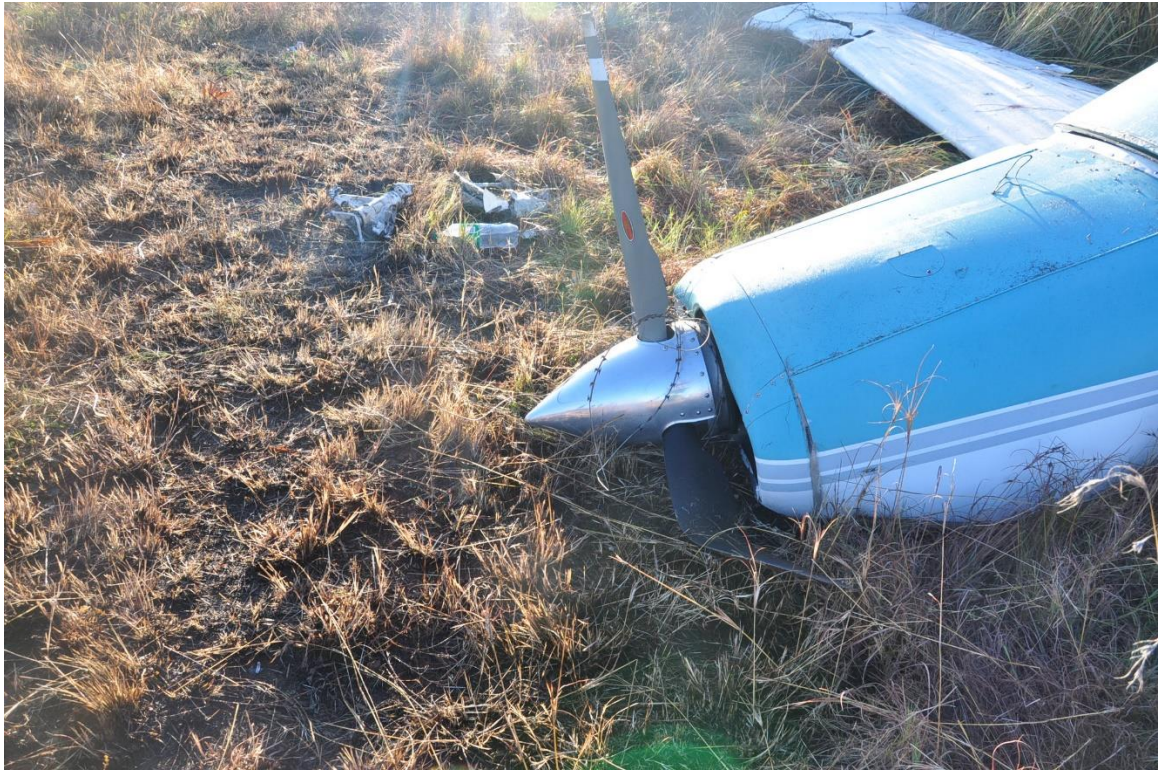
**Figure 7:** The propellor with the barbed wire fence around it.

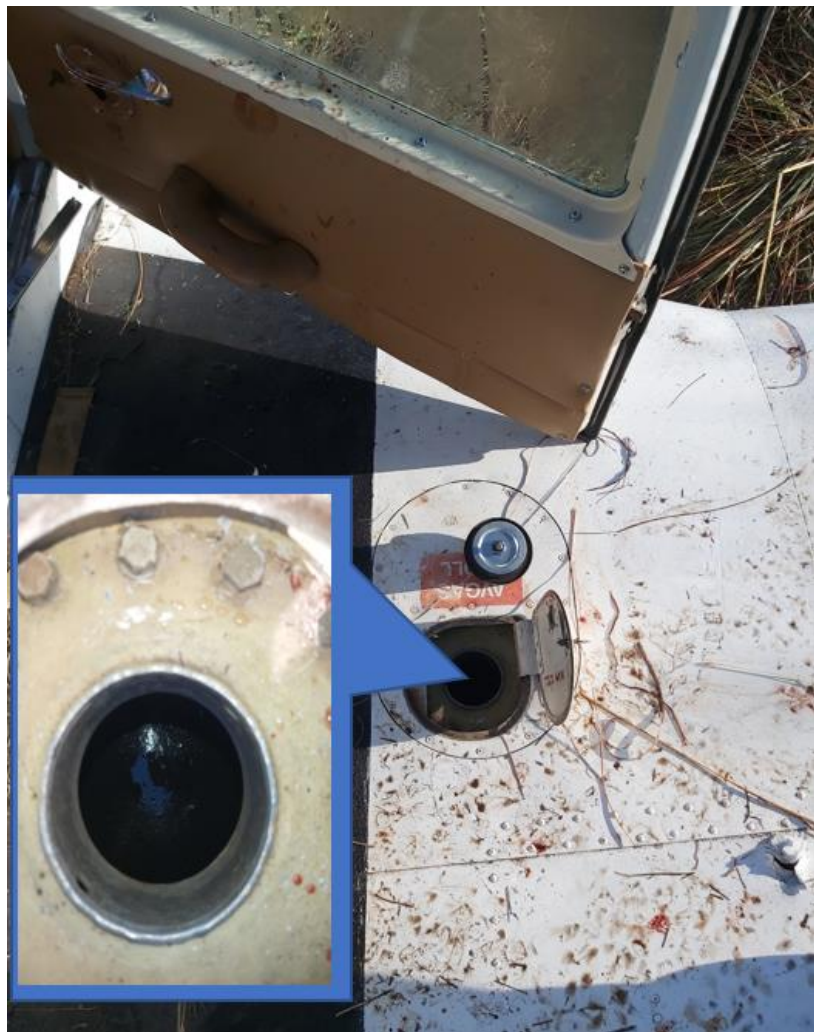
**Figure 8:** The right-side main fuel tank with no fuel.

- 1.16.1 When the investigators arrived at the accident site, they did not find fuel in the main tanks of the aircraft. The fuel that was found in the auxiliary tanks added to approximately 4 litres (both tanks combined).

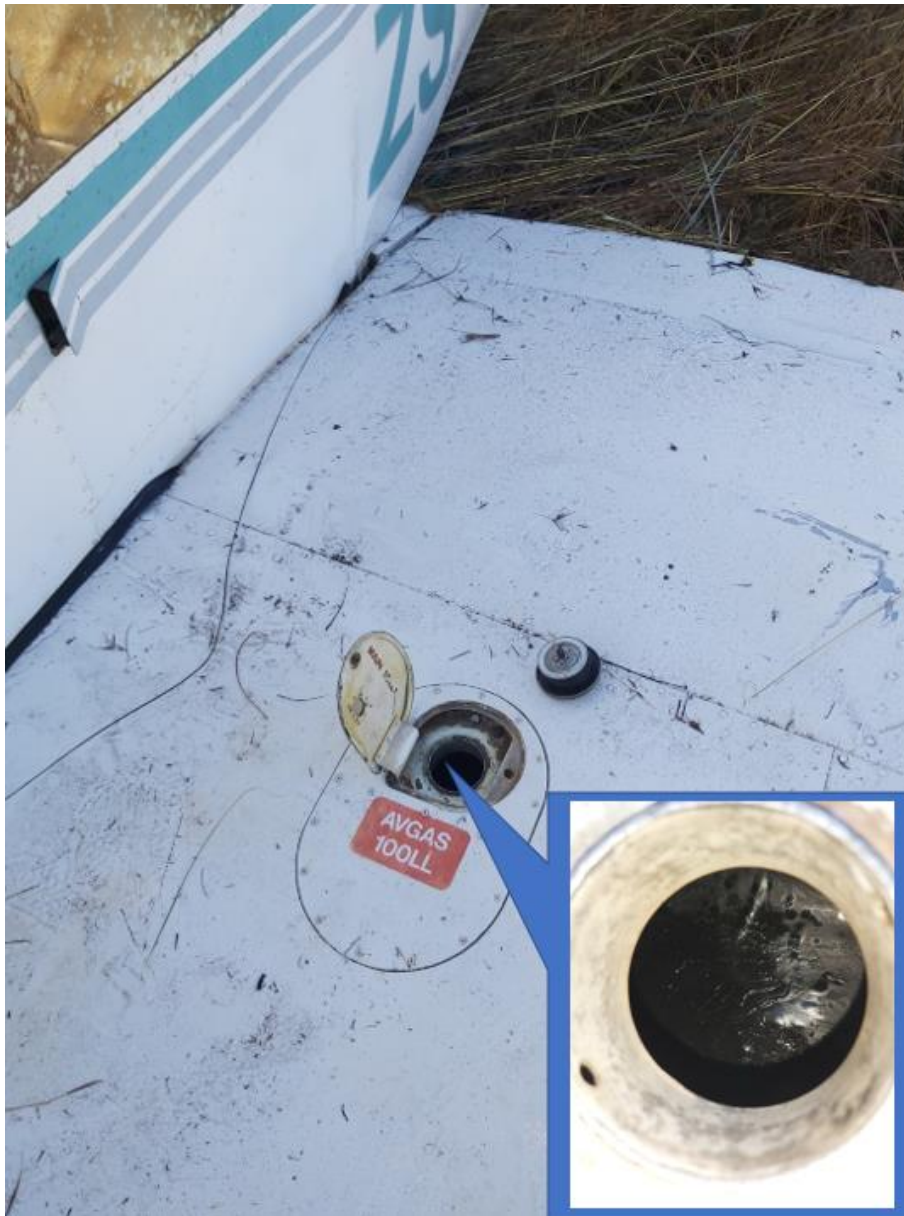
**Figure 9:** The left main fuel tank with no fuel.

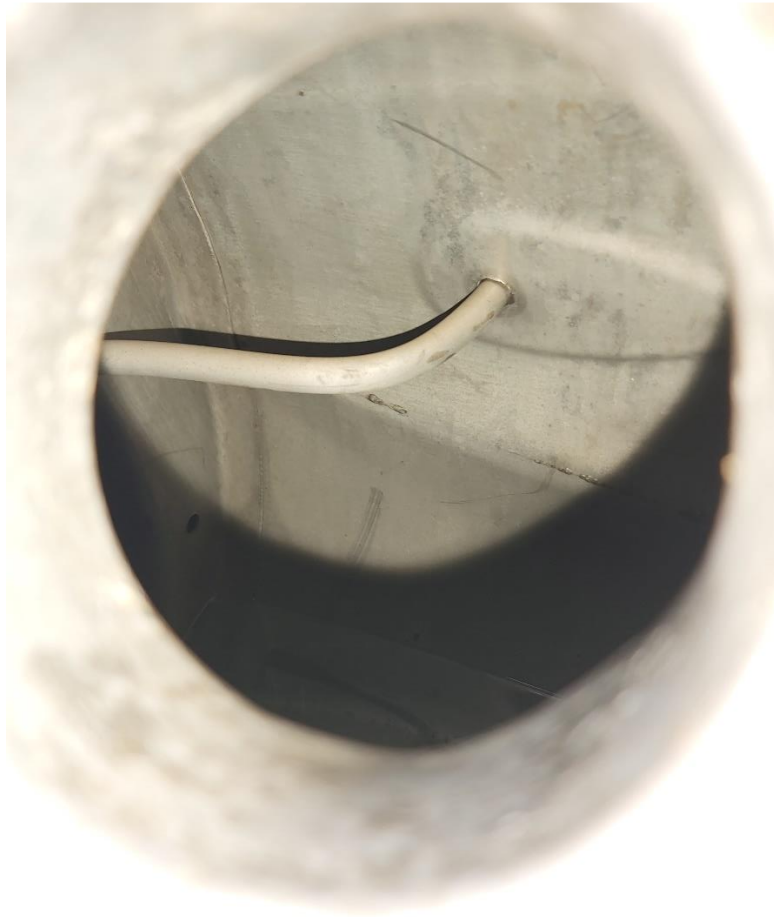
**Figure 10:** The right auxiliary (tip) fuel tank with no fuel.

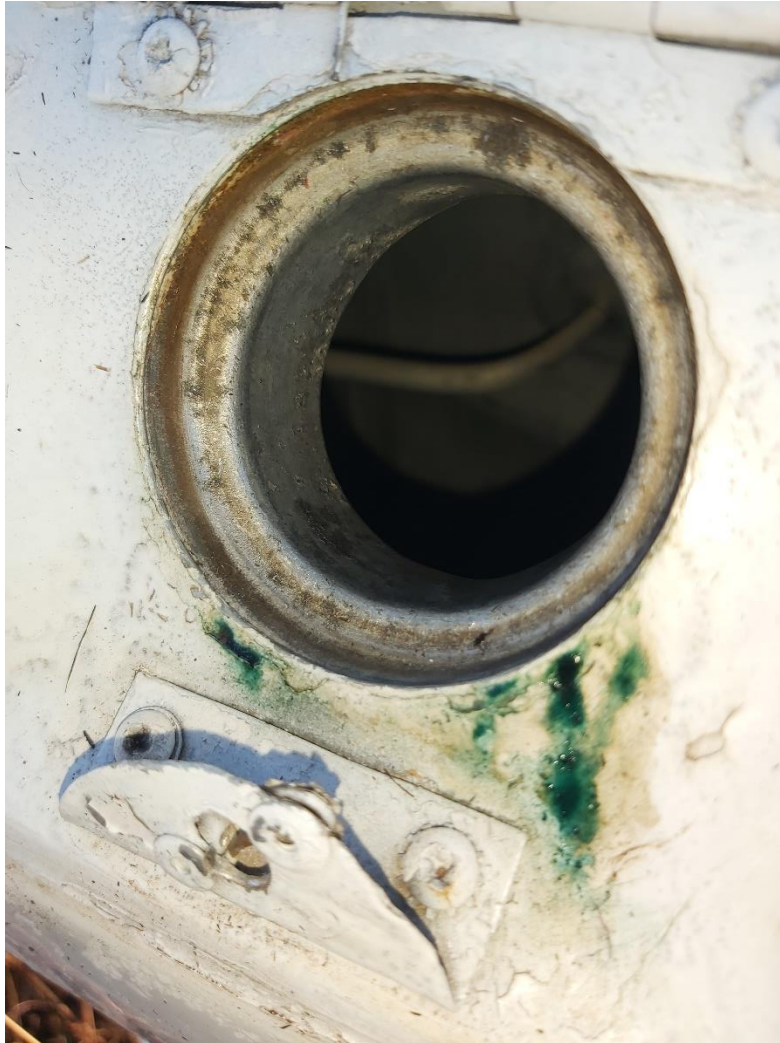
**Figure 11:** The left auxiliary (tip) fuel tank with no fuel.

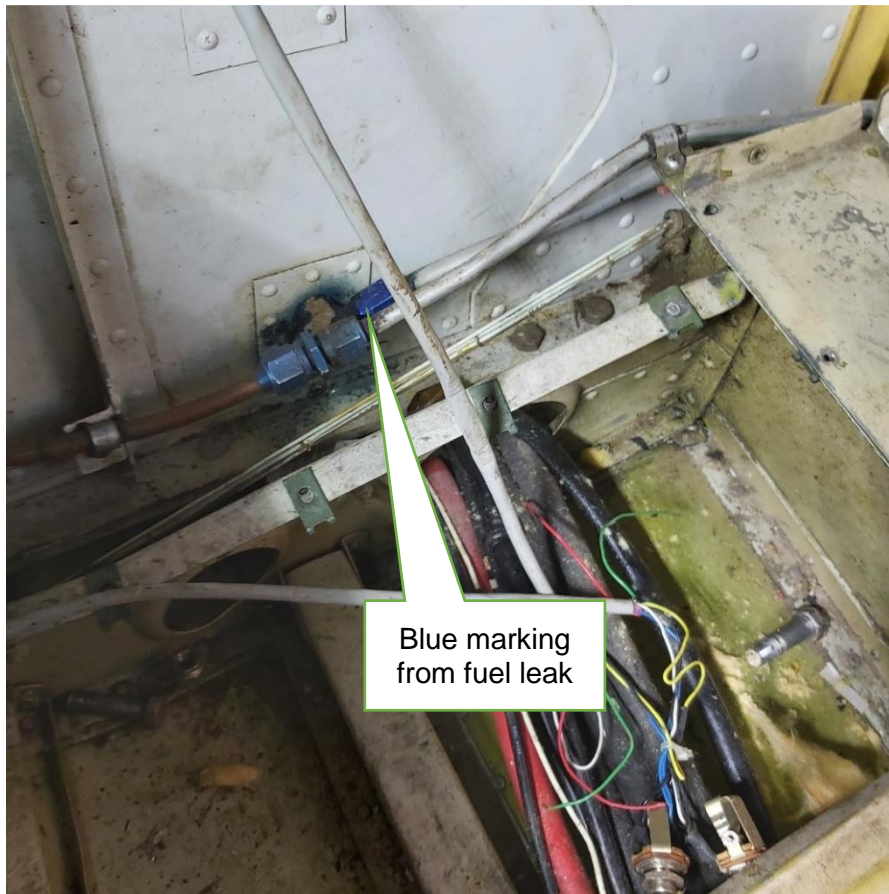
- 1.16.2 During the recovery of the aircraft, a leak was found on the right-side wing auxiliary tank. The right-side coupling was loose as it was not properly tightened according to the AME who was assigned to recover the aircraft.

**Figure 12:** Fuel leak on connections.

- 2.2.16 The engine ran rough during the flight and subsequently stopped due to fuel exhaustion which was caused by a leak found on the right-side wing auxiliary tank coupling. The coupling was loose as it was not properly tightened after maintenance. The aircraft lost height which led to a rapid forward acceleration and the subsequent crash beyond the perimeter fence of

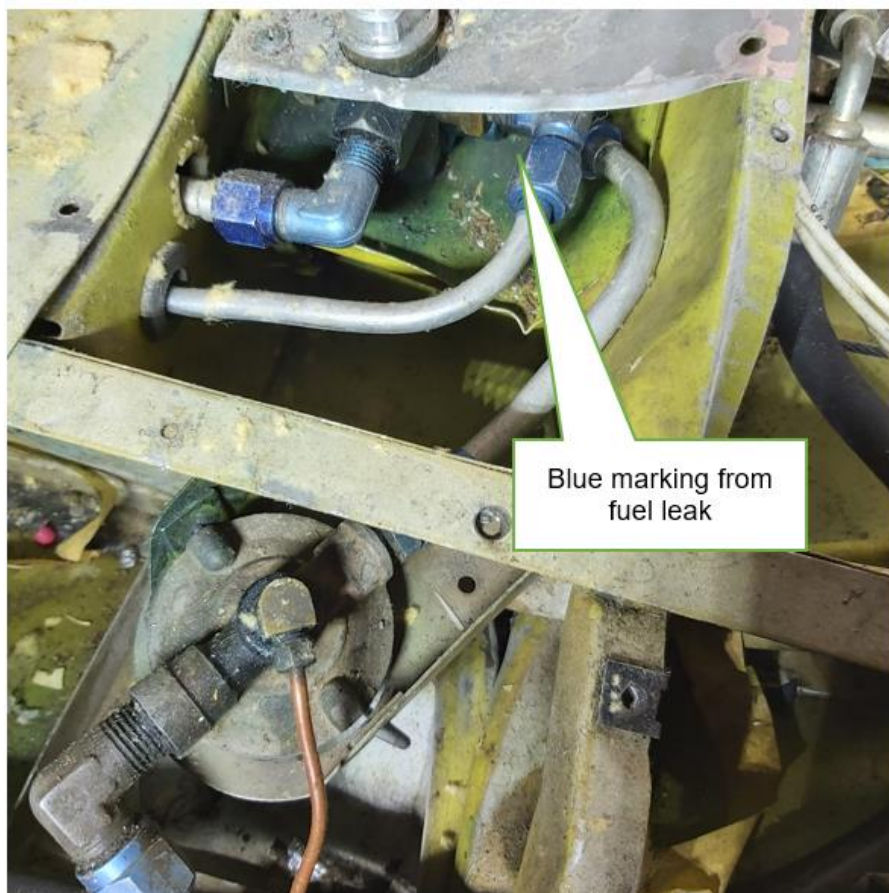
**Figure 13:** Blue fuel stains on connections.
