AIRCRAFT ACCIDENT REPORT AND EXECUTIVE SUMMARY

Reference:		CA18/2/3/10167	
Aircraft Registration	ZS-WAP	Date of Accident	1 June 2022		Time of Accident	0935Z	
Type of Aircraft	Piper PA-28R-200 Cherokee Arrow II		Type of Operation		Training (Part 141)		
Pilot-in-command Licence Type	Commercial Pilot Licence (CPL)		Age	25	Licence Valid	Yes	
Pilot-in-command Flying Experience	Total Flying Hours		1486.3		Hours on Type	494	
Last Point of Departure	Cape Town International Airport (FACT), Western Cape Province						
Next Point of Intended Landing	Stellenbosch Airport (FASH), Western Cape Province						
Damage to Aircraft	Destroyed						
Location of the accident site with reference to easily defined geographical points (GPS readings if possible)							
R44 road in Firgrove, Stellenbosch, at Global Positioning System (GPS) co-ordinates determined to be 34°01'29.23" South 18°49'12.39" East at an elevation of 95 feet (ft)							
Meteorological Information	Wind: 040° at 05kts, Temperature: 17°C, Clouds cover: Nil, Dew Point: 10°C, Cloud Base 3200ft, Visibility: 10km and QNH: 1030hPa

Probable Cause							
The flight instructor executed a forced landing on the R44 road following an engine failu

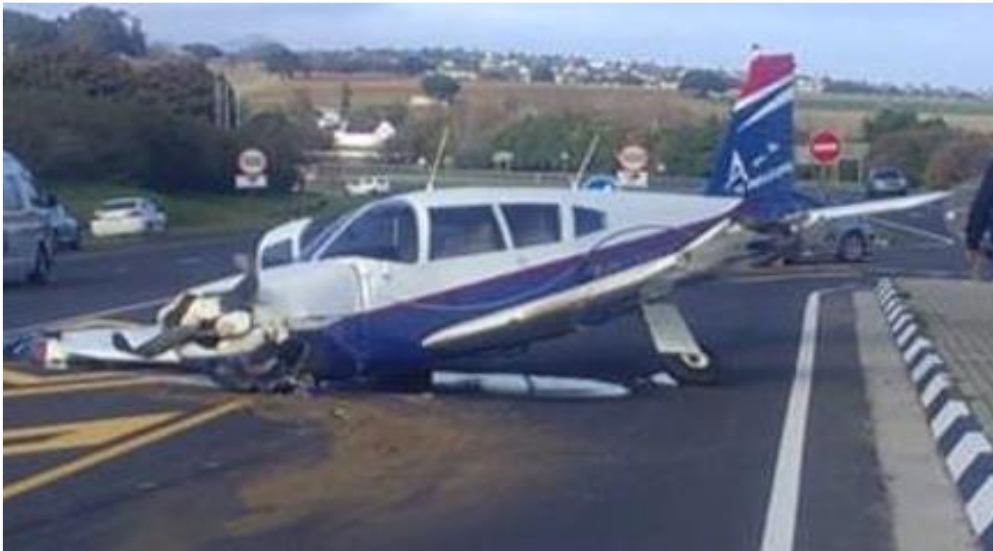
- 1.3.1 The aircraft was destroyed during the accident sequence.

Figure 2: The aircraft at the accident site.

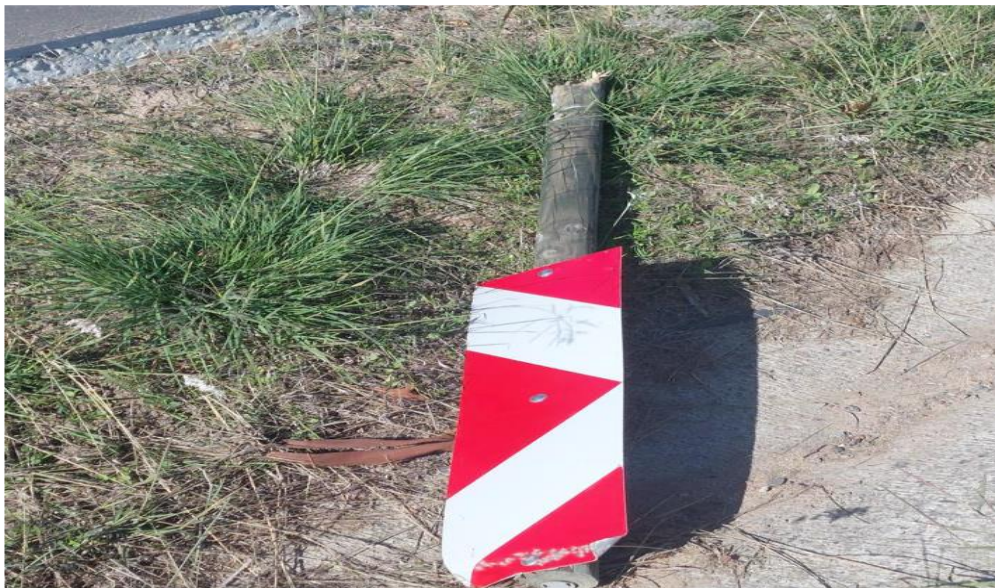
1.4.1 The aircraft impacted the road traffic sign pole with its left wing.

Figure 3: The severed road traffic sign pole.

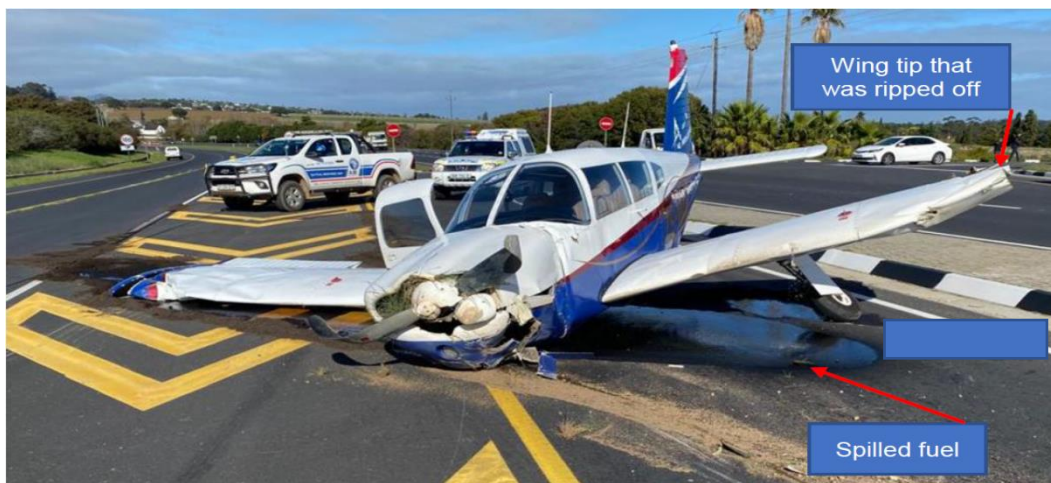
1.12.2. Examination of the aircraft revealed substantial damage on both wings and fuselage, the engine and the nose section were displaced upward and aft of the aircraft. The wing tip of the left wing got ripped off, which caused the fuel to leak. The propeller sustained scratches on the leading edges of both blades, and the blade tips curled backwards. The landing gear was damaged. The wreckage was recovered by the aircraft maintenance organisation (AMO) to allow for the speedy re-opening of the road. The witness marks on the road indicated that the aircraft skidded from the initial point of impact to its final resting position. Figures 4 and 5 show the aircraft at the accident site and the skid marks on the road.

Figure 4: The aircraft at the accident site. (Source: Operator)

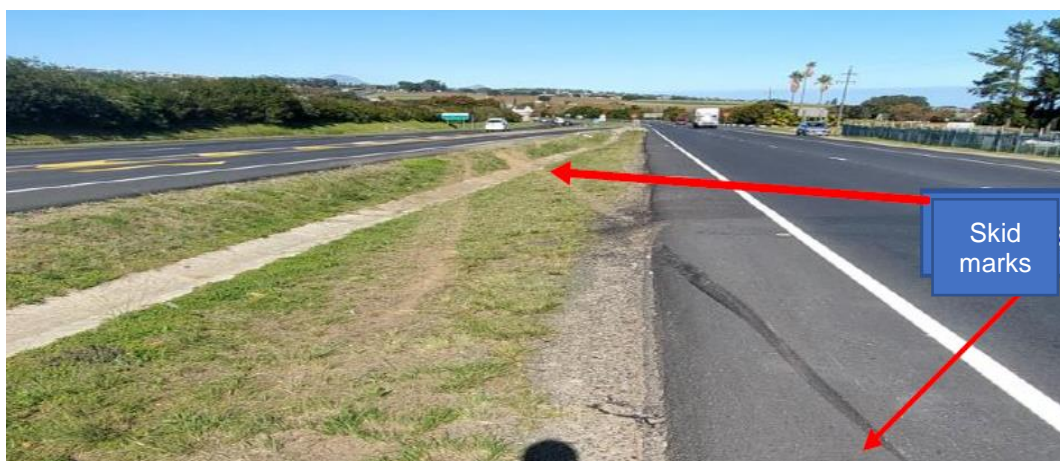
1.12.1. Examination of the accident scene revealed that upon touchdown, the aircraft skidded for approximately 30m (see Figure 5) before it came to rest in an upright position in the middle (centre island) of four lanes of the tarred R44 road, facing the opposite direction from which it had approached.

Figure 5: Skid marks on the R44 road and on the dirt centre island.

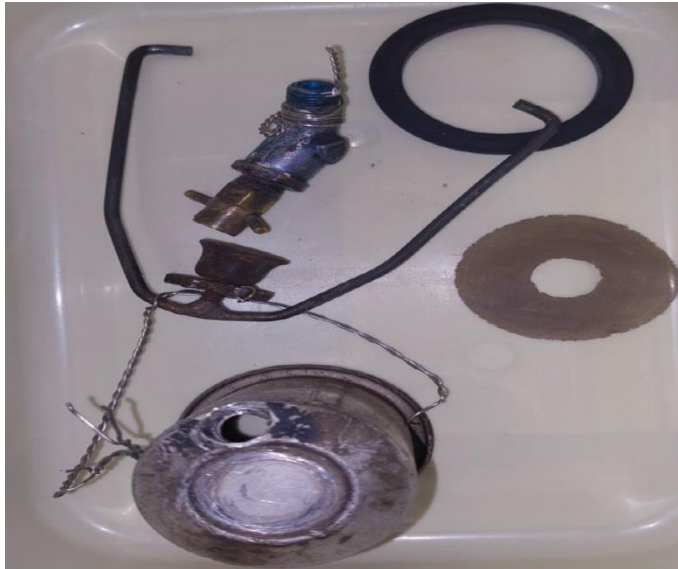
1.12.3. The gascolator did not contain fuel as it was damaged during impact.

Figure 6: The damaged gascolator.

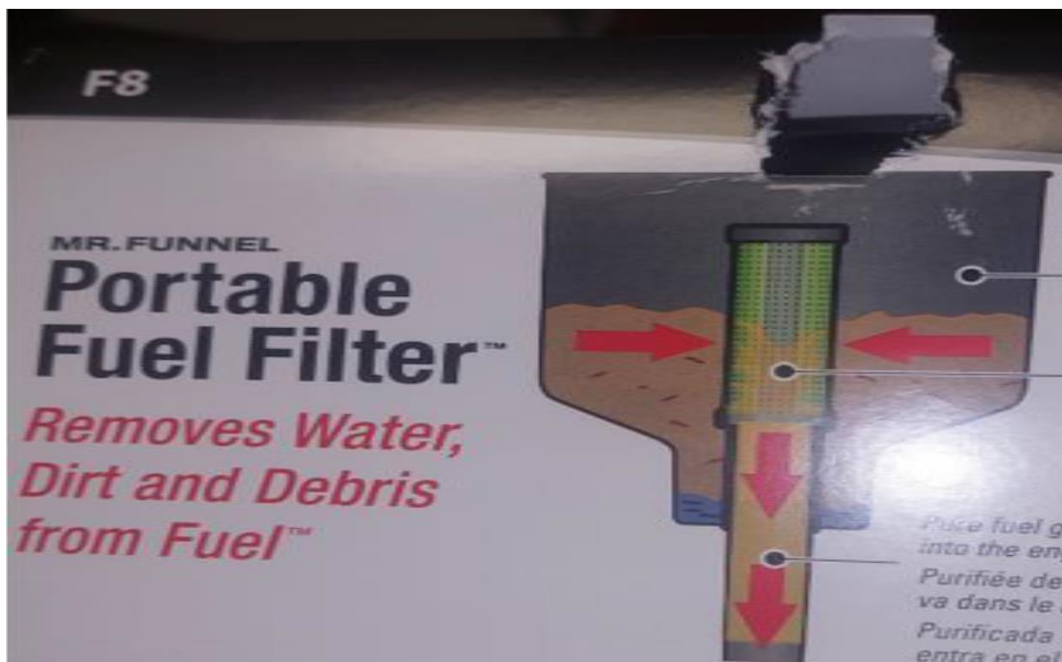
1.12.4. Examination of the fuel tanks revealed that fuel was present in the tanks. The fuel lines to the injectors were still intact. During fuel drainage, the AMO used a portable fuel filter that removes (separates) water, dirt and debris from fuel (see Figure 7). The 120L (32 gallons) of fuel that was drained from the aircraft was clear and free of water or visible contamination (see Figure 8). The engine oil on the dipstick showed the correct level and appeared clean (see Figure 9).

Figure 7: The Portable Fuel Filter that was used by the AMO.

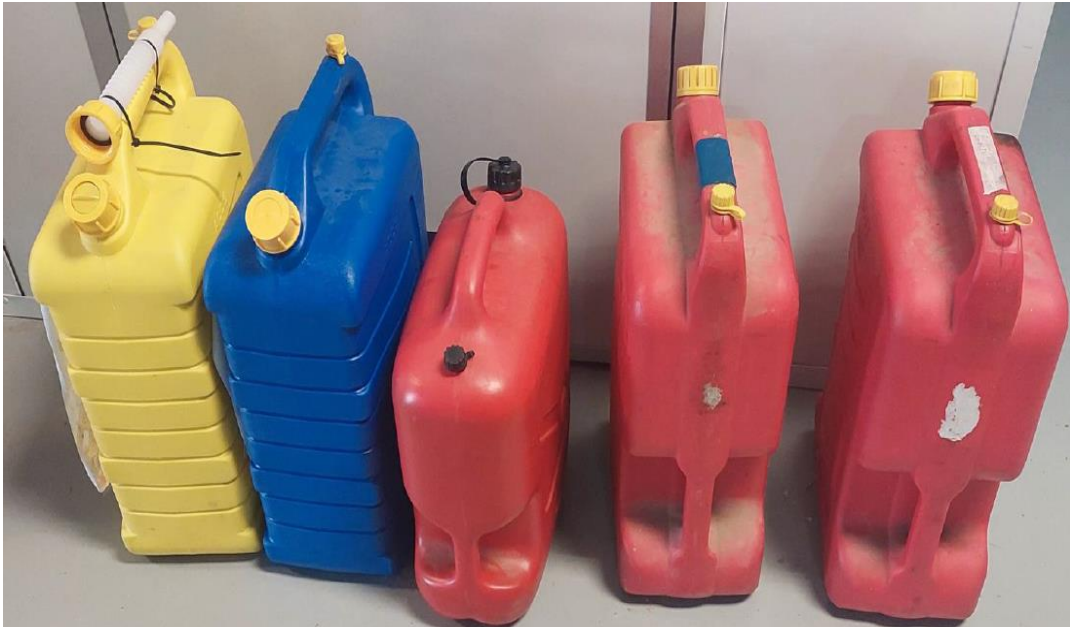
Figure 8: The 25-litre canisters containing 120L of fuel that was drained from the fuel tanks.

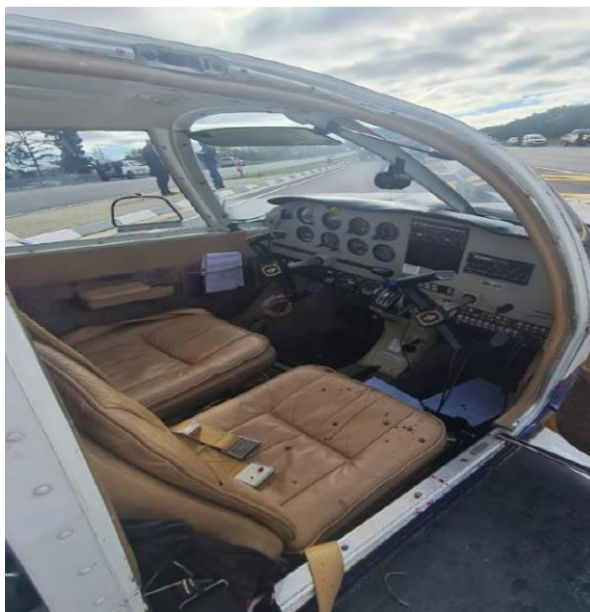
1.15.1 The accident was considered survivable as no damage was caused to the cockpit and cabin structure of the aircraft.

Figure 9: Cabin structure of the accident aircraft.

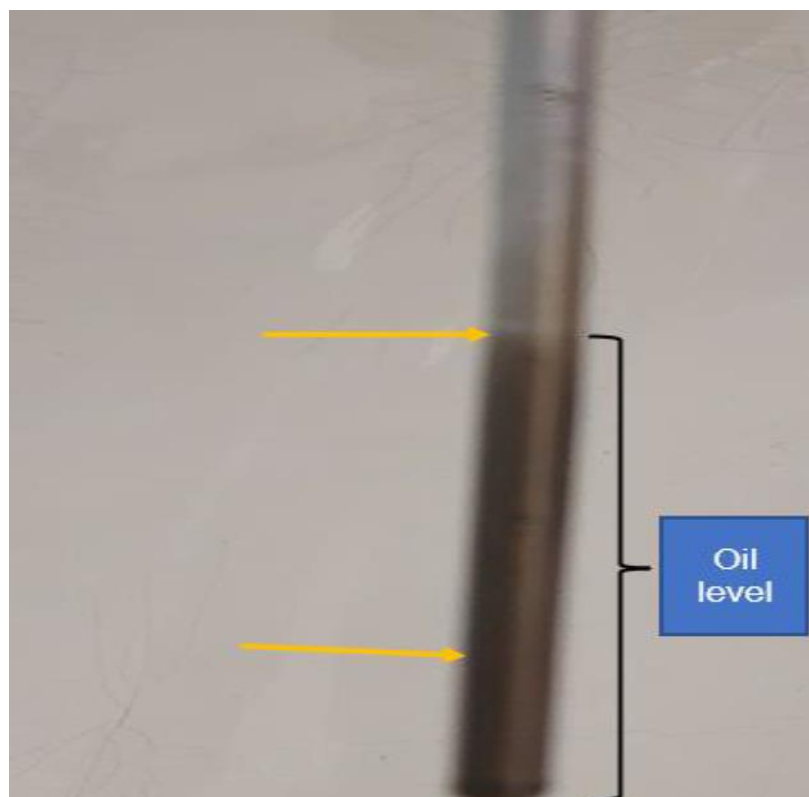
1.16.1. Post-accident examination of the engine at the AMO's facility in the presence of the investigator showed no visible damage in the engine compartment. The engine drive train was rotated by turning the propeller by hand; compression was evident on all four cylinders and all rockers/valves moved normally. Both magnetos remained secured to the engine. Examination showed that the magneto-to-engine timing was set according to the manufacturer's specification and was tested for functionality. The propeller and its governing system were examined and did not exhibit any pre-impact damage. The propeller was rotating when the aircraft struck the ground. Approximately 7 quarts of oil was found in the oil tank (see Figure 10), and the minimum safe quantity is 2 quarts, according to the POH. Examination of the aircraft revealed that fuel was present in the tanks and the fuel lines leading to the injectors.

Figure 10: The dipstick shows sufficient oil level in the tanks. The top arrow shows 7 quarts, and the bottom arrow indicates 2 quarts.
