**LIMITED OCCURRENCE INVESTIGATION REPORT – FINAL**

<b>Reference Number</b>	CA18/2/3/10168						
<b>Classification</b>	Accident	<b>Date</b>	3 June 2022		<b>Time</b>	0925Z	
<b>Type of Operation</b>	Private (Part 91)						
<b>Location</b>							
Place of Departure	Hoedspruit Civil Aerodrome (FAHT), Limpopo Province		Place of Intended Landing		Ximuwu Private Airstrip, Klaserie, Mpumalanga Province		
Place of Occurrence	Ximuwu Private Airstrip in Klaserie, Mpumalanga Province						
GPS Co-ordinates	Latitude	S24°17'56.44"	Longitude	E31°05'29.07"	Elevation	1581.24ft	
<b>Aircraft Information</b>							
Registration	2-ELLY						
Make; Model; S/N	Cessna T206H (Serial Number: T20608576)						
Damage to Aircraft	Substantial			Total Aircraft Hours	801.3		
<b>Pilot-in-command</b>							
Licence Type	Private Pilot Licence (Aeroplane)		Gender	Female		Age	31
Licence Valid	Yes	Total Hours	641.1		Total Hours on Type	467.1	
Total Hours 30 Days	4.7		Total Flying on Type Past 90 Days	18.50

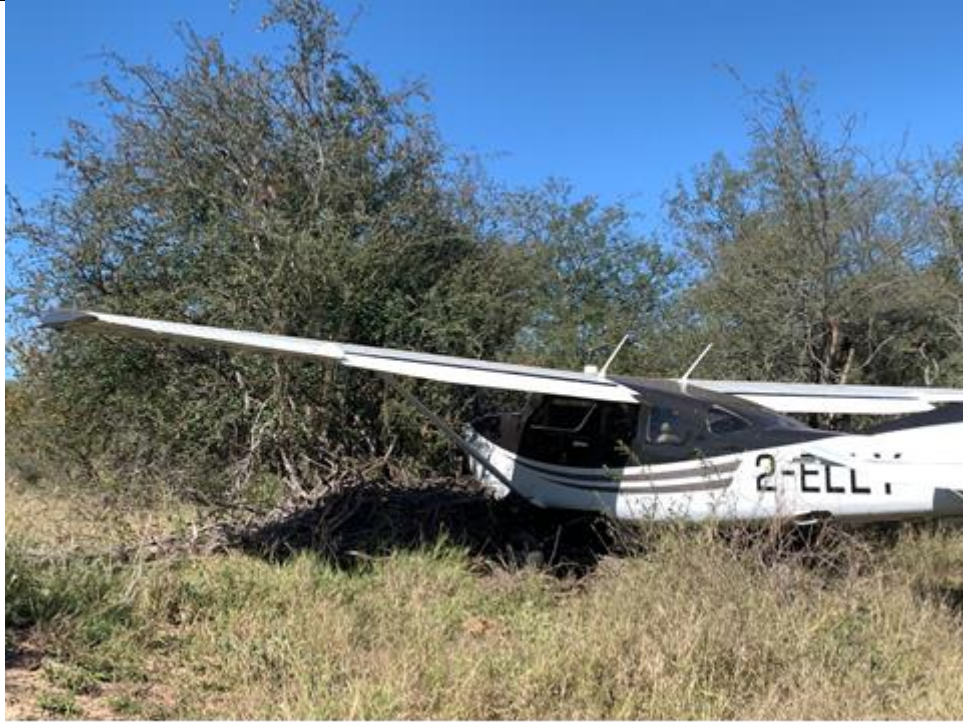
**Figure 1:** The aircraft at its resting position post-accident. (Source: Owner)

The aircraft landed deep and overshot the runway, and subsequently collided with a tree. The damage to the brake line was attributed to the aircraft overshooting the runway.

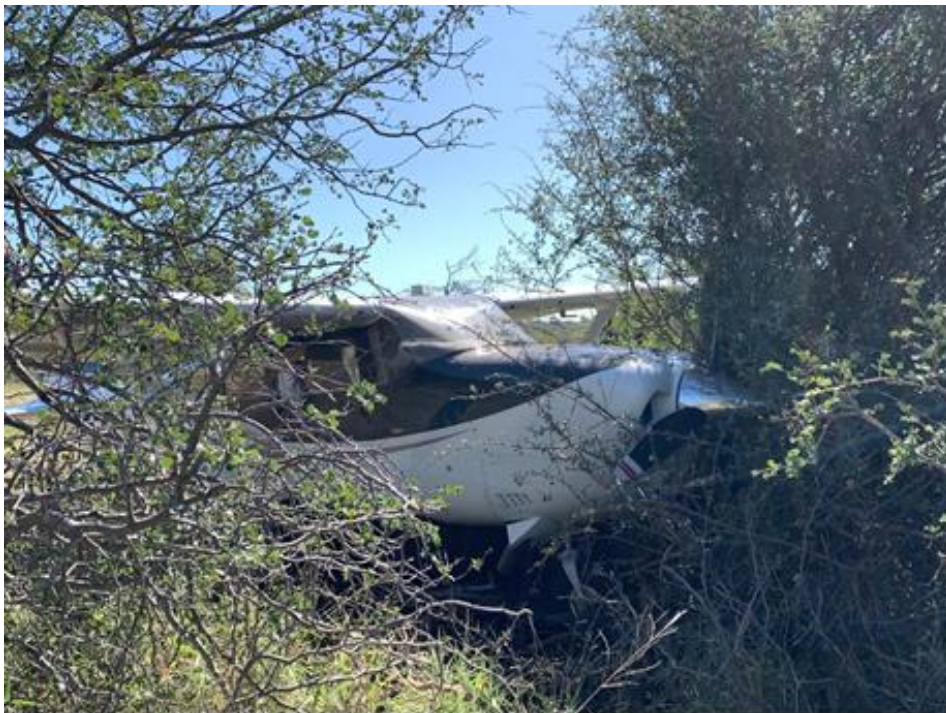
**Figure 2:** The aircraft with its nose section against the shrub. (Source: Owner)

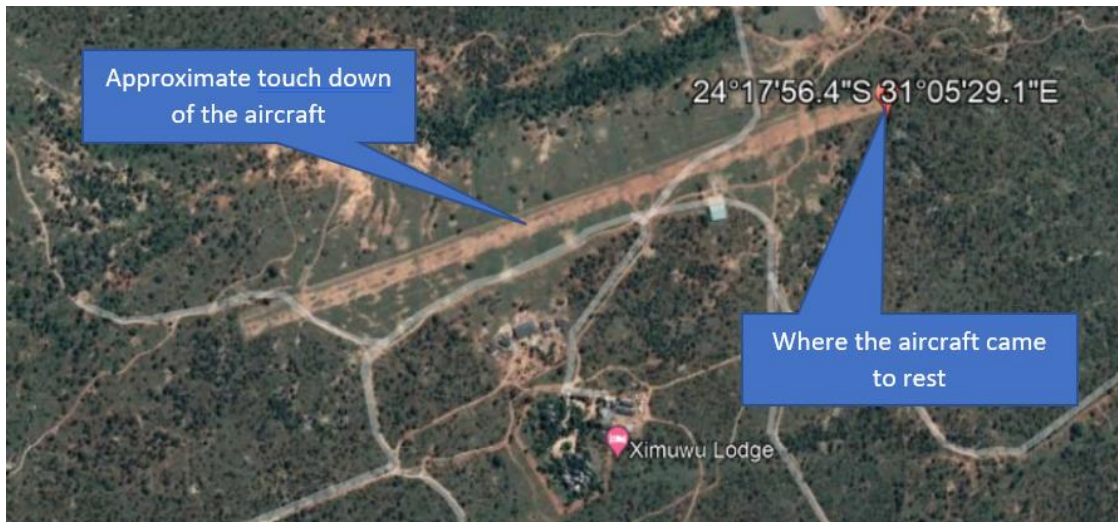
- The private airstrip length is 947 metres, and the required landing distance for a Cessna T206H is 224 metres. The accident aircraft touched down 415 metres beyond the runway threshold, and the remaining distance was 532 metres, which was sufficient to land the aircraft.

- The aircraft landed deep and the pilot was unable to bring the aircraft to a stop. This resulted in the aircraft overshooting the runway. It could not be determined why the aircraft could not stop on the runway.
- The damage to the brake line was attributed to the aircraft overshooting the runway.

**Figure 4:** Overview of the accident site. (Source: Google Earth)

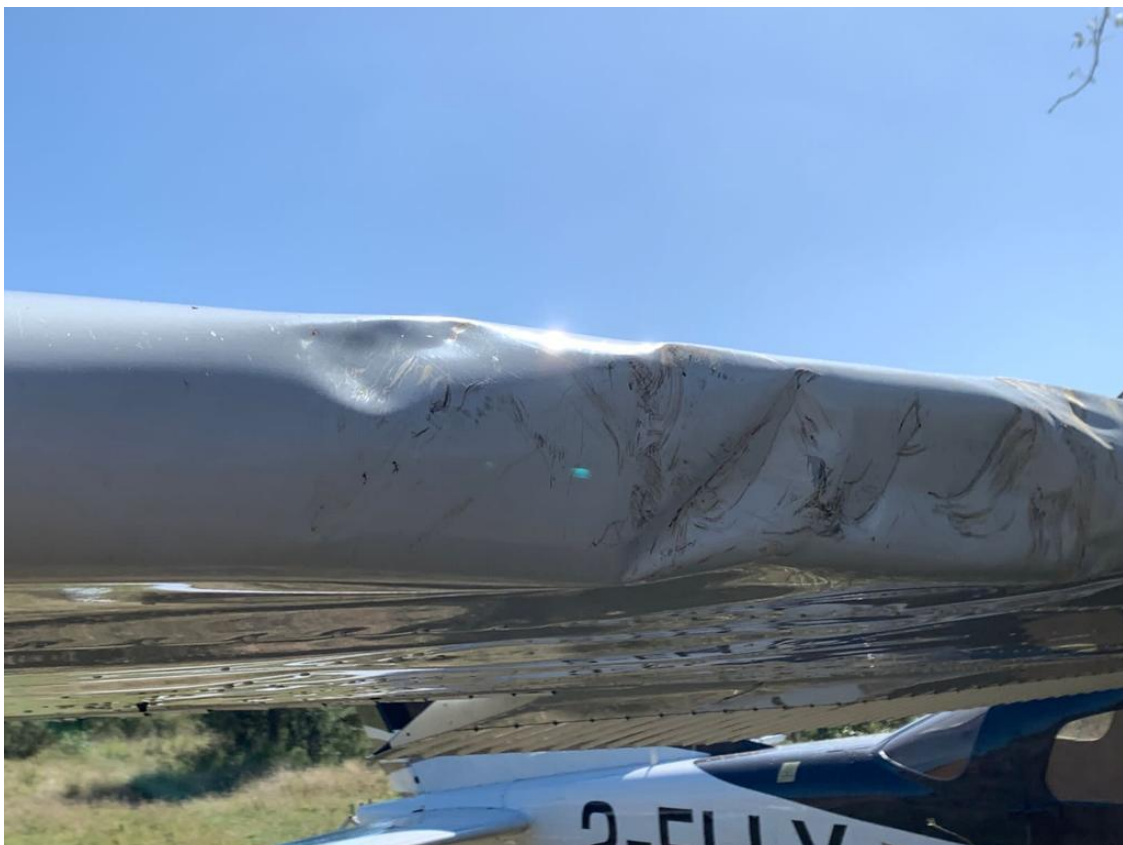
**Figure 5:** Damage to the right-side wing leading edge outboard. (Source: Owner)

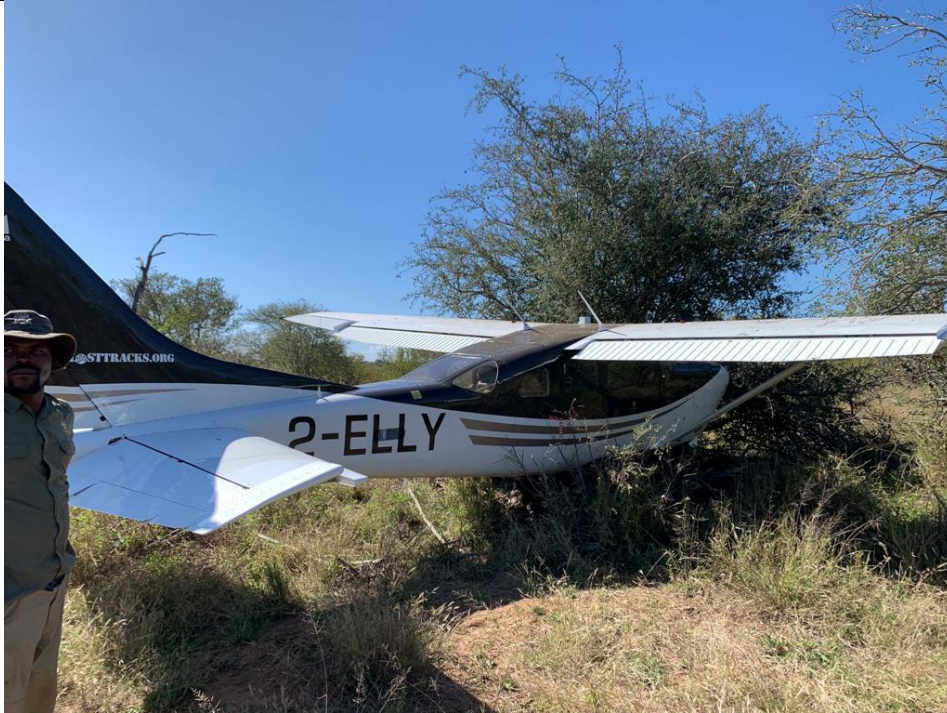
**Figure 6:** The aircraft post-accident. (Source: Pilot)
