LIMITED OCCURENCE INVESTIGATION REPORT – FINAL

Reference Number	CA18/2/3/10172						
Classification	Accident	Date	12 June 2022	Time	0900Z		
Type of Operation	Private (Part 94)						
Location							
Place of Departure	Worcester Aerodrome (FAWC), Western Cape Province		Place of Intended Landing	Worcester Aerodrome, Western Cape province			
Place of Occurrence	Worcester Aerodrome (FAWC)						
GPS Co-ordinates	Latitude	33°39'55.80" S	Longitude	019°25'04.04" E	Elevation	663ft	
Aircraft Information							
Registration	ZS-GUJ						
Make; Model; S/N	Glaser-Dirks; DG-500M (Serial Number: 5E114M51)						
Damage to Aircraft	Substantial			Total Aircraft Hours	2 207.7		
Pilot-in-command							
Licence Type	Glider Pilot Licence		Gender	Male		Age	47
Licence Valid	Yes	Total Hours	1 782.1		Total Hours on Type	46.7	
Total Hours 30 Days	10.9		Total Hours on Type Past 90 Days	10.9			
People On-board	1 + 1	Injuries	0	Fatalities	0	Other (on ground)	0
What Happened							
<p>On Sunday morning, 12 June 2022, a pilot and a passenger on-board a Glaser-Dirks DG-500M self-launch power glider with registration ZS-GUJ intended to engage in a private flight with the take-off from Runway 33 at Worcester Aerodrom

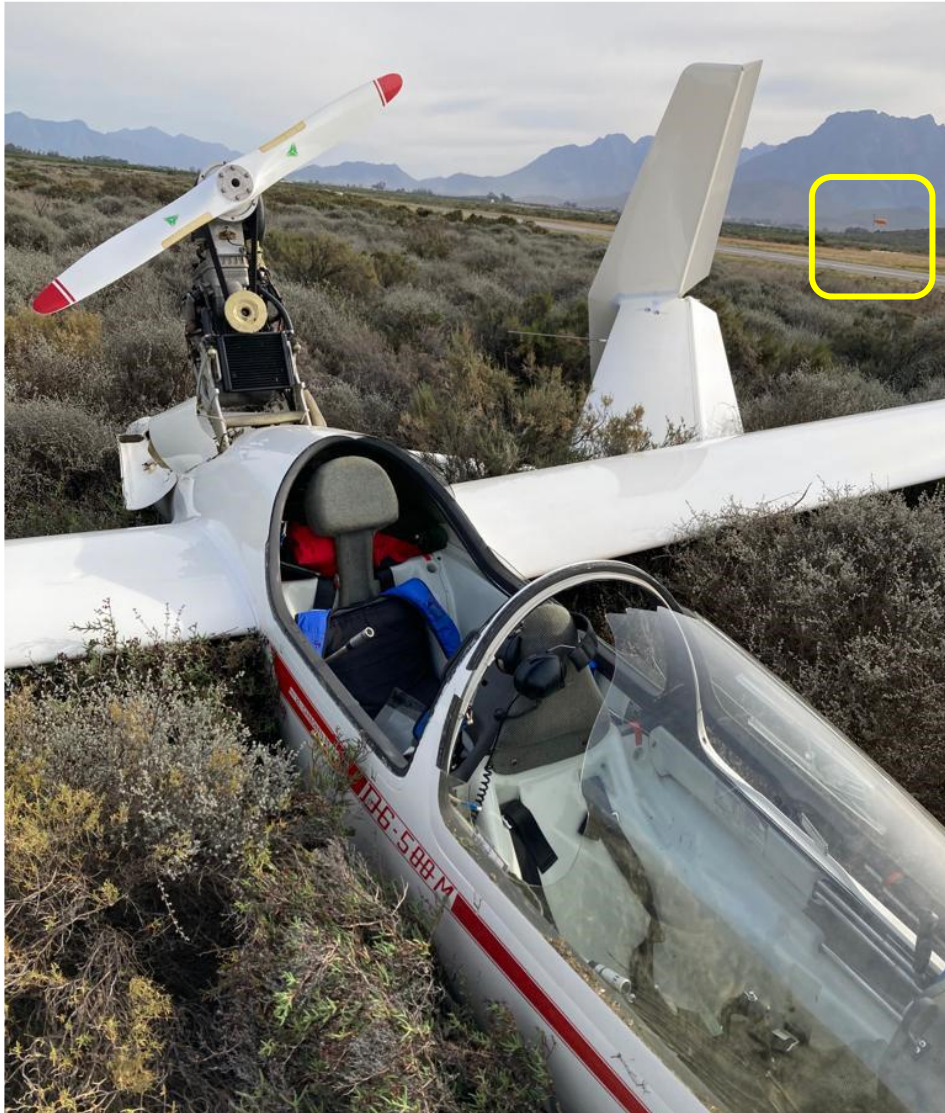
visibility was 10 kilometres (km). No person was injured during the accident sequence. The glider was substantially damaged.

Figure 1: The motorised glider as it came to rest. (Source: Owner)
The windsock in the yellow window indicates wind blowing from the north-west.

Probable Cause(s)
Incorrect technique during take-off and lack of situational awareness during low-level wind shear and buffeting. The aircraft's speed was too low at lift-off.
Contributing Factor(s)
None.
Safety Action(s)
None.
Safety Message and/or Safety Recommendation/s
None.
About this Report
<i>The decision to conduct a limited investigation is based on factors, including whether the cause is known and the evidence supporting the cause is clear, the level of safety benefit likely to be obtained from an investigation</i>
