**LIMITED OCCURRENCE INVESTIGATION REPORT – FINAL**

<b>Reference Number</b>	CA18/2/3/10175							
<b>Classification</b>	Accident	<b>Date</b>	18 June 2022			<b>Time</b>	1015Z	
<b>Type of Operation</b>	Operation of Non-type Certificated Aircraft (Part 94)							
<b>Location</b>								
Place of Departure	Bundu Fly-Inn Estate Aerodrome, Gauteng Province			Place of Intended Landing	Grasslands Aerodrome, Gauteng Province			
Place of Occurrence	Left of Runway 27 at Bundu Fly-Inn Estate Aerodrome							
GPS Co-ordinates	Latitude	25°39'19.86" S	Longitude	028°02'01.16" E	Elevation	4 352ft		
<b>Aircraft Information</b>								
Registration	ZU-EXK							
Make; Model; S/N	Ekolot, KR-030 Topaz (Serial Number: 30-01-07)							
Damage to Aircraft	Substantial			Total Aircraft Hours	731.0			
<b>Pilot-in-command</b>								
Licence Type	National Pilot Licence			Gender	Male		Age	59
Licence Valid	Yes	Total Hours	188.6		Total Hours on Type	28.2		
Total Hours: 90 Days	14.5			Total Flying Hours on Type: Past 90 Days	9.6

**This report is issued by:**  
**Accident and Incident Investigations Division**  
**South African Civil Aviation Authority**  
**Republic of South Africa**

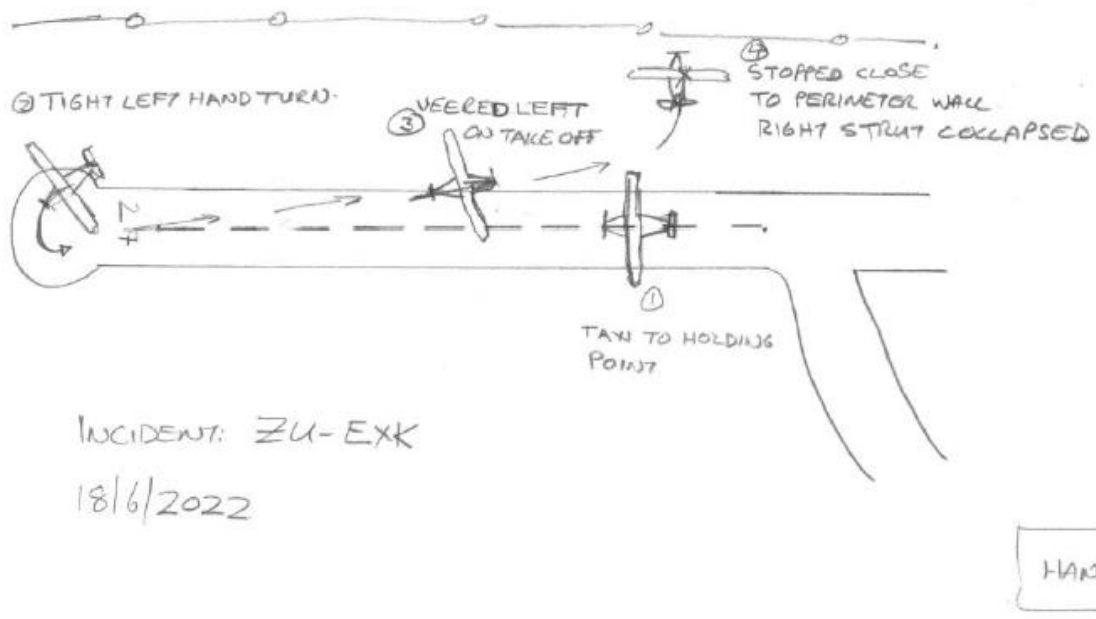
**Diagram 1:** The sketch of the occurrence as supplied by the pilot.

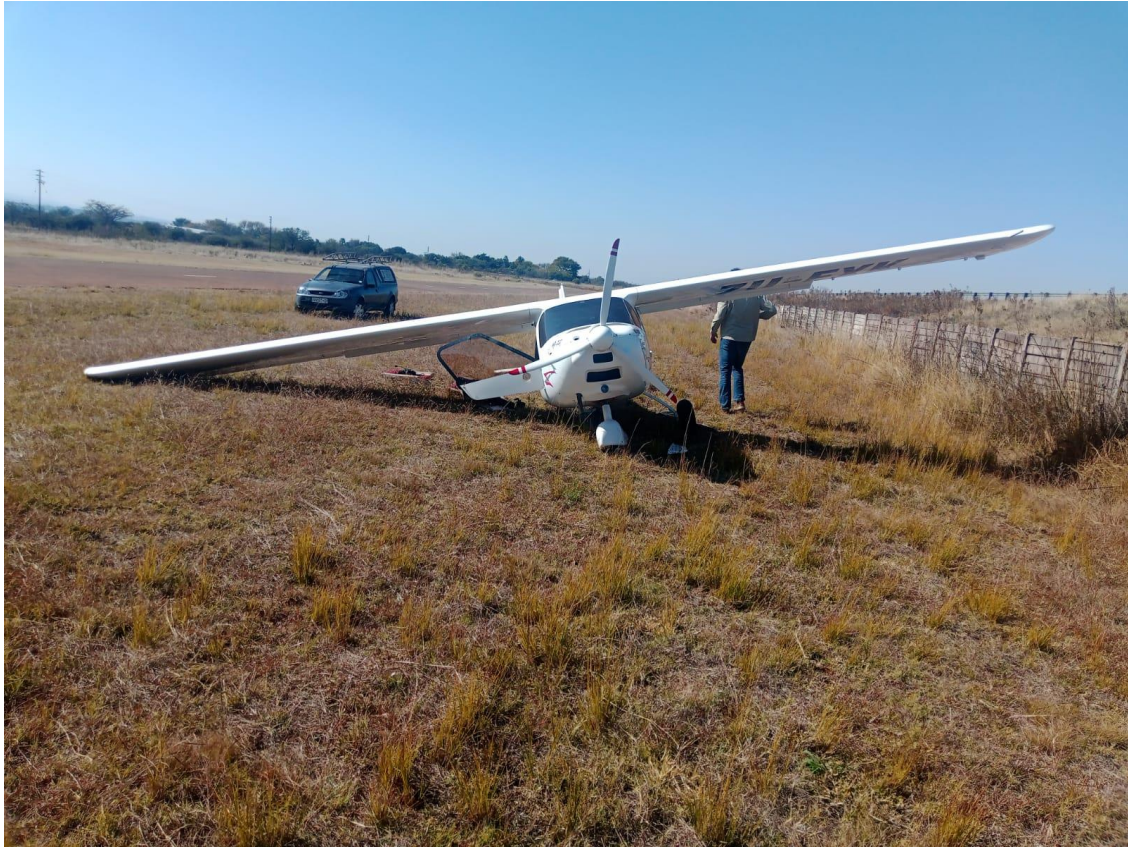
<b>People On-board</b>	1 + 0	<b>Injuries</b>	0	<b>Fatalities</b>	0	<b>Other (on ground)</b>	0	
<b>What Happened</b>								
<p>On Saturday morning, 18 June 2022, a pilot on-board the Ekolot KR-030 Topaz aircraft with registration ZU-EXK departed Grasslands Aerodrome for Bundu Fly-Inn Aerodrome where he spent some time with his friends. Both aerodromes are located in Gauteng province. The flight was conducted under the provisions of Part 94 of the Civil Aviation Regulations (CAR) 2011 as amended.</p> <p>Later the same day, the pilot prepared for his return flight to Grasslands Aerodrome. After start-up, he taxied and backtracked along the runway to the threshold of Runway 27 as the prevailing wind was from the west (on the nose side). He then executed a 180° turn to the left in the turning circle at the threshold of the runway to line up the aircraft for take-off.</p> <p>During the initial phase of the take-off roll, the aircraft veered off to the left-side of the runway centreline, which the pilot was able to correct. However, shortly thereafter, the aircraft veered off to the left-side again; this time, departing the runway surface and onto the grass area at 90° to the runway heading in a southerly direction. The pilot managed to turn the aircraft to the right to avoid impacting a concrete perimeter wall. Following this input/action, the right main gear strut collapsed and folded underneath the fuselage. The right-wing tip contacted the ground, which caused the outer section of the wing tip area to delaminate. The pilot was not injured during the accident sequence.</p>

**Figure 2:** The aircraft as it came to rest on the left-side of Runway 27. (Source: Pilot)

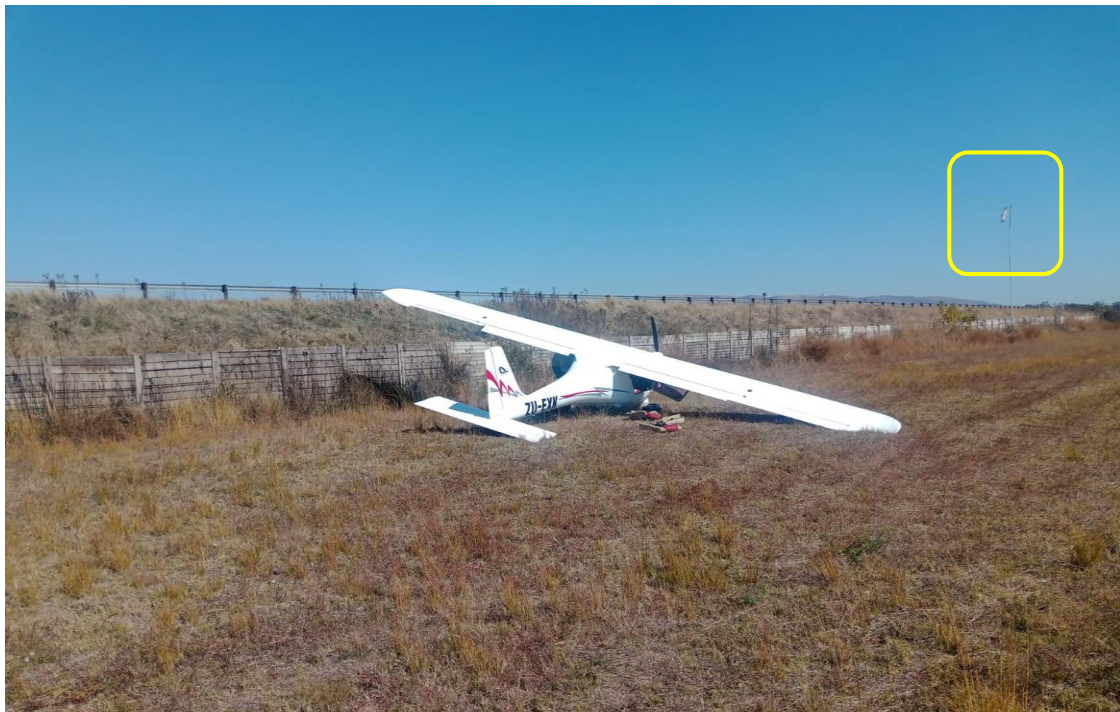
**Figure 3:** Aft view of the aircraft with the windsock in the yellow window. (Source: Pilot)

- (vii) Fine weather conditions with a light westerly wind prevailed at the time, indicated by the windsock in Figure 3.
- (viii) The aircraft sustained substantial damage during the accident sequence.

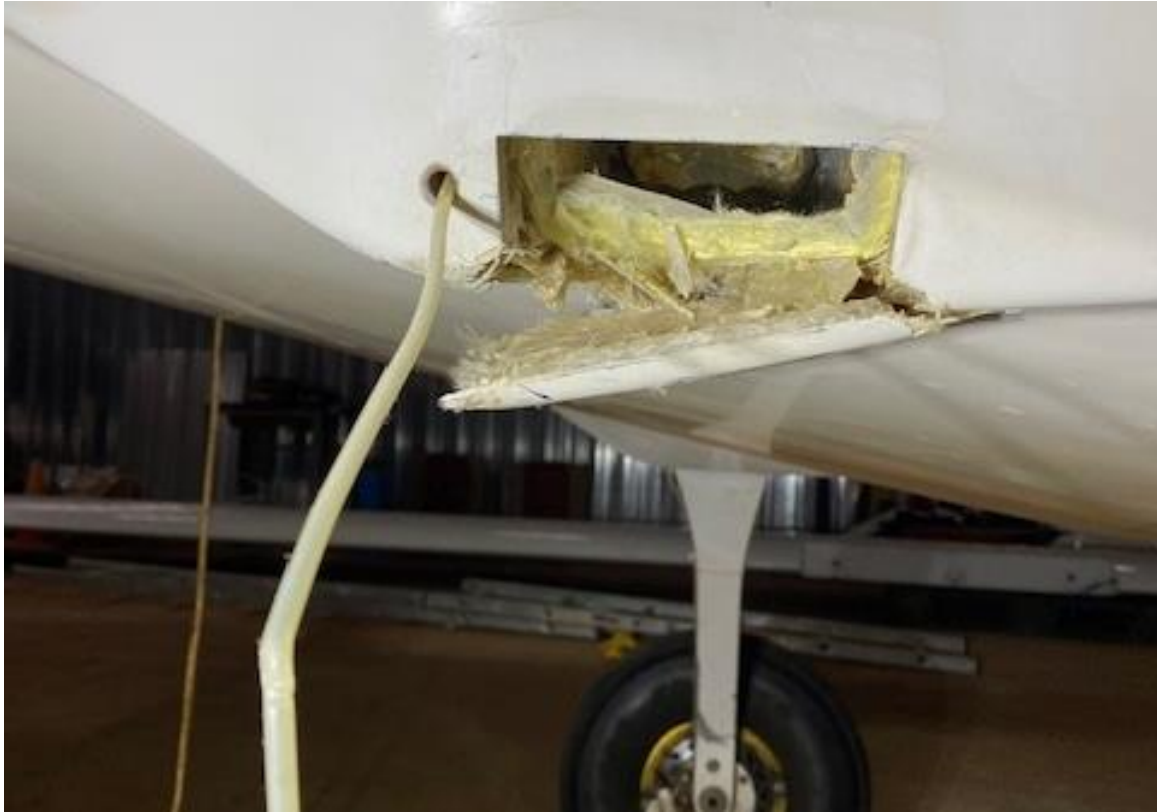
**Figure 4:** Damage caused to the fuselage where the right main gear strut was fitted. (Source: Pilot)

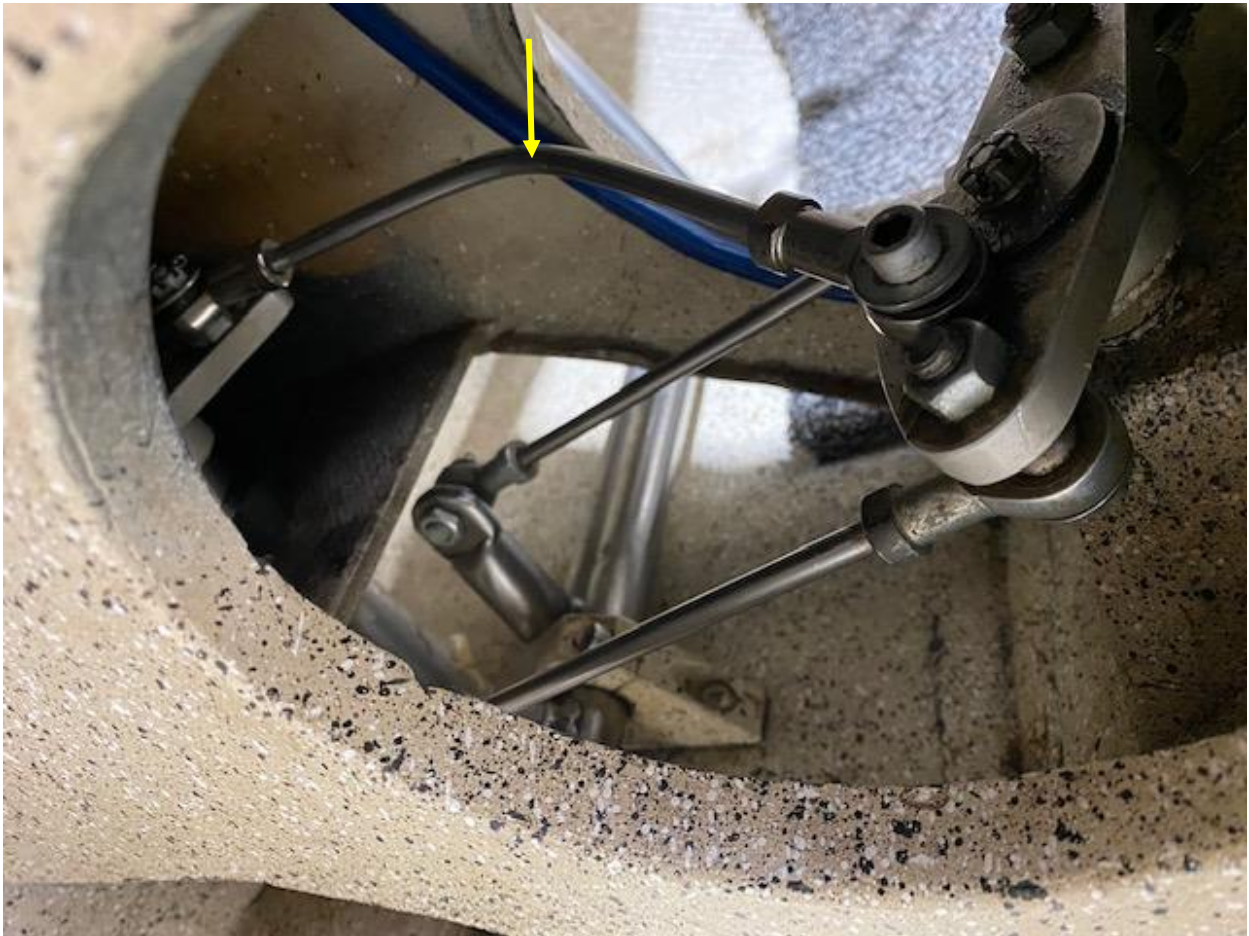
The aircraft owner recovered the aircraft to his facility at Grasslands Aerodrome. After inspecting the aircraft, it was found that the nose gear steering rod was bent (see Figure 5).

The original equipment manufacturer (OEM) was contacted and asked if they ever had an occurrence in the past in which the nose gear steering rod got bent. The OEM's response was: *"There were several cases of such damage to this rod (in the 25-year period of production of our aircraft), but they were always caused by a hard landing, which consequently resulted in damage to the front landing gear."*

The OEM indicated that the steering rod was 8mm in diameter and was made of 1H18N9T stainless steel. It should be noted that 1H18N9T is the code for stainless steel produced in Poland, which is the State of Design and Manufacture for this aircraft.

**Figure 5:** The yellow arrow indicates the bend in the nose gear steering rod. (Source: Pilot)

- (v) The aircraft was issued an Authority to Fly on 26 February 2020 with an expiry date of 28 February 2023.
- (vi) Post-accident inspection of the aircraft revealed the bent nose gear steering rod.

<b>Probable Cause</b>
Loss of directional control of the aircraft during the take-off roll which was most probably induced by the bent nose wheel steering rod.
<b>Contributing Factor</b>
The bend on the nose wheel steering rod most probably occurred when the aircraft turned left at the threshold of Runway 27 prior to lining up for take-off.
<b>Safety Action/s</b>
None.
<b>Safety Message and/or Safety Recommendation/s</b>
None.
<b>About this Report</b>
<p><i>The decision to conduct a limited investigate is based on factors, including whether the cause is known and the evidence supporting the cause is clear, the level of safety benefit likely to be obtained from an investigation and that will determine the scope of an investigation. For this occurrence, a limited investigation has been conducted, and the Accident and Incident Investigations Division (AIID) has relied on the information submitted by the affected person/s and organisation/s to compile this limited report. The report has been compiled using information supplied in the initial notification, as well as from follow-up desk top enquiries to bring awareness of potential safety issues to the industry in respect of this occurrence, as well as possible safety action/s that the industry might want to consider in preventing a recurrence of a similar occurrence.</i></p> <p><i>All times given in this report are Co-ordinated Universal Time (UTC) and will be denoted by (Z). South African Standard Time is UTC plus 2 hours.</i></p>

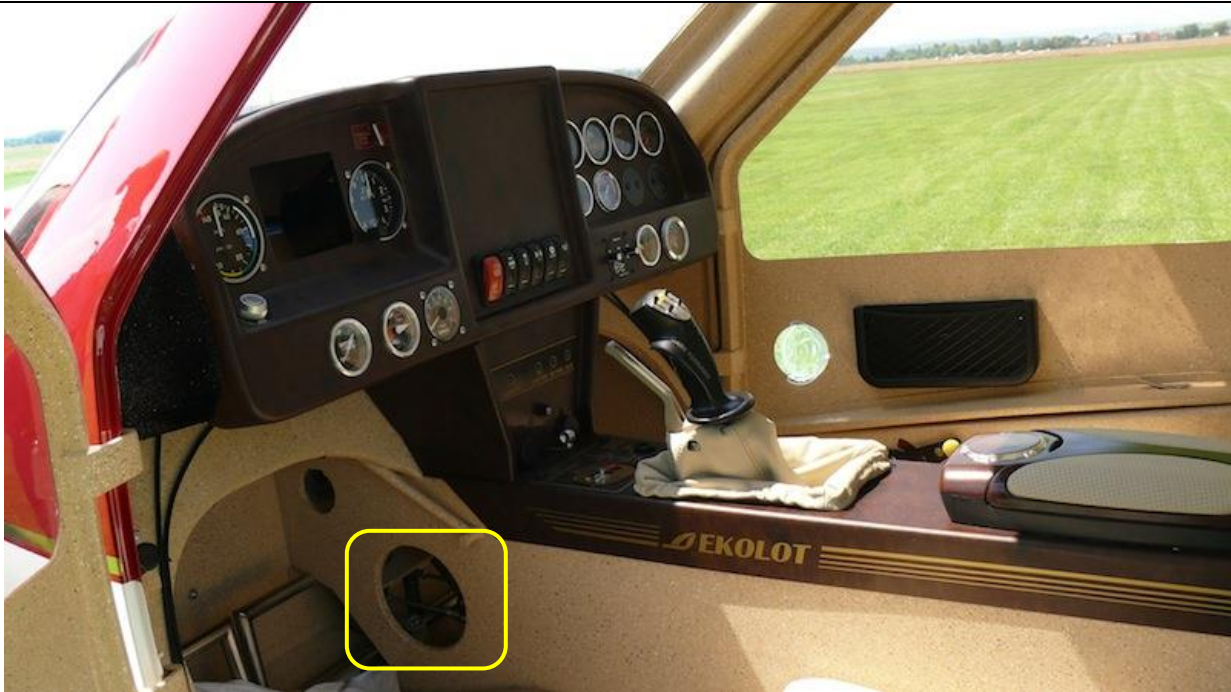
**Figure 6:** The yellow window indicates the inspection hole. (from Figure 5)
