LIMITED OCCURRENCE INVESTIGATION REPORT – FINAL

Reference Number	CA18/2/3/10177						
Classification	Accident	Date	31 October 2022		Time	1210Z	
Type of Operation	Private (Part 94)						
Location							
Place of Departure	Nieu-Bethesda Airfield, Eastern Cape Province		Place of Intended Landing	New Tempe Aerodrome (FATP), Free State Province			
Place of Occurrence	On an uneven terrain, approximately 90 metres from the threshold of Runway 28 at FATP						
GPS Co-ordinates	Latitude	29°01'44.1" S	Longitude	26°10'11.4" E	Elevation	4 547 ft	
Aircraft Information							
Registration	ZU-EWZ						
Make; Model; S/N	PPHU Ekolot; KR-030 Topaz (Serial Number: 30-01-05)						
Damage to Aircraft	Substantial			Total Aircraft Hours	1001.8		
Pilot-in-command							
Licence Type	National Pilot Licence (NPL)		Gender	Male		Age	59
Licence Valid	Yes	Total Hours	532.37		Total Hours on Type	15.8	
Total Hours Past 30 Days	15.8		Total Flying Hours on Type Past 90 Days	15.8			
People On-board	1 + 0	Injuries	0	Fatalities	0	Other (on ground)	0

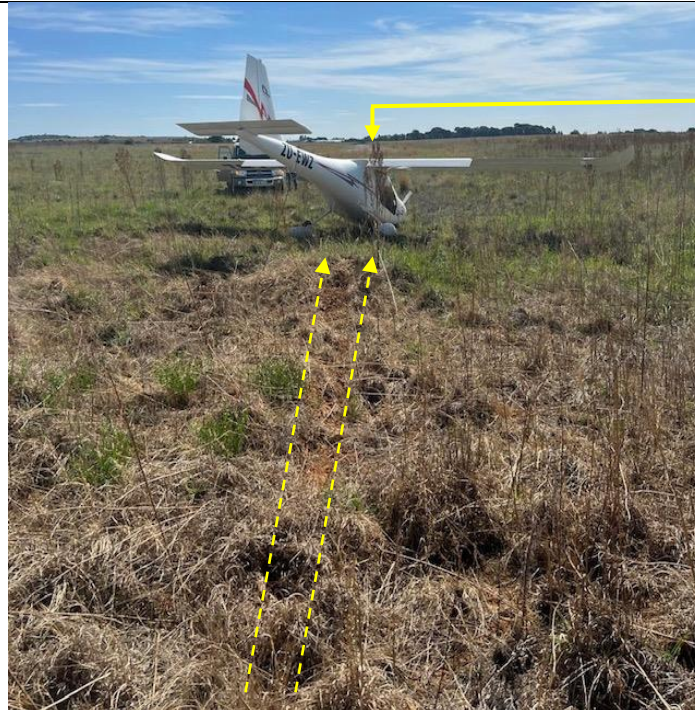
The threshold of Runway 28, approximately 90m from the place of the accident.

Figure 2: Touchdown point and the final position of the ZU-EWZ aircraft post-accident.

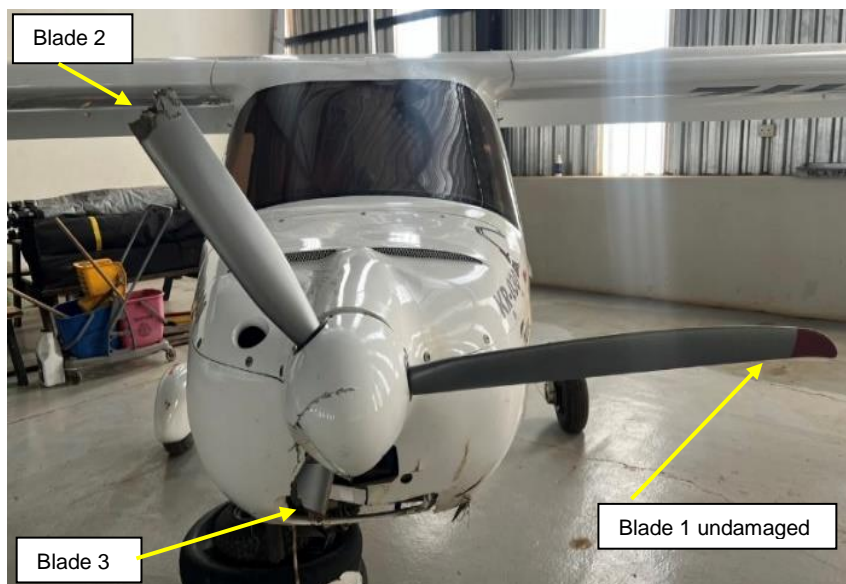
Propeller blade number 1 was found in a good condition and undamaged. The damaged propeller blades number 2 and 3 were analysed; both propeller blade tips showed chip marks or nicks associated with stones that were swept up in the prop wash during operation. The blade number 2 contacted the ground first after the collapse of the nose gear strut, before it broke off about midspan. The blade number 3 contacted the ground last with the already fractured tip. The blade number 3 cord area showed a fractured surface, consistent with a backward bend load as the aircraft slid on the soft ground before it broke off at the root. The broken-off parts of the fractured blade number 3 tip were not found.

Figure 4: The propeller blades post-accident.

All three blades showed no evidence of abnormal play within the hubs. The hub bolt torques were checked by unscrewing the bolts with a calibrated torque wrench. All six hub bolts were found to be within the required tightening torque value of 20 Newton meter (Nm) as recommended in the overhaul manual.

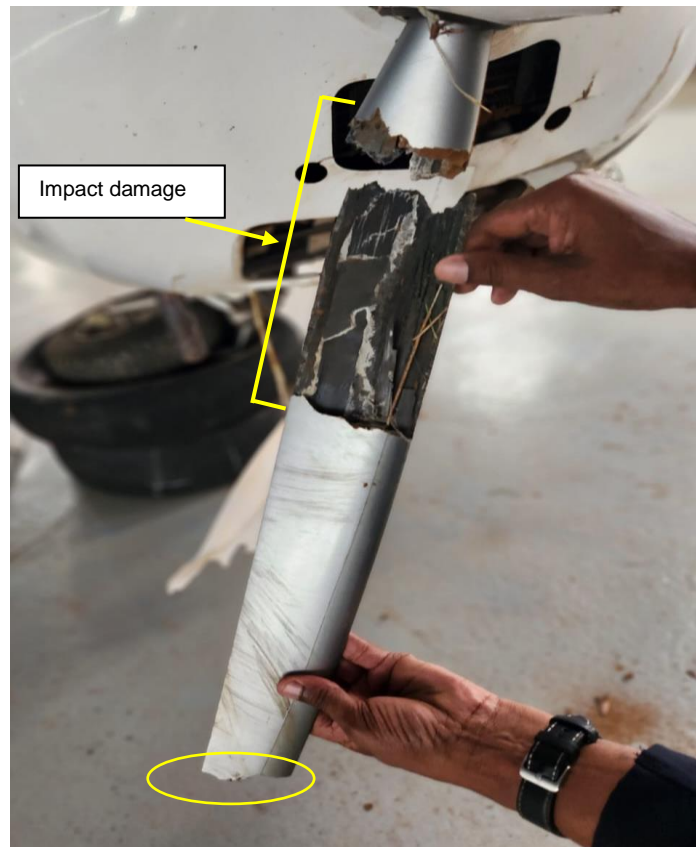
The propeller was removed from the engine by the South African Civil Aviation Authority (SACAA) approved person (AP) for examination. The propeller blade pitch angles on all blades were measured in accordance with (IAW) the procedures in the overhaul manual. The results showed pitch angles of 20.5° on all three blades and were statically balanced, meaning that all three blades were moving evenly when they were rotating. Examination of the internal faces of the hub bores indicated normal contact marks made from the clamping of the propeller blade roots, and no visible evidence of rotation of the blade roots within the hub. The clearance between the hub halves when assembled were also within the prescribed limits as recommended by the overhaul manual. About 100 millimetres (mm) of the blade number 3 tip had fractured.

Figure 5: Reconstructed blade number 3 showing damage sustained on the cord and the tip that had fractured.

The investigation concluded that the fractured blade number 3 tip seemed to have occurred after hitting a stone that could have been swept up in the propeller wash during take-off from the gravel runway. During the latter stages of the flight, the weakened blade tip separated due to centrifugal forces imposed on it. Examination of the fractured surface on blade number 3 tip showed evidence of carbon fibre pulling apart as it separated.

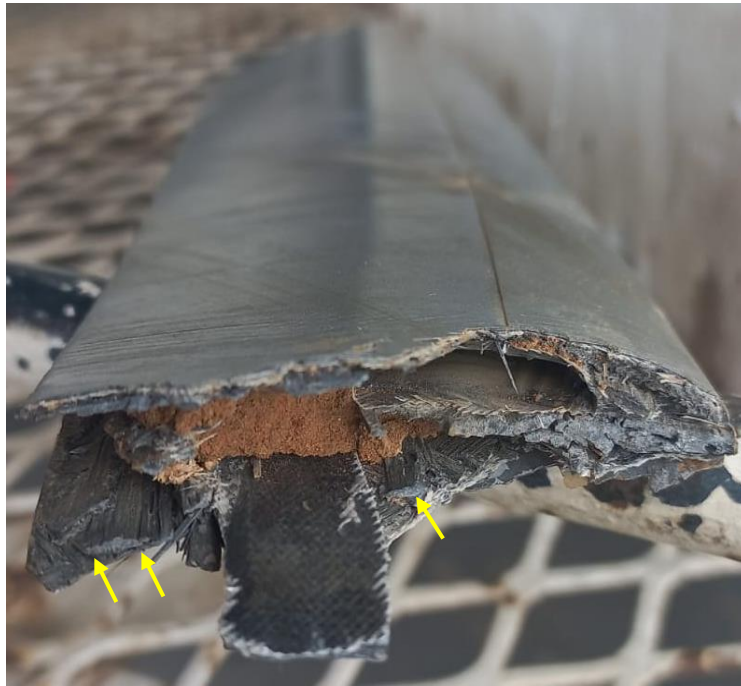
Figure 6: An enlarged blade number 3 tip showing carbon fibre layers.

(x) The duration of the flight was 1.9 hours and approximately 35l of fuel remained in the ZU-EWZ aircraft tanks.
(xi) The pilot was not injured.
Probable Cause
The blade number 3 tip separated due to centrifugal forces after it had hit a stone that was likely swept up in the prop wash during take-off from an unpaved runway.
Contributing Factor
Operating the aircraft from a gravel runway.
Safety Action(s)
None.
Safety Message and/or Safety Recommendation/s
None.
About this Report
<i>The decision to conduct a limited investigation is based on factors including whether the cause is known and the evidence supporting the cause is clear, the level of safety benefit likely to be obtained from an investigation and that will determine the scope of an investigation. For this occurrence, a limited investigation has been conducted, and the Accident and Incident Investigations Division (AIID) has relied on the information submitted by the affected person/s and organisation/s to compile this limited report. The report has been compiled using information supplied in the initial notification, as well as from follow-up desk top enquiries to bring awareness of potential safety issues to the industry in respect of this occurrence, as well as possible safety action/s that the industry might want to consider in preventing a recurrence of a similar occurrence.</i>
