LIMITED OCCURRENCE INVESTIGATION REPORT – FINAL

Reference Number	CA18/2/3/10179						
Classification	Accident	Date	26 June 2022		Time	1428Z	
Type of Operation	Private (Part 94)						
Location							
Place of Departure	Mokopane Aerodrome (FAQR) Limpopo Province		Place of Intended Landing		Mokopane Aerodrome (FAQR), Limpopo Province		
Place of Occurrence	Moorddrift Dairy Farm, Limpopo Province						
GPS Co-ordinates	Latitude	24°16'02" S	Longitude	028°57'50" E	Elevation	3608 ft	
Aircraft Information							
Registration	ZU-EZK						
Make; Model; S/N	Ekolot Topaz, KR-030 (Serial Number: 30-01-08)						
Damage to Aircraft	Destroyed			Total Aircraft Hours	616.6		
Pilot-in-command							
Licence Type	National Pilot Licence (NPL) A		Gender	Male		Age	37
Licence Valid	Yes	Total Hours	377		Total Hours on Type	105.3	
Total Hours 30 Days	2.7		Total Flying on Type Past 90 Days	7			
People On-board	1 + 1	Injuries	2	Fatalities	0	Other (on ground)	0
What Happened

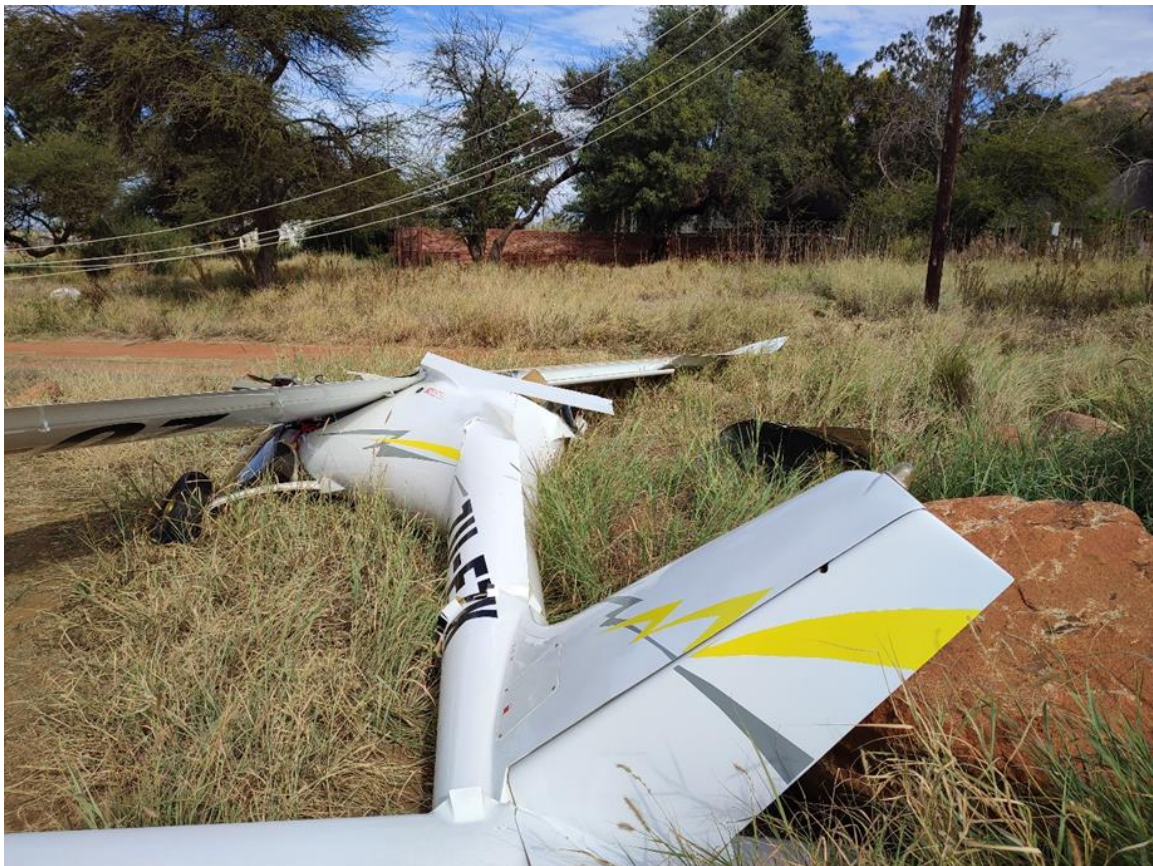
Figure 2: Damage to the aircraft and the power lines. (Source: AIID)

Probable Cause
Loss of engine power in-flight which led to loss of control of the aircraft and the subsequent collision with the power lines.
Contributing Factors
The passenger accidentally knocked close the power throttle in-flight. Insufficient height for recovery.
Safety Action(s)
None.
Safety Message
There should be a clear warning or guard on the passenger side throttle control lever to warn the passenger not to touch/disturb.

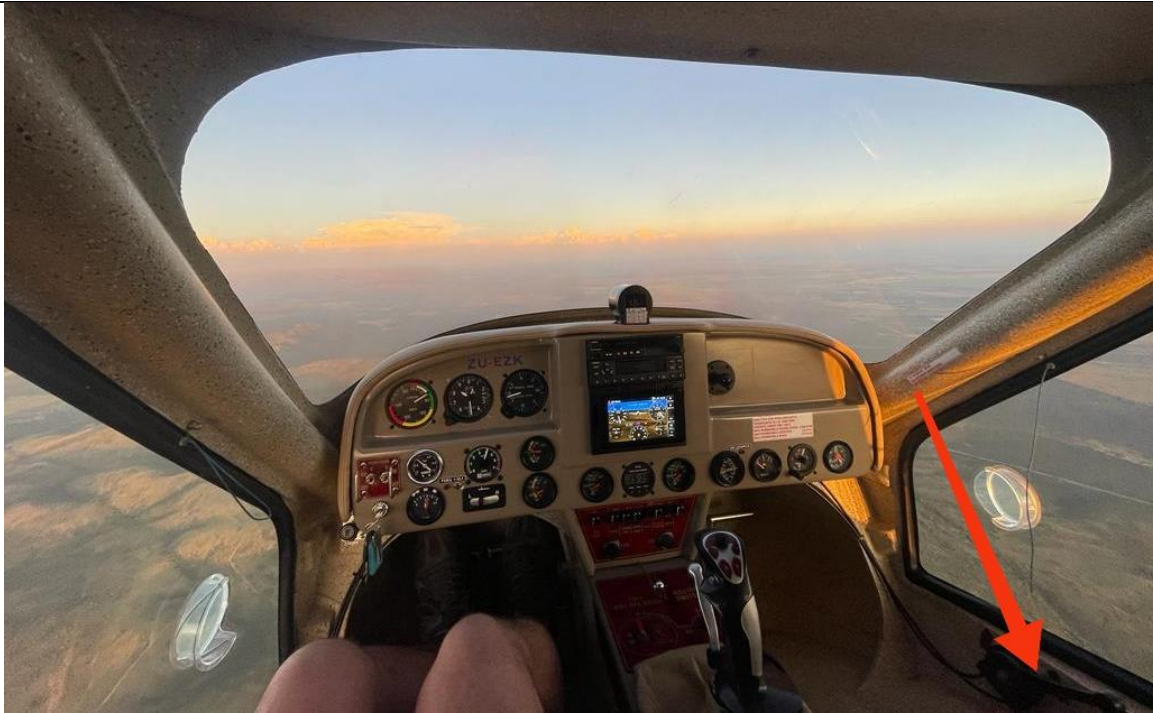
Figure 3: Position of the passenger throttle lever (red arrow). (Source: Pilot)

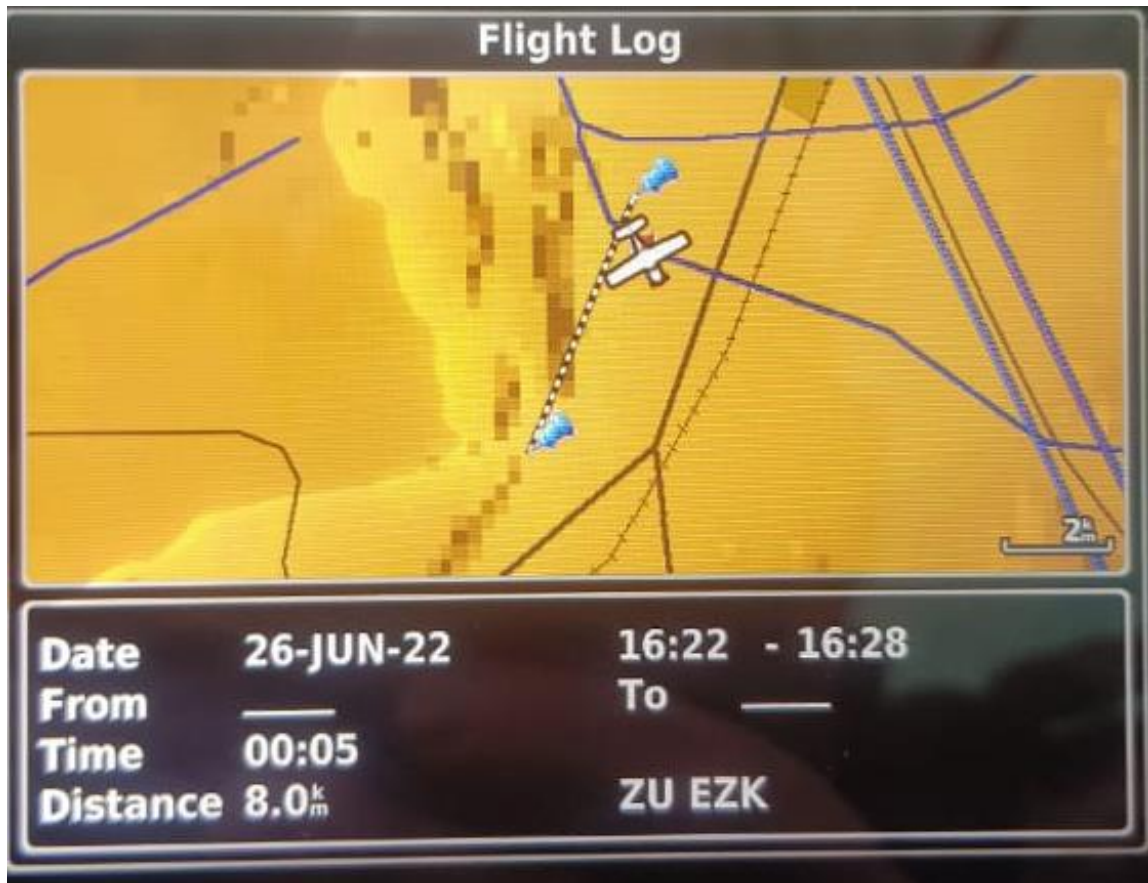
Figure 4: ZU-EZK Flight Log. (Source: Pilot)
