LIMITED OCCURRENCE INVESTIGATION REPORT – FINAL

Reference Number	CA18/2/3/10181						
Classification	Accident	Date	29 June 2022	Time	1625Z		
Type of Operation	Training (Part 141)						
Location							
Place of Departure	Grand Central Aerodrome (FAGC), Gauteng Province		Place of Intended Landing	Grand Central Aerodrome (FAGC), Gauteng Province			
Place of Occurrence	Runway 17, Grand Central Aerodrome (FAGC), Gauteng Province						
GPS Co-ordinates	Latitude	25° 98' 94" S	Longitude	28° 13' 96" E	Elevation	5 325 ft	
Aircraft Information							
Registration	ZS-MBY						
Make; Model; S/N	Piper PA-34-220T Seneca III (Serial Number: 34-8133020)						
Damage to Aircraft	Substantial		Total Aircraft Hours	3 403.4			
Pilot-in-command							
Licence Type	Airline Transport Pilot Licence (ATPL) Aeroplane (A)		Gender	Male	Age	30	
Licence Valid	Yes	Total Hours on Type	83	Total Flying Hours	4 405.1		
People On-board	2 + 0	Injuries	0	Fatalities	0	Other (on ground)	0
What Happened

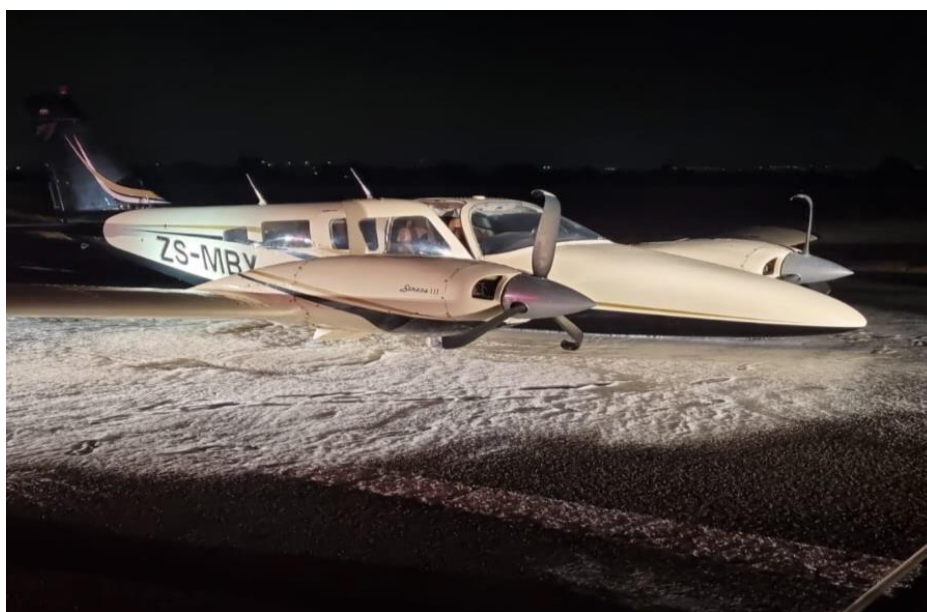
As the aircraft flew over the threshold of RWY 17, the SP waited for the aircraft to touch down on its main landing wheels. But instead, there was a loud grinding noise from the underbelly of the aircraft with sparks on either side of the fuselage as the aircraft slid for about 90 metres (m) before it came to a halt in the middle of the runway. Both pilots reported that they did not hear the landing gear warning horn prior to landing.

The ARFF dispatched to the accident scene. Although there was no smell of fuel and smoke and no indication of fire, the ARFF sprayed foam on and around the aircraft as a precautionary measure. The aircraft sustained substantial damage to the underbelly, both propellers, flaps and both engines. None of the pilots was injured.

Figure 1: The aircraft post-accident. (Source: FAGC ARFF)

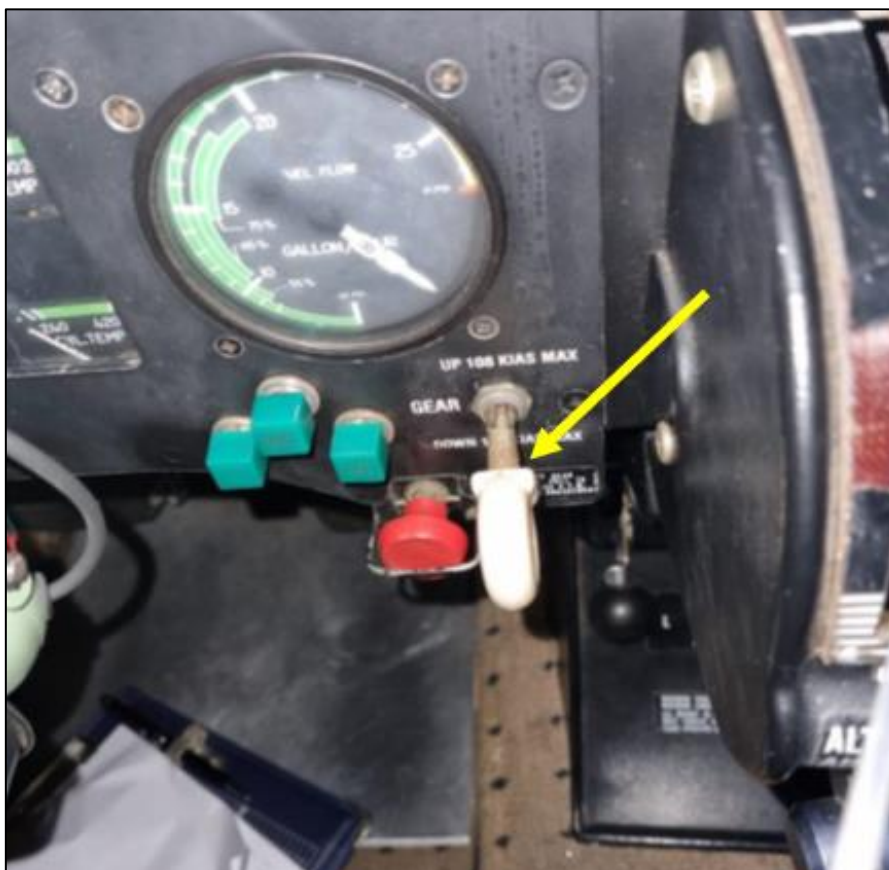
- 2.1. According to the aircraft maintenance engineer (AME) who conducted the post-accident examination of the aircraft, the landing gear toggle switch was found in the down position.

Figure 2: The arrow shows the position of the gear control switch as found post-accident. (Source: FAGC ARFF)

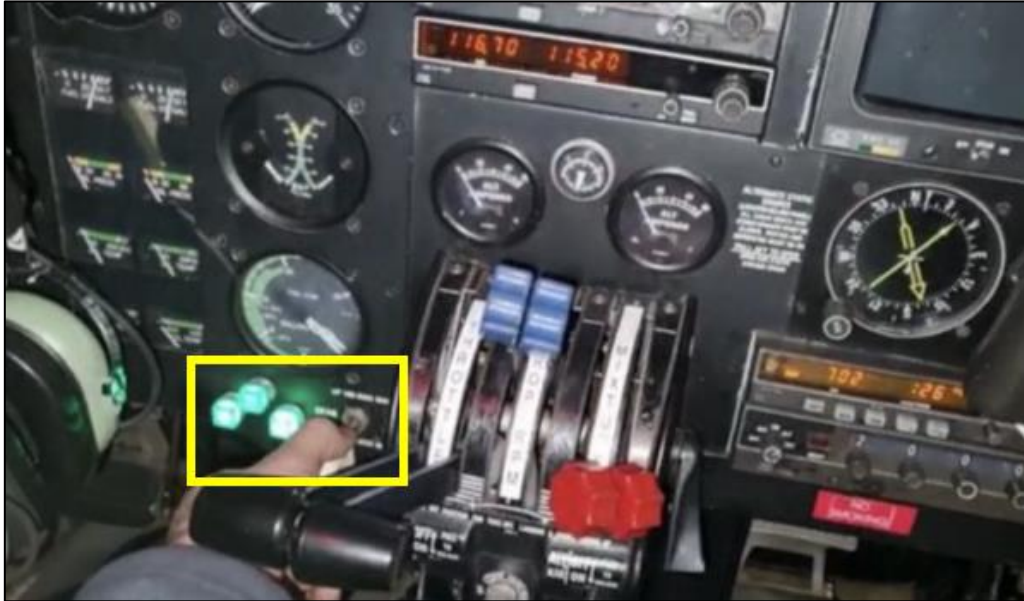
- 2.2. Before the aircraft was towed to the hangar, an engineering inspection was conducted. No fault was found with the landing gear system or landing gear warning system.

The aircraft was placed on hydraulic jacks and the main landing gears were cycled several times, with both pilots present, and the landing gear warning system operated normally. According to the AME, the three green landing gear lights illuminated, and the landing gear warning horn activated as the gear was retracted with the flaps extended. Based on the fact that the gear and warning system functioned satisfactorily, the AME deduced that gear toggle switch appeared to have been selected to the down/extended position after the accident.

Figure 3: The landing gear in a down and locked position during the test with the three green lights illuminated. (Source: Operator)

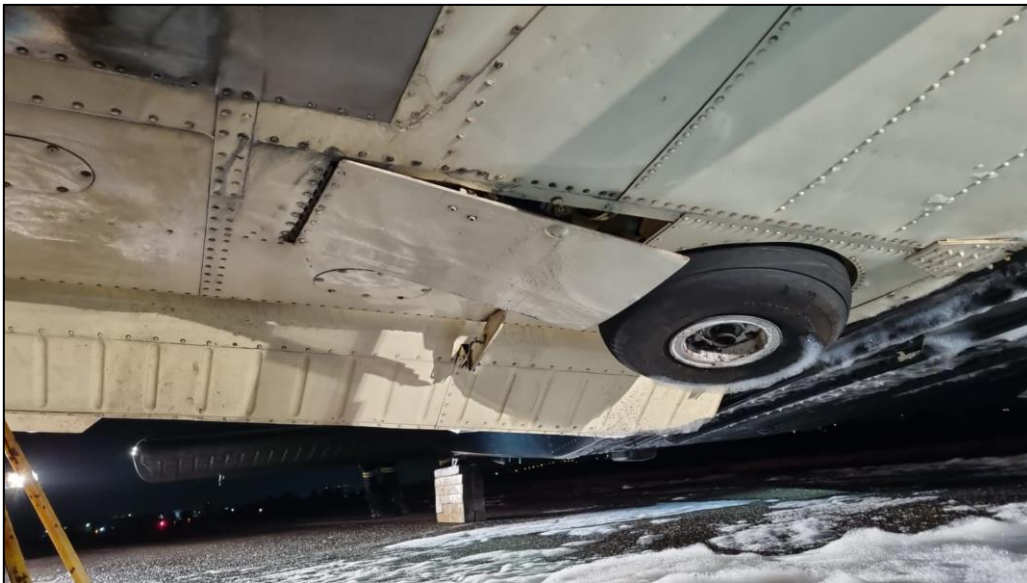
- 2.3. The damage to the underside of the fuselage and the absence of damage (scraping marks) to the landing gear doors and landing gear indicated that the landing gear was fully retracted during the landing phase.

Figure 4: Main landing doors were found intact with no signs of scrape marks on the outside. (Source: FAGC ARFF)
