LIMITED OCCURRENCE INVESTIGATION REPORT – FINAL

Reference Number	CA18/2/3/10182						
Classification	Accident	Date	1 July 2022		Time	1400Z	
Type of Operation	Private (Part 94)						
Location							
Place of Departure	Potchefstroom Aerodrome (FAPS), North West Province		Place of Intended Landing		Brits Aerodrome (FABS), North West Province		
Place of Occurrence	Runway (RWY) 02 at Brits Aerodrome (FABS)						
GPS Co-ordinates	Latitude	25°32'10"S	Longitude	27°46'32"E	Elevation	3 750 ft	
Aircraft Information							
Registration	ZU-IKT						
Make; Model; S/N	Revolution Aviation Inc; RAI-6 Foxtrot (Serial number: F-014)						
Damage to Aircraft	Substantial			Total Aircraft Hours	37.7		
Pilot-in-command							
Licence Type	Private Pilot Licence (PPL)		Gender	Male		Age	61
Licence Valid	Yes	Total Hours	1019.6		Total Hours on Type	11	
Total Hours 30 Days	0		Total Flying on Type Past 90 Days		232		
People On-board	1+1	Injuries	0	Fatalities	0	Other (on ground)	0

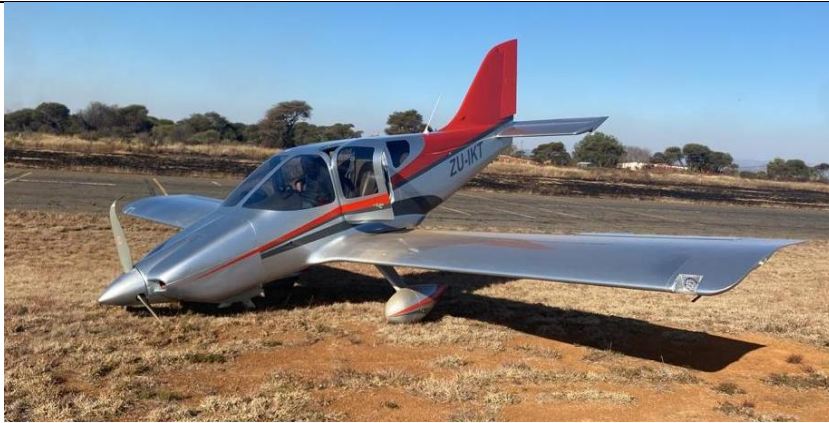
Figure 1: The aircraft at the accident site. (Source: Operator)

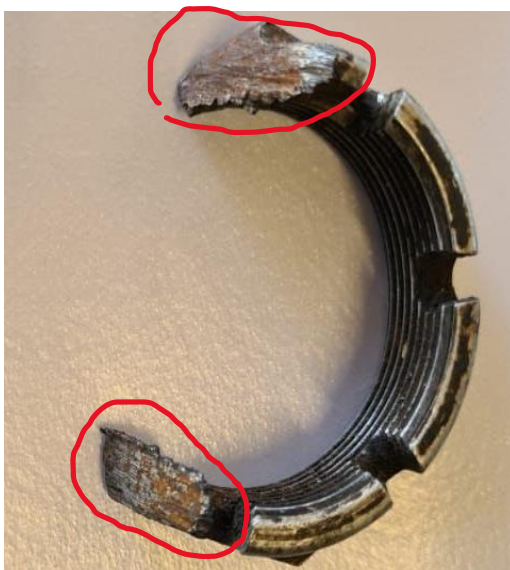
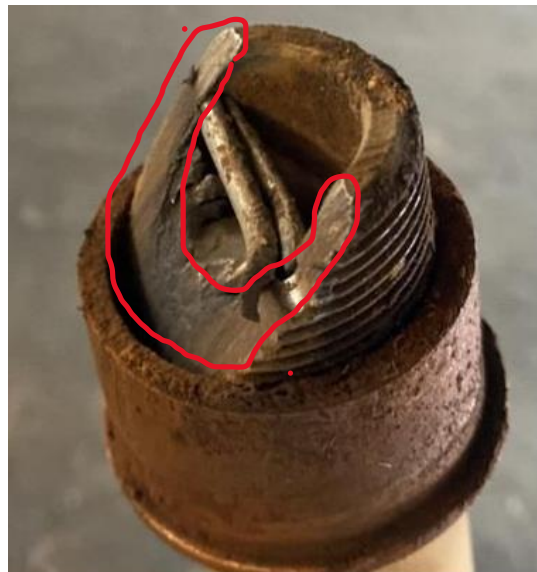
The lower-end part of the nose gear, which is secured by a castellated nut and split pin, scraped against the runway surface due to the hard landing. This caused the lower-end of the nose gear as well as the castellated nut and split pin to shear and separate from the main nose gear strut.

Figures 2 and 3: The sheared castellated nut (left) and the nose gear strut bottom area with a split pin. (Source: Operator)

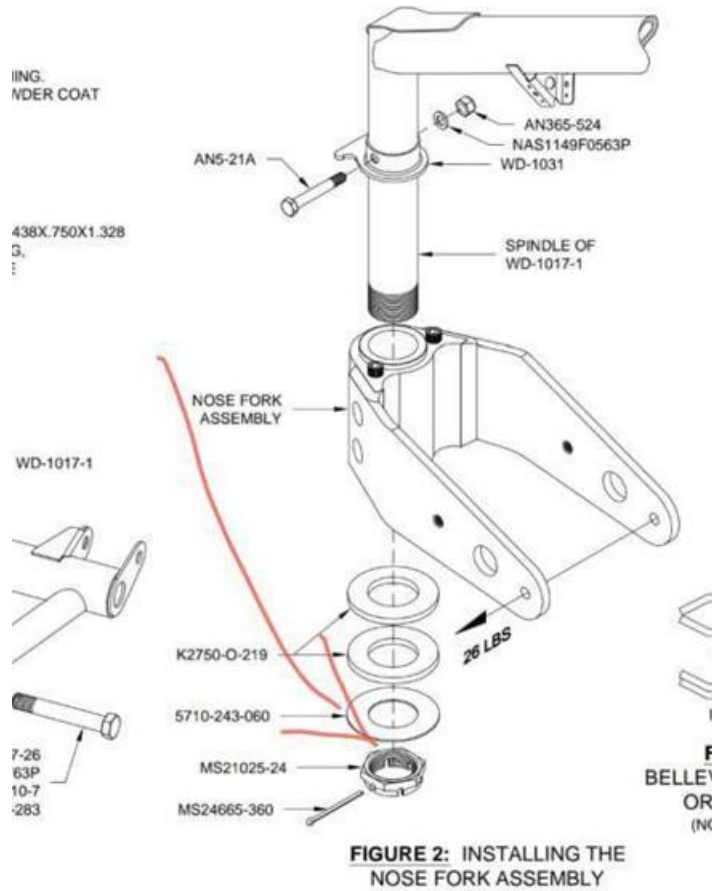
Illustration 1: The schematic diagram of the nose gear strut with the arrow showing the castellated nut. (Source: Illustrated Parts Catalogue)

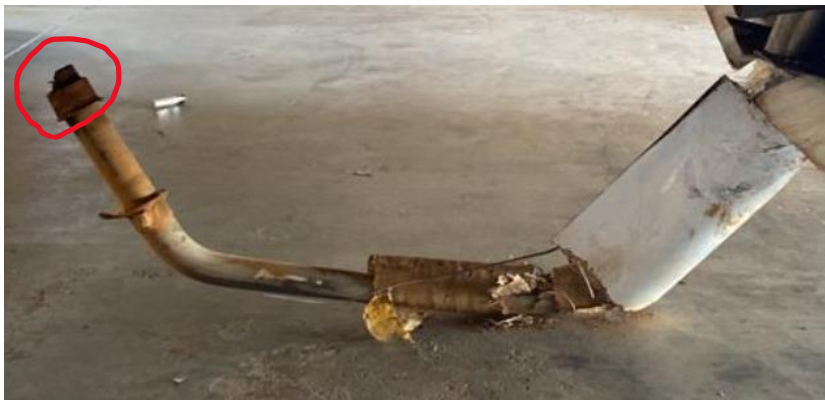
Figure 4: The nose gear strut that bent backward. (Source: Operator)

The aircraft descended at a high angle-of-attack, which caused the nose to slam down; this was followed shortly by a nose wheel shimmy. The pitch attitude remained flat, which indicated that no attempt was made to reduce the weight on the nose wheel. As a result, the front gear folded backward, and the aircraft skidded on its front wheel fork assembly.

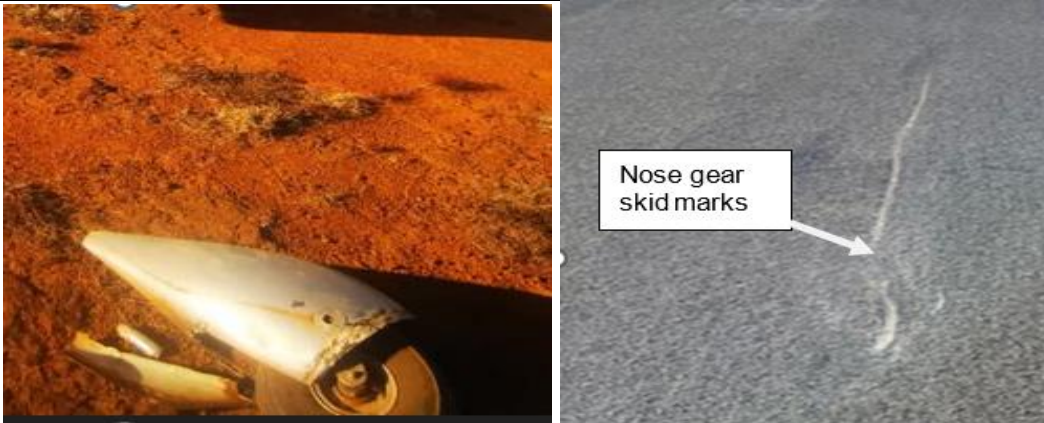
Figures 5 and 6: The separated lower end part of the nose gear (left) and the skid marks on the runway surface (right). (Source: Operator)
