LIMITED OCCURRENCE INVESTIGATION REPORT – FINAL

Reference Number	CA18/2/3/10185							
Classification	Accident	Date	09 July 2022		Time	0550Z		
Type of Operation	Private (Part 94)							
Location								
Place of Departure	Empangeni Airfield (FAEM), KwaZulu-Natal Province		Place of Intended Landing		Empangeni Airfield (FAEM), KwaZulu-Natal Province			
Place of Occurrence	At an open field in KwaZulu-Natal Province							
GPS Co-ordinates	Latitude	28°35'41.82"S	Longitude	32°14'53.26"E	Elevation	1865ft		
Aircraft Information								
Registration	ZU-CJB							
Make; Model; S/N	Windlass Aquilla (Serial Number: WA 908)							
Damage to Aircraft	Substantial			Total Aircraft Hours	704.4			
Pilot-in-command								
Licence Type	National Pilot Licence (NPL)		Gender	Male		Age	60	
Licence Valid	Yes	Total Hours	96.0		Total Hours on Type	64.2		
Total Hours 30 Days	5.4		Total Flying on Type Past 90 Days		11.5			
People On-board	1+1	Injuries	2	Fatalities	0		Other (on ground)	0

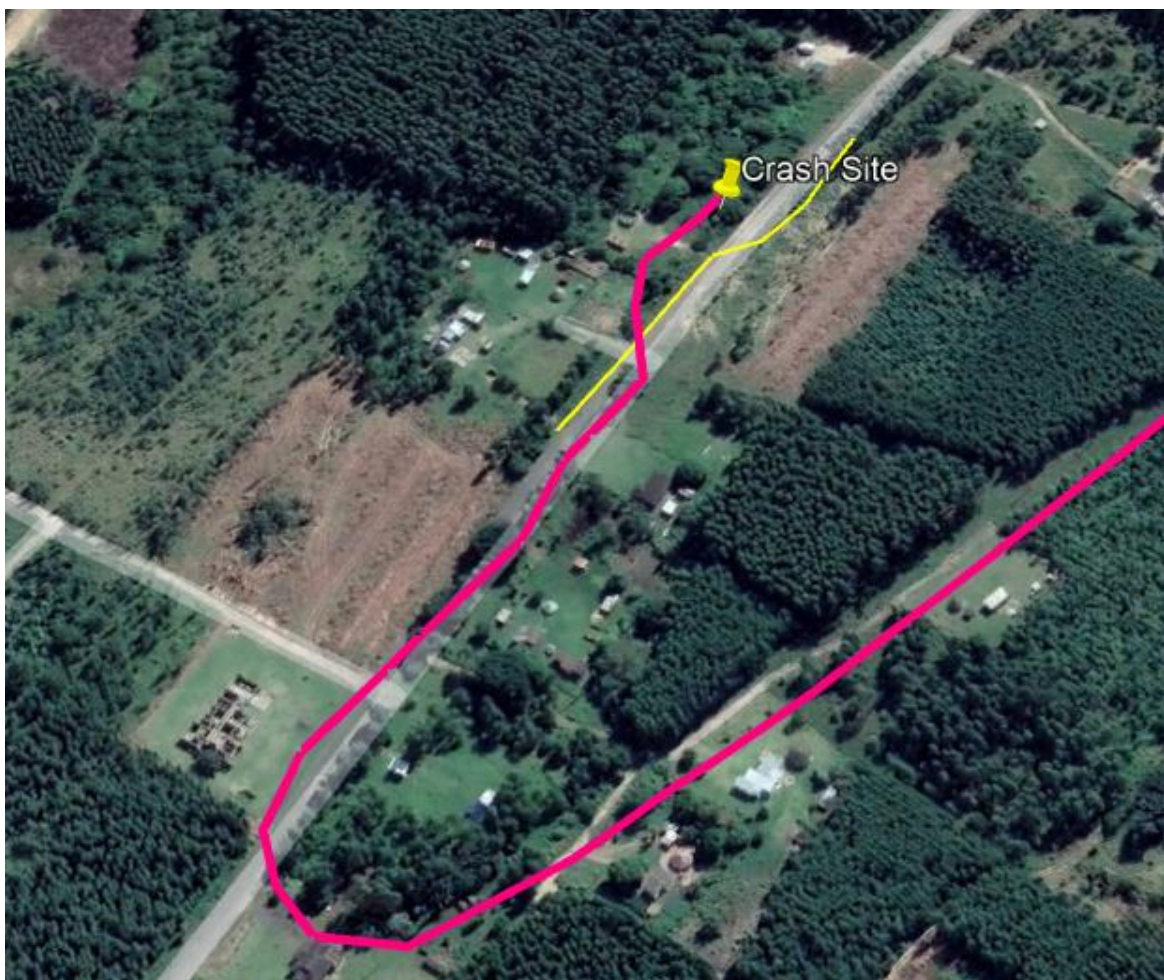
Figure 1: The pink line shows the flight path before impact. (Source: Owner)

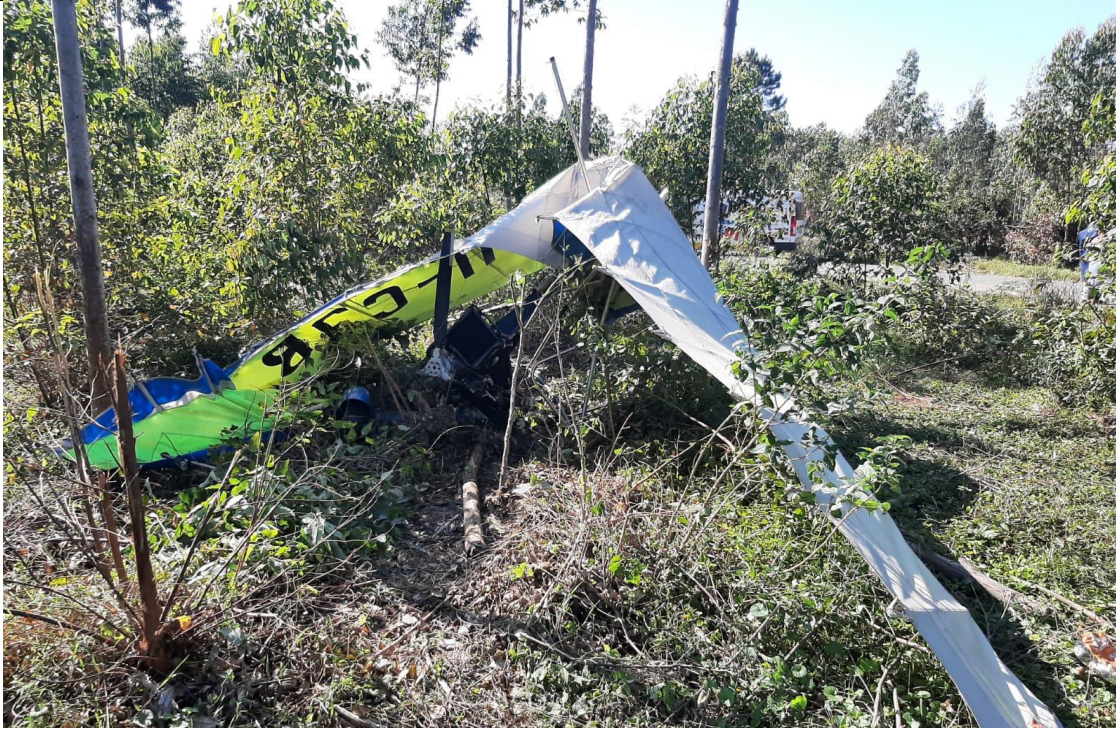
Figure 2: The wreckage after the pilot and the passenger were removed. (Source: Medic responders)

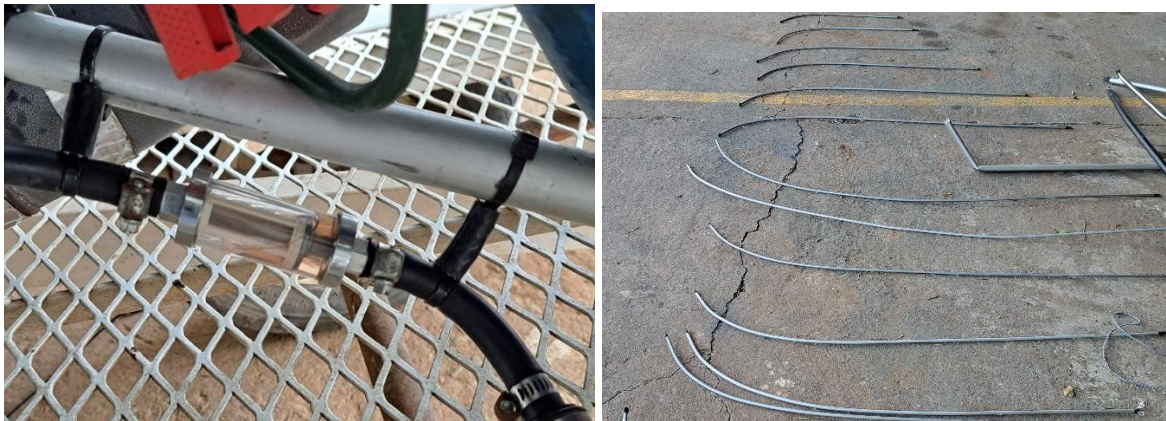
Figure 3 and 4: Fuel filter with some fuel and vacuum (left), and bent wing ribs (right).

Probable Cause
Fuel exhaustion due to extended flight in strong head wind conditions which led to an unsuccessful force landing.
Contributing Factors
<ul style="list-style-type: none"> • The pilot did not obtain the weather information. • Uplifted fuel was not sufficient for the flight.
Safety Action(s)
None.
Safety Message and/or Safety Recommendation/s
Pilots are advised to obtain weather information before each flight. This would ensure their awareness of the weather conditions throughout their navigational routes.
About this Report
<i>Decisions to conduct a limited investigate is based on factors, including whether the cause is known and the evidence supporting the cause is clear, the level of safety benefit likely to be obtained from an investigation and that will determine the scope of an investigation. For this occurrence, a limited investigation has been conducted, and the Accident and Incident Investigations Division (AIID) has relied on the information submitted by the affected person/s and organisation/s to compile this limited report. The report has been compiled using information supplied in the initial notification, as well as from follow-up desk top enquiries to bring awareness</i>
