**LIMITED OCCURRENCE INVESTIGATION REPORT – FINAL**

<b>Reference Number</b>	CA18/2/3/10186						
<b>Classification</b>	Accident	<b>Date</b>	9 July 2022			<b>Time</b>	0900Z
<b>Type of Operation</b>	Training (Part 141)						
<b>Location</b>							
Place of Departure	Worcester Aerodrome (FAWC), Western Cape Province		Place of Intended Landing	Worcester Aerodrome (FAWC), Western Cape Province			
Place of Occurrence	Extended centreline on Runway 15, Worcester Aerodrome						
GPS Co-ordinates	Latitude	33°40'10.31" S	Longitude	019°25'35.73" E	Elevation	672 feet (ft)	
<b>Aircraft Information</b>							
Registration	ZS-FMO						
Make; Model; S/N	Piper Aircraft Company, Piper PA-28-180 Cherokee (Serial number: 28-4895)						
Damage to Aircraft	Destroyed			Total Aircraft Hours	9 971.0		
<b>Pilot-in-command</b>							
Licence Type	Commercial Pilot Licence		Gender	Male		Age	45
Licence Valid	Yes	Total Hours	352.9		Total Hours on Type	21.6	
Total Hours 90 Days	20.4		Total Flying Hours on Type Past 90 Days	6.7

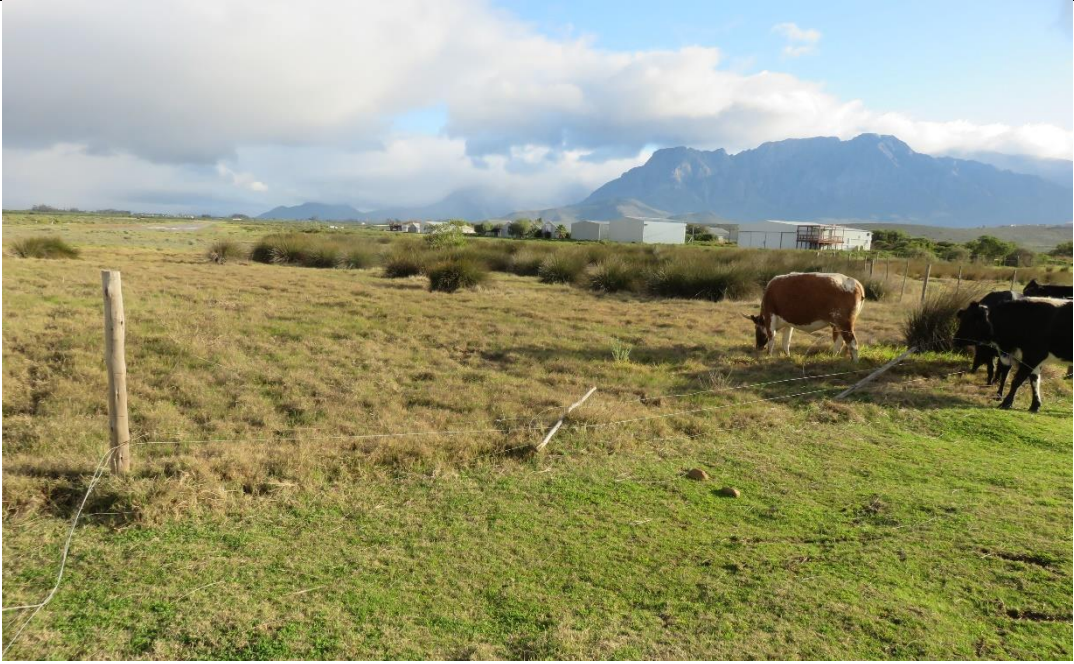
**Figure 3:** The first of the three fences that the aircraft careered through.

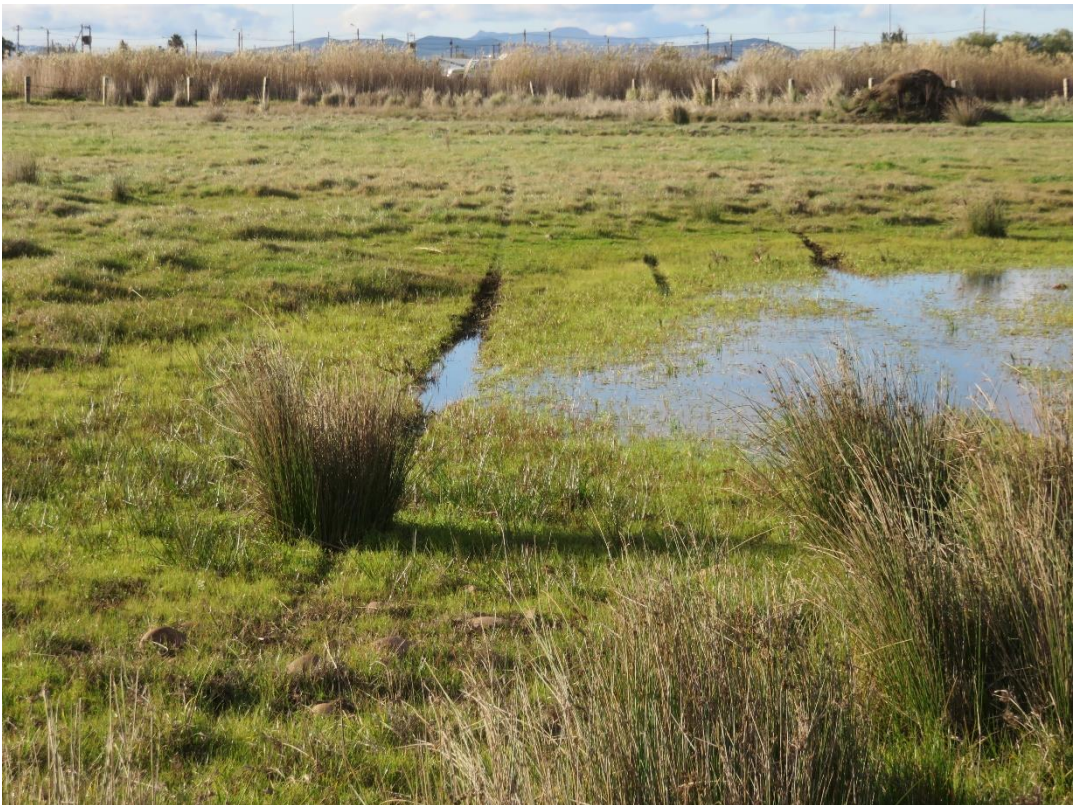
**Figure 4:** The wheel markings of the aircraft on the swamp vegetation.  
This was before the aircraft collided with the third fence.

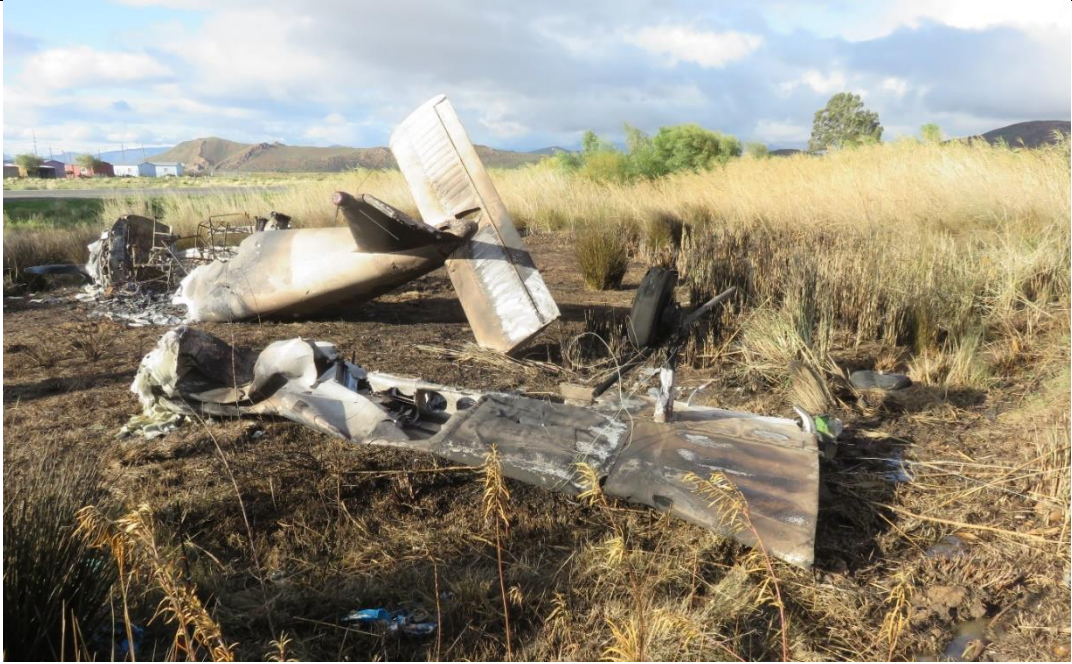
Smoke was observed shortly after the aircraft came to rest. The pilot went back to the wreckage to retrieve a portable fire extinguisher, which he handed to the person who had been assisting them to douse the fire. However, he was unable to put it out. The fire consumed the entire wreckage except for the right wing, which had separated from the fuselage. This separation was due to the right wing impacting the fence made up of cement pillars. The local fire service responded swiftly to the scene and extinguished the fire which was fuelled by the strong wind. Both occupants were attended to at the scene by emergency medical personnel who had responded to the accident scene. Apart from the pilot who sustained scratches to his left knee, no other injuries were reported.

**Figure 5:** The wreckage was consumed by post-impact fire.

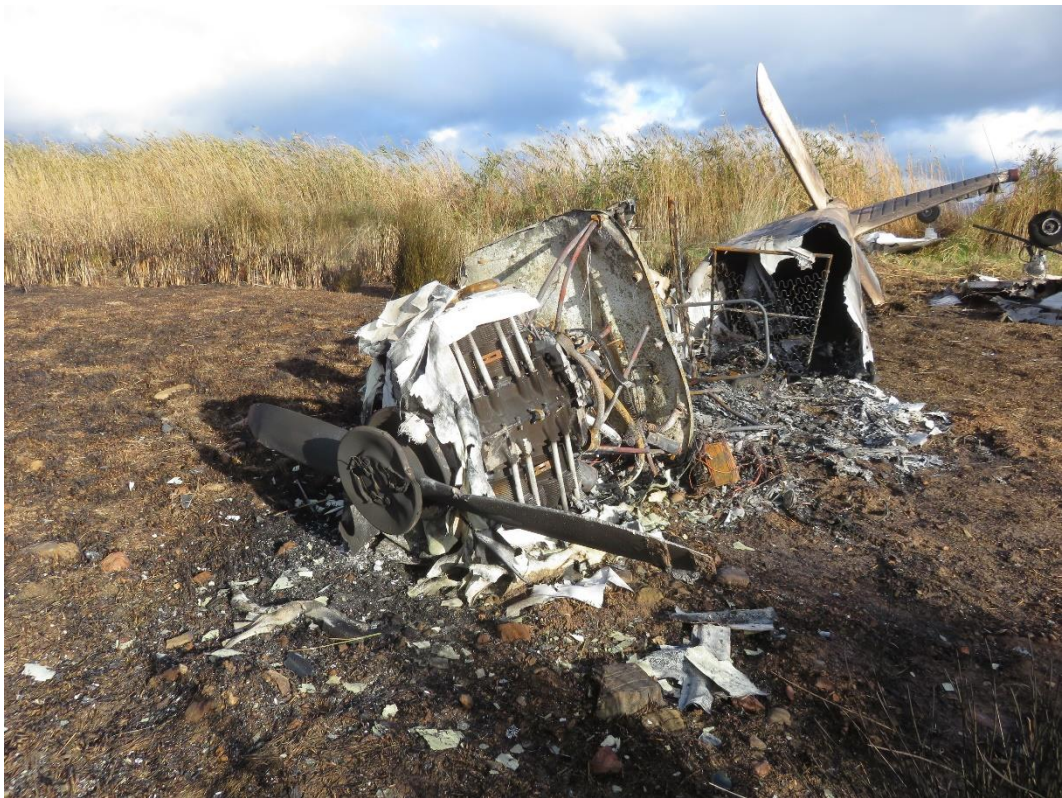
**Figure 6:** The front view of the charred wreckage.

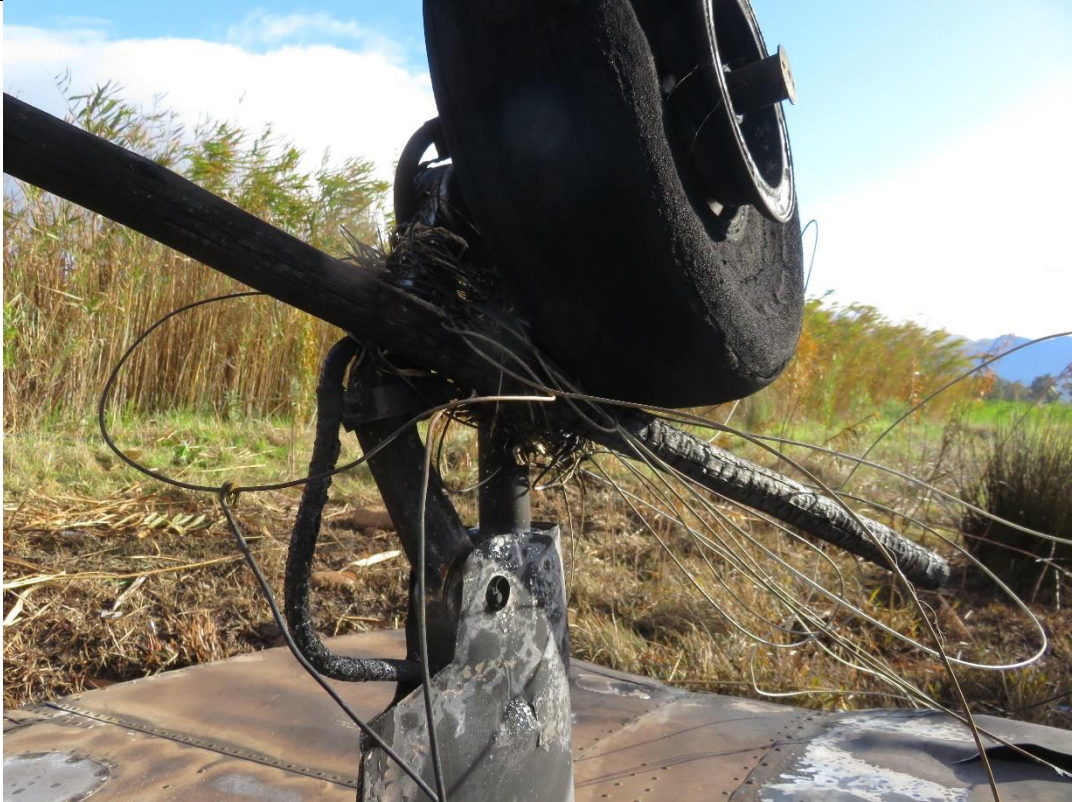
**Figure 7:** The left main gear with the barbed wire wrapped around it.

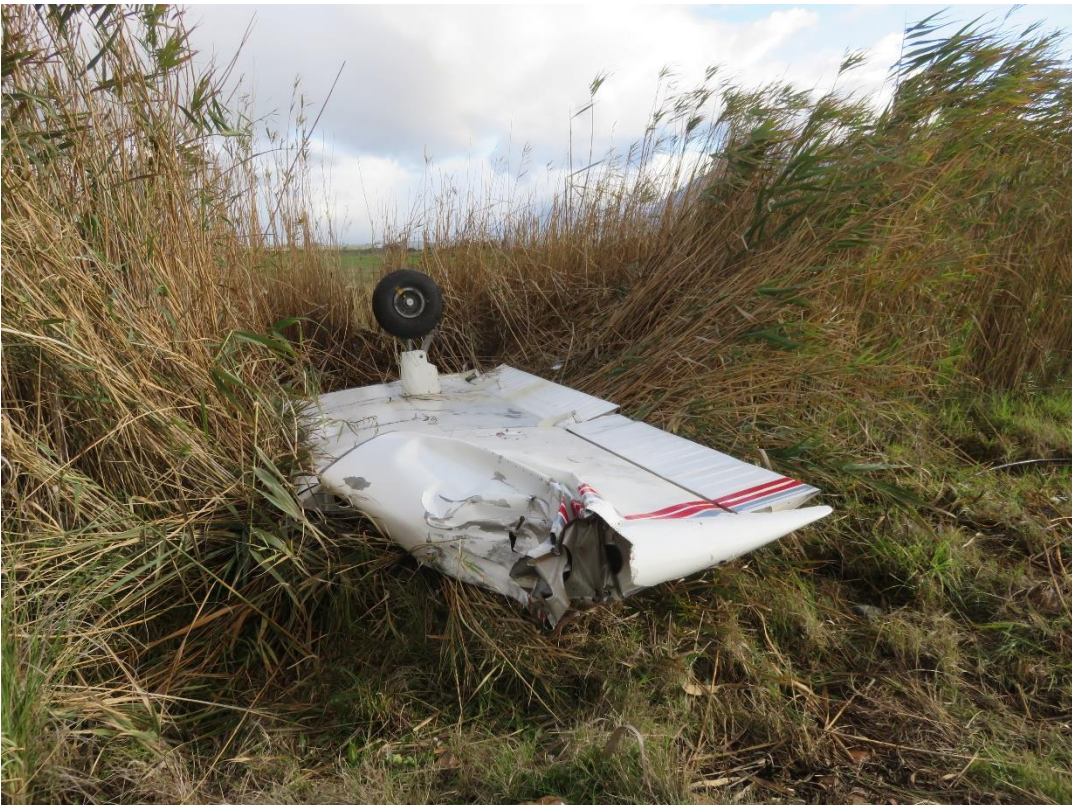
**Figure 8:** The right wing which was ripped off from the fuselage.

Failure to make a proper assessment of the prevailing wind conditions upon return from the general flying area. A committed downwind landing resulted in the aircraft touching down approximately 1 350m (250m from the end of the runway) beyond the threshold of Runway 15 and the aircraft could not be brought to a safe stop, which led to a runway excursion. The aircraft careered for approximately 518m after leaving the asphalt runway surface before it came to rest with both wings ripped off from the fuselage.

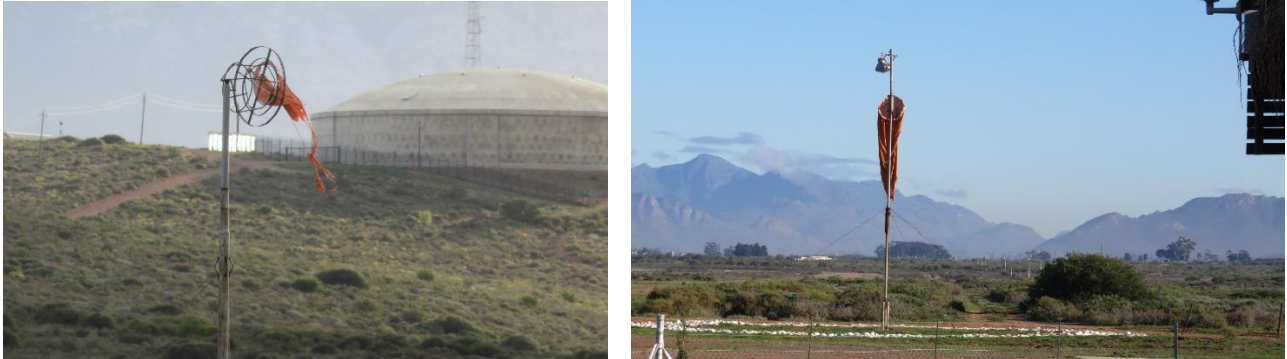
**Figure 12:** The dilapidated windsock (left side), and the primary windsock (right side).  
These photographs were taken during the on-site investigation.

- (ix) The flight was accordingly authorised in the flight authorisation sheet.
- (x) FAWC is a licensed aerodrome. Only the primary windsock was found to be in good condition to provide the prevailing wind conditions at the aerodrome. Parts of the gravel runway surface of Runway 15 were waterlogged, which was regarded as unsafe for aircraft making use of the runway.

An option to perform a go-around was not considered as (the pilot) indicated post-accident that he wanted to get the aircraft on the ground.
<b>Safety Action(s)</b>
None.
<b>Safety Message and/or Safety Recommendation/s</b>
<ul style="list-style-type: none"> <li>• With FAWC being a licensed aerodrome, it is recommended that the facility be maintained in accordance with the guidelines for Category 1 aerodromes. It is essential that pilots making use of a licensed aerodrome ensure that they will have the necessary infrastructure to facilitate a safe landing at all times.</li> <li>• The seating of instructors during introductory flights should always be on the side with the toe brakes.</li> <li>• Pilots should take extra care in observing weather conditions thoroughly before undertaking a flight.</li> </ul>
<b>About this Report</b>
<p><i>The decision to conduct limited investigation is based on factors, including whether the cause is known and the evidence supporting the cause is clear, the level of safety benefit likely to be obtained from an investigation and that will determine the scope of an investigation. For this occurrence, a limited investigation has been conducted, and the Accident and Incident Investigations Division (AIID) has relied on the information submitted by the affected person/s and organisation/s to compile this limited report. The report has been compiled using information supplied in the initial notification, as well as from follow-up desktop enquiries to bring awareness of potential safety issues to the industry in respect of this occurrence, as well as possible safety action/s that the industry might want to consider in preventing a recurrence of a similar occurrence.</i></p> <p><i>All times given in this report are Co-ordinated Universal Time (UTC) and will be denoted by (Z). South African Standard Time is UTC plus 2 hours.</i></p>

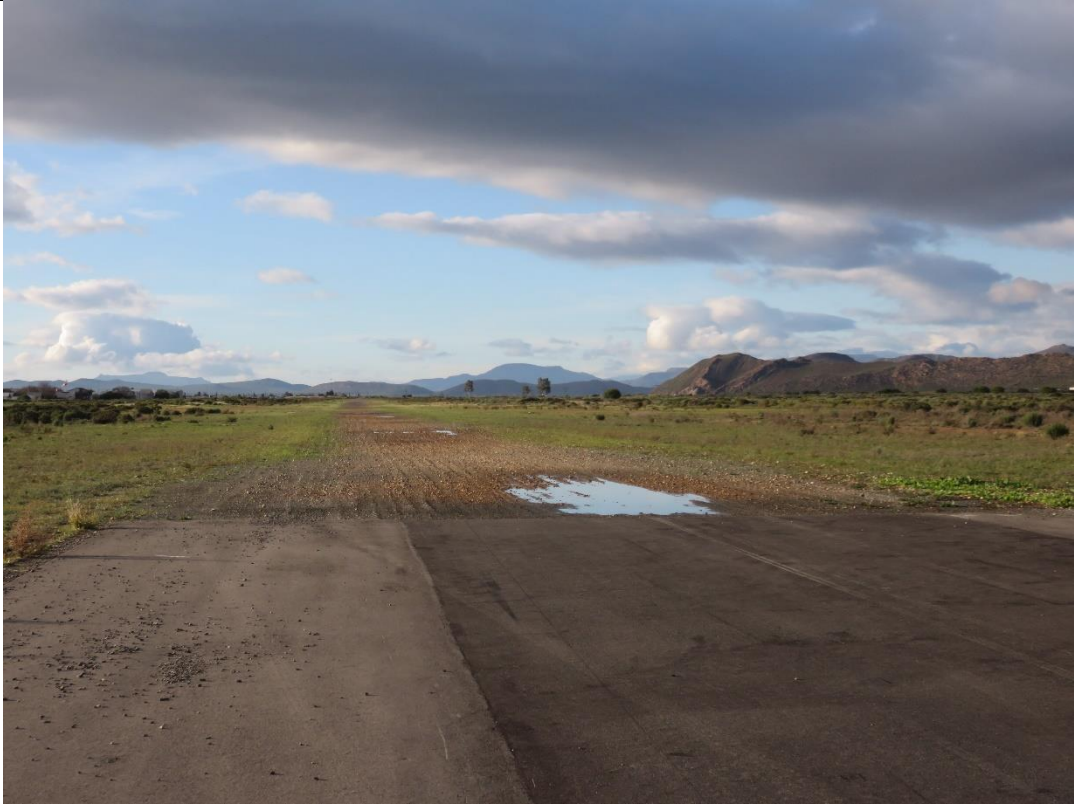
**Figure 14:** The end of the first asphalt section and the start of the gravel surface.

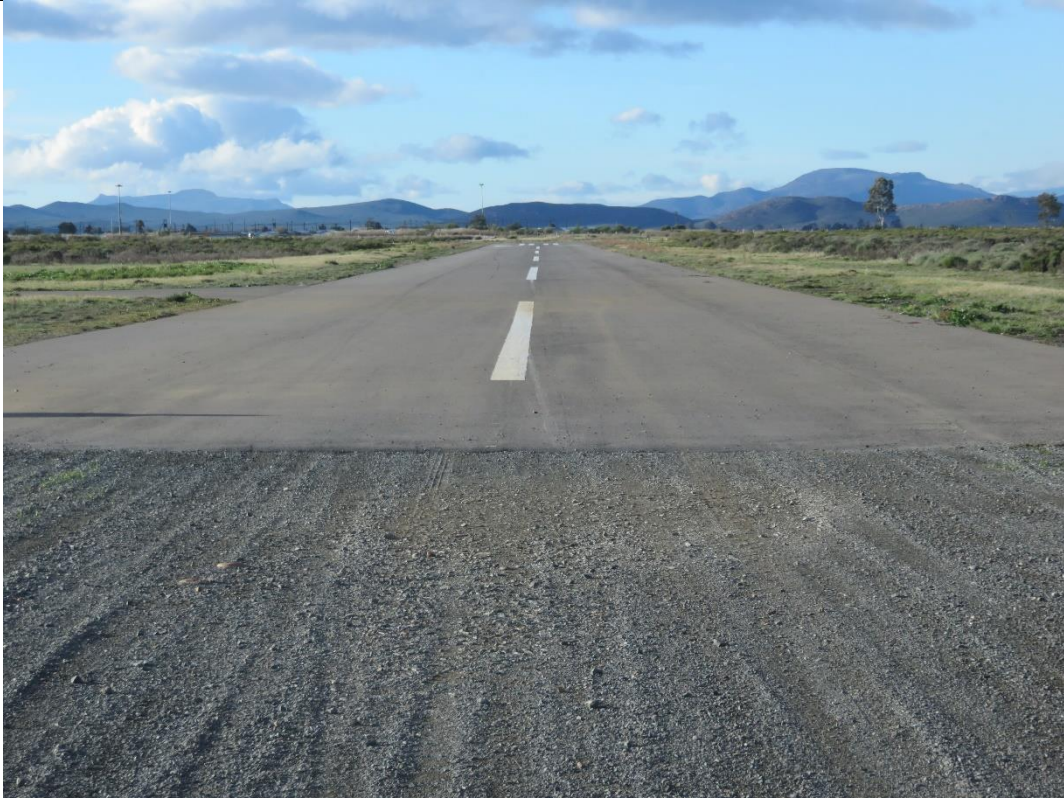
**Figure 16:** End of the gravel runway surface and the beginning of the last section of the asphalt surface.
