LIMITED OCCURRENCE INVESTIGATION REPORT – FINAL

Reference Number	CA18/2/3/10187						
Classification	Accident	Date	10 July 2022	Time	0910Z		
Type of Operation	Training (Part 141)						
Location							
Place of Departure	Lanseria International Airport (FALA), Gauteng Province		Place of Intended Landing	Lanseria International Airport (FALA), Gauteng Province			
Place of Occurrence	On Runway 07 at Lanseria International Airport (FALA), Gauteng Province						
GPS Co-ordinates	Latitude	25° 55' 44.81" S	Longitude	27°56'17.67" E	Elevation	4 393ft	
Aircraft Information							
Registration	ZS-ZIP						
Make; Model; S/N	Cirrus SR20 (Serial Number: 1496)						
Damage to Aircraft	Substantial			Total Aircraft Hours	7 164.8		
Pilot-in-command							
Licence Type	Student Pilot Licence (SPL)		Gender	Male		Age	44
Licence Valid	Yes	Total Hours	73.2	Total Hours on Type	26.5		
Total Hours 30 Days	6.6		Total Flying on Type Past 90 Days	26.6			
People On-board	1+0	Injuries	0	Fatalities	0	Other (on ground)	0

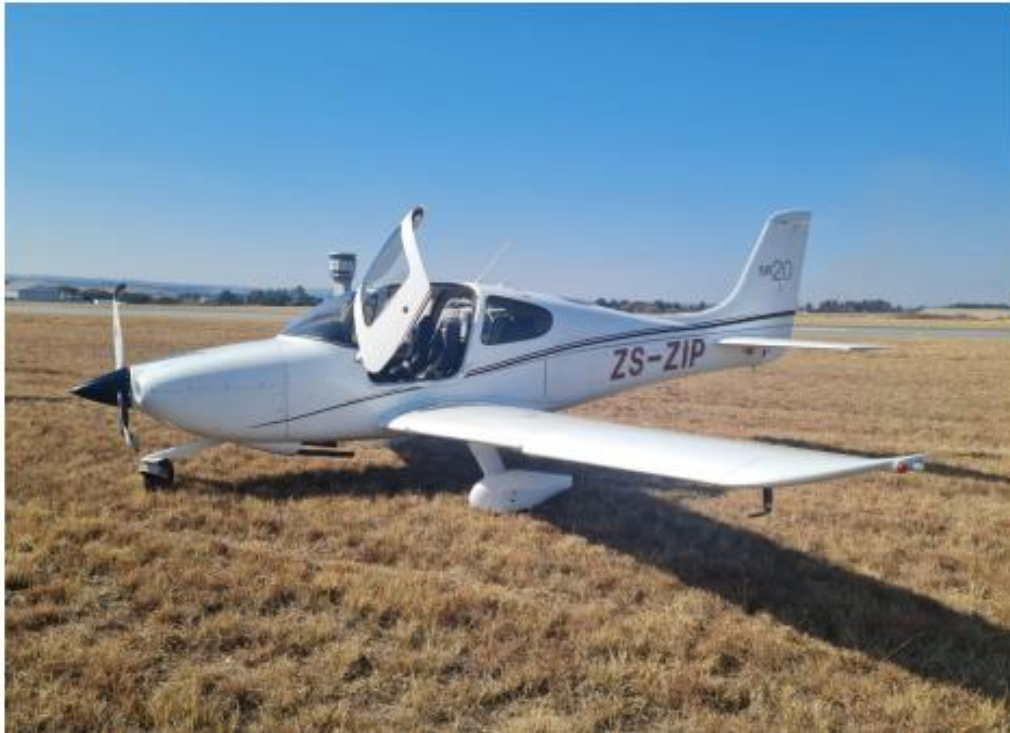
before touchdown. During touchdown, the aircraft bounced. The student pilot then pulled back on the control stick to settle the aircraft. However, the aircraft experienced a series of bounces before the nose gear bent forward, causing the aircraft to veer off to the left-side of the runway. The student pilot applied the left pedal to vacate the runway; and thereafter, he applied the brakes. During this process, the propeller struck the runway surface. The aircraft came to a stop a few metres from the left edge of the runway. The student pilot then switched off the electrics and shut off the fuel valve before he vacated the aircraft unassisted. The aircraft sustained damages to the nose gear, engine cradle and propeller blades. No person was injured during the accident sequence.

Figure 1: The final rest position of the aircraft post-accident. (Source: ATO)

The aircraft was low on approach, which led the pilot to increase power, reduce flap setting to 50% and increase speed to 83kt in preparation for a go-around. When the aircraft was over the runway threshold, the pilot elected to land the aircraft which caused it to porpoise due to high air speed and 50% flap setting. The pilot reduced the speed, which resulted in the aircraft landing hard and bouncing several times before veering off to the left-side of the runway.

❖ A decision was taken by the ATO that *the student pilot will fly a remedial flight of 5 hours with the primary instructor and the following aspects will be focused on:*

- *Flying stable approach.*
- *Recovery from low approaches.*
- *Controlling the aircraft with power on during landings.*
- *Go-around technique at different altitudes, power settings and configurations.*
- *Recap of all circuit emergencies.*

- ❖ *The student pilot is to be briefed on circuit emergencies with emphasis on unstable approaches, bouncing, ballooning on landing and recovery techniques.*
- ❖ *The student pilot is to watch Cirrus Approach take-off and landing videos.*
- ❖ *After the above training is complete, the student pilot will fly with the chief flight instructor (CFI) or head of training as an initial solo sign out in the circuit before solo training can be commenced.*
