**LIMITED OCCURRENCE INVESTIGATION REPORT – FINAL**

| <b>Reference Number</b> | CA18/2/3/10189 | | | | | | |
| <b>Registration</b> | ZS-JBP | | | | | | |
| <b>Make; Model; S/N</b> | Cessna 172 M (Serial Number: 172-63637) | | | | | | |

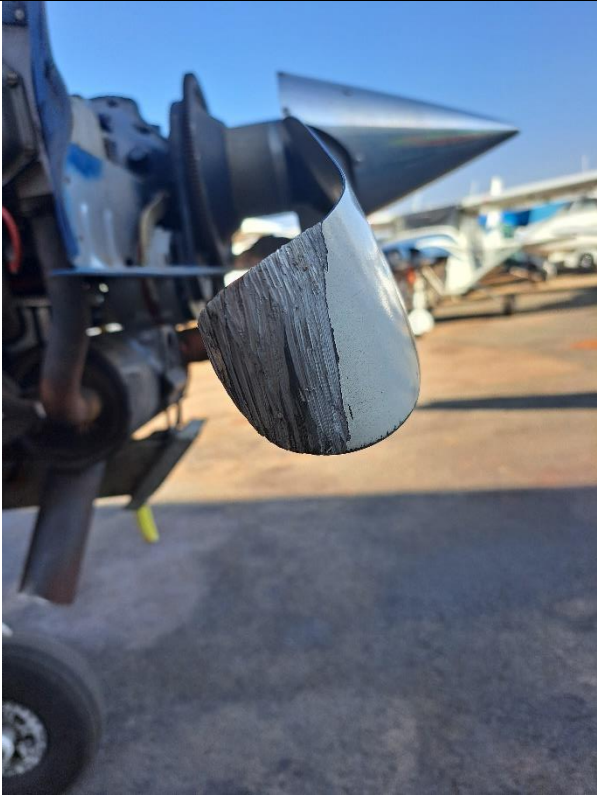
a go-around; as a result, the aircraft's nose pointed up and the student pilot responded by pushing the control column forward to get the nose to point down and to increase the air speed. The aircraft touched down hard on the runway which caused damage to the nose gear oleo. Subsequently, the propeller blades struck the runway surface whilst the rudder counterweight separated from the aircraft. The student pilot taxied the aircraft to the parking bay without informing the ATC about the accident and without requesting assistance from the fire and rescue service.

The aircraft sustained substantial damage to the firewall, nose gear oleo, propeller blades and engine cradle, whilst the rudder counterweight separated during the accident sequence. There were no injuries reported post-accident.

**Figures 2 and 3:** The damaged propeller blade (left) and the rudder without the counterweight that got separated (right).

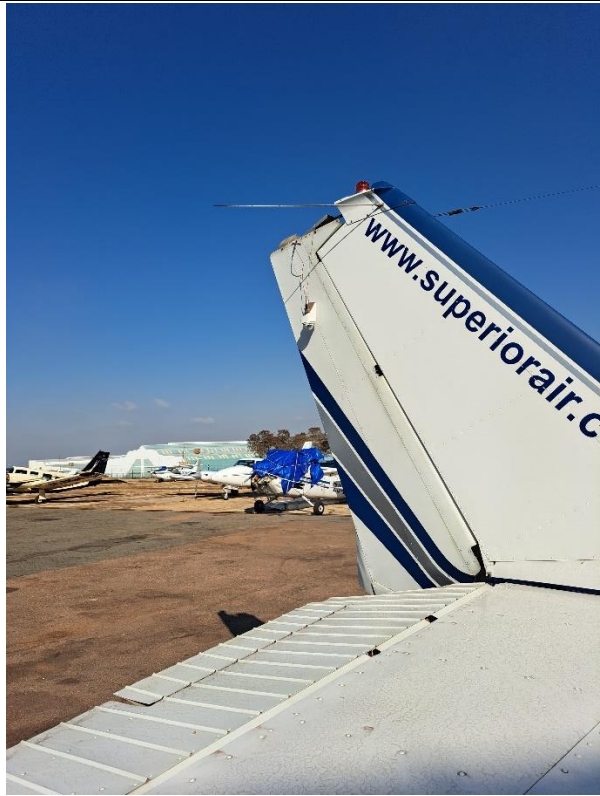
When the aircraft taxied past the aircraft maintenance organisation's (AMO's) hangar on its way to the parking bay, the AMO's engineer noticed some damages on the aircraft. The engineer followed the aircraft to the parking bay where he inspected it further. He then alerted the aerodrome's fire chief about the accident, who in turn, relayed the information to the ATO instructors and ATC. The fire and rescue service personnel conducted a runway inspection. A rudder counterweight was found on the runway during the inspection.

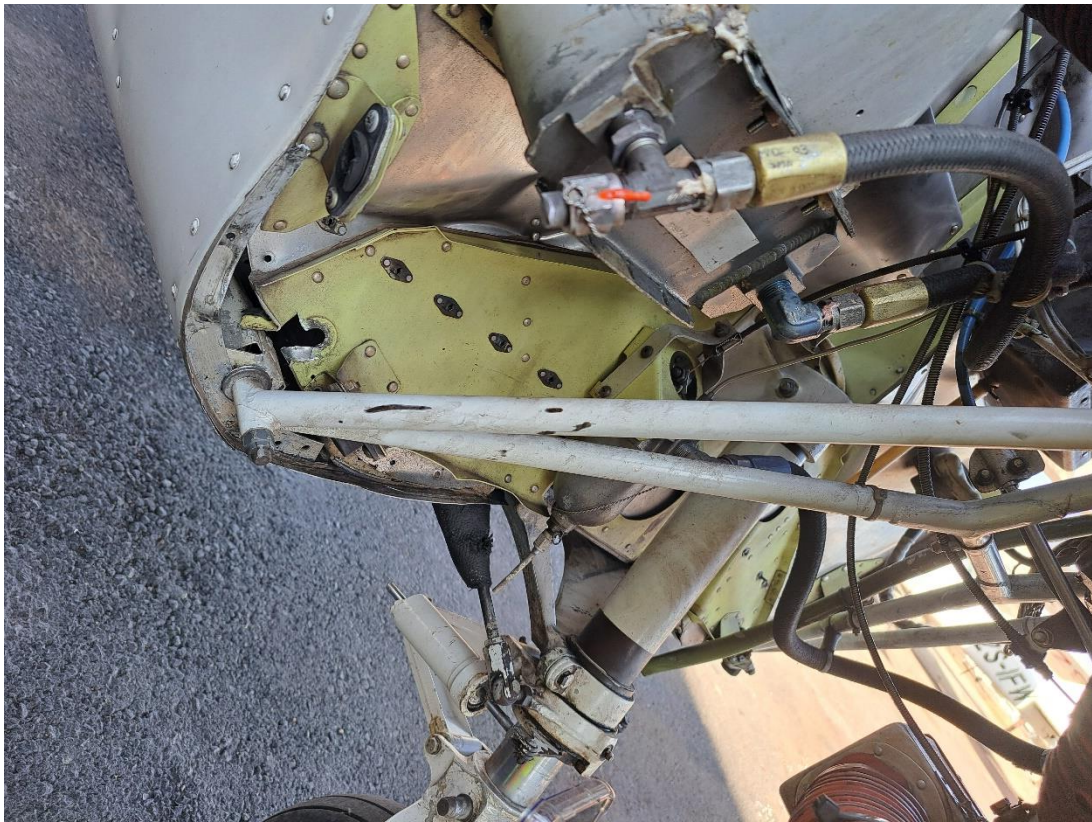
**Figure 4:** The damaged firewall and the deflated oleo.

| The aircraft was too low on approach and, whilst the aircraft was configured for a go-around, the nose lifted too high, which resulted in a stall and the hard impact on the runway. |
