AIRCRAFT ACCIDENT REPORT AND EXECUTIVE SUMMARY

Reference:		CA18/2/3/10190	
Aircraft Registration	ZU-ECG	Date of Accident	16 July 2022		Time of Accident	1120Z	
Type of Aircraft	Rainbow Cheetah		Type of Operation		Private (Part 94)		
Pilot-in-command Licence Type	NPL Aeroplane	Age	50	Licence Valid	Yes		
Pilot-in-command Flying Experience	Total Flying Hours		434.8	Hours on Type	128.3		
Last Point of Departure	Wings Park Aerodrome, Eastern Cape Province						
Next Point of Intended Landing	Wavecrest Aerodrome, Eastern Cape Province						
Damage to Aircraft	Substantial						
Location of the accident site with reference to easily defined geographical points (GPS readings if possible)							
Wings Park Aerodrome RWY04, Eastern Cape Province, at Global Positioning System (GPS) determined to be 32°49'22.63"S 027°50'05.88"E at an elevation of 675 feet							
Meteorological Information	Wind velocity: 110° at 6kts; Temperature: 22°C; Dew Point: 11°C; Visibility: ≥10000m; Cloud: CAVOK; QNH: 1024 hPa

Reference Number : CA18/2/3/10190
Occurrence Category : Accident
Type of Operation : Private (Part 94)
Name of Operator : J N Moolman
Aircraft Registration : ZU-ECG
Aircraft Make and Model : Rainb

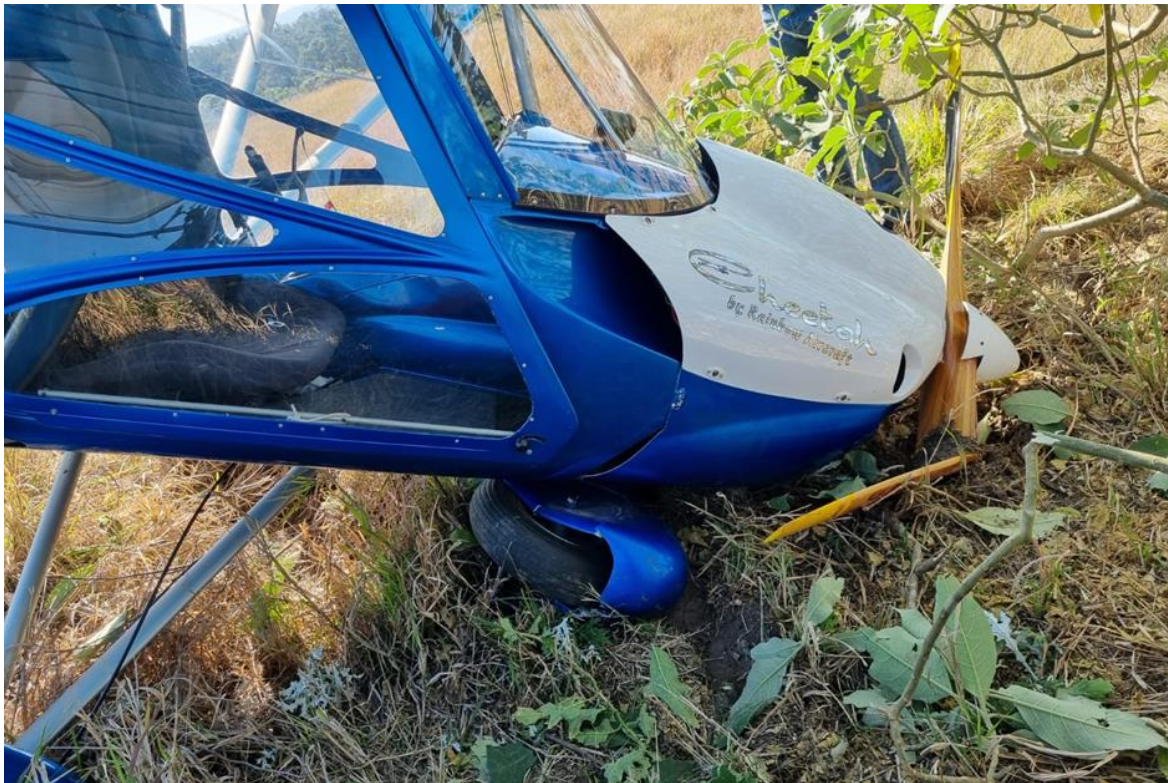
1.3.1. The aircraft sustained damage to the nose gear and the propeller.

Figure 2: The damage sustained by the aircraft. (Source: Pilot)

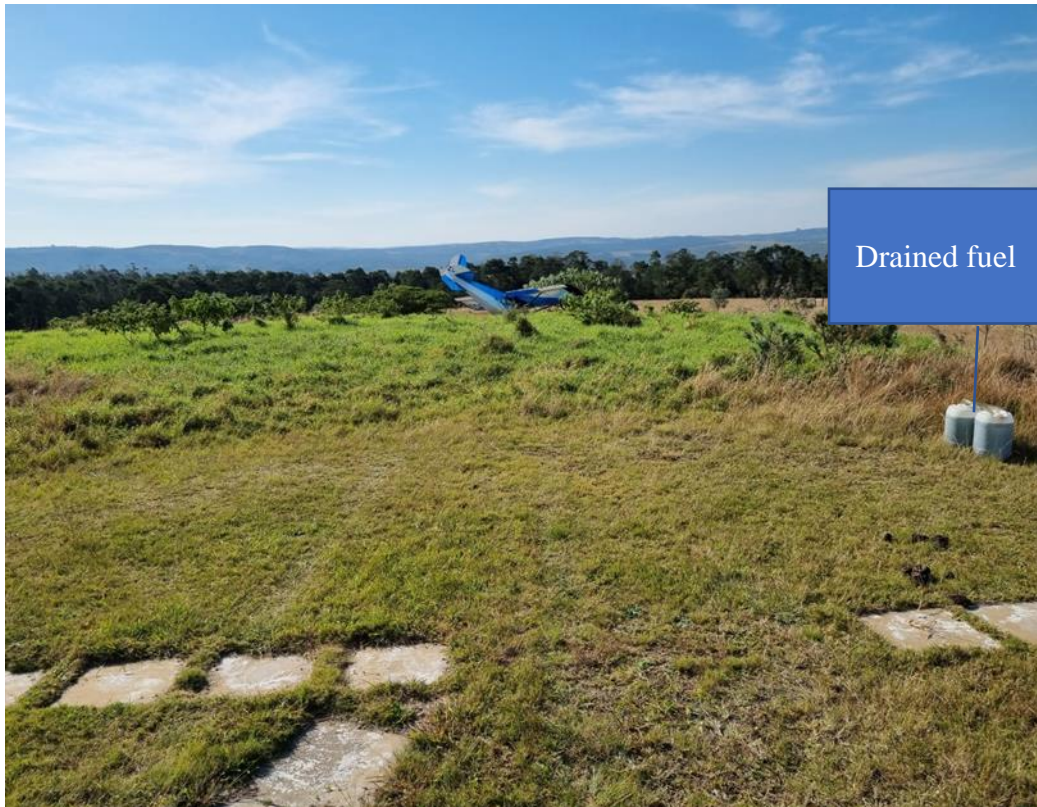
1.12.2. The aircraft came to rest on the stopway of RWY04 in a nose-down attitude. It sustained damage to the nose gear and the propeller.

Figure 3: The aircraft post-accident; and the fuel drained from aircraft).
(Source: Pilot)
