LIMITED OCCURRENCE INVESTIGATION REPORT – FINAL

Reference Number	CA18/2/3/10191						
Classification	Accident	Date	17 July 2022		Time	1030Z	
Type of Operation	Training (Part 141)						
Location							
Place of Departure	Wings Park Airfield near East London, Eastern Cape Province		Place of Intended Landing		Wings Park Airfield near East London, Eastern Cape Province		
Place of Occurrence	On the right-side of Runway 09 at Wings Park Airfield						
GPS Co-ordinates	Latitude	32° 49' 17" S	Longitude	27° 50' 18" E	Elevation	1276ft	
Aircraft Information							
Registration	ZU-FXJ						
Make; Model; S/N	Jabiru 170 (Serial Number: 349)						
Damage to Aircraft	Substantial			Total Aircraft Hours	416.8		
Pilot-in-command							
Licence Type	Student Pilot Licence (SPL)		Gender	Male		Age	31
Licence Valid	Yes	Total Hours	33.5		Total Hours on Type	4.8	
Total Hours Past 30 Days	1.5		Total Hours on Type Past 90 Days		2.5		
People On-board	1 + 0	Injuries	0	Fatalities	0	Other (on ground)	0

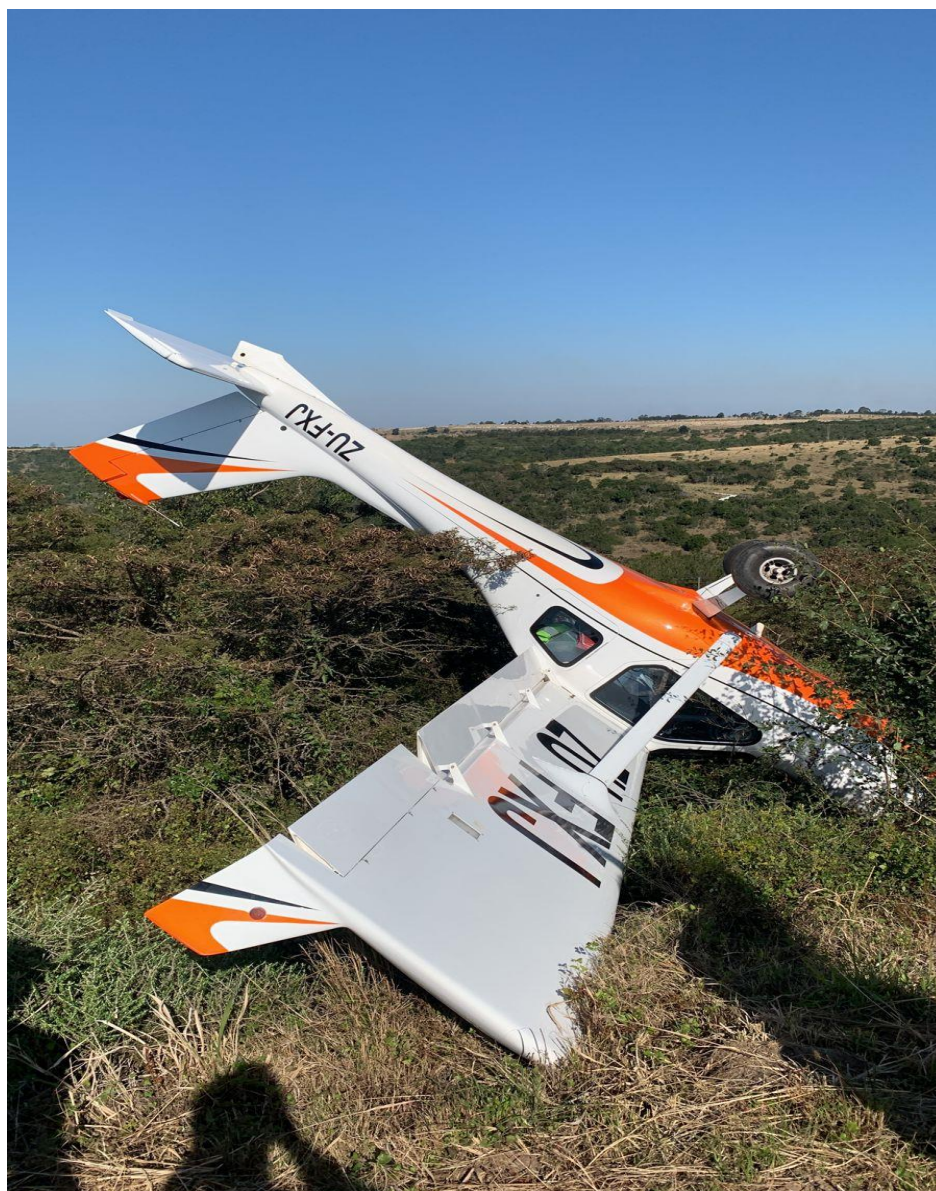
The student pilot switched off the master switch and evacuated the aircraft unassisted. He was not injured during the accident sequence; however, the aircraft sustained substantial damage to the nose gear strut, the propeller blades, lower engine cowling and both wings.

Figure 1: The aircraft as it came to rest. (Source: Pilot)

Probable Cause
The aircraft was unstable on approach for landing, and it ballooned. As a result, the nose wheel broke off and the aircraft nosed over before it came to rest in an inverted position.
Contributing Factor(s)
None.
Safety Action(s)
None.
Safety Message and/or Safety Recommendation/s
None.
About this Report
<i>The decision to conduct a limited investigation is based on factors, including whether the cause is known and the evidence supporting the cause is clear, the level of safety benefit likely to be obtained from an investigation and that will determine the scope of an investigation. For this occurrence, a limited investigation has been conducted, and the Accident and Incident Investigations Division (AIID) has relied on the information submitted by the affected person/s and organisation/s to compile this limited report. The report has been compiled using information supplied in the initial notification, as well as from follow-up desk top enquiries to bring awareness of potential safety issues to the industry in respect of this occurrence, as well as possible safety action/s that the industry might want to consider in preventing a recurrence of a similar occurrence.</i>
