**LIMITED OCCURRENCE INVESTIGATION REPORT - FINAL**

<b>Reference Number</b>	CA18/2/3/10193						
<b>Classification</b>	Accident		<b>Date</b>	18 July 2022		<b>Time</b>	1540Z
<b>Type of Operation</b>	Private Non-type Certificated Aircraft (Part 91)						
<b>Location</b>							
Place of Departure	Grand Central Aerodrome (FAGC), Gauteng Province		Place of Intended Landing		Zebula Aerodrome, Limpopo Province		
Place of Occurrence	Left of Runway 26 (RWY26) Zebula Aerodrome						
GPS Co-ordinates	Latitude	25°45'25.01" S	Longitude	027°58'12.99" E	Elevation	4212 ft	
<b>Aircraft Information</b>							
Registration	ZS-PSW						
Make; Model; S/N	Cessna Aircraft Company, C172M (Serial Number: 17261665)						
Damage to Aircraft	Substantial			Total Aircraft Hours	3 234.8		
<b>Pilot-in-command</b>							
Licence Type	Private Pilot Licence (Aeroplane)		Gender	Male		Age	27
Licence Valid	Yes	Total Hours	121.7		Total Hours on Type	109.1	
Total Hours 30 Days	3.3		Total Flying on Type Past 90 Days	11.8

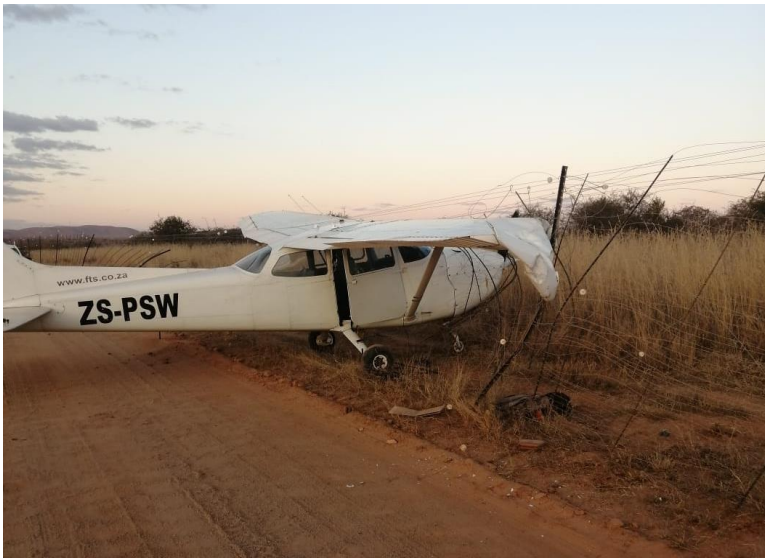
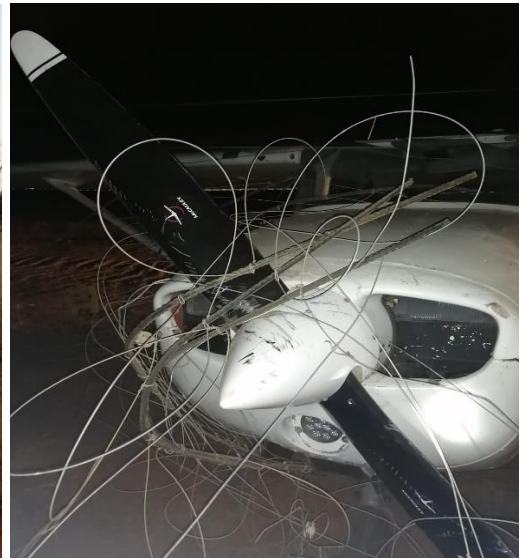
<b>People On-board</b>	1 + 1	<b>Injuries</b>	0	<b>Fatalities</b>	0	<b>Other (on ground)</b>	0
<b>What Happened</b>							
<p>On Monday afternoon, 18 July 2022 at 1400Z, a pilot and a passenger on-board a Cessna 172M aircraft with registration ZS-PSW took off on an hour building flight from Grand Central Aerodrome (FAGC) in Gauteng province to Zebula Aerodrome in Limpopo province. The flight plan was filed for the flight. Clear weather conditions prevailed at the time of the flight. The flight was conducted under visual flight rules (VFR) by day and under the provisions of Part 91 of the Civil Aviation Regulations (CAR) 2011 as amended.</p> <p>The pilot reported that the flight to Zebula proceeded as scheduled. Once overhead the aerodrome, the pilot followed the unmanned aerodrome joining procedure at 1000 feet (ft) above circuit altitude. No aircraft or animals in the vicinity of the runway were observed. The pilot then joined the circuit for landing on Runway 26 (RWY26).</p> <p>Whilst on short final approach, a tower of giraffes was in the process of crossing the runway from the left-side to the right. In response, the pilot applied full power during flare with the intention to perform a go-around, but the aircraft touched down hard on the runway and bounced as it had lost airspeed. As a result, the pilot lost directional control and the aircraft veered off to the left-side of the runway and crashed on the perimeter fence, which was approximately 55 metres from the runway edge before it came to rest. No person was injured during the accident sequence, and the two occupants disembarked the aircraft unaided. The aircraft sustained damage to both wings, propeller and the spinner.</p>

**Figures 2 and 3:** The aircraft at the scene of the accident. (Source: Pilot)

Loss of directional control on the ground during the landing roll after a failed go-around in an attempt to avoid colliding with wildlife on the runway.
