LIMITED OCCURRENCE INVESTIGATION REPORT – FINAL

Reference Number	CA18/2/3/10194						
Classification	Accident	Date	28 October 2022	Time	0655Z		
Type of Operation	Training (Part 141)						
Location							
Place of Departure	Wonderboom Aerodrome (FAWB), Gauteng Province		Place of Intended Landing	Wonderboom Aerodrome (FAWB), Gauteng Province			
Place of Occurrence	Wonderboom Aerodrome (FAWB), Gauteng Province						
GPS Co-ordinates	Latitude	25° 39' 26.93" S	Longitude	028° 12' 53.12" E	Elevation	4110ft	
Aircraft Information							
Registration	ZS-FOR						
Make; Model; S/N	Piper PA-28-140 (SN: 28-24105)						
Damage to Aircraft	Substantial		Total Aircraft Hours	11 548.92			
Pilot-in-command							
Licence Type	Student Pilot Licence (SPL)		Gender	Male		Age	26
Licence Valid	Yes	Total Hours	25.7		Total Hours on Type	25.7	
Total Hours 30 Days	7.7		Total Flying on Type Past 90 Days	12.0			
People On-board	1+0	Injuries	0	Fatalities	0	Other (on ground)	0
What Happened

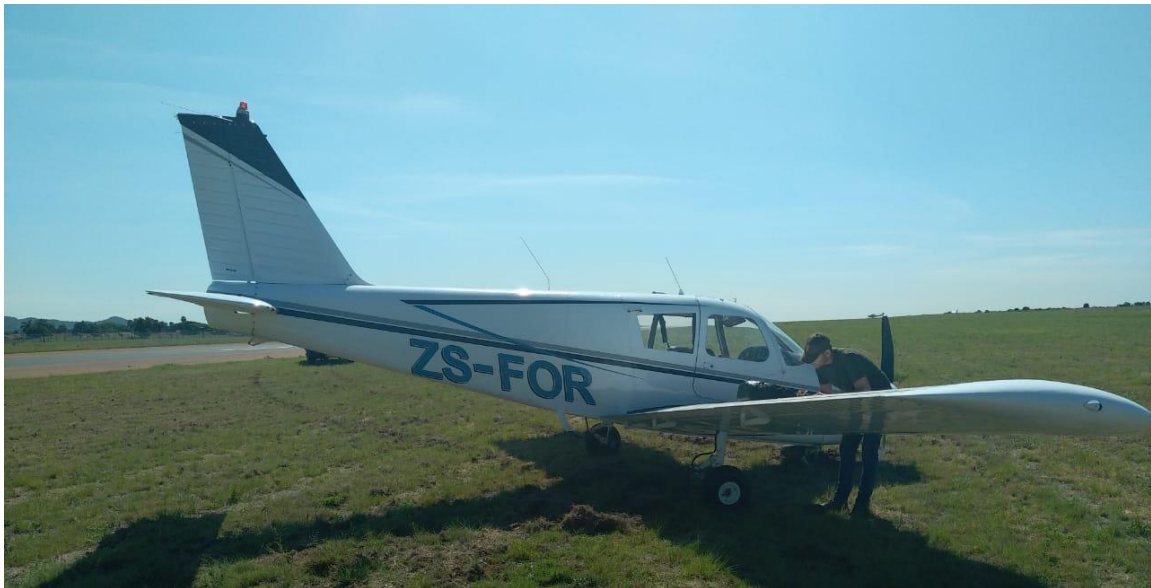
Figure 1: The final resting position of the aircraft at FAWB. (Source: ATO)

7. It is likely that the student pilot was too fast during landing and, on round-out, the aircraft ballooned. The student pilot released the back pressure slightly on the control column which caused the aircraft to stall. The aircraft impacted the ground hard and bounced. It then touched down hard with the nose gear first, damaging it before it veered off to the left, exiting the runway.

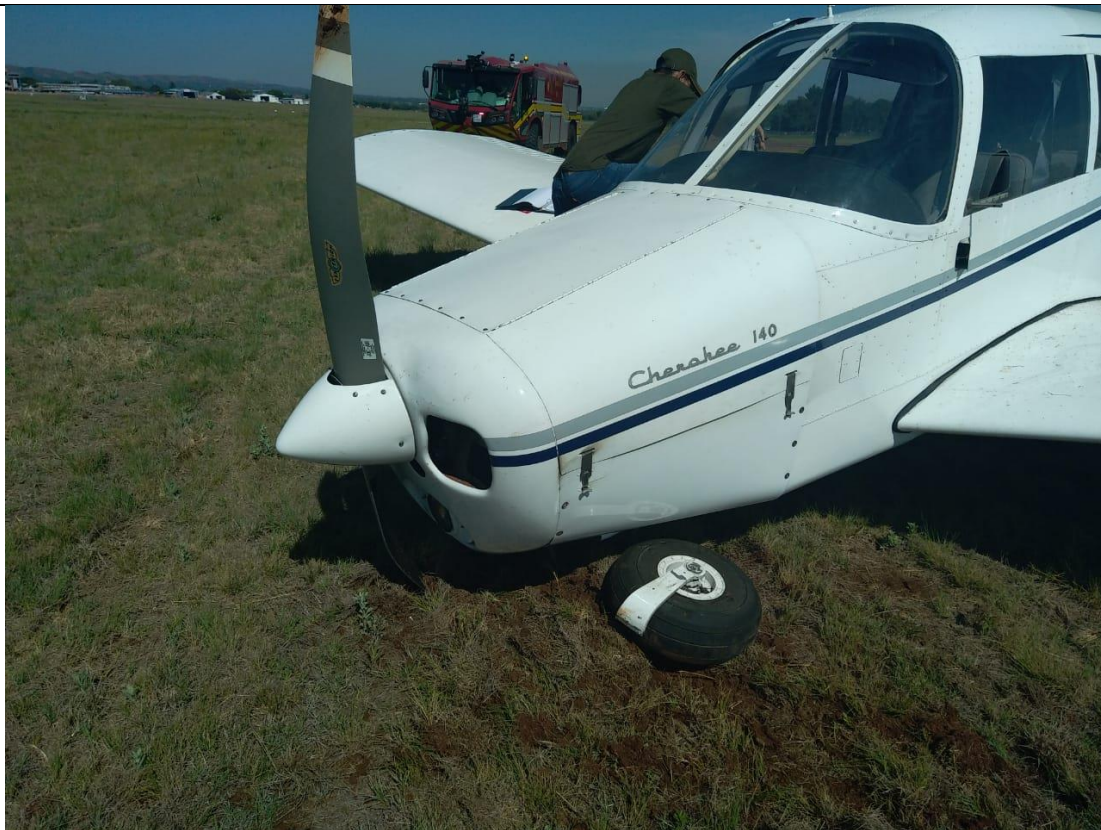
<p>On 28 October 2022 at 0615Z, a student pilot on-board a Piper PA-28 with registration ZS-FOR took off on a circuit training flight from Wonderboom Aerodrome (FAWB) in Gauteng province. The flight was conducted in visual meteorological conditions (VMC) by day and under the provisions of Part 141 of the Civil Aviation Regulations (CAR) 2011 as amended.</p> <p>The student pilot stated that he conducted three uneventful circuit-and-landing exercises on Runway 29. Whilst on the fourth circuit during landing and on round-out, the aircraft ballooned. To remedy the situation, the student pilot released the back pressure slightly on the control column which resulted in the aircraft landing hard, followed by a bounce. The student pilot retracted the flaps from 40 degrees to 10 degrees, but the aircraft landed hard again; this time, the nose wheel broke off and the propeller struck the ground. The aircraft veered off to the left-side of the runway. The student pilot responded by applying the right rudder and brakes, but the aircraft continued to veer off and finally exited the runway. The aircraft sustained damage to the nose gear and the propeller blades.</p>

Figure 2: The broken nose wheel and the bent propeller blades. (Source: ATO)

It is likely that the aircraft's speed was high on approach and, during the round-out, the aircraft ballooned and landed hard before it exited the runway.

Pilots should elect to execute a go-around when the aircraft is not stable on approach (speed high/not on the normal glide slope [high/low in height]). This accident could have been averted should a go-around been executed.
