LIMITED OCCURRENCE INVESTIGATION REPORT – FINAL

Reference Number	CA18/2/3/10195						
Classification	Accident	Date	19 July 2022	Time	0805Z		
Type of Operation	Private (NTCA Part 94)						
Location							
Place of Departure	Bapsfontein Aerodrome (FABA), Gauteng Province		Place of Intended Landing	Bapsfontein Aerodrome (FABA), Gauteng Province			
Place of Occurrence	On Runway 21 at FABA, Gauteng Province						
GPS Co-ordinates	Latitude	25° 59' 20.83" S	Longitude	28° 24' 58.22" E	Elevation	5 272 ft	
Aircraft Information							
Registration	ZU-FHP						
Make; Model; S/N	Rainbow Skyreach (Pty) Ltd; Cheetah XLS (Serial Number: CH109)						
Damage to Aircraft	Substantial			Total Aircraft Hours	525.4		
Pilot-in-command							
Licence Type	National Pilot Licence (NPL)			Gender	Male	Age	34
Licence Valid	Yes	Total Hours on Type	121.3		Total Flying Hours	121.3	
People On-board	1 + 1	Injuries	0	Fatalities	0	Other (on ground)	0
What Happened							
<p>On 19 July 2022, a pilot and a passenger on-board a Cheetah XLS aircraft with registration ZU-FHP took off on a private flight from Bapsfontein Aerodrome (FABA), also known as Microland Flight Park, in Gauteng province, to Petit Airfield (FARA) in

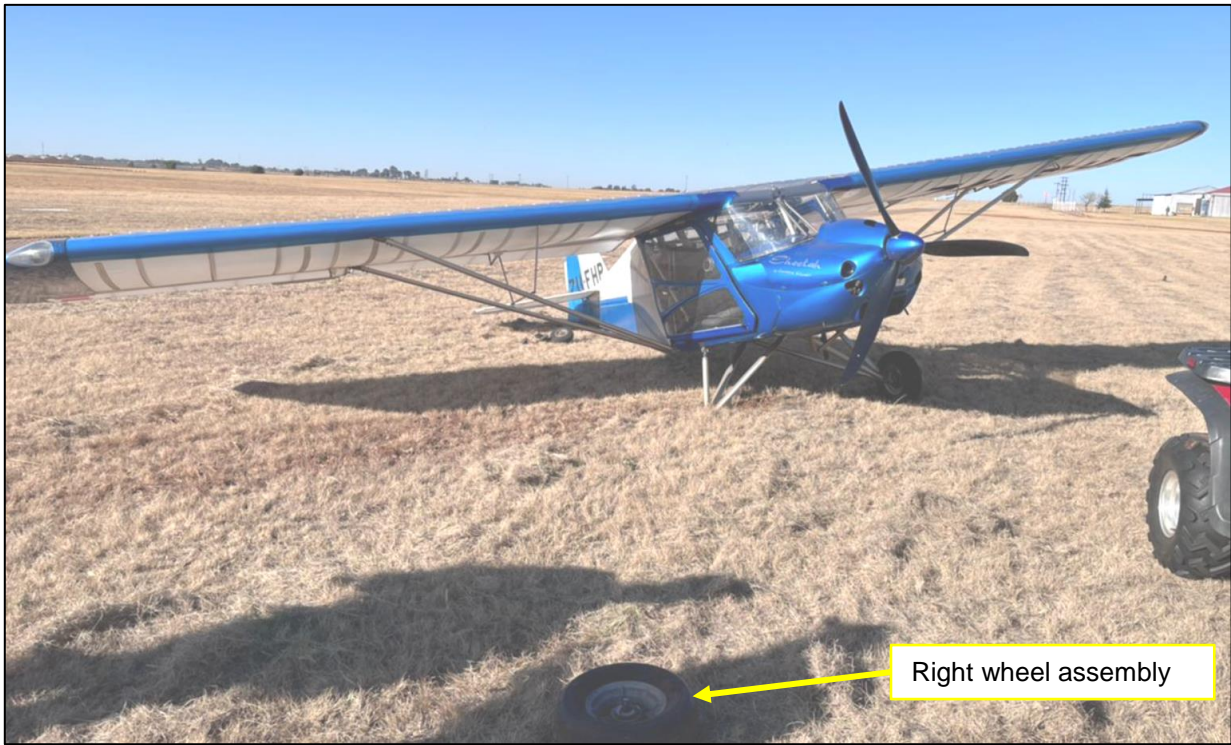
Figure 1: The aircraft post-accident. (Source: Owner)

- 2.5. The aircraft was substantially damaged; and the occupants were uninjured during the accident.

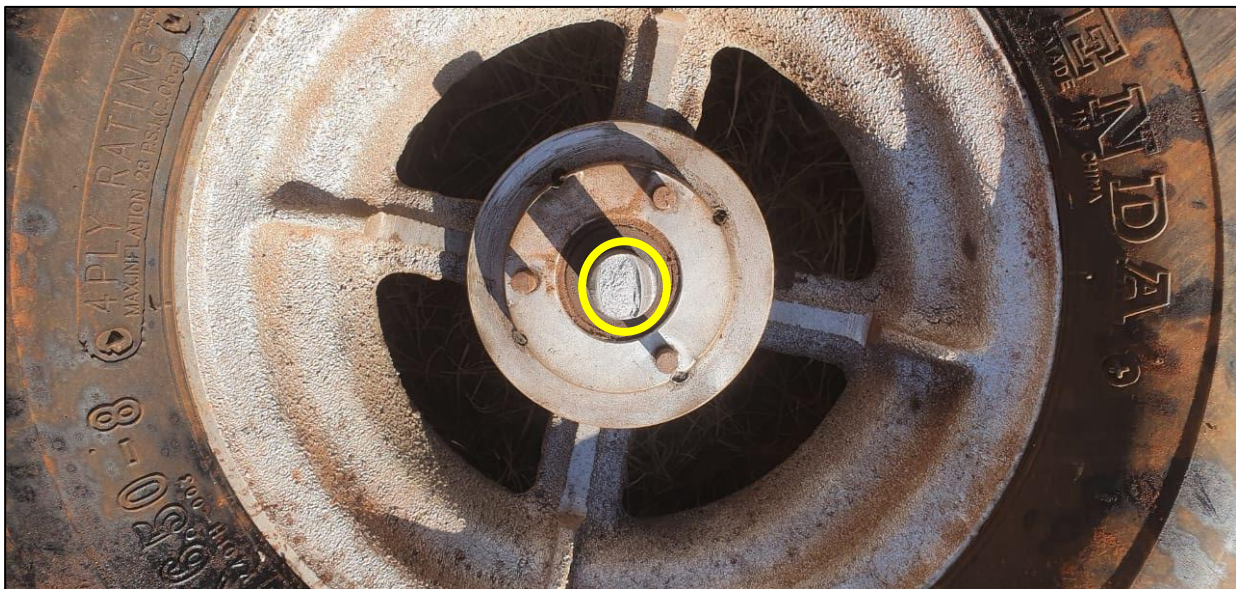
Figure 2: Location of the right axle fracture (in the yellow circle). (Source: Owner)

5.2. Based on the calculation above, the aircraft's recommended approach speed was exceeded by 9.5 mph (8 kt), therefore, the aircraft's sink rate was too rapid during the flare because of the high landing speed, which led to a hard landing and, most likely, a bounce. This resulted in the primary spring-loaded tail gear flat bar breaking off as well as the damage on the rudder during impact. The pilot lost directional control of the aircraft on touchdown, resulting in damage to the right main landing gear.

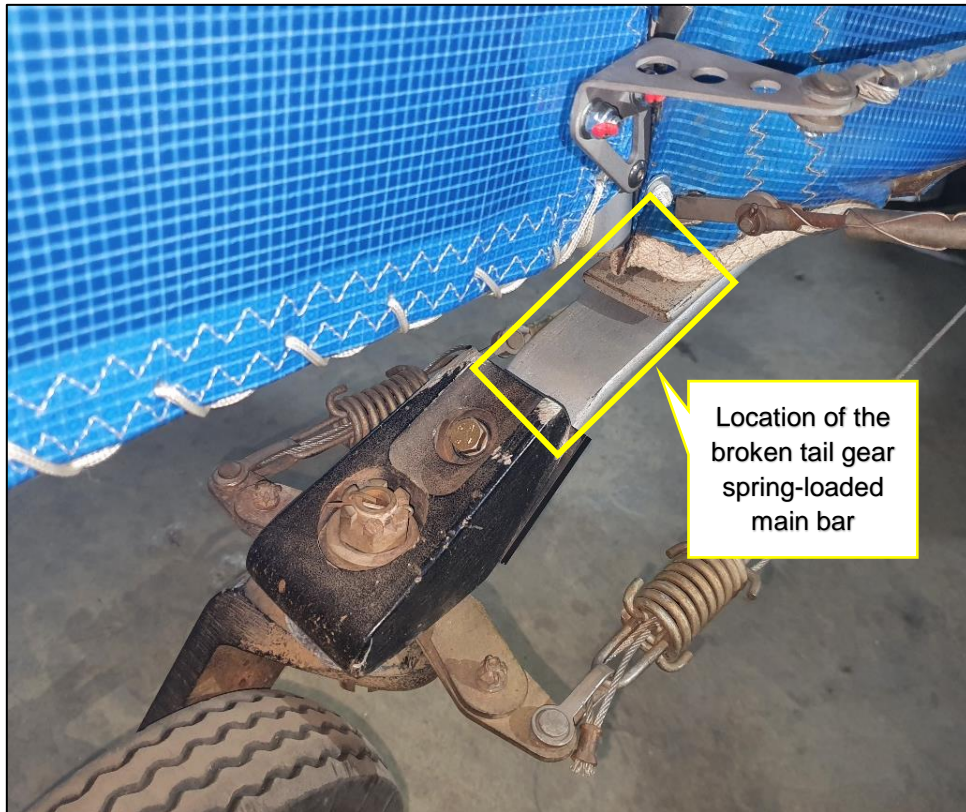
- 3.2. Based on the Training Supplements issued to owners by the manufacturer in section 3.1, it is possible that the aircraft experienced a rapid sink rate during the flare, which led to a hard landing with the tailwheel first. As a result, the main spring-loaded tail gear flat bar broke off and the pilot lost directional control of the aircraft, which veered off to the right-side of the active runway where it came to rest. The aircraft was substantially damaged during the accident sequence.

Figure 3: Location of the tailwheel primary spring-loaded tail gear flat bar that failed.

During a three-point landing, the aircraft's landing speed was higher than normal, which led to an inadvertent tail-first hard landing; as a result, the primary spring-loaded tail gear flat bar broke off, followed by loss of directional control.

Pilots should execute a go-around immediately if they recognise that their approach is unstable. This is a proven risk mitigation when it comes to avoiding a hard touchdown which may result in damaging the aircraft and/or injuring persons.
