**LIMITED ACCIDENT INVESTIGATION REPORT**

<b>Reference Number</b>	CA18/2/3/10196						
<b>Classification</b>	Accident	<b>Date</b>	22 July 2022	<b>Time</b>	1256Z		
<b>Type of Operation</b>	Private (Part 94)						
<b>Location</b>							
Place of Departure	Brits Aerodrome (FABS), North West Province		Next Point of Intended Landing	Wonderboom Aerodrome (FAWB), Gauteng Province			
Place of Accident	Open field, approximately 8 nautical miles (nm) north of FAWB						
GPS Co-ordinates	Latitude	25° 33'29. 3" S	Longitude	028° 10'.45.5" E	Elevation	4 058ft	
<b>Aircraft Information</b>							
Registration	ZU-FCT						
Make/Model	Sling 2 (Serial Number: 081)						
Damage to Aircraft	Substantial		Total Aircraft Hours	2979.05			
<b>Pilot-in-command</b>							
Licence Type	Private Pilot Licence (PPL)		Gender	Male		Age: 20	
Licence Valid	Yes						
Total Hours on Type	31.12		Total Flying Hours	103.49			
<b>People On-board</b>	1 + 0	Injuries	0	Fatalities	0	Other (On ground)	0

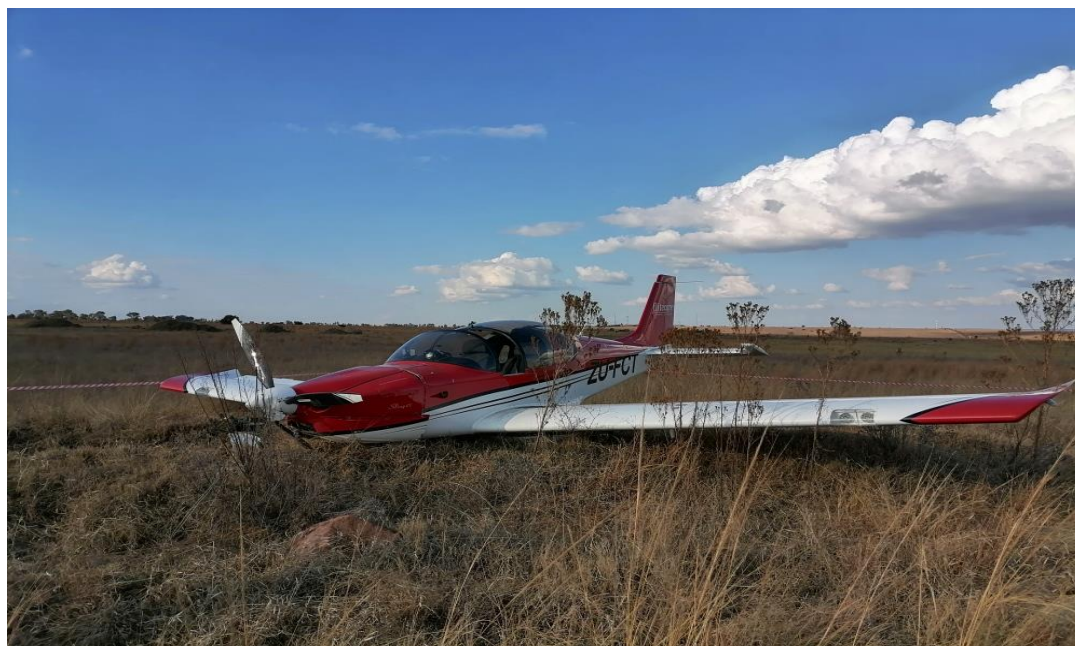
**Figure 1:** The aircraft post-accident. (Source: Operator)

- x. The aircraft sustained substantial damage during the accident sequence.
- xi. The pilot was not injured during the accident sequence.

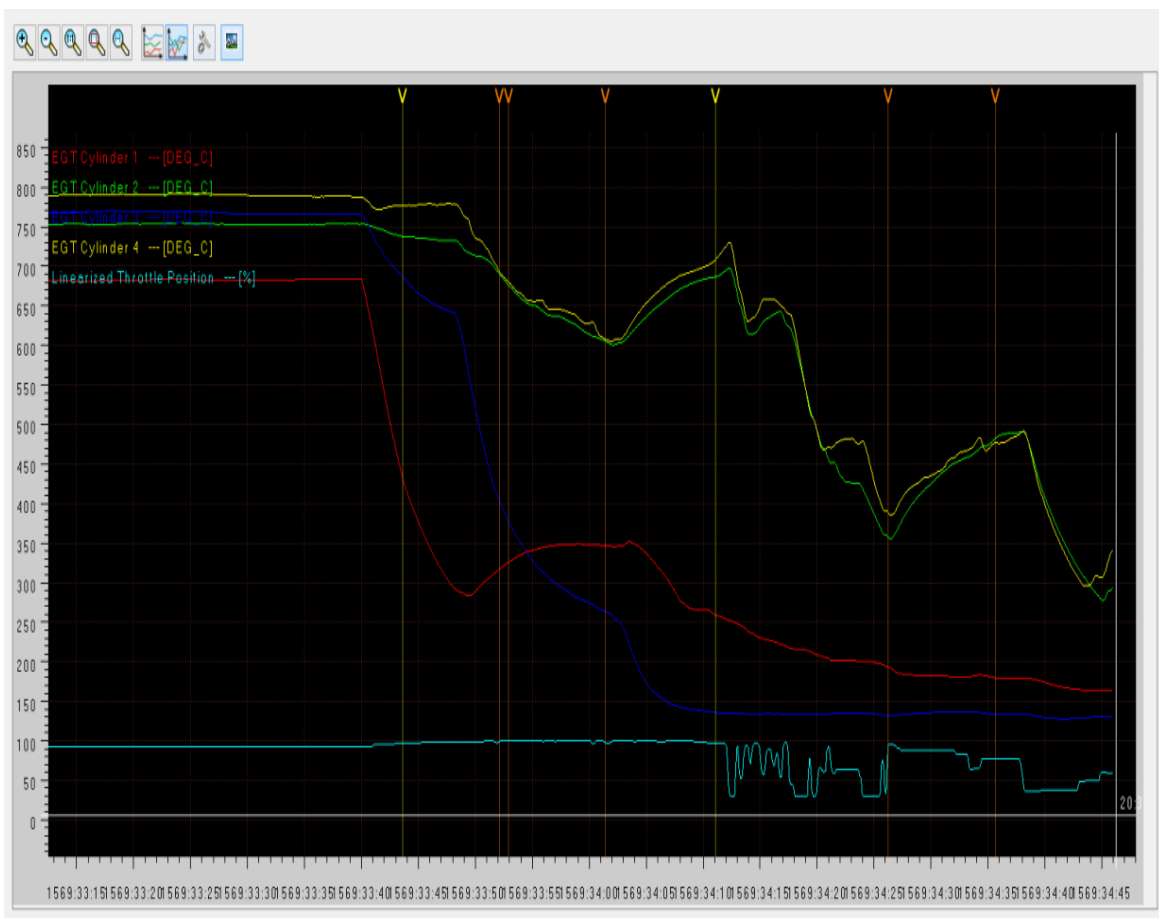
A sample of fuel was drained from the drain valves; its odour and colour was consistent with Mogas 95-octone fuel. Upon opening the cowlings, the engine was noted to be in good condition. No loose or broken fuel pipes or lines were evident. The engine check valve that is designed to allow fuel to bypass the fine fuel filter should it be clogged, showed no signs of abnormality. The fuel injection system temperature and pressure sensors were intact and correctly fitted. The oil reservoir was intact and contained sufficient oil. The induction system was examined and was found to be in a satisfactory condition. The wings were removed before the wreckage was recovered to the aircraft maintenance organisation (AMO) at FAWB for further investigation. The operator, in the presence of the IIC, downloaded data from the engine control unit (ECU) following the manufacturer's procedures. The information/flight logs that were downloaded showed a decrease in exhaust gas temperatures (EGT) for cylinders 1 and 3.

**Figures 2:** Flight logs indicating a drop in EGT for cylinders 1 and 3.

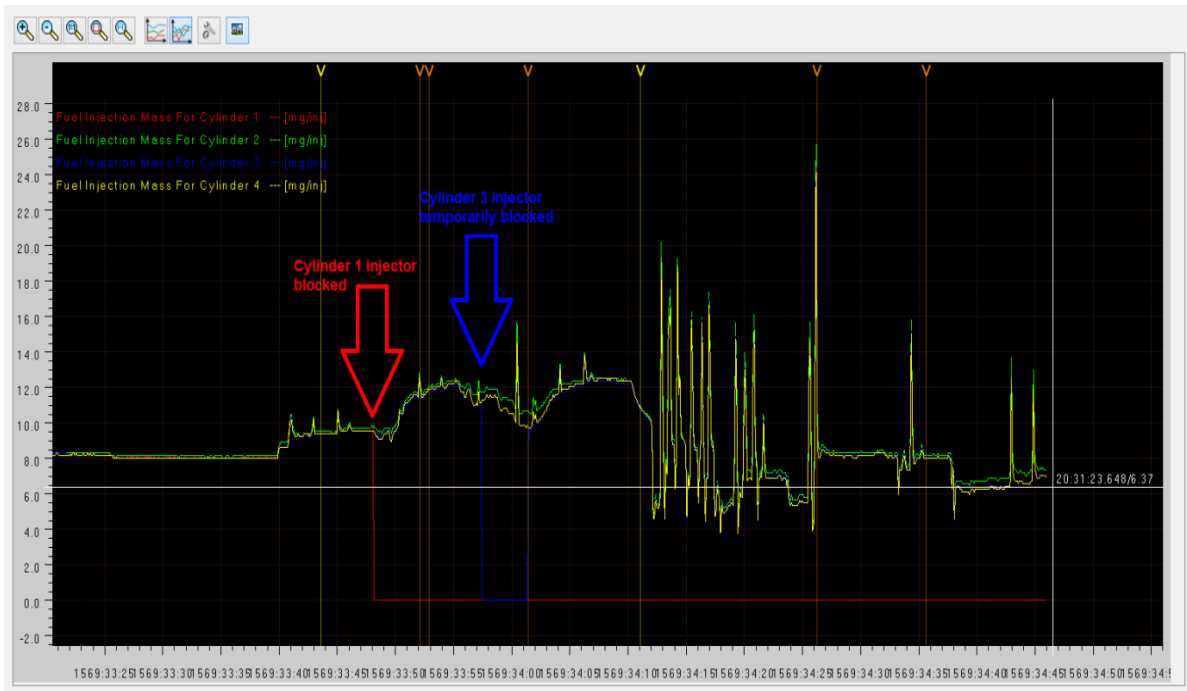
Another flight log showed that fuel supply through the injector nozzles for cylinders 1 and 3 was blocked, which explained the reduced EGT. Moreover, this indicated that cylinders 1 and 3 were receiving a leaner mixture whilst cylinders 2 and 4 were receiving a richer mixture. The spark plugs for cylinders 2 and 4 were clean, and the insulators and the electrodes had light grey-brown shade, indicative of normal ignition process. Carbon deposit was evident on cylinders 1 and 3 spark plugs.

**Figure 3:** The ECU flight logs shows obstructed fuel injectors.

Loss of engine power in-flight caused by dirt that was obstructing fuel flow to the fuel injector nozzles in cylinders 1 and 3, which resulted in an unsuccessful forced landing.

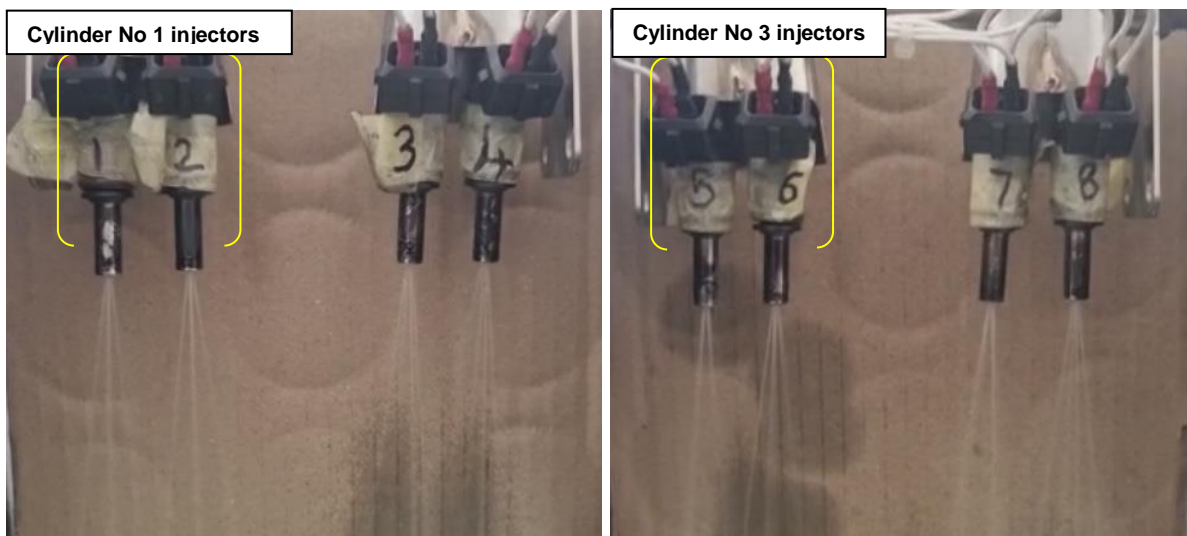
The engine was again examined in the presence of a Rotax agent for the engine type; no abnormalities were noted. The fuel system was subjected to a flow test. To test the fuel system, the fuel supply line to the fuel rail was disconnected and the fuel flow from both pumps was tested. A clean and dry container was used to capture fuel. Both pumps supplied approximately 120 litres of fuel per hour (p/h). All eight injectors were removed from the engine and were taken to a Rotax-approved agent in Gauteng, Germiston, to determine their fuel flow characteristic. All injectors were then fitted to the fuel rail. During the test at 40 pounds per square inch (psi), injectors for cylinders 1 and 3 showed irregular spray pattern caused by dirt build-up in their nozzles, which explained the engine's loss of power in-flight. The affected injector nozzles were not cleaned; however, all the built-up dirt cleared automatically as the test progressed.

**Figures 4 and 5:** The eight fuel injectors indicating equal and continuous spray pattern.

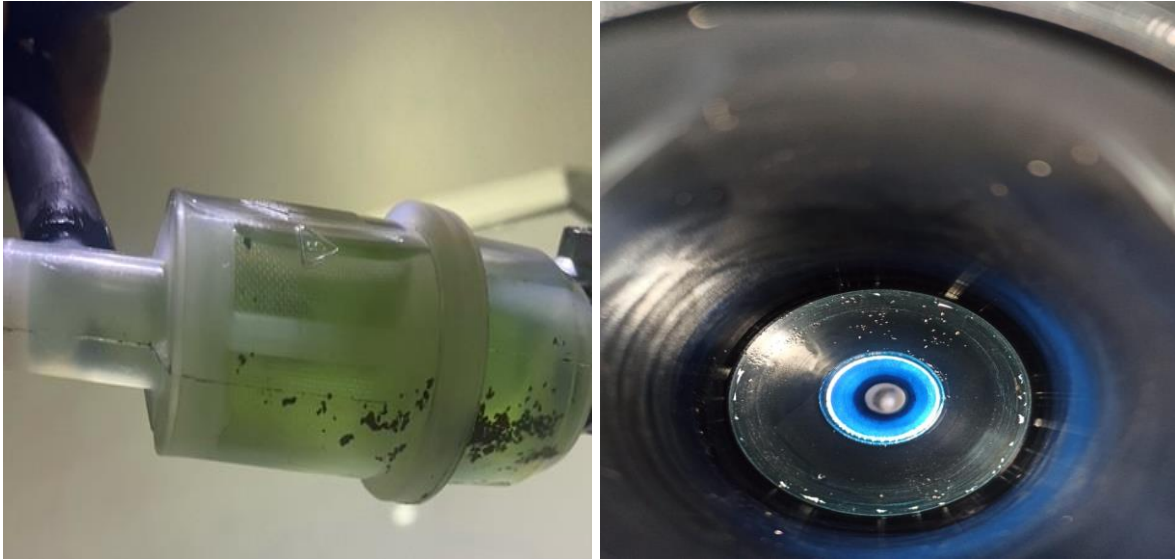
The electrical system/wiring to the fuel injectors was examined; no anomalies were found. Inspection of the left-wing tank revealed fuel contamination on the left-side coarse fuel filter (Figure 6). The composition of debris seemed to be metal particles and fragments of the PRC (aerospace sealant). Further inspection of the fine fuel filter showed further traces of smaller contaminants (Figure 7). The fuel pressure regulator housing was then removed to ascertain if the contaminants did not enter the fuel rail. Contaminants were found, which seemed to have obstructed the fuel injector nozzles, thus, preventing the engine from responding IAW the throttle inputs from the cockpit to obtain the desired RPM.

**Figures 6 and 7:** Metal particles inside the left tank fuel filter (left picture). Foreign particles found inside the fine fuel filter (right picture).

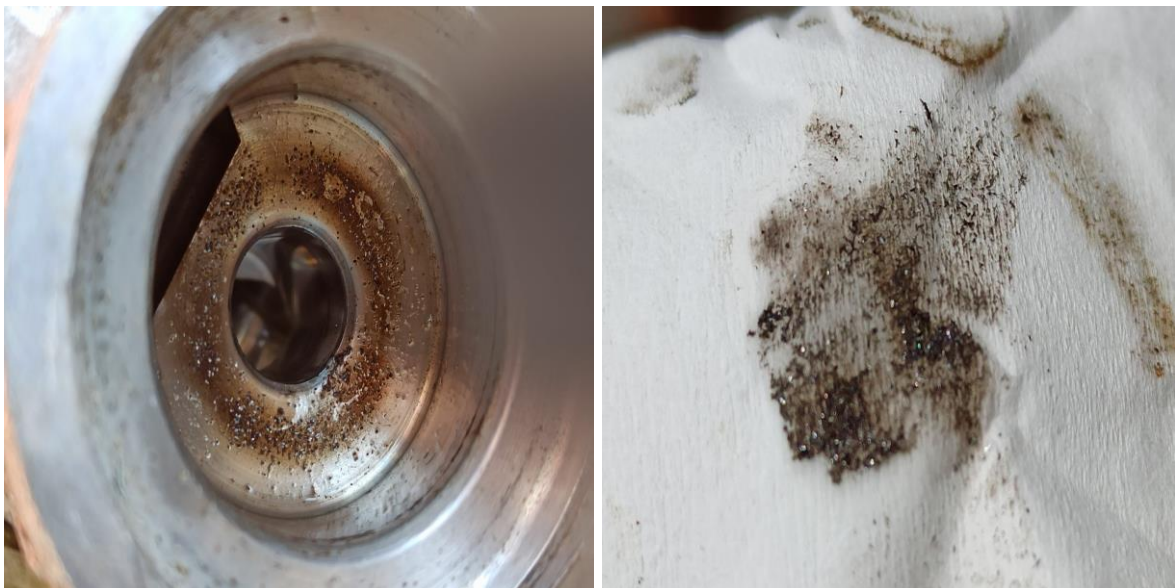
**Figures 8 and 9:** Dirt found inside the fuel pressure regulator (left picture). The cloth used to clean the fuel pressure regulator (right picture).
