**LIMITED OCCURRENCE INVESTIGATION REPORT – FINAL**

<b>Reference Number</b>	CA18/2/3/10197						
<b>Classification</b>	Accident	<b>Date</b>	25 July 2022		<b>Time</b>	0810Z	
<b>Type of Operation</b>	Private (Part 94)						
<b>Location</b>							
Place of Departure	Morningstar Aerodrome, Western Cape Province		Place of Intended Landing	Morningstar Aerodrome, Western Cape Province			
Place of Occurrence	Grass area on the left-side of Runway 20 at Morningstar Aerodrome, Western Cape						
GPS Co-ordinates	Latitude	33° 45' 44" S	Longitude	018° 32' 54" E	Elevation	2001ft	
<b>Aircraft Information</b>							
Registration	ZU-FNN						
Make; Model; S/N	Sling 2 (Serial Number: 028)						
Damage to Aircraft	Substantial		Total Aircraft Hours	6 764.0			
<b>Pilot-in-command</b>							
Licence Type	Private Pilot Licence (PPL)		Gender	Male		Age	57
Licence Valid	Yes	Total Hours	52		Total Hours on Type	21.5	
Total Hours 30 Days	2.3		Total Flying on Type Past 90 Days	21.5

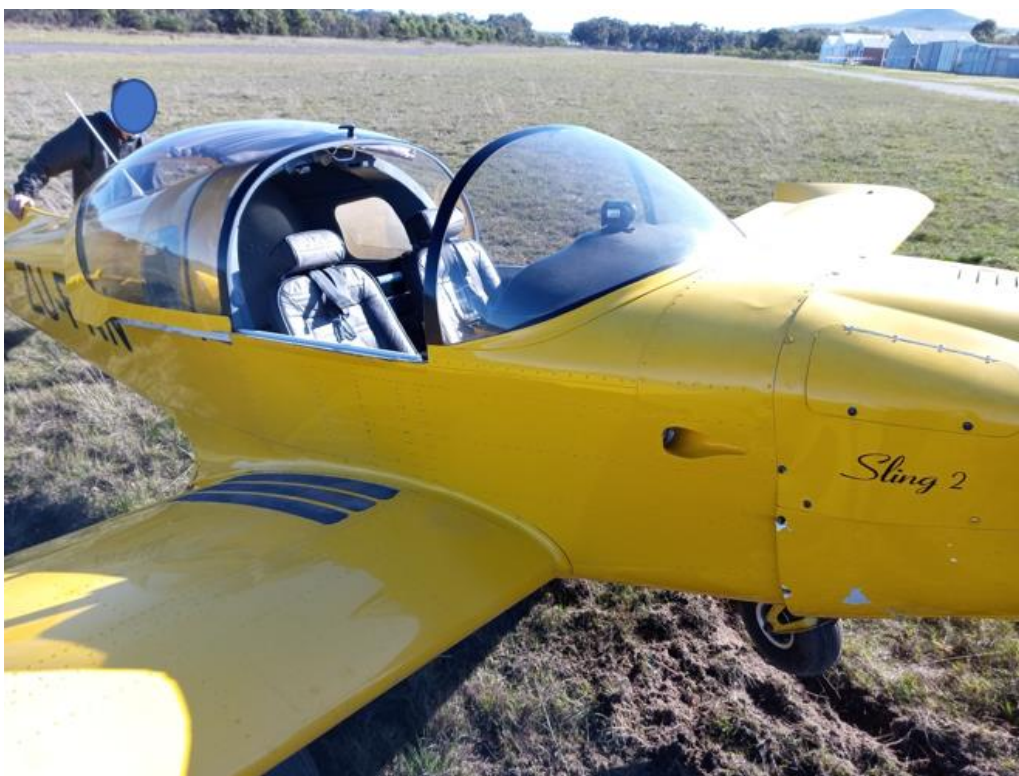
<b>People On-board</b>	1 + 1	<b>Injuries</b>	0	<b>Fatalities</b>	0	<b>Other (on ground)</b>	0
<b>What Happened</b>							
<p>On 25 July 2022 at approximately 0810Z, a pilot and a passenger on-board a Sling 2 aircraft with registration ZU-FNN took off on a private flight from Morning Star Aerodrome in Cape Town, Western Cape province, with the intention to land back at the same aerodrome. Visual meteorological conditions (VMC) by day prevailed at the time of the flight. The flight was conducted under the provisions of Part 94 of the Civil Aviation Regulations (CAR) 2011 as amended.</p> <p>The pilot stated that upon their return to Morning Star Aerodrome, the aircraft was correctly configured for landing on Runway 20 (RWY 20). The approach speed was 74 knots indicated airspeed (KIAS). During short finals whilst at 100 feet (ft) above ground level (AGL), the aircraft experienced a wind shear after flying over the trees which are located before the threshold of Runway 20. This caused the aircraft to veer off to the right-side of the extended centreline. To re-align the aircraft to the centreline, the pilot initiated aileron and rudder inputs.</p> <p>Upon touchdown, the aircraft bounced twice and the pilot lost control in the process. The aircraft veered off to the right-side of Runway 20 and onto the soft sand. The nose wheel sunk into the soft sand and the propeller hit the ground. Furthermore, the nose gear strut collapsed from overload</p>

before it came to a stop in a nose-down attitude. The aircraft was substantially damaged; however, no person was injured during the accident sequence.

**Figure1:** The aircraft at the accident site. (Source: Owner)

<b>Probable Cause</b>
The aircraft was unstable on approach which led to a hard landing and a couple of bounces. As a result, the pilot lost control and the aircraft veered off to the left-side of the runway. The nose gear failed before the aircraft came to a stop.
<b>Contributing Factor(s)</b>
None.
<b>Safety Action(s)</b>
None.
<b>Safety Message and/or Safety Recommendation/s</b>
None.
<b>About this Report</b>
<p><i>The decision to conduct a limited investigation is based on factors, including whether the cause is known and the evidence supporting the cause is clear, the level of safety benefit likely to be obtained from an investigation and that will determine the scope of an investigation. For this occurrence, a limited investigation has been conducted, and the Accident and Incident Investigations Division (AIID) has relied on the information submitted by the affected person/s and organisation/s to compile this limited report. The report has been compiled using information supplied in the initial notification, as well as from follow-up desk top enquiries to bring awareness of potential safety issues to the industry in respect of this occurrence, as well as possible safety action/s that the industry might want to consider in preventing a recurrence of a similar occurrence.</i></p> <p><i>All times given in this report are Co-ordinated Universal Time (UTC) and will be denoted by (Z). South African Standard Time is UTC plus 2 hours.</i></p>
