LIMITED OCCURRENCE INVESTIGATION REPORT – FINAL

Reference Number	CA18/2/3/10200						
Classification	Accident	Date	6 August 2022			Time	0810Z
Type of Operation	Private Non-type Certificated Aircraft (Part 94)						
Location							
Place of Departure	Bethlehem Aerodrome (FABM), Free State Province		Place of Intended Landing		Bethlehem Aerodrome (FABM), Free State Province		
Place of Occurrence	On Preekstoel Road whilst on short final approach for Runway 11 at Bethlehem Aerodrome (FABM)						
GPS Co-ordinates	Latitude	28°14'52.15" S	Longitude	028°19'46.10" E	Elevation	5 517ft	
Aircraft Information							
Registration	ZU-BLJ						
Make; Model; S/N	Kopke GJ, GK-1 (Serial Number: GJK-002)						
Damage to Aircraft	Substantial			Total Aircraft Hours	119.5		
Pilot-in-command							
Licence Type	Commercial Pilot Licence		Gender	Male		Age	65
Licence Valid	Yes	Total Hours	6 499.9		Total Hours on Type	0.3	
Total Hours 90 Days	14.0		Total Flying Hours on Type Past 90 Days		0.3

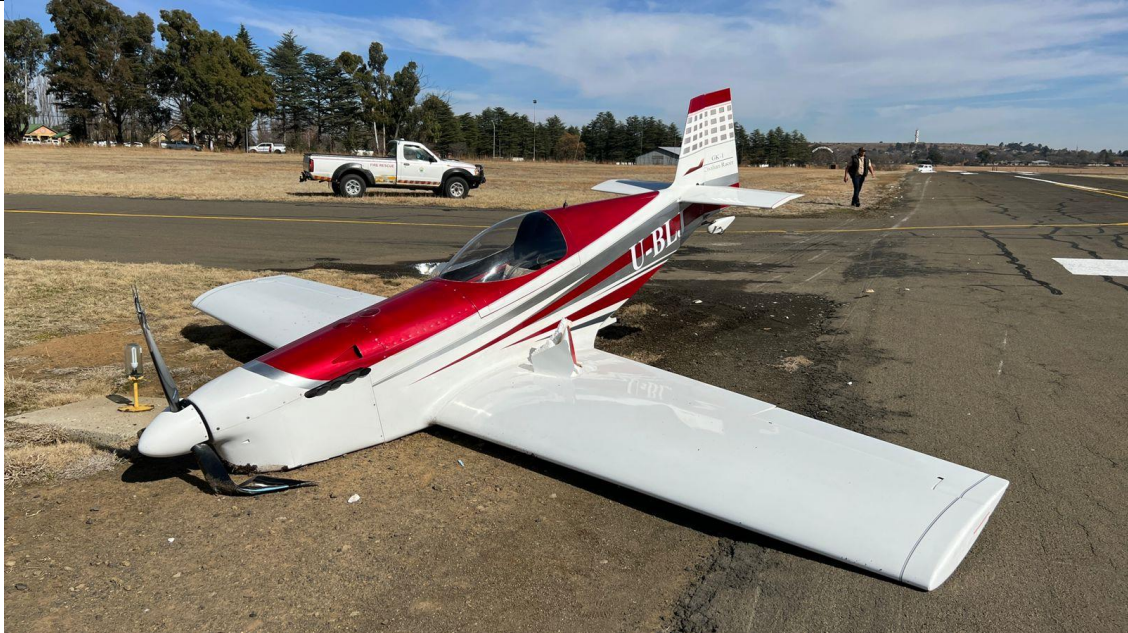
Figure 2: The aircraft as it came to rest. (Source: Disaster Management)

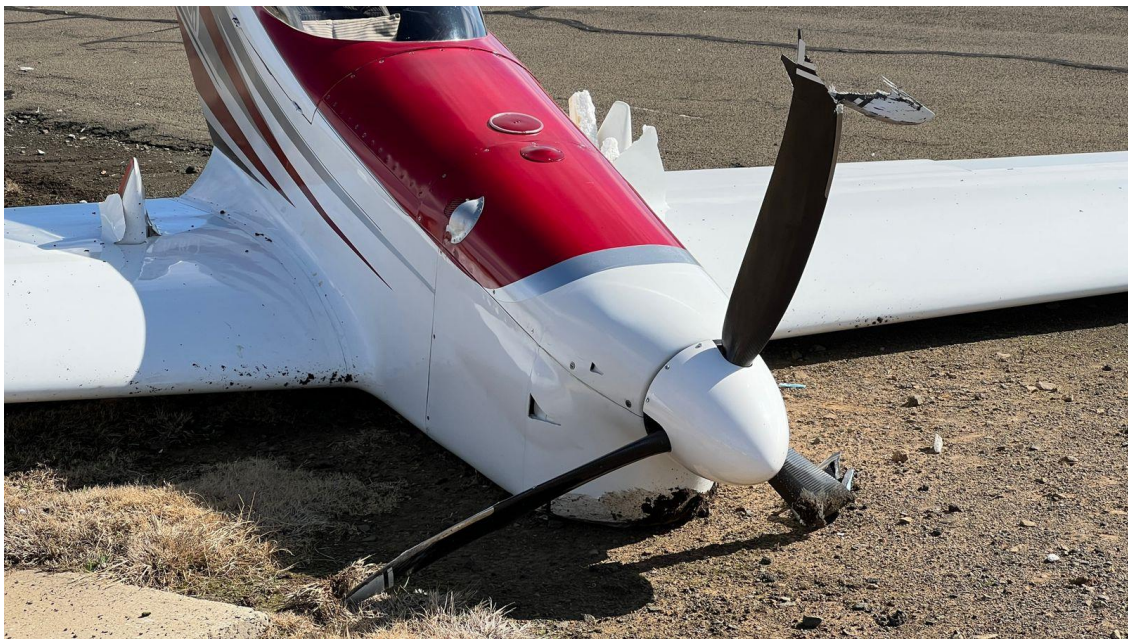
Figure 3: Damage to the propeller. (Source: Disaster Management)

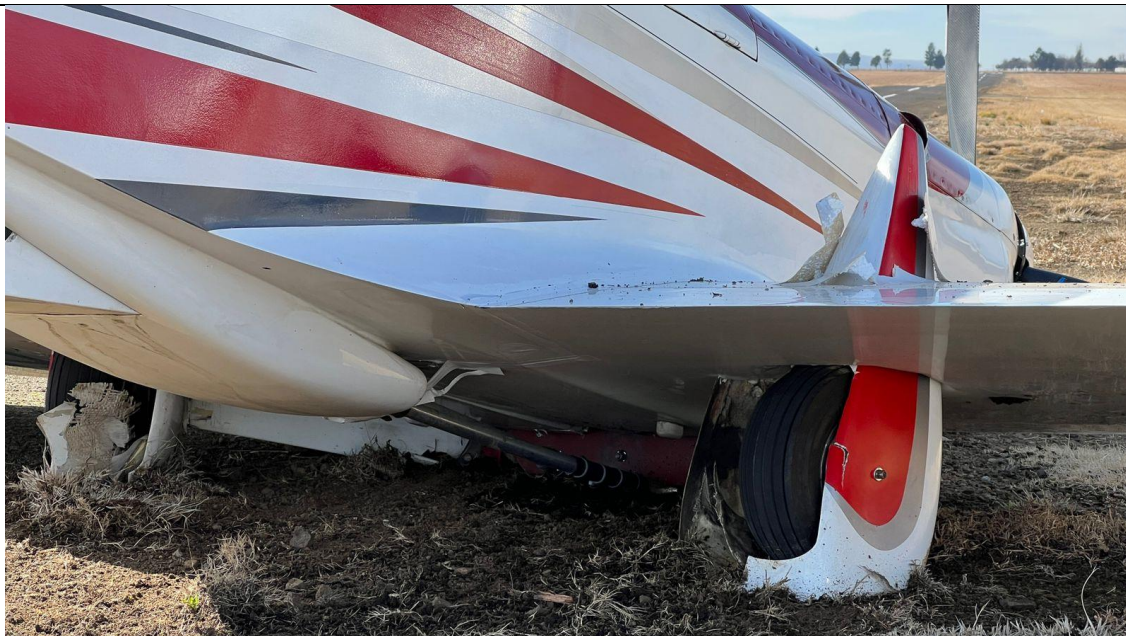
Figure 4: Landing gear penetrated the wings on both sides. (Source: Disaster Management)

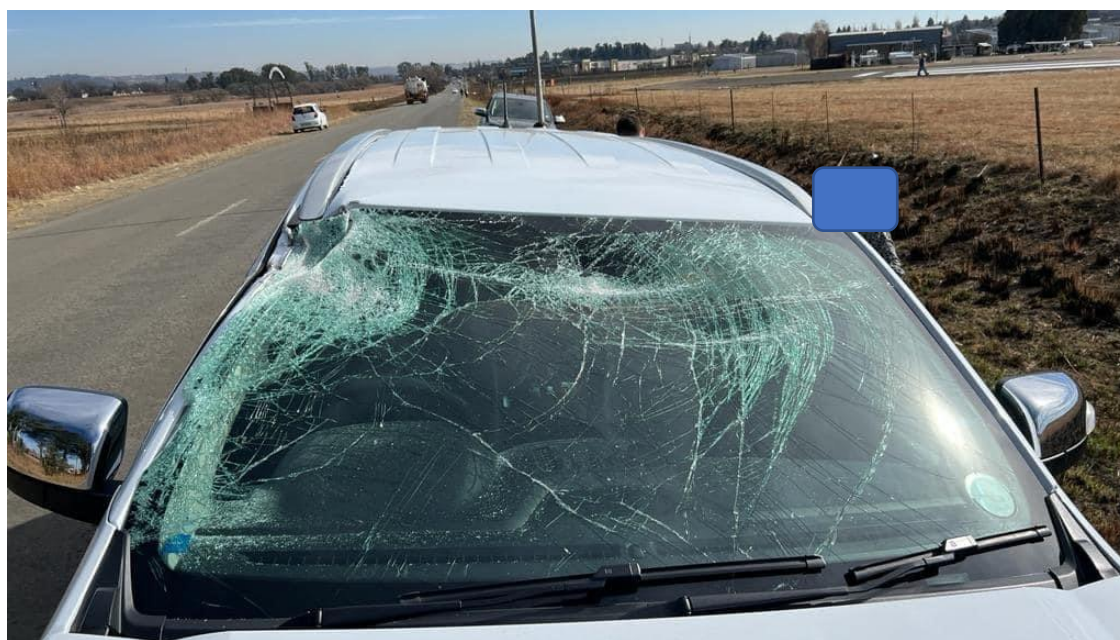
The pilot was not injured during the accident sequence, whilst the aircraft sustained substantial damage. The driver of the vehicle was also not injured, but the vehicle was substantially damaged (see Figures 5, 6 and 7). The driver, a sole occupant in the vehicle, was severely traumatised by the experience.

Figure 5: A view of the damaged vehicle from the front. (Source: Disaster Management)

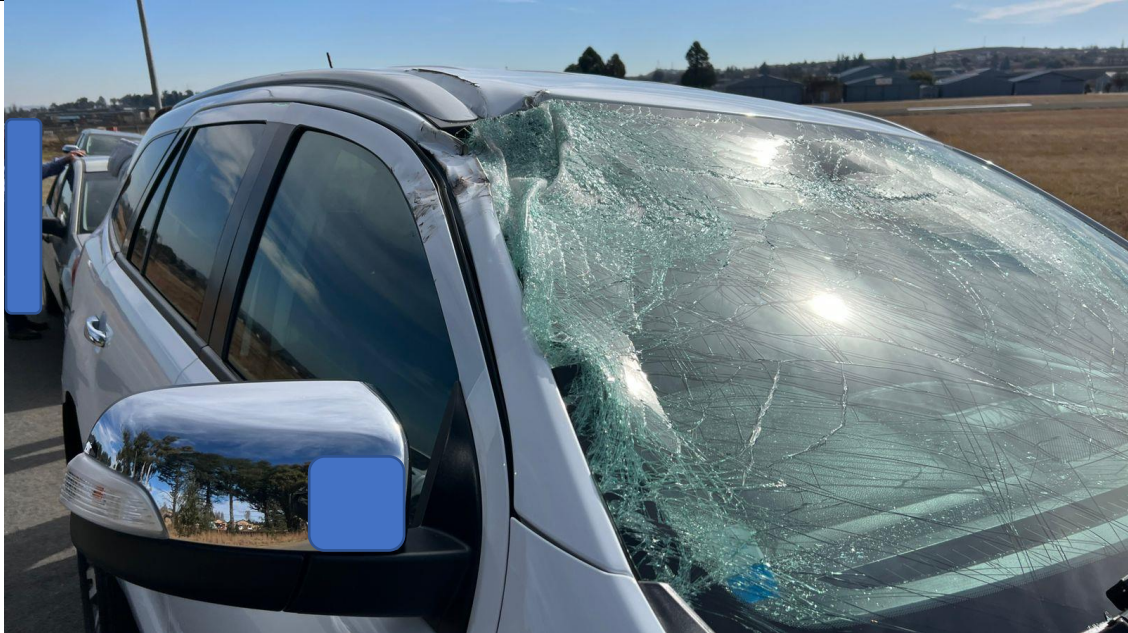
Figure 6: A closer view of the damage to the vehicle. (Source: Disaster Management)

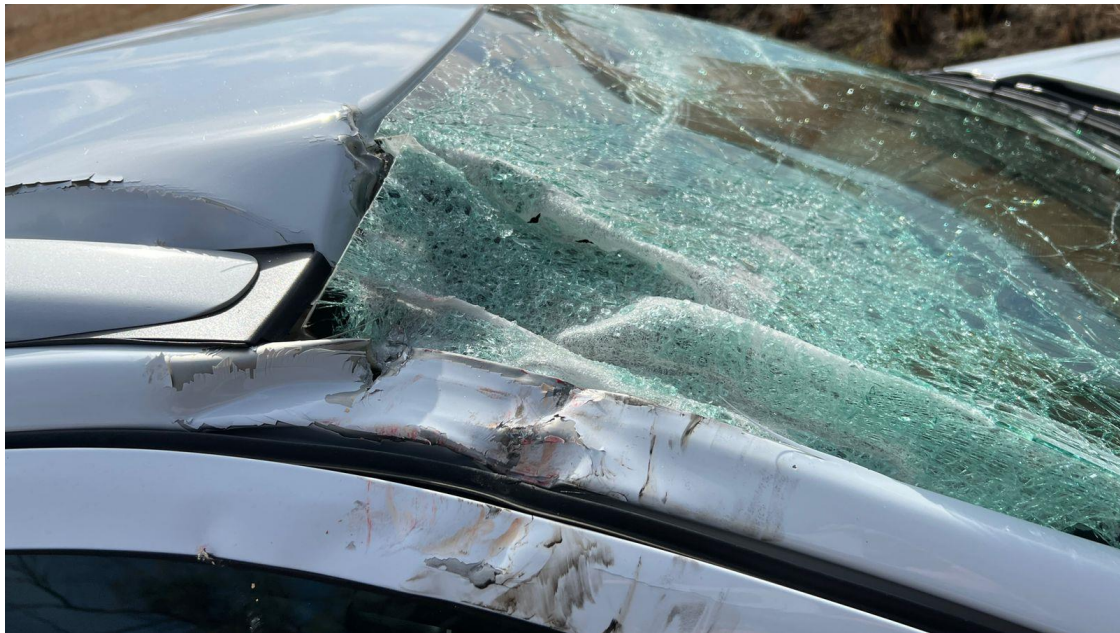
Figure 7: Impact markings from the aircraft on the vehicle. (Source: Disaster Management)

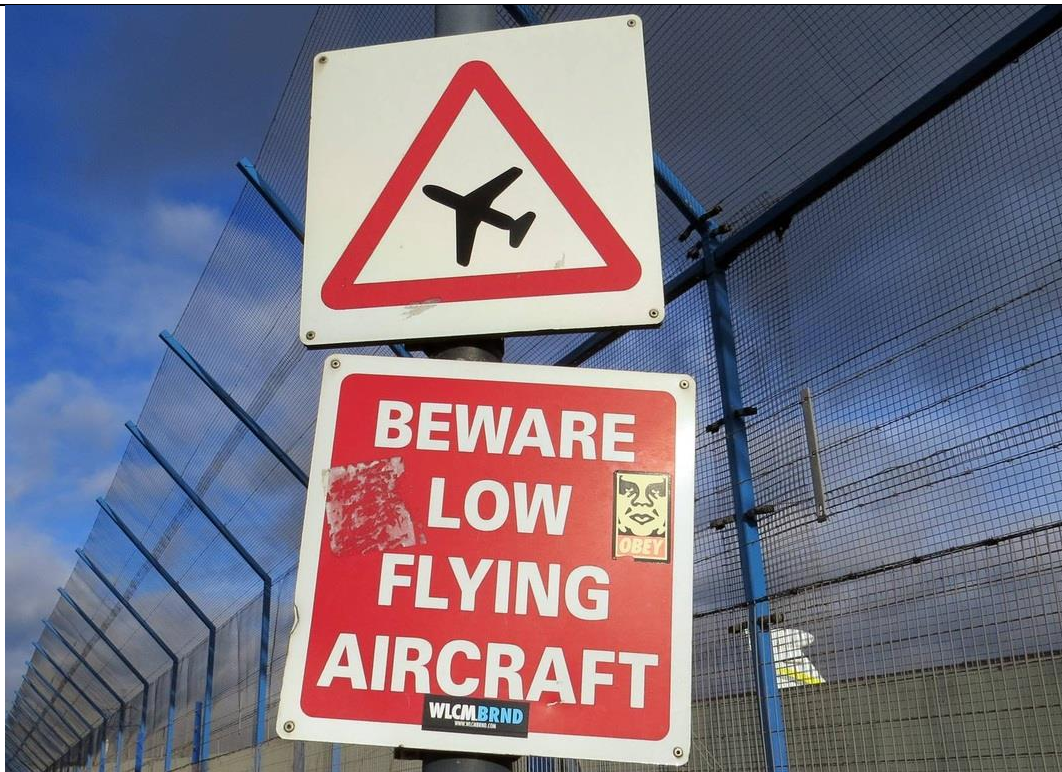
Figure 8: Example of a road marking, warning motorist of low flying aircraft.

Probable Cause
The aircraft was very low on approach for Runway 11, causing the main landing gear to strike a vehicle whilst in motion on Preekstoel Road, west of the aerodrome's perimeter fence.
Contributing Factor
None.
Safety Action
None.
Safety Message and/or Safety Recommendation/s
It is recommended that the Municipality of Dihlabeng consider installing a road sign (as per Figure 8) on both sides of Preekstoel Road to warn motorists of low flying aircraft.
