LIMITED OCCURRENCE INVESTIGATION REPORT – FINAL

Reference Number	CA18/2/3/10201						
Classification	Accident	Date	9 August 2022		Time	0520Z	
Type of Operation	Private (Part 94)						
Location							
Place of Departure	Kaalfontein Farm, Victoria West District, Northern Cape Province			Place of Intended Landing	Kaalfontein Farm, Victoria West District, Northern Cape Province		
Place of Occurrence	Kaalfontein Farm, Victoria West District in the Northern Cape Province						
GPS Co-ordinates	Latitude	31° 07' 03" S	Longitude	023° 09' 06" E	Elevation	4094 feet	
Aircraft Information							
Registration	ZU-EKY						
Make; Model; S/N	Microlight; Windlass Aquilla (Serial Number: WA1150)						
Damage to Aircraft	Substantial			Total Aircraft Hours	456.3		
Pilot-in-command							
Licence Type	National Pilot Licence (NPL)		Gender	Male		Age	52
Licence Valid	Yes	Total Hours	65.8		Total Hours on Type	65.8	
Total Hours 30 Days	1.8		Total Flying on Type Past 90 Days	24.4

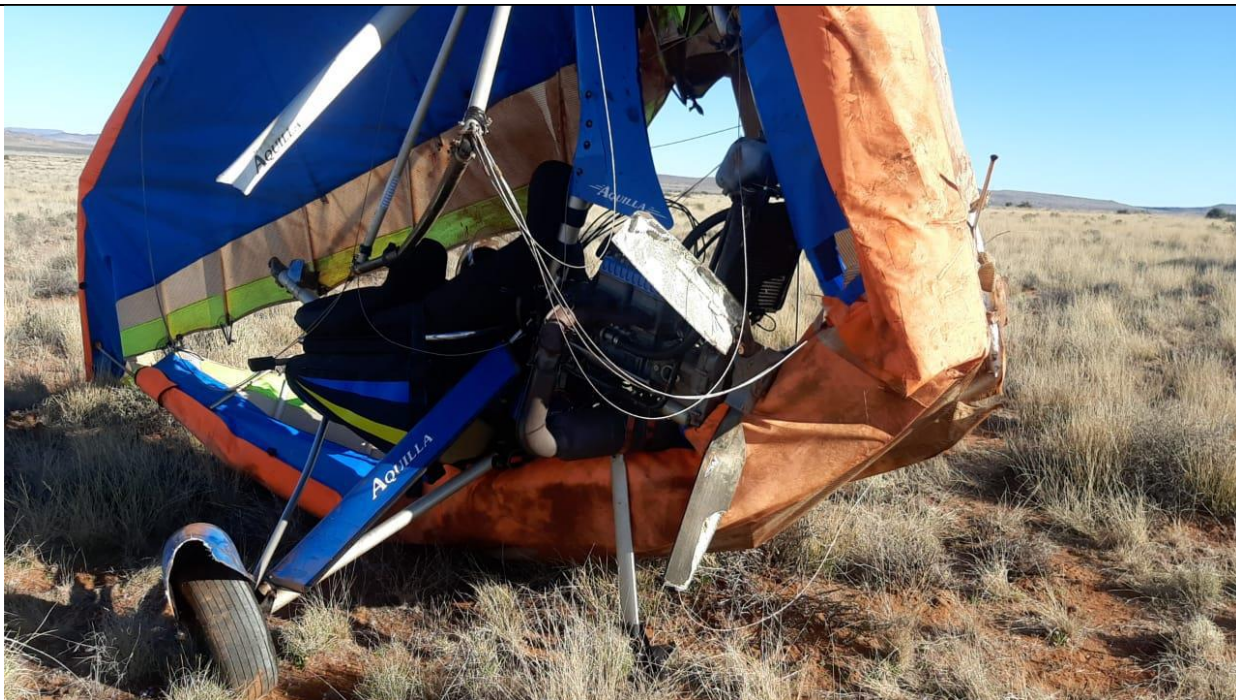
telephone pole, the pilot turned the aircraft more to the right, but it was losing height. Subsequently, the nose gear contacted the ground and the aircraft flipped over and came to rest in that position.

Figure 2: The aircraft at its resting position. (Source: Pilot)

The pilot lost control of the aircraft after take-off from a dirt road, and it veered off to the right-side before it flipped over.

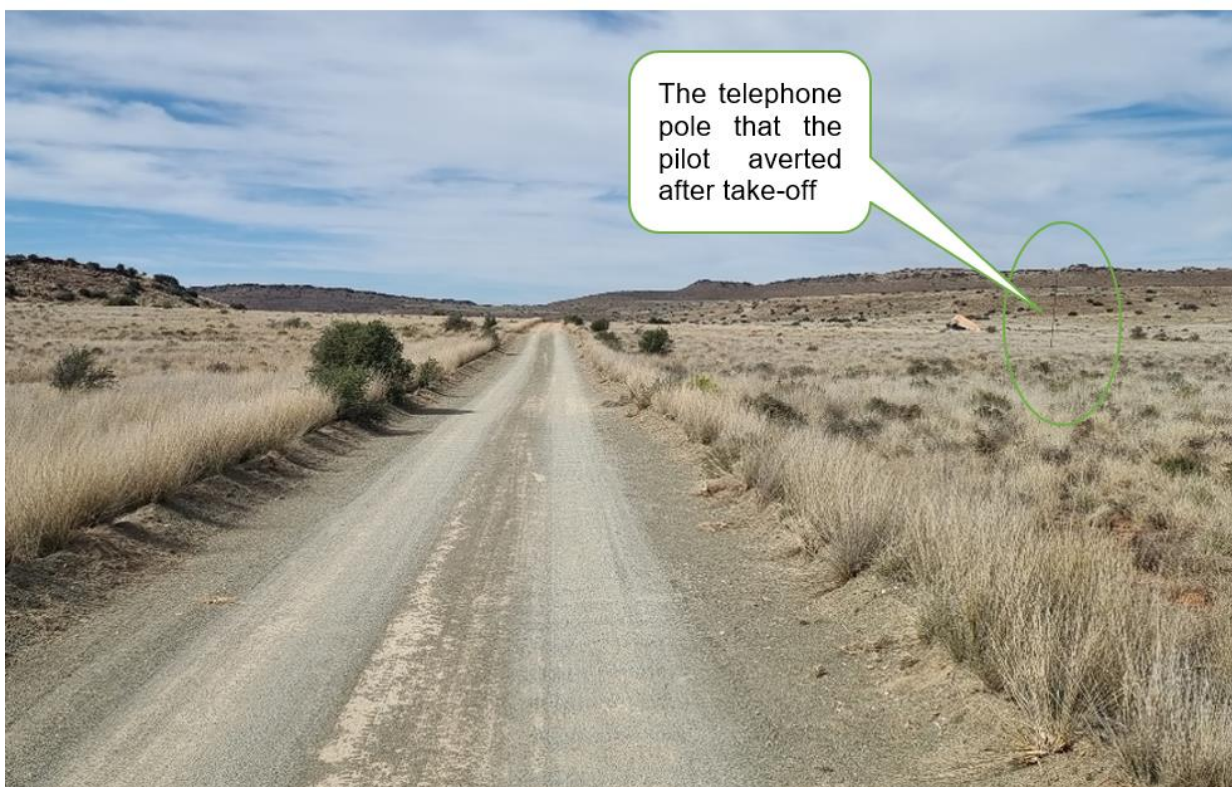
Figure 3: The dirt road on Kaalfontein private farm. (Source: Pilot)
