LIMITED OCCURRENCE INVESTIGATION REPORT – FINAL

Reference Number	CA18/2/3/10202						
Classification	Accident	Date	9 August 2022		Time	0720Z	
Type of Operation	Aerial Work Operations – Game Capturing (Part 137)						
Location							
Place of Departure	Stone Hill Game Farm, North West Province		Place of Intended Landing	Stone Hill Game Farm, North West Province			
Place of Occurrence	Stone Hill Game Farm						
GPS Co-ordinates	Latitude	26°39'29.15" S	Longitude	026°30'36.15" E	Elevation	4 730 ft	
Aircraft Information							
Registration	ZS-RSO						
Make; Model; S/N	Robinson Helicopter Company, R44 Raven II (Serial Number: 10145)						
Damage to Aircraft	Substantial			Total Aircraft Hours	3 039.9		
Pilot-in-command							
Licence Type	Commercial Pilot Licence (H)		Gender	Male	Age	35	
Licence Valid	Yes	Total Hours	1 248.6	Total Hours on Type	873.6		
Total Hours 30 Days	76.0		Total Flying Hours on Type Past 90 Days	94.5			
People On-board	1 + 1	Injuries	1	Fatalities	0	Other (on ground)	0

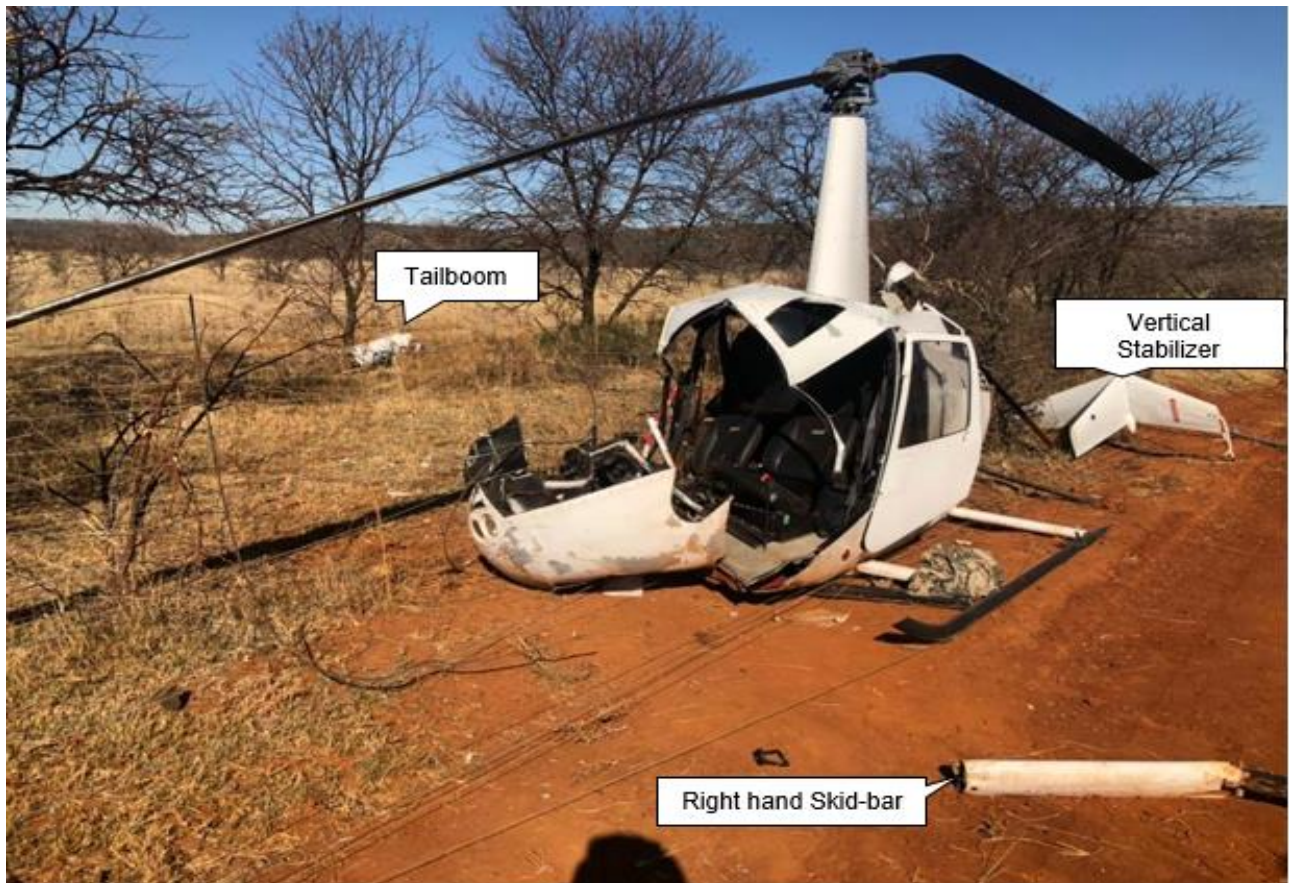
the condition, but he was unable to as the helicopter height was too low. He then aimed for the gravel road to execute an emergency landing but collided with a barbed wire fence before the helicopter landed hard on the ground. During impact, the main rotor blades severed the tail boom. The visible damage on the main rotor blades indicated a low main rotor RPM inertia impact. The cockpit and the cabin area were severely damaged, whilst the skid gear was flattened.

Figure 1: The helicopter wreckage after the accident. (Source: Pilot)

- (vi) The helicopter was issued a C of A on 3 June 2022 with an expiry date of 31 May 2023.
- (vii) The helicopter sustained substantial damage during the accident sequence.

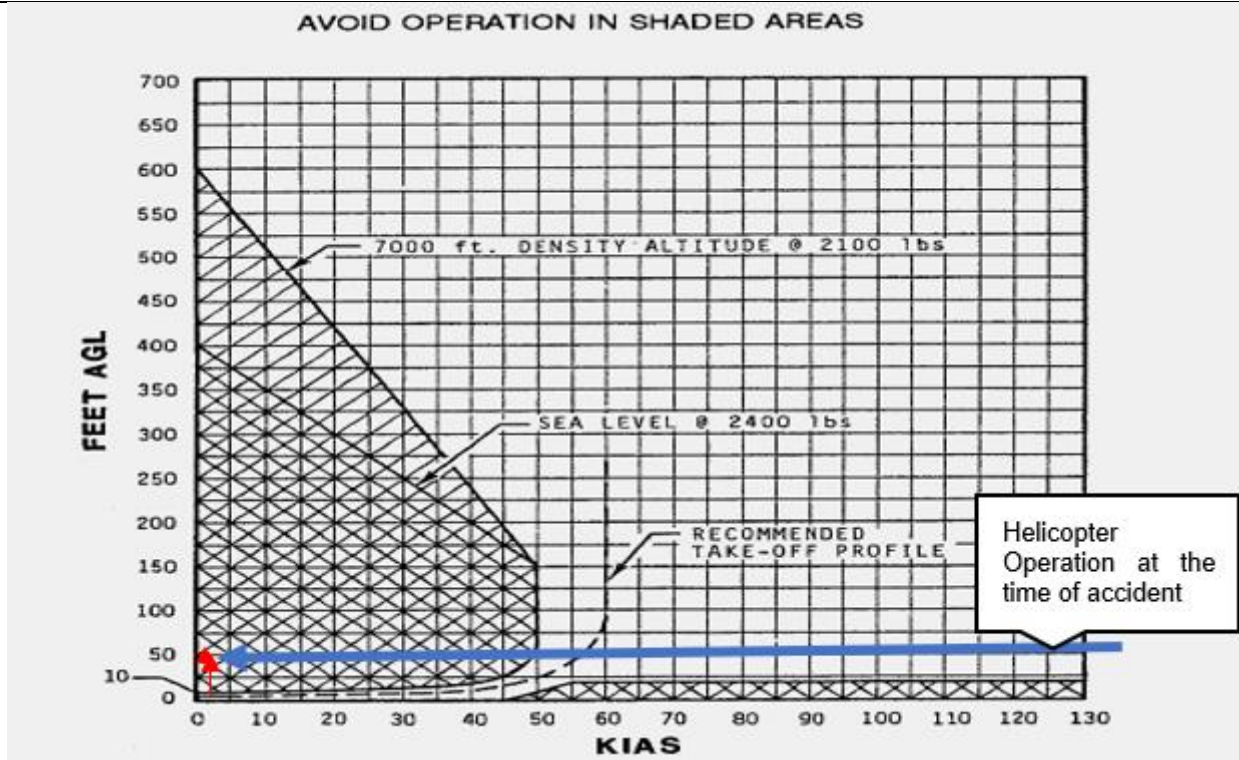
The pilot stated that whilst at 50 feet (ft) AGL, he aggressively manoeuvred the helicopter by conducting a quick stop and pulling up the collective to move out of the downwash so as to hover at a safer height. This action involved manipulating the collective and cyclic controls. The aggressive manoeuvre and pulling up of the collective advanced the helicopter to settle with power, and also impeded the power, preventing the helicopter from attaining the required lift. *The helicopter's governor does not respond well to sudden/ aggressive inputs.* The deflected rotor blade's high angle-of-attack encountered a high drag resistance (relative air flow) which reduced the rotor's RPM to a critical point. In turn, the helicopter settled with power; however, it could not sustain the required lift following the manoeuvres. Instead, it lost height rapidly due to the induced low rotor condition.

At the time of the flight, the helicopter was operated in a low height-velocity and low forward speed, indicated by the shaded area in the diagram below.

Diagram 1: Height-velocity of the helicopter at the time of the flight.

During a game capture operation whilst the pilot manipulated the flight controls, the main rotor RPM decayed, which resulted in the helicopter losing height and crash-landing as there was insufficient height available to recover.
