**LIMITED OCCURRENCE INVESTIGATION REPORT – FINAL**

<b>Reference Number</b>	CA18/2/3/10203						
<b>Classification</b>	Accident	<b>Date</b>	08 August 2022	<b>Time</b>	1308Z		
<b>Type of Operation</b>	Private (Part 91)						
<b>Location</b>							
<b>Place of Departure</b>	Secunda Aerodrome (FASC), Mpumalanga Province			<b>Place of Intended Landing</b>	Richmond Aerodrome (FARM), KwaZulu-Natal Province		
<b>Place of Occurrence</b>	Runway 11 at Richmond Aerodrome (FARM), KwaZulu-Natal Province						
<b>GPS Co-ordinates</b>	<b>Latitude</b>	S 29°52'20.6"	<b>Longitude</b>	E 030°17'34.4"	<b>Elevation</b>	2732 ft	
<b>Aircraft Information</b>							
<b>Registration</b>	ZS-OAB						
<b>Make; Model; S/N</b>	Beechcraft, Baron 58 (Serial Number: TH-622)						
<b>Damage to Aircraft</b>	Substantial			<b>Total Aircraft Hours</b>	9304.3		
<b>Pilot-in-command</b>							
<b>Licence Type</b>	Airline Transport Pilot Licence (ATPL)		<b>Gender</b>	Female	<b>Age</b>	40	
<b>Licence Valid</b>	Yes	<b>Total Hours</b>	4425	<b>Total Hours on Type</b>	1160.4

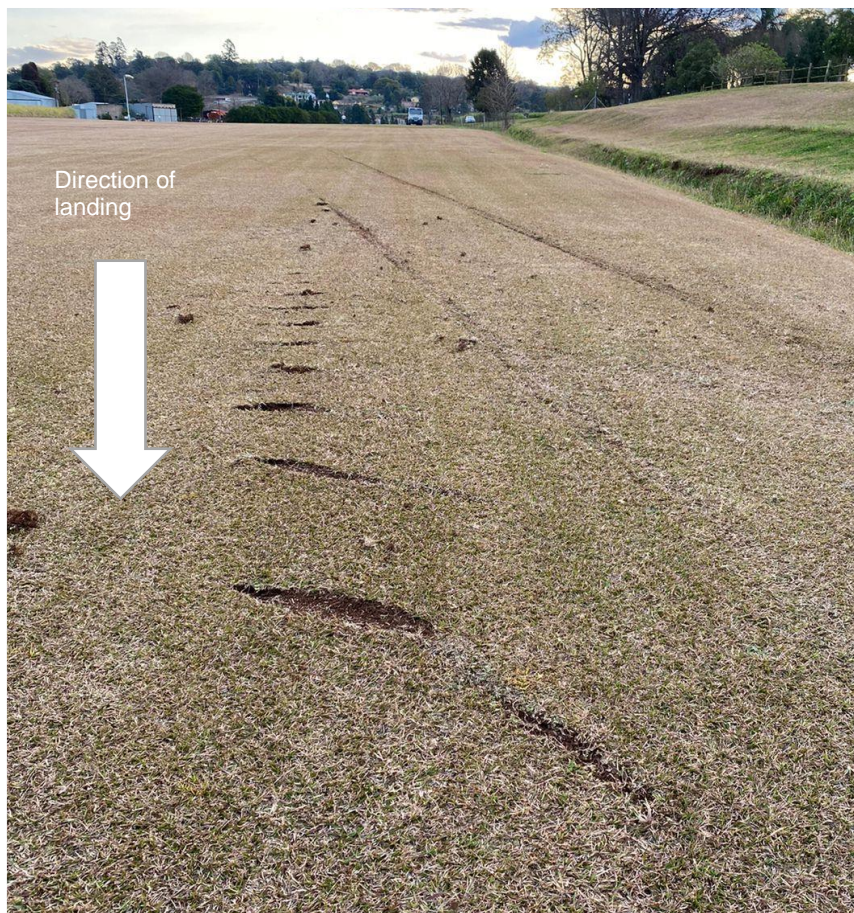
**Figure 1:** The strike marks caused by the left engine propeller blades and the tyre marks left by a vehicle that came to assist post-accident. (Source: Owner)

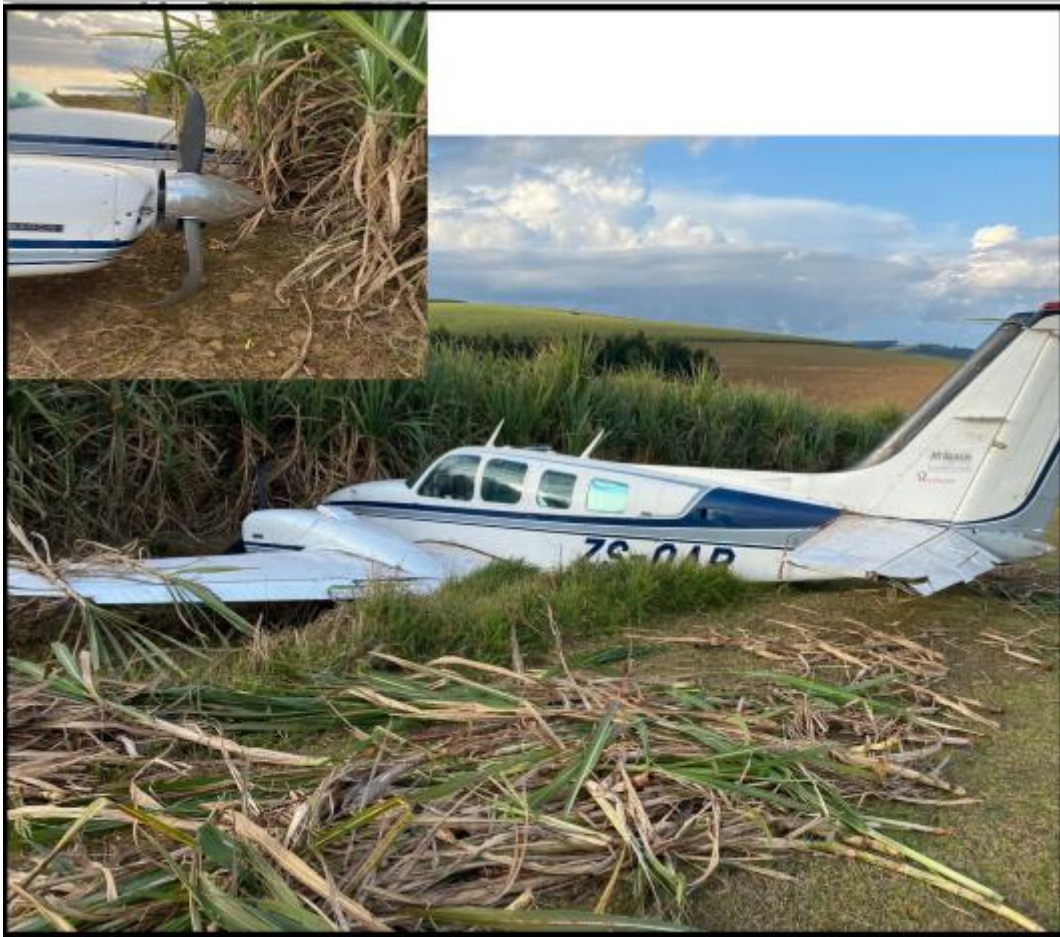
The pilot stated that the aircraft came to a stop in a ditch next to the runway, and that she and the two passengers were not injured. After they had disembarked from the aircraft, the pilot noticed that the landing gear doors had detached from the aircraft, and that the right engine had impacted the ground during the accident sequence. The nose gear was also damaged after impacting the side of the ditch before it came to a stop. The aircraft sustained substantial damage to the underbelly, fuselage, propeller blades and undercarriage.

**Figure 2:** The aircraft at the accident site. The inset image shows the damaged propeller. (Source Owner)

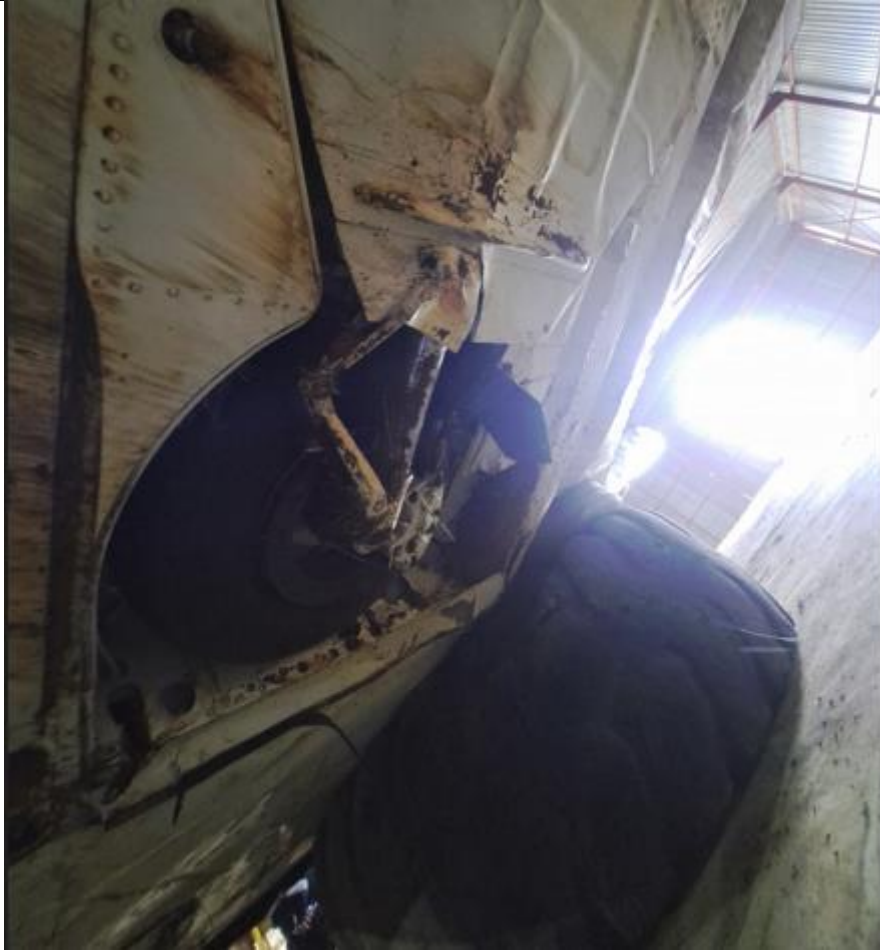
**Figure 3:** The left landing gear with the missing wheel well cover.

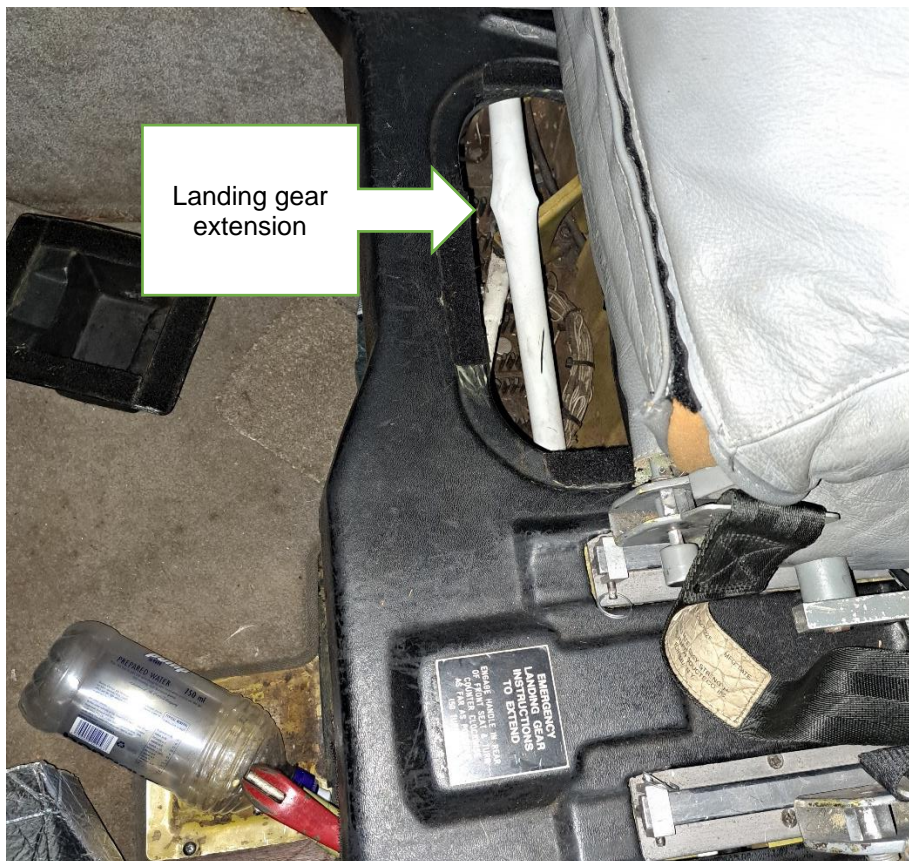
The condition of the undercarriage was inspected, and it was discovered that the push arms which extend the undercarriage had bent, and it was impossible to lower the undercarriage without damaging them further.

**Figure 4:** The bent left-side landing gear extension.

It is likely that the main landing gears were still in transit during touchdown and collapsed into their wheel well upon contacting the ground resulting in the aircraft veering off the runway.
