**LIMITED OCCURRENCE INVESTIGATION REPORT – FINAL**

<b>Reference Number</b>	CA18/2/3/10204						
<b>Classification</b>	Accident	<b>Date</b>	11 August 2022	<b>Time</b>	1710Z		
<b>Type of Operation</b>	Private (Part 91)						
<b>Location</b>							
Place of Departure	Port Elizabeth Airport (FAPE), Eastern Cape Province		Place of Intended Landing	Port Elizabeth Airport (FAPE), Eastern Cape Province			
Place of Occurrence	On Runway 08 at Port Elizabeth Airport (FAPE), Eastern Cape Province						
GPS Co-ordinates	Latitude	33° 59'26.76"S	Longitude	025° 36'21.32"E	Elevation	229 ft	
<b>Aircraft Information</b>							
Registration	ZS-TLS						
Make; Model; S/N	Mooney M-20M; (Serial Number: 27-0217)						
Damage to Aircraft	Substantial		Total Aircraft Hours	856			
<b>Pilot-in-command</b>							
Licence Type	Commercial Pilot Licence (CPL)		Gender	Male		Age	19
Licence Valid	Yes	Total Hours	255		Total Hours on Type	30.1	
Total Hours 30 Days	5.2		Total Flying on Type Past 90 Days	10.3

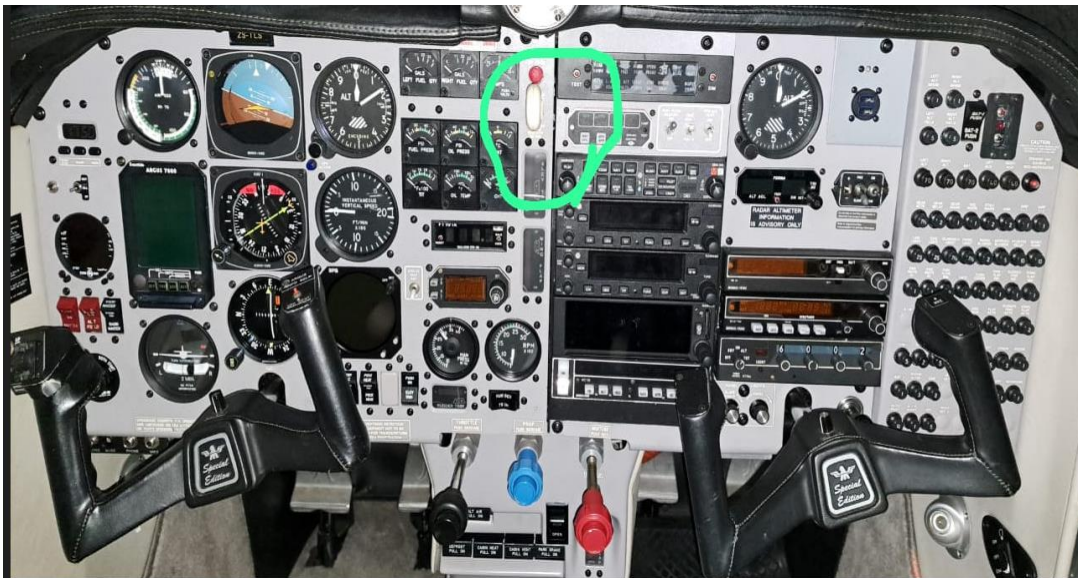
**Figure 1:** The instrument panel showing the landing gear control lever in the UP position.

- (v) The landing gear selector lever was found to be in the UP position.
- (vi) Post-accident, the pilot stated that he forgot to select the landing gear lever to the DOWN position as he was hurrying to accommodate the inbound scheduled traffic. He further stated that he did not hear the landing gear unsafe warning horn sound prior to landing, and was not sure if the aircraft had a warning horn installed.

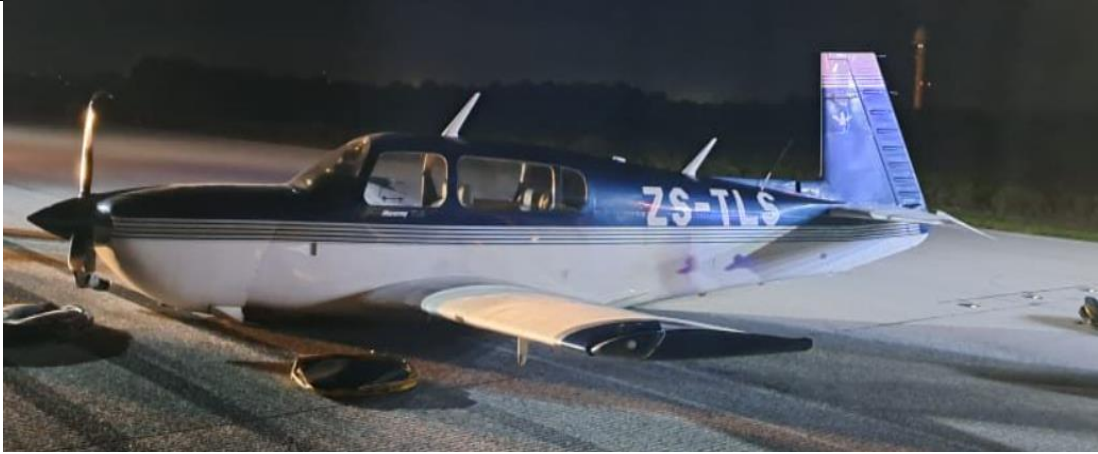
**Figure 2:** The aircraft at the accident site. (Source: Operator)

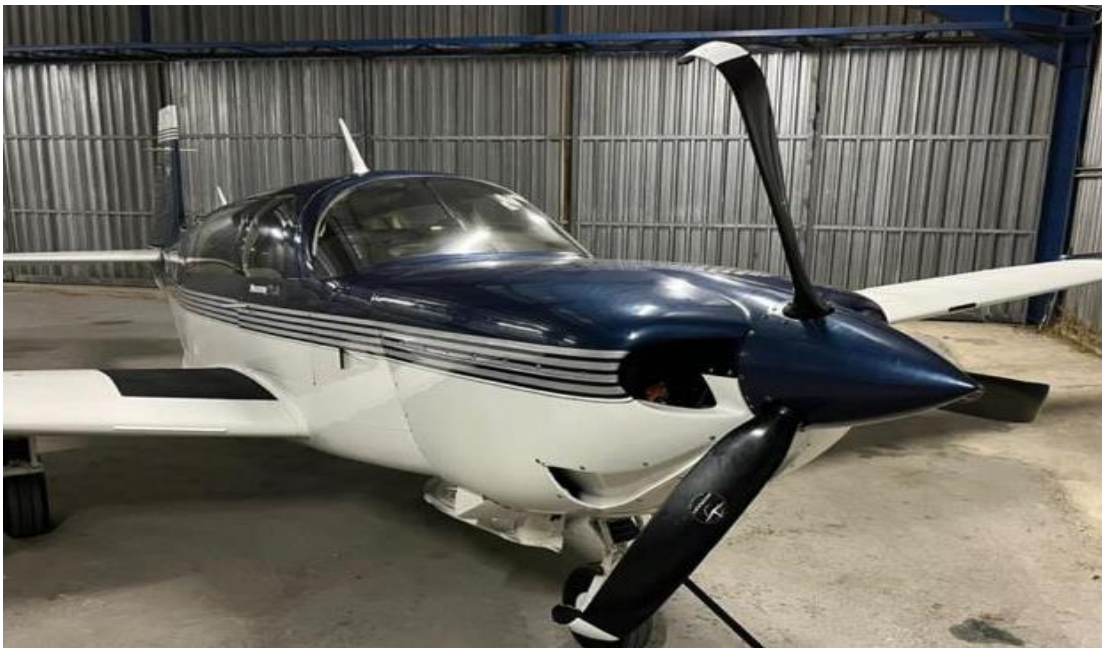
The aircraft sustained scratches to the underbelly skin and the landing gear doors; the propeller blades were bent at the tips. None of the occupants sustained any injuries during the accident sequence.

**Figure 3:** The bent propeller blades. (Source: Operator)

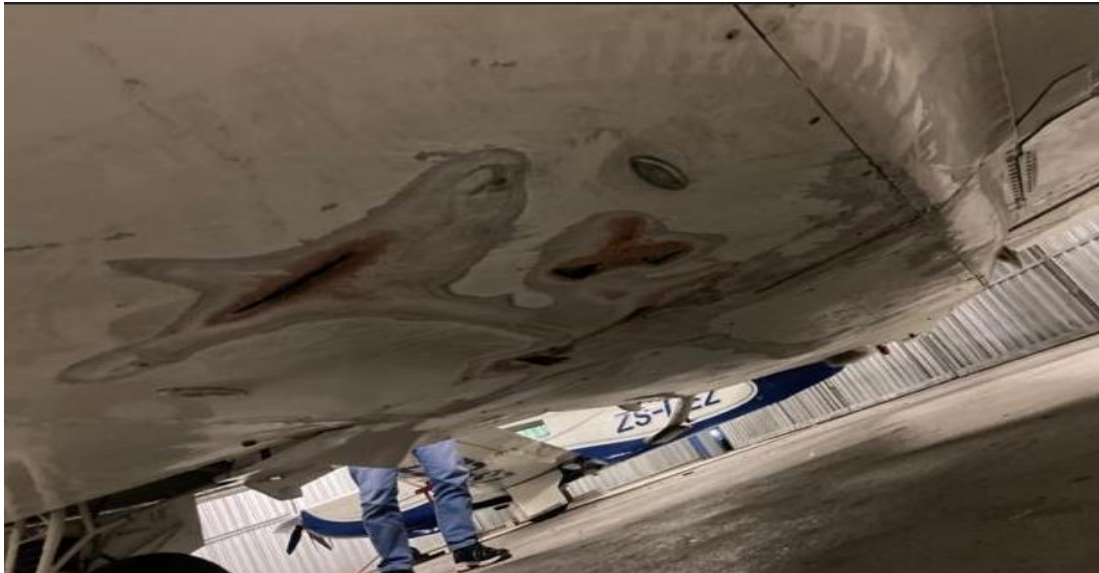
**Figure 4:** The scratched underbelly cover. (Source: Operator)
