LIMITED OCCURRENCE INVESTIGATION REPORT – FINAL

Reference Number	CA18/2/3/10205						
Classification	Accident	Date	11 August 2022		Time	2031Z	
Type of Operation	Training Flight (Part 141)						
Location							
Place of Departure	Beaufort West Aerodrome (FABW), Western Cape Province		Place of Intended Landing		Beaufort West Aerodrome (FABW), Western Cape Province		
Place of Occurrence	On Runway 08 at FABW in the Western Cape Province						
GPS Co-ordinates	Latitude	32° 18' 09.23" S	Longitude	22° 39' 58.61" E	Elevation	2 929 feet	
Aircraft Information							
Registration	ZS-SXS						
Make; Model; S/N	Piper; PA-28-161 Warrior II (Serial Number: 28-42385)						
Damage to Aircraft	Substantial			Total Aircraft Hours	6 226.2		
Pilot-in-command							
Licence Type	Commercial Pilot Licence (CPL)		Gender	Female		Age	26
Licence Valid	Yes	Total Hours	753.8		Total Hours on Type	242.3	
Total Hours 90 Days	113.6		Total Flying on Type Past 90 Days	3.7			
People On-board	2 + 0	Injuries	0	Fatalities	0	Other (on ground)	0

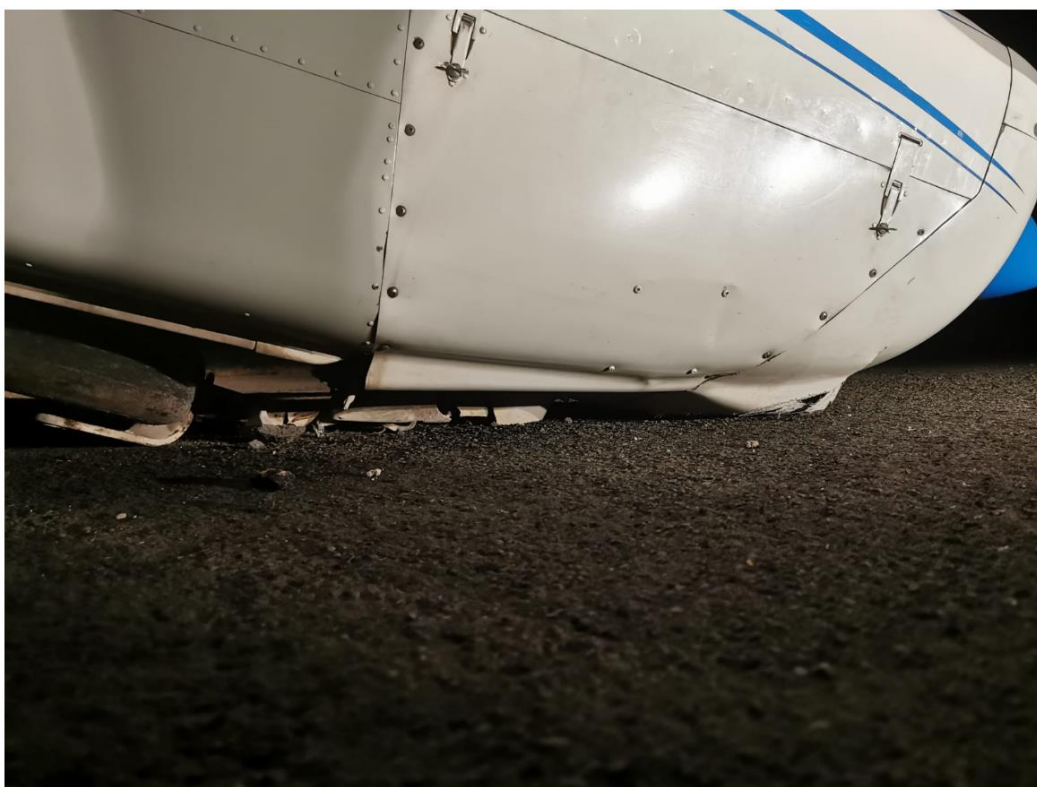
collapsed after touchdown. The aircraft veered off to the left of the runway before it came to a stop on the left-side of Runway 08. The aircraft sustained damage to the nose landing gear oleo, torque link and the bottom engine cowling. Both occupants were not injured during the accident sequence.

Figure 2: The collapsed nose landing gear. (Operator)

Probable Cause
The aircraft collided with an antelope during take-off, which led to the collapse of the nose landing gear during the landing roll; hence, the subsequent damage to the nose landing gear oleo, torque link and bottom engine cowling.
Contributing Factor
The boundary fence is not strong and high enough to prevent animals from accessing the aerodrome grounds.
Safety Action
The operator is currently investigating the option of installing infrared cameras to assist in spotting animal activity at night.
Safety Message
To avoid occurrences such as this one, Approved Training Organisations (ATOs) are advised to always ensure nighttime training is conducted at aerodromes with properly secured fencing to avoid unauthorised access to the aerodrome.
About this Report
<i>The decision to conduct a limited investigation is based on factors including whether the cause is known and the evidence supporting the cause is clear, the level of safety benefit likely to be obtained from an investigation and that will determine the scope of an investigation. For this occurrence, a limited investigation has been conducted, and the Accident and Incident Investigations Division (AIID) has relied on the information submitted by the affected person/s and organisation/s to compile this limited report. The report has been compiled using information supplied in the initial notification, as well as from follow-up desk top enquiries to bring awareness of potential safety issues to the industry in respect of this occurrence, as well as possible safety action/s that the industry might want to consider in preventing a recurrence of a similar occurrence.</i>

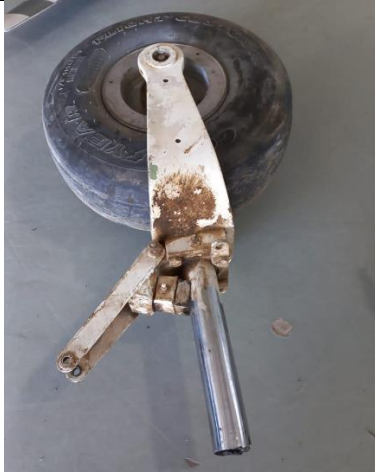
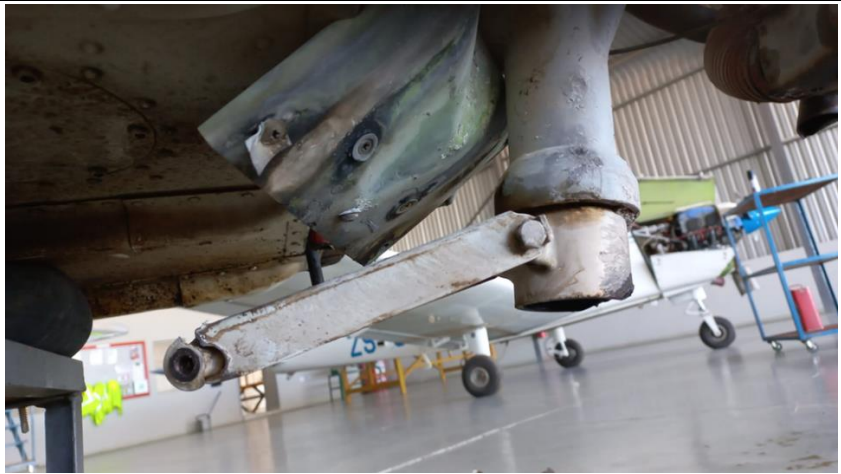
Figures 3 and 4: The separated nose gear wheel (left), and the severed oleo and torque link (right)
(Source: Operator)
