LIMITED OCCURRENCE INVESTIGATION REPORT – FINAL

Reference Number	CA18/2/3/10207						
Classification	Accident	Date	10 August 2022		Time	1540 Z	
Type of Operation	Private (Part 94)						
Location							
Place of Departure	Wonderboom Aerodrome (FAWB), Gauteng Province		Place of Intended Landing		Klerksdorp Aerodrome (FAKD), North West Province		
Place of Occurrence	Runway 29 (RWY29) at Orient Aerodrome (FAOI), Gauteng Province						
GPS Co-ordinates	Latitude	26° 02' 15.15" S	Longitude	027° 35' 33.94" E	Elevation	5100 ft	
Aircraft Information							
Registration	ZU-FNS						
Make; Model; S/N	Jabiru J430 (Serial Number: 791)						
Damage to Aircraft	Substantial			Total Aircraft Hours	438.0		
Pilot-in-command							
Licence Type	Private Pilot Licence (A)		Gender	Male		Age	64
Licence Valid	Yes	Total Hours	136.0		Total Hours on Type	2.8	
Total Hours 30 Days	4.5		Total Flying on Type Past 90 Days	4.5			
People On-board	1 + 0	Injuries	0	Fatalities	0	Other (on ground)	0

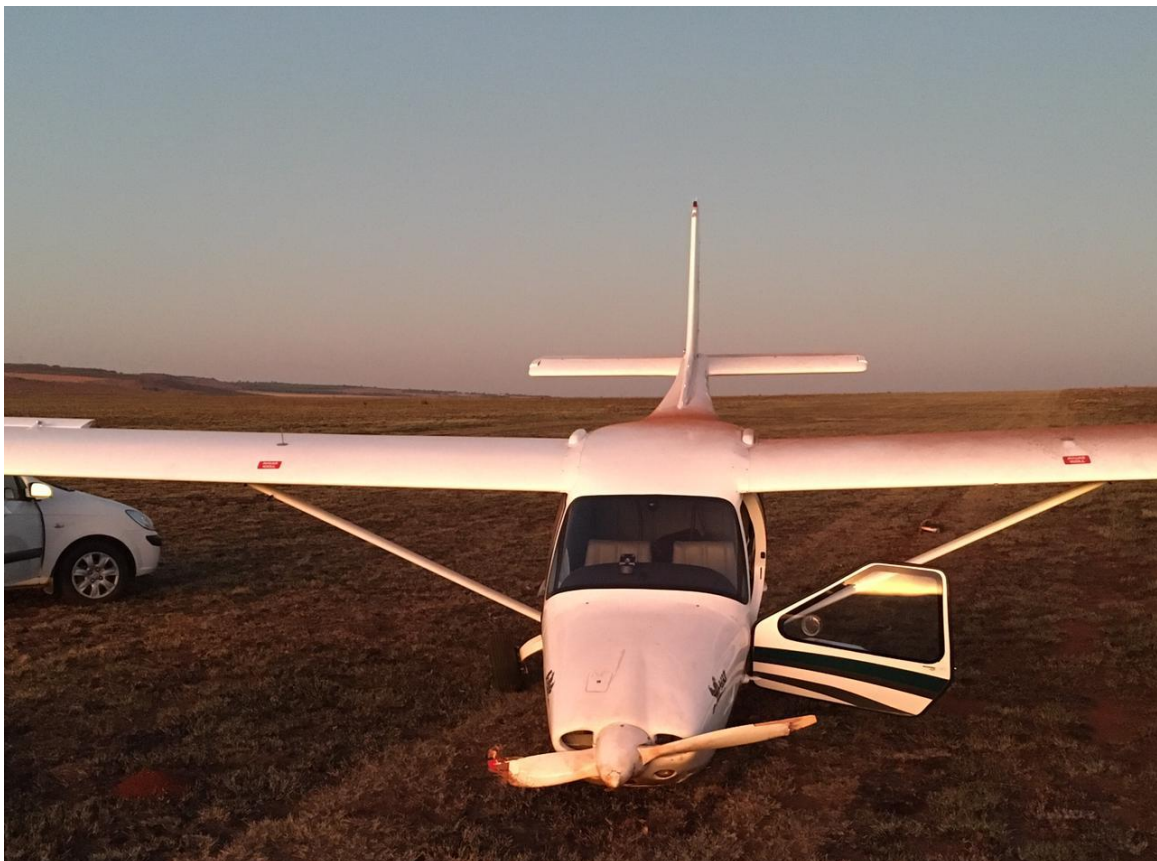
propeller struck the grass-covered runway surface before it came to a stop in a nose-down attitude. The pilot was not injured during the accident sequence; he disembarked the aircraft unassisted. The nose gear assembly and the propeller were substantially damaged.

Figure 2: The aircraft at the scene of the accident. (Source: Pilot)

The aircraft approached at a high speed, which led to the aircraft ballooning during the flare; this was followed by a nose-first hard landing.

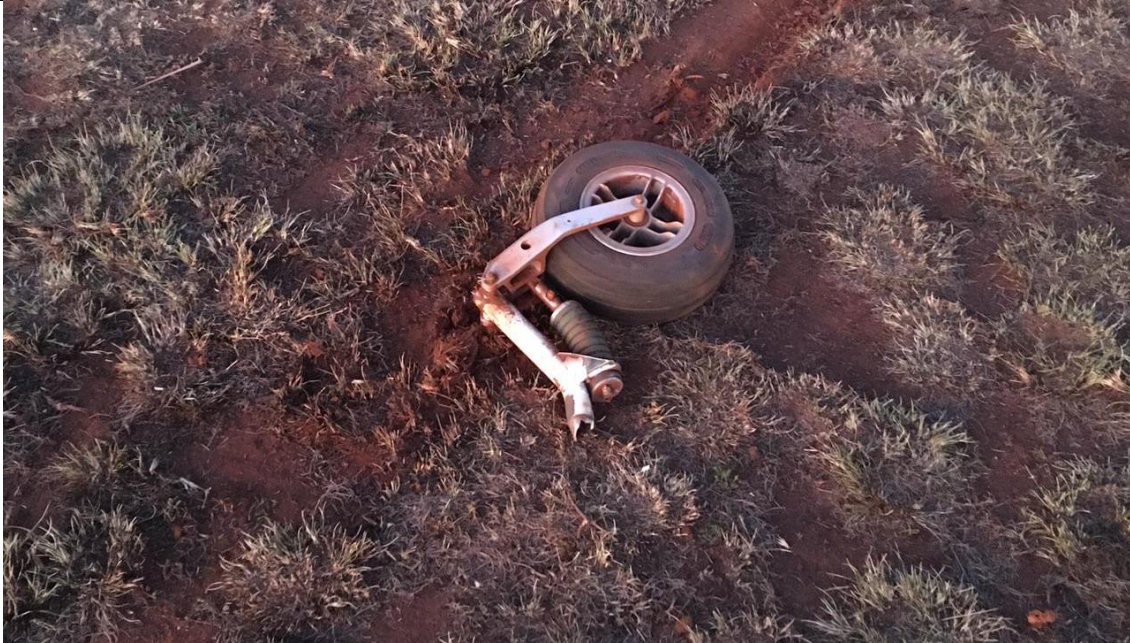
Figure 3: The detached nose gear assembly. (Source: Pilot)
