LIMITED OCCURRENCE INVESTIGATION REPORT – FINAL

Reference Number	CA18/2/3/10208						
Classification	Accident	Date	14 August 2022	Time	1200Z		
Type of Operation	Private (Part 94)						
Location							
Place of Departure	Brakpan Airfield (FABB), Gauteng Province		Place of Intended Landing	Brakpan Airfield (FABB), Gauteng Province			
Place of Occurrence	Runway 18 at Brakpan Airfield (FABB)						
GPS Co-ordinates	Latitude	26°14'00.85"S	Longitude	28°17'59.03" E	Elevation	5383 ft	
Aircraft Information							
Registration	ZU-RGV						
Make; Model; S/N	Auto-Gyro GmbH (Serial Number: ZA 10S10)						
Damage to Aircraft	Substantial			Total Aircraft Hours	343.6		
Pilot-in-command							
Licence Type	National Pilot Licence (NPL) & Airline Transport Pilot Licence (ATPL)		Gender	Male	Age	65	
Licence Valid	Yes	Total Hours	19 095.0	Total Hours on Type	115.0		
Total Hours Past 90 Days	60.0		Total Hours on Type Past 90 Days	5.0			
People On-board	1 + 1	Injuries	0	Fatalities	0	Other (on ground)	0

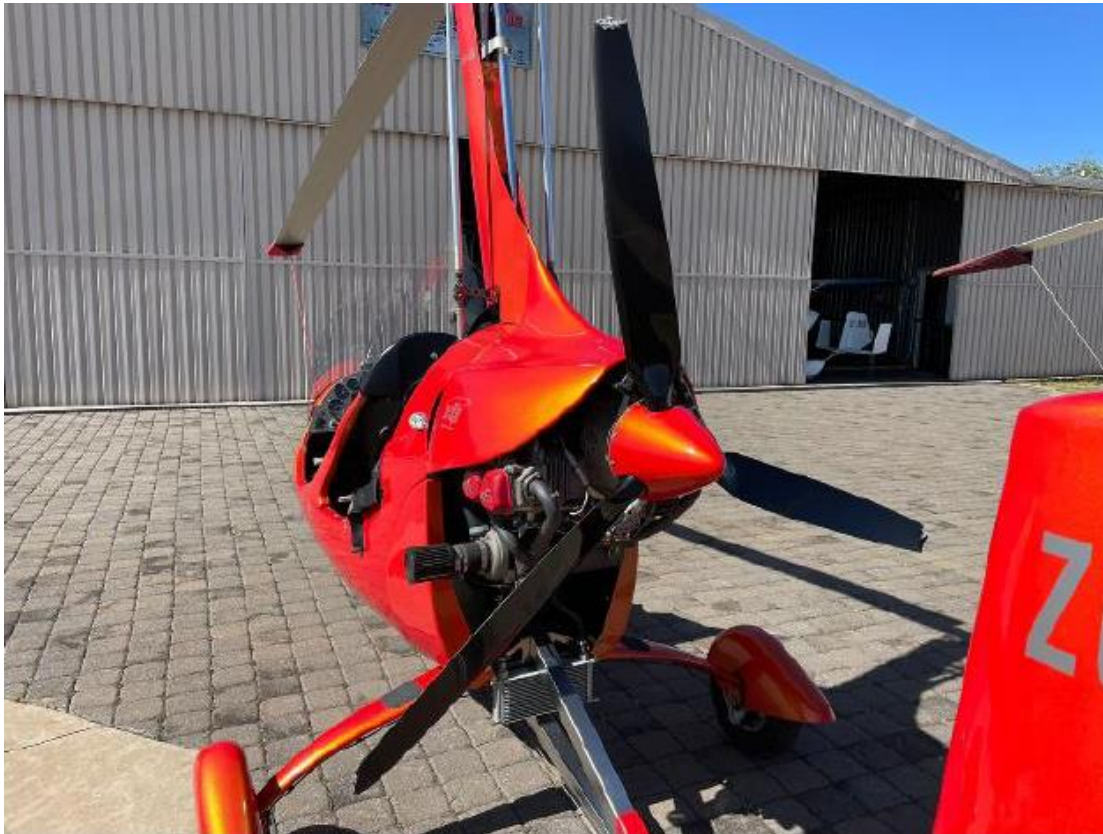
Figure 2: Damaged propeller blade tips. (Source: Pilot)

2.8	The POH states that the gyrocopter must be rotated at 200 rotor RPM; however, the pilot rotated the gyrocopter at 120 rotor RPM.
Probable Cause	
The gyrocopter was rotated at low rotor RPM, which caused the main rotor blades to tilt to the far-aft position beyond the take-off operational angle; this resulted in the main rotor blades contacting the propeller blades and the tail section (rudder) of the gyrocopter.	
Contributing Factors	
<ul style="list-style-type: none"> • Incorrect take-off technique. • Pilot's limited experience on the gyrocopter. 	
Safety Action	
None.	
Safety Message and/or Safety Recommendation/s	
None.	
About this Report	
<p><i>The decision to conduct a limited investigation is based on factors, including whether the cause is known and the evidence supporting the cause is clear, the level of safety benefit likely to be obtained from an investigation and that will determine the scope of an investigation. For this occurrence, a limited investigation has been conducted, and the Accident and Incident Investigations Division (AIID) has relied on the information submitted by the affected person/s and organisation/s to compile this limited report. The report has been compiled using information supplied in the initial notification, as well as from follow-up desk top enquiries to bring awareness of potential safety issues to the industry in respect of this occurrence, as well as possible safety action/s that the industry might want to consider in preventing a recurrence of a similar occurrence.</i></p> <p><i>All times given in this report are Co-ordinated Universal Time (UTC) and will be denoted by (Z). South African Standard Time is UTC plus 2 hours.</i></p>

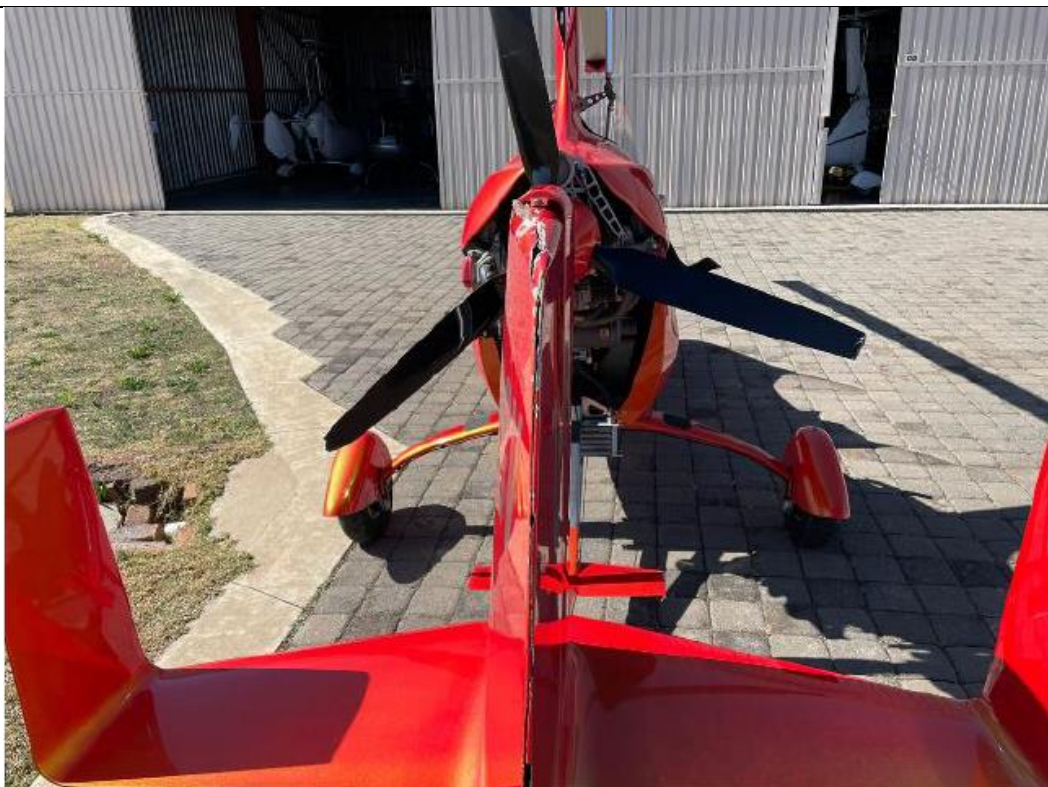
Figure 3: Damaged rudder. (Source: Pilot)
