**LIMITED OCCURRENCE INVESTIGATION REPORT – FINAL**

<b>Reference Number</b>	CA18/2/3/10210						
<b>Classification</b>	Accident	<b>Date</b>	28 June 2022	<b>Time</b>	0737Z		
<b>Type of Operation</b>	Aerial Survey (Part 101)						
<b>Location</b>							
Place of Departure	Groote Schuur Hospital, Western Cape Province		Place of Intended Landing	Groote Schuur Hospital, Western Cape Province			
Place of Occurrence	Groote Schuur Hospital, Western Cape Province						
GPS Co-ordinates	Latitude	33° 56' 28.47" S	Longitude	18° 27' 41.83" E	Elevation	197 ft	
<b>Aircraft Information</b>							
Registration	ZT-UKZ						
Make; Model; S/N	DJI Phantom 4 PRO; (Serial Number: OAXDECD00S1736)						
Damage to Aircraft	Substantial		Total Aircraft Hours	122.36			
<b>Pilot-in-command</b>							
Licence Type	Remote Pilot Licence (RPL)		Gender	Male	Age	57	
Licence Valid	Yes	Total Hours	254.42	Total Hours on Type	245.30		
Total Hours 90 Days	12.07		Total Flying on Type Past 90 Days	9.08

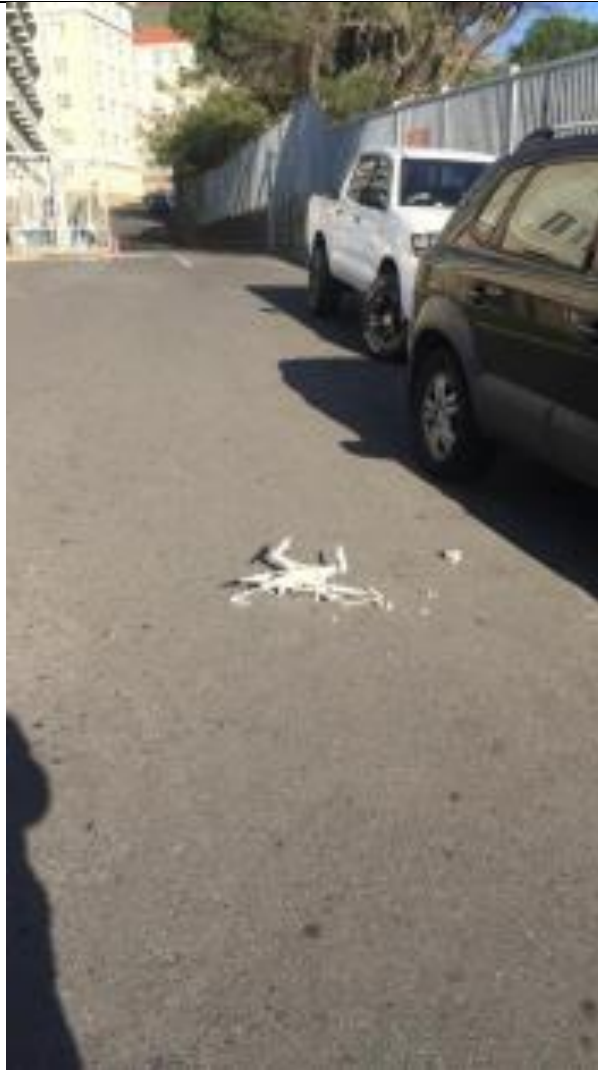
The pilot stated that he lost sight of the RPA even though it was suspected to have been approximately 150 metres (m) to 200m from his position. The pilot attempted to re-establish connection but without success. He deduced that the RPA might have crashed. The RPA was located on one of the roads in the hospital; it had 28% battery power remaining at the time of the accident.

**Figure 2:** The RPA at the accident site. (Source: Pilot)

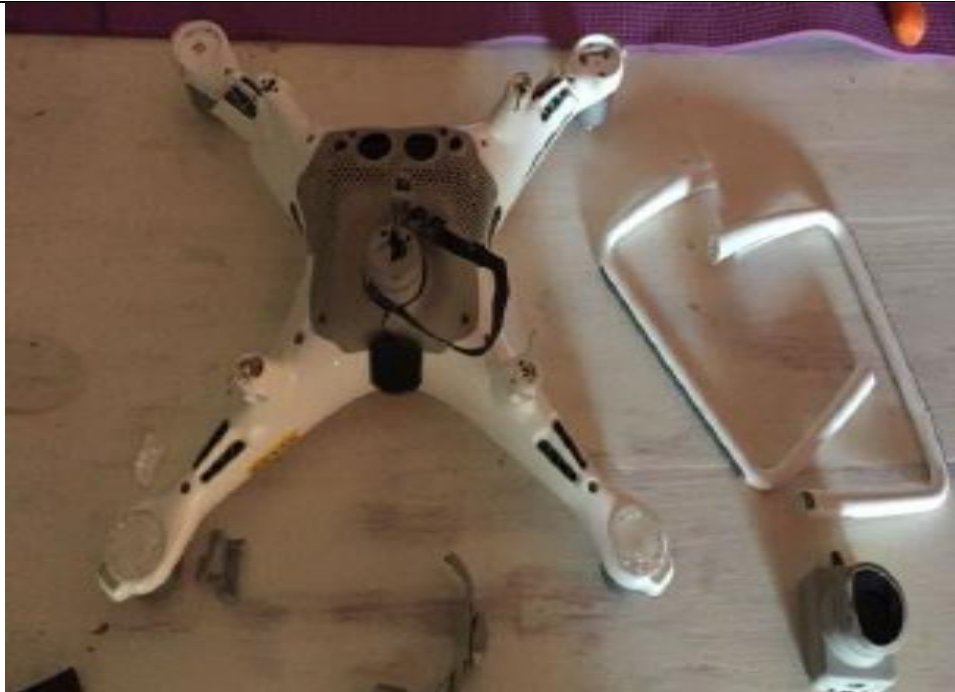
The RPA sustained damage to the landing gear, camera, gimbal mount and body during the accident sequence. No people on the ground were injured and there was no damage to property.

**Figure 3:** The damaged RPA post-accident. (Source: Pilot)

During a surveillance flight, the control and command link between the RPA and the pilot was lost, and the RPA crashed; the cause of loss of control and command link could not be determined.
