LIMITED OCCURRENCE INVESTIGATION REPORT – FINAL

Reference Number	CA18/2/3/10211						
Classification	Accident	Date	23 August 2022		Time	0949Z	
Type of Operation	Training (Part 141)						
Location							
Place of Departure	Port Elizabeth International Airport (FAPE), Eastern Cape Province		Place of Intended Landing		Port Elizabeth International Airport (FAPE), Eastern Cape Province		
Place of Occurrence	On Runway 08 at Port Elizabeth International Airport (FAPE)						
GPS Co-ordinates	Latitude	33° 59' 20.3" S	Longitude	025° 36' 34.1" E	Elevation	226ft	
Aircraft Information							
Registration	ZU-FUS						
Make; Model; S/N	The Airplane Factory; Sling 2 (Serial Number: 080)						
Damage to Aircraft	Substantial			Total Aircraft Hours	6652.3		
Pilot-in-command							
Licence Type	Student Pilot Licence (SPL)		Gender	Male		Age	21
Licence Valid	Yes	Total Hours	23.2		Total Hours on Type	23.2	
Total Hours 30 Days	10.8		Total Flying on Type Past 90 Days		10.8

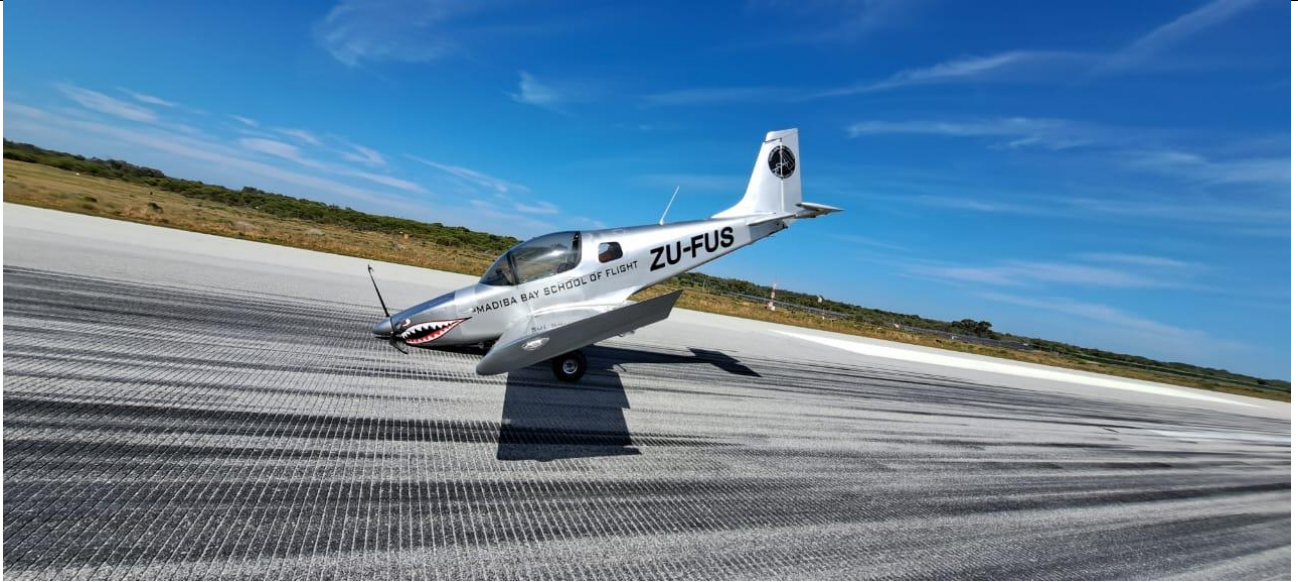
Figure 1: The aircraft as it came to rest. (Source: Pilot)

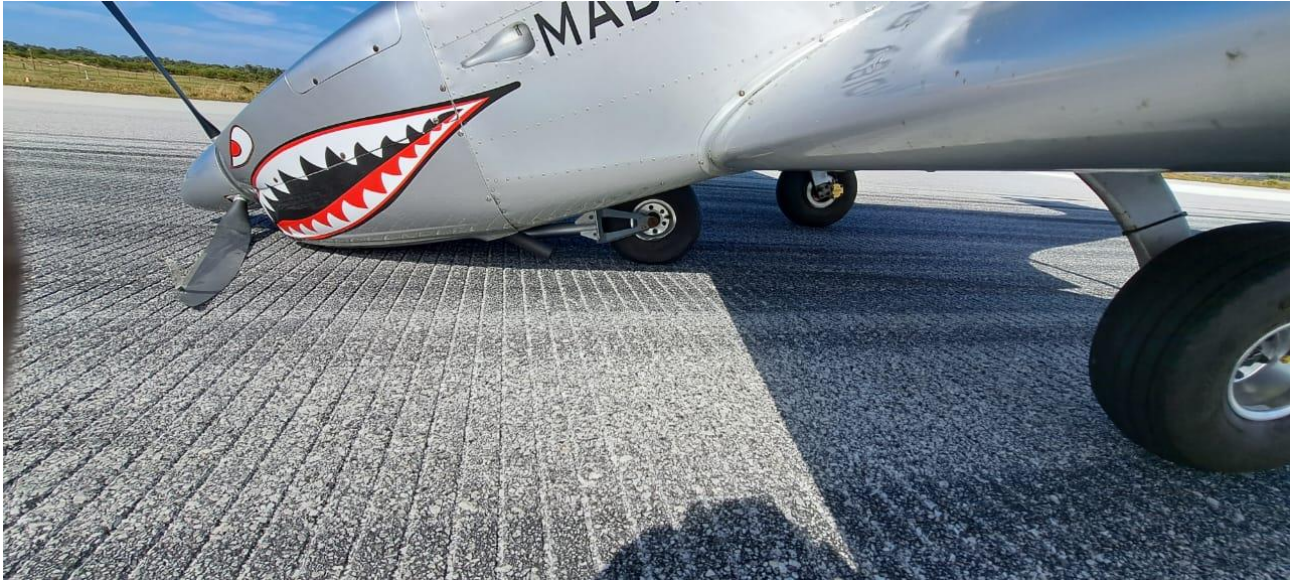
Figure 2: The bent nose gear and the damaged propeller. (Source: Pilot)

The aircraft was unstable on approach, which led to a bounce and a hard landing; as a result, the nose gear bent backward.
