LIMITED OCCURRENCE INVESTIGATION REPORT – FINAL

Reference Number	CA18/2/3/10212					
Classification	Accident	Date	6 October 2022	Time	1515Z	
Type of Operation	Private (Part 94)					
Location						
Place of Departure	Potchefstroom Aerodrome (FAPS), North West Province		Place of Intended Landing	Potchefstroom Aerodrome (FAPS), North West Province		
Place of Occurrence	On a private farm, approximately 20 kilometres (km) north-west of Klerksdorp Aerodrome (FAKD)					
GPS Co-ordinates	Latitude	26° 42'. 17" S	Longitude	26° 37'. 17" E	Elevation	4352 ft
Aircraft Information						
Registration	ZS-GKL					
Make; Model; S/N	LS1 Glider (Serial Number: 77)					
Damage to Aircraft	Substantial		Total Aircraft Hours	1877		
Pilot-in-command						
Licence Type	Glider Student Pilot Licence (GSPL)		Gender	Male	Age	24
Licence Valid	Yes	Total Hours	660	Total Hours on Type	660	
Total Hours Past 30 Days	5.5		Total Hours on Type Past 90 Days		60	
People On-board	1+0	Injuries	0	Fatalities	0	Other (on ground) 0

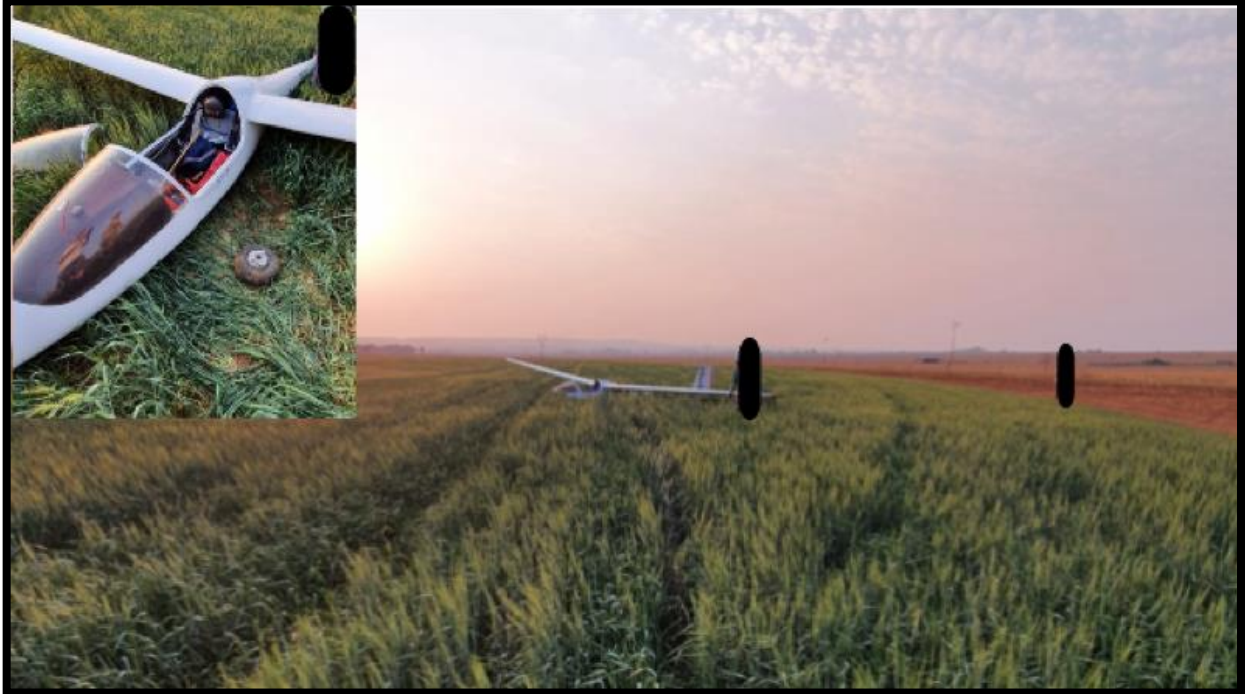
Figure 1: The glider came to a stop on a maize crop field. Inset shows some of the damaged crops.
(Source: Operator)

Rapid loss of height in-flight because of lack of thermals, which prompted the pilot to perform an off-field landing on a maize field. This resulted in substantial damage to the glider.
