LIMITED OCCURRENCE INVESTIGATION REPORT – FINAL

Reference Number	CA18/2/3/10213					
Classification	Accident	Date	24 August 2022	Time	0815Z	
Type of Operation	Private (Part 94)					
Location						
Place of Departure	George Aerodrome (FAGG), Western Cape Province		Place of Intended Landing	Douglas Airfield (FADC), Northern Cape Province		
Place of Occurrence	Runway 08 at Beaufort West Aerodrome					
GPS Co-ordinates	Latitude	32° 18' 00.00"S	Longitude	022° 40' 00.00"E	Elevation	2929 ft
Aircraft Information						
Registration	ZU-TDH					
Make; Model; S/N	Shadow Lite; Jabiru J 230 (Serial Number: 988)					
Damage to Aircraft	Substantial		Total Aircraft Hours	5.0		
Pilot-in-command						
Licence Type	National Pilot Licence (NPL)		Gender	Male	Age	74
Licence Valid	Yes	Total Hours	1487.4	Total Hours on Type	5.3	
Total Hours 30 Days	2.9		Total Flying Hours on Type Past 90 Days		5.3	
People On-board	1+0	Injuries	0	Fatalities	0	Other (on ground) 0
What Happened

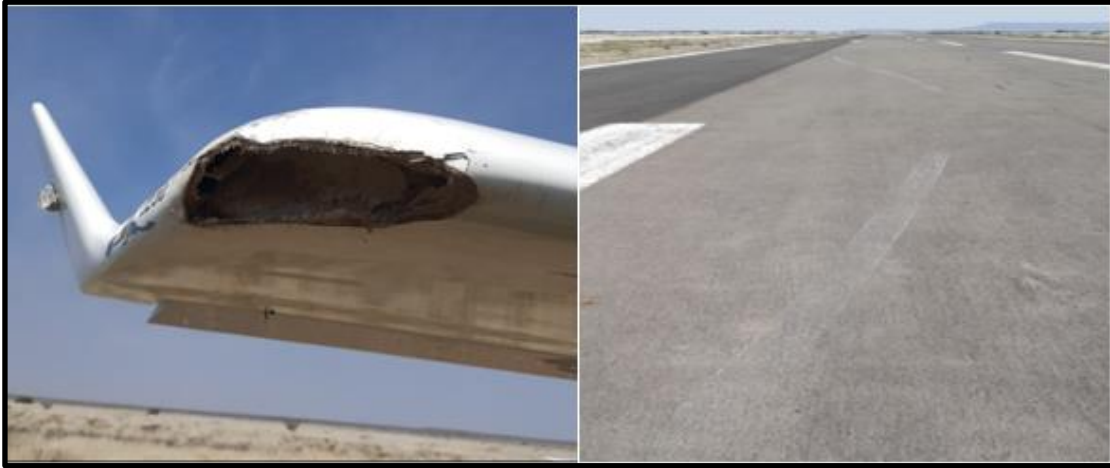
Figure 1: Damage to the right-wing tip (left) and the wing scrape marks on the runway surface (right).

The aircraft landed in strong wind conditions, which led to loss of control; subsequently, the right-wing tip scraped the runway surface during the landing roll.

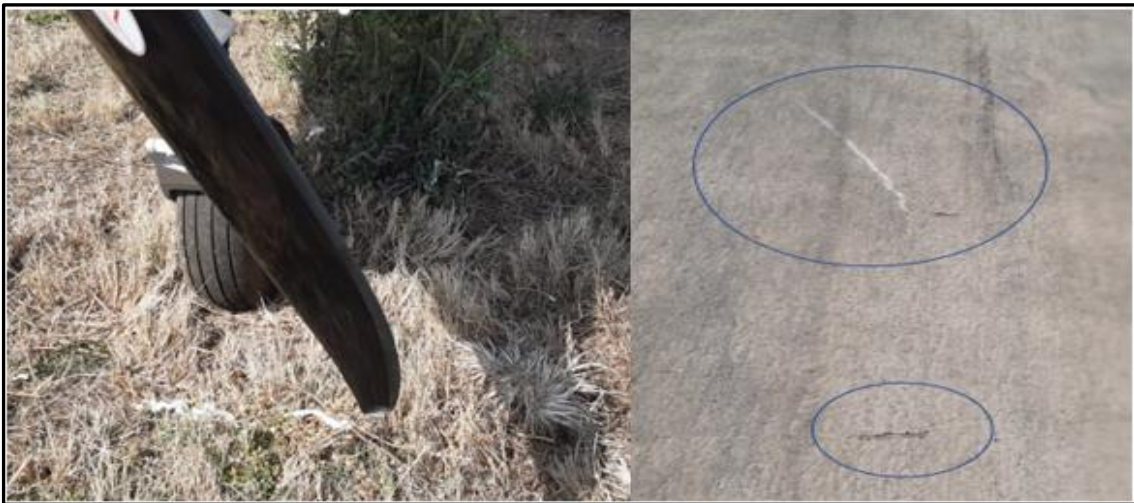
Figure 2: Damage on one of the propeller blades tip (left), and the propeller strike marks on the runway surface (right).

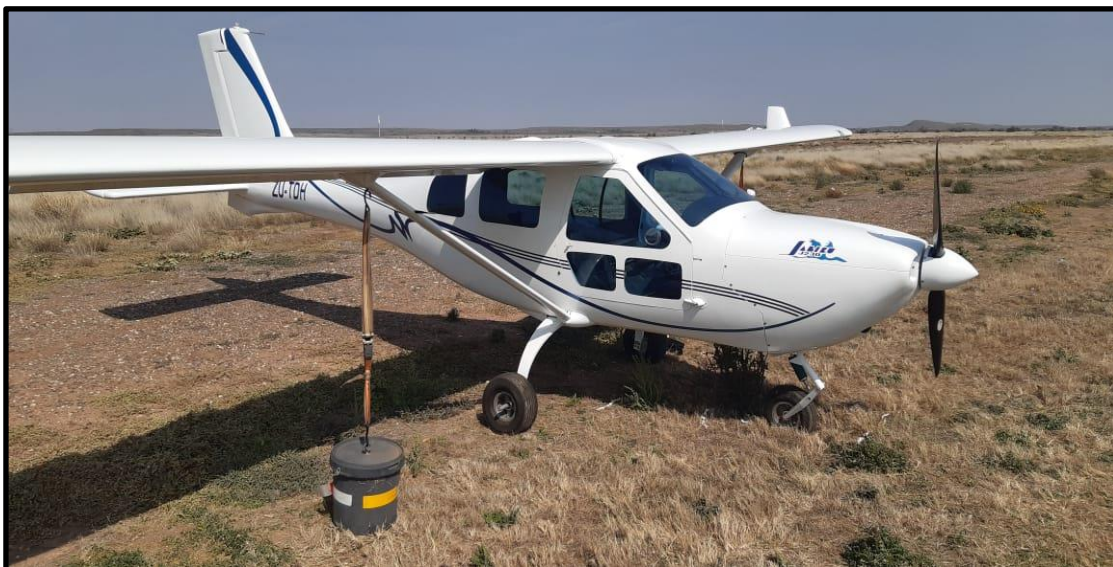
Figure 3: The aircraft after the accident.
